Crystal River Nuclear Plant
Docket No. 50-302
Operating License No. DPR-72

Subject: LICENSEE EVENT REPORT (LER) 50-302/01-004-00

Reactor Pressure Vessel Head Leakage Due to Control Rod Drive Mechanism (CRDM) Nozzle Degradation

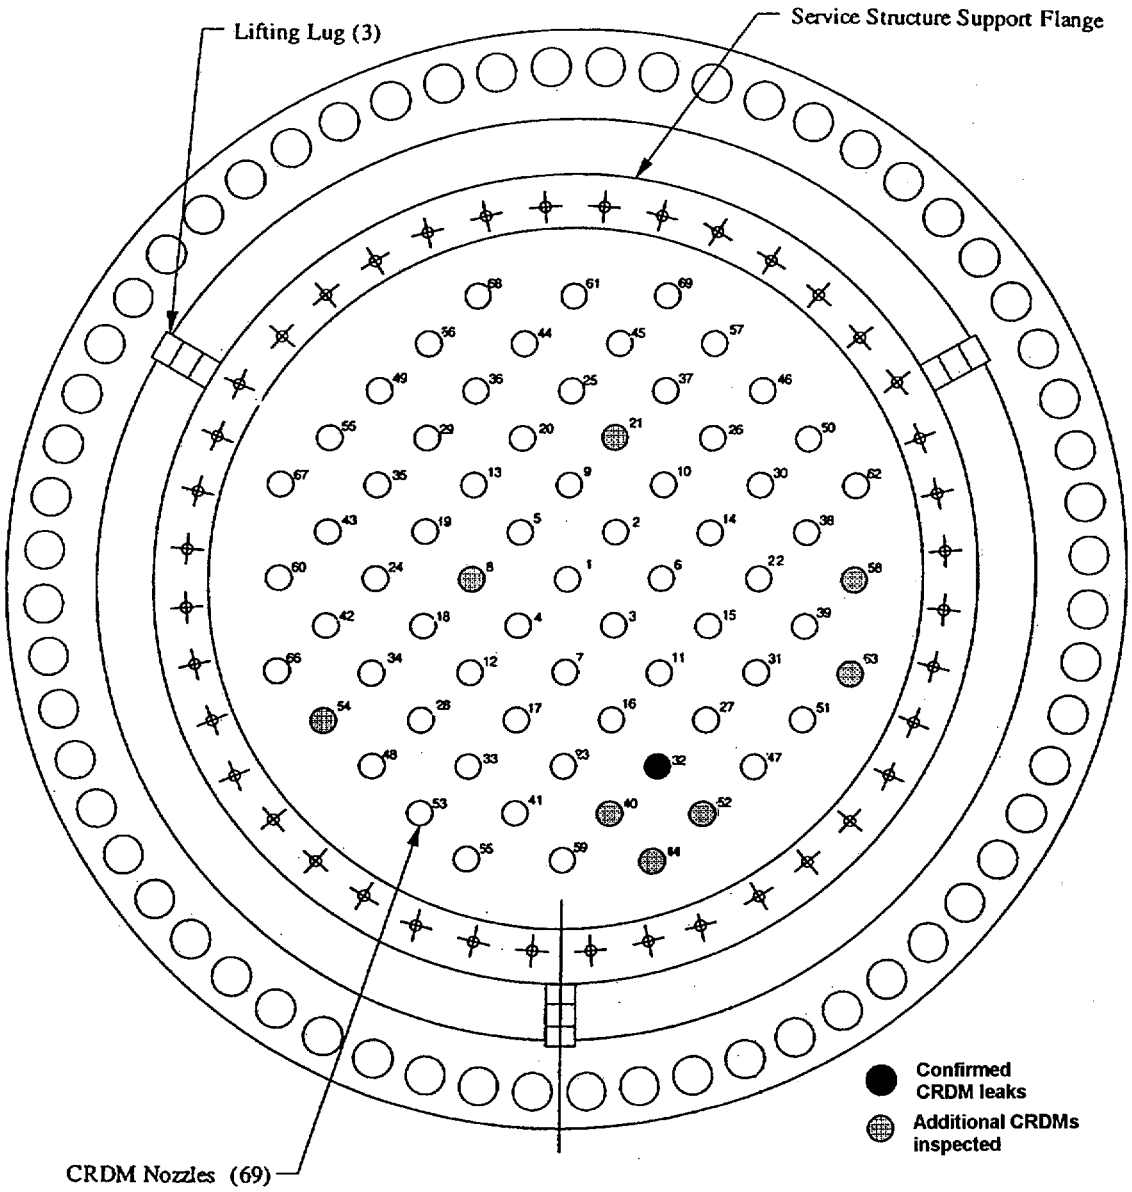
Figure 1

There are 69 Control Rod Drive Mechanism (CRDM) nozzles [AB, NZL] that penetrate the Reactor Vessel Head (RVH) [AB, RCT] (see Figure 1). The CRDM nozzles are approximately 5 feet long and are welded to the RVH at various radial locations from the centerline of the RVH. The nozzles are constructed from 4 inch outside diameter (OD) alloy 600 material. The lower end of the nozzle extends about 6 inches below the inside of the RVH.

Eight (8) CRDM's that were removed to support CRDM maintenance activities were inspected using UT. The locations of the eight additional nozzle inspections were 8 (L2), 21 (G5), 40 (G13), 52 (E13), 54 (O11), 58 (B8), 63 (B10), and 64 (F14). The results of the additional UT's indicated that there were no recordable indications in the eight CRDM nozzles inspected.
