EA No. 00-179

SUBJECT: NRC SPECIAL INSPECTION REPORT 05000247/2000-010
STEAM GENERATOR TUBE FAILURE

IR 05000247-00-010, March 7 thru July 20, 2000; Consolidated Edison of New York, Inc.; Indian Point Unit 2; Special Team Inspection reviewing the causes for the February 15, 2000, steam generator tube failure, in accordance with NRC Inspection Procedure 93812. Findings in steam generator eddy current test examination program corrective actions and technique qualification.

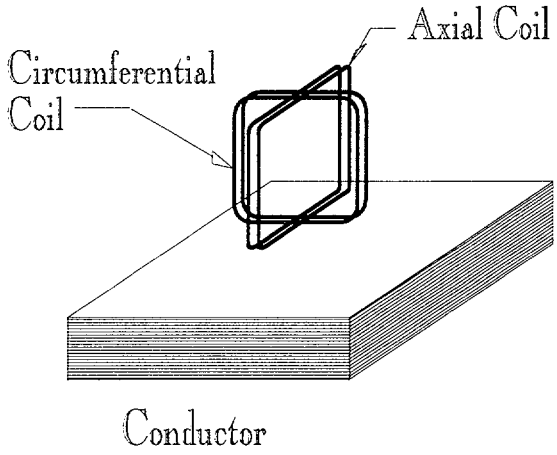
Figure 2 Directional pancake probe

Single coil probes as shown in Figure 2 will induce the eddy current in only one direction, which is a compressed mirror image of the current in the coils. If the defect is not in the direction which interrupts the eddy current flow (parallel to the defect direction rather than perpendicular to the current flow), then that particular coil will not detect the defect. Specially designed ECT probes can classify defects as axial cracks, circumferential cracks or both.

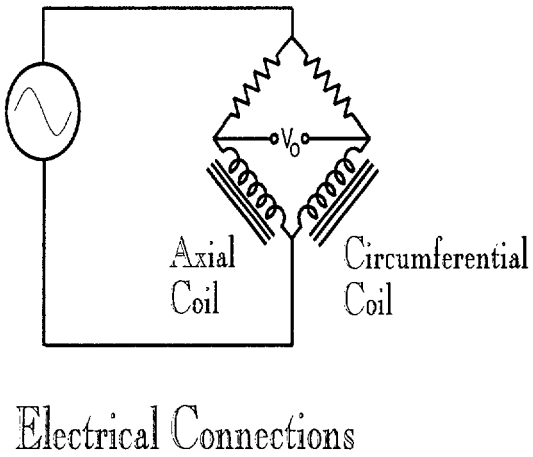
Figure 3 Plus Point probe

The Plus Point probe consists of two coils wound at 90 degrees to each other, as shown in Figure 3. The coils are mounted on a shoe that rotates as it passes through the tube to allow a complete examination. The turns of the two coils are interleaved so that both are effectively the same distance from the surface of the conductor. The coils are connected in a bridge circuit, as shown in Figure 4, and the voltage difference between the two signals is amplified. The two coils allow the scanning for both axial and circumferential defects. The mid-range Plus Point probe used during the 1997 examination is a multifrequency probe, operating at 10, 100, 300, and 400 kHz.

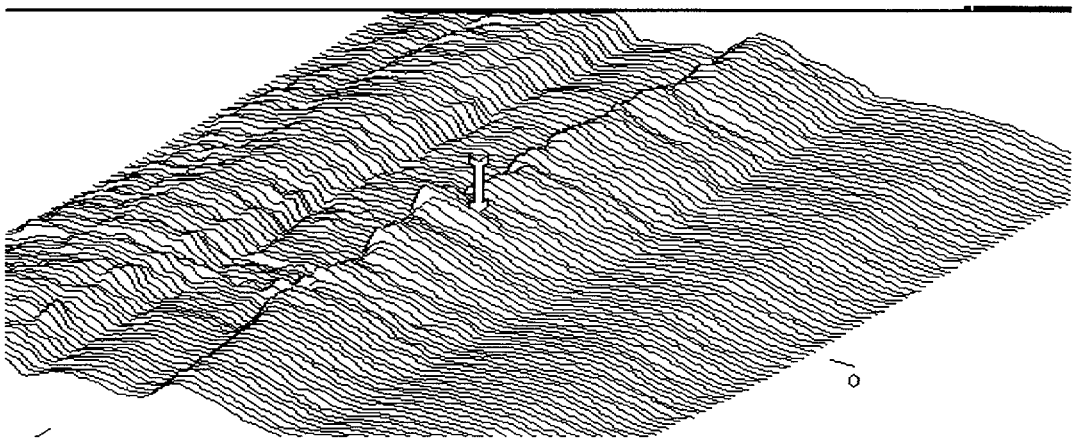
Figure 5 R2C5C-scan with1997 phase setting.

1. R2C5 in SG 24 - Figure 5 is a c-scan plot of the vertical component of the ECT voltage signal. The defect signal, indicated by the arrow, sits on a noise ridge that runs the length of the tube. This noise ridge is about 1-volt in amplitude and measures as a deep ID defect. This ridge makes both the detection and sizing of this defect more difficult. Figures 6 and 7 are the lissajous plots for the flaw area and the noise ridge, respectively. These figures show that a flaw signal is distinguishable from the characteristic noise signal, as was the case in the other tubes profiled. No year 2000 data is available since the tube failed.

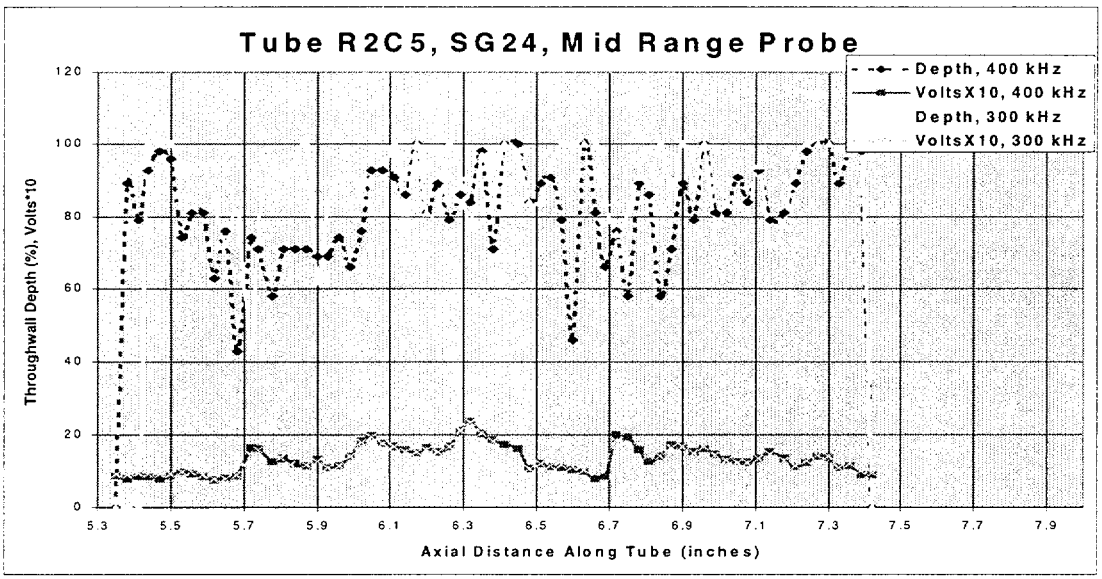
The indication has been profiled for both the 300- and 400-kHz inspection frequencies, as is shown in Figure 4. The signal-to-noise ratio is slightly better for the 400-kHz frequency than for the 300-kHz . The voltage above 1.2-volts indicates the defect; however, there is considerable noise. The depth estimate based on 1997 data is 87-percent TW.

Figure 8 - Contour of the crack in tube R2C5 in SG24 using the 1997 data from the mid-range plus-point probe.

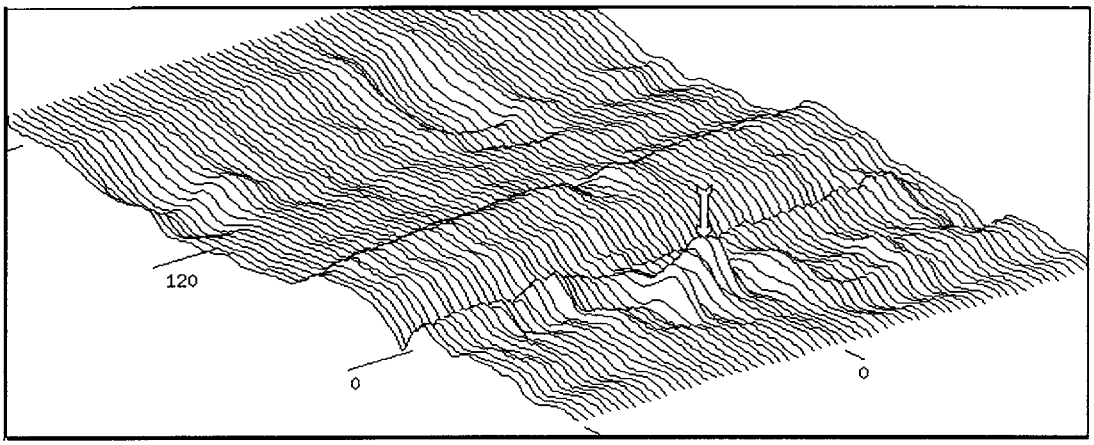
Figure 9 - 1997Mid- range scan .

2. R2C69 in SG 24 - Figure 9 shows the c-scan plot for the 1997 data. There is considerable noise present. For comparison, the c-scan plot for the 2000 data is included as Figure 10. The noise features between the 1997 and 2000 data are similar enough to verify that this is the same defect at the same location. Figure 11 shows the profile. The defect voltage is only about 1 volt, and there is a considerable amount of noise on the tube, relative to the defect signal. The depth estimate based on 1997 data is 52.6-percent TW.

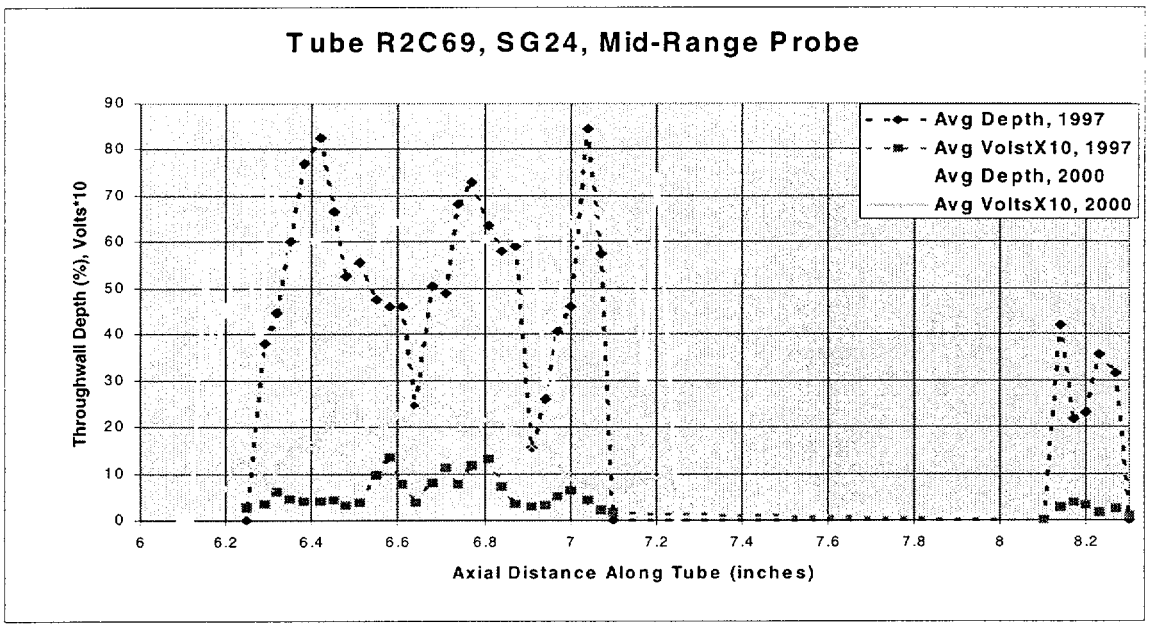
Figure 11 - Profile of Growth between 1997 and 2000

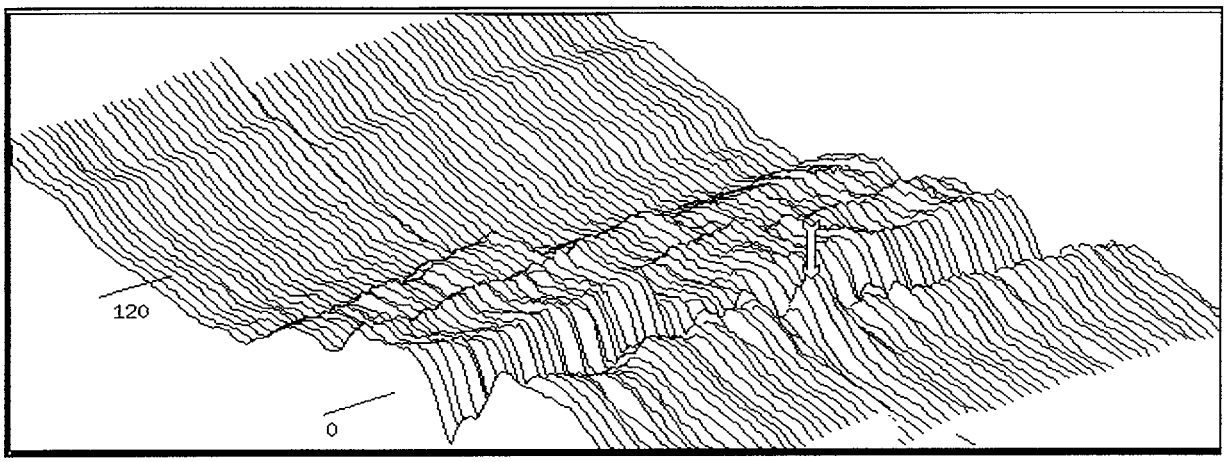
Figure 12 - 1997 scan

3. R2C72 in SG 24 - Figure 12 shows the c-scan plot of the 1997 data. There is considerable noise present. The crack is sitting in a ridge of noise and barely extends above a ridge of deposits. For comparison, the c-scan plot for the 2000 data is included as Figure 13. Figure 14 shows the profile. The crack barely extends above a 1-volt amplitude for a short length, and this is the only part of the crack that can be profiled reliably. The depth estimate based on 1997 data is 79.2-percent TW.

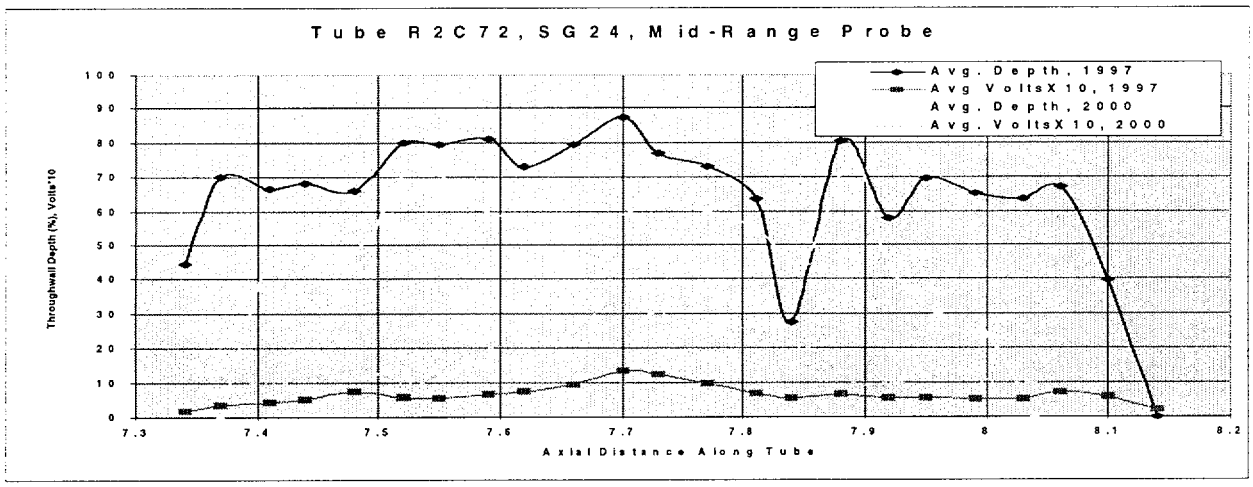
Figure 14 Profile of crack growth of tube R2 C72 of SG24 between 1997 and 2000

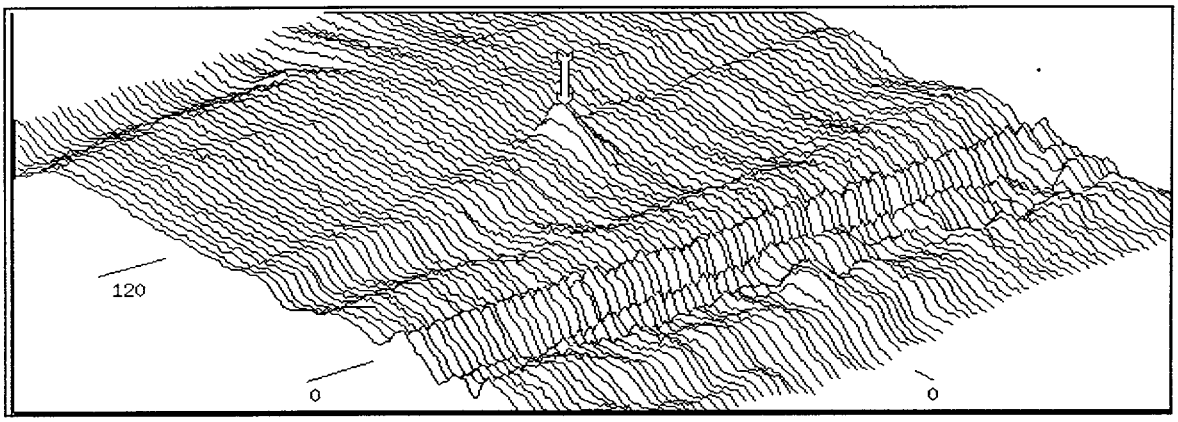
Figure 15 - 1997 scan

4. R2C87 in SG 21 - this tube was identified as having several cracks. Figure 15 shows the c-scan plot of the 1997 data. The most prominent crack is sitting in a relatively clean area of the tube. For comparison, the c-scan plot for the 2000 data is included as Figure 16. Figure 17 shows the profile of the most prominent crack. The depth estimate based on 1997 data is 63.7-percent TW.

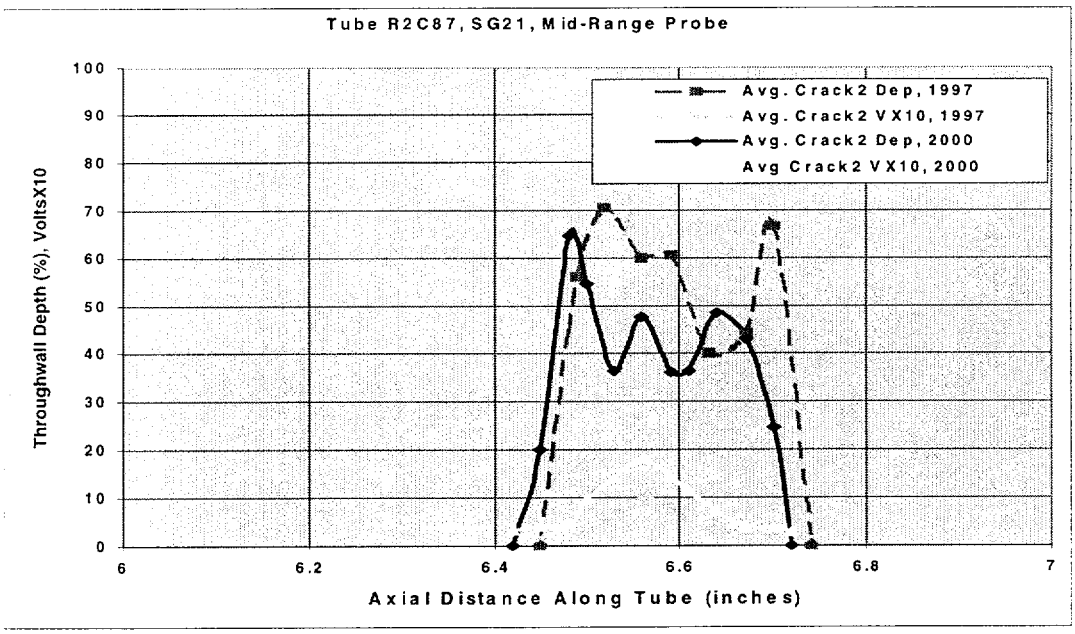
Figure 17- Profile of crack growth of tube R2 C87.

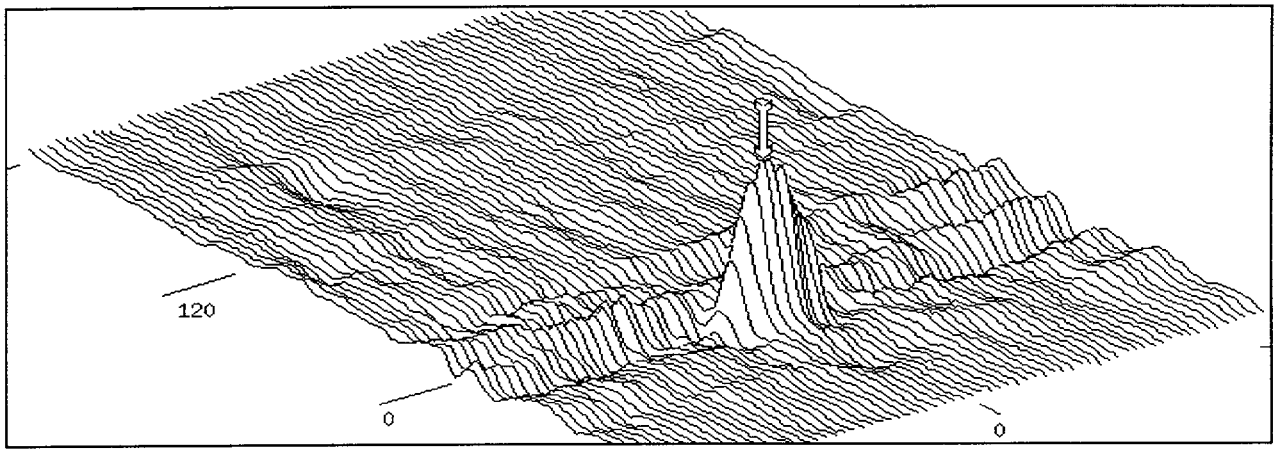
The c-scan plot of the 1997 data from R2C67 is shown in Figure 18. The crack sits beside a ridge, in a valley, and is in an easily detectable portion of the tube. The large amplitude of the voltage signal, in relation to the standard calibration notch, would indicate that this is a "mature" crack. No year 2000 data is available since the tube was plugged in 1997. Figure 19 shows the profile. The depth estimate based on 1997 data is 87.5-percent TW.

While the flaw was identified and the tube plugged, neither Con Edison nor its ECT contractor recognized the discovery of the low-row U-bend apex indication as a significant condition adverse to quality and did not enter the issue into its corrective action program. Identification of this flaw was significant, because it was the first observation of this type of degradation in the U-bend area in SG tubes at Indian Point 2. There was no specific review as to the significance of this flaw or the possible extent of the condition.

Figure 18 - Crack in tube 2-67 of steam generator 24, found in 1997.
