Subject: Beaver Valley Power Station, Unit No. 1
BV-1 Docket No. 50-334, License No. DPR-66
Supplemental Response to Bulletin 2002-01, Reactor Pressure Vessel Head Degradation and Reactor Coolant Pressure Boundary Integrity

Attachment A
BVPS Supplemental Response to NRC Bulletin 2002-01

Figure 1
BV- 1 Reactor Vessel Head Map

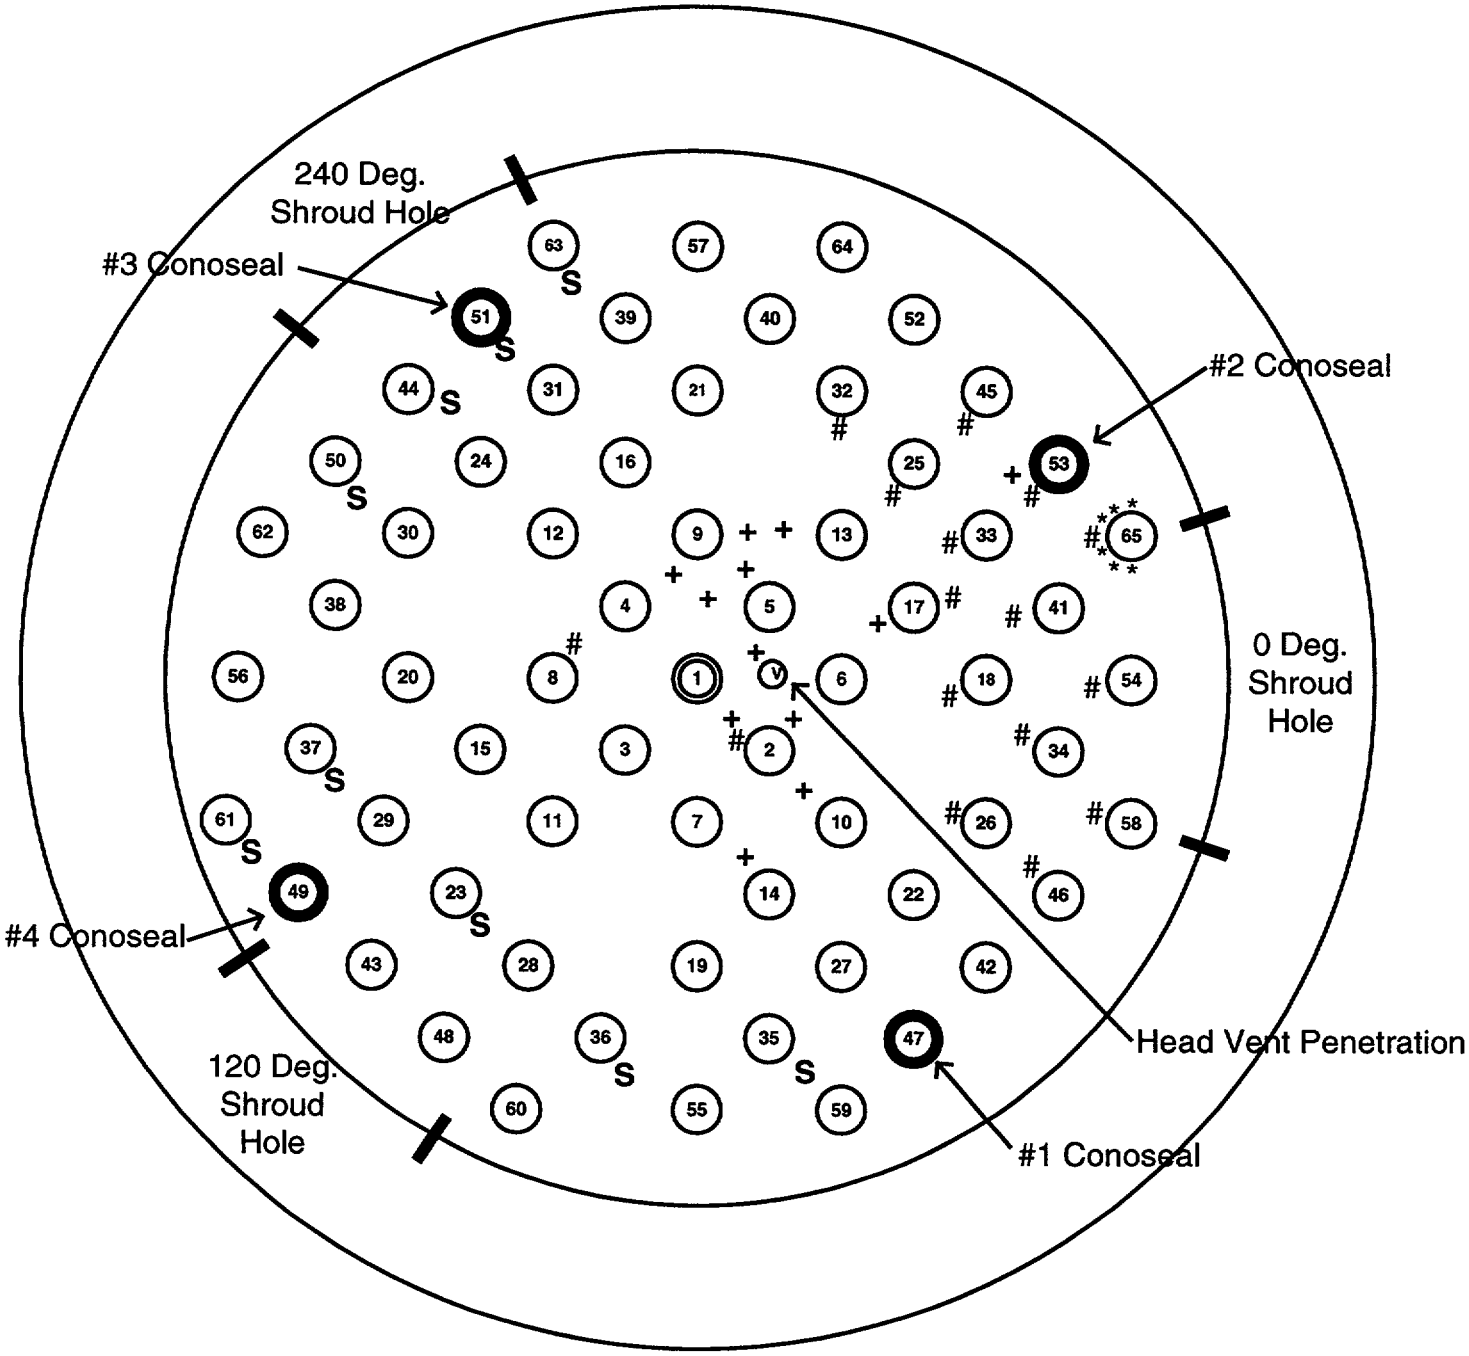
Based on the visual examinations performed in September 2001 on the Unit 1 reactor vessel head area captured on video, a mapping of the entire head has been performed. The map (Figure 1) includes a legend to denote the various degrees of boric acid residue on the head surface, ranging from a light dusting to larger flakes and debris, as well as photos (Figures 2 through 6) to depict examples of the various conditions present. Figure 7 is provided to illustrate the mirror insulation configuration (plan view). The four conoseal joints identified in Figure 1 as penetrations #47, #53, #51, and #49 are located above the insulation and shroud.

Greater than 90% of the reactor vessel head surface within the shroud periphery has a light dusting of boric acid residue. This dusting is primarily white in color and is generally less than 1/32" in thickness, and is illustrated in Figure (2)

- **+ = Head surface areas with larger, loose flakes and other debris present. (Figure 3)**
- **# = Penetrations with loose debris in vicinity of penetration (usually "uphill"). (Figure 4)**
- **S = Head surface areas with pronounced white stains (Figure 5)**
- *** = Corrosion adjacent to Penetration # 65 (Figure 6)**

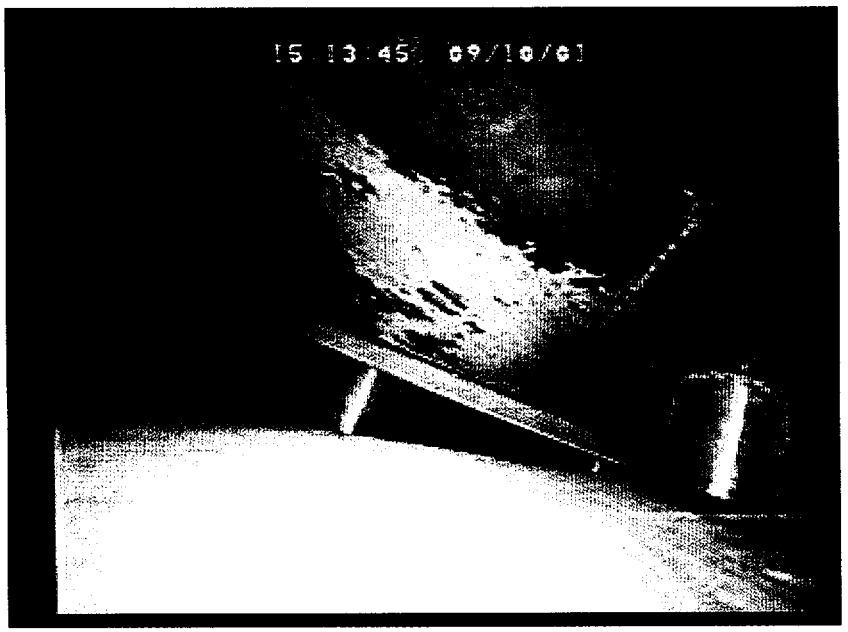
Image from the crawler camera looking uphill toward penetration #9. This illustrates some of the boric acid coating on the overhead mirror insulation as well as the general overall condition of the head surface. In many cases the crawler camera was used to navigate and confirm penetration locations and to assess the overall head condition. The crawler was also used to deliver the video probe to selected locations for specific examinations. The image foreground is saturated by the crawler light reflection.

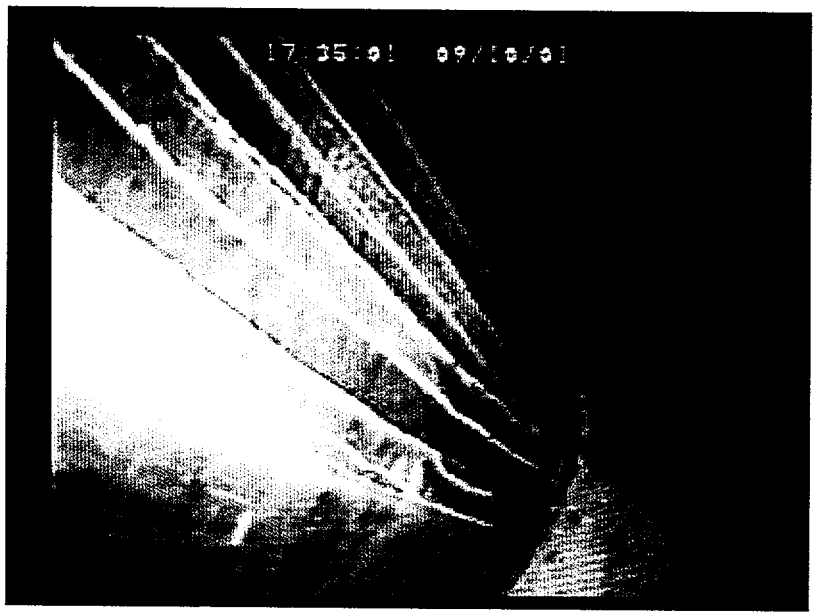
Figure 5
Typical Areas with distinct stains (**S** symbol on map)

View looking down from penetration 44 clearly shows boric acid residue from previous leakage above the insulation running down the penetration, resulting in a white stain on the penetration and at the head surface. This indicates the leakage was minor, which is borne out by the lack of rust, discoloration or other evidence of damage in this head quadrant.

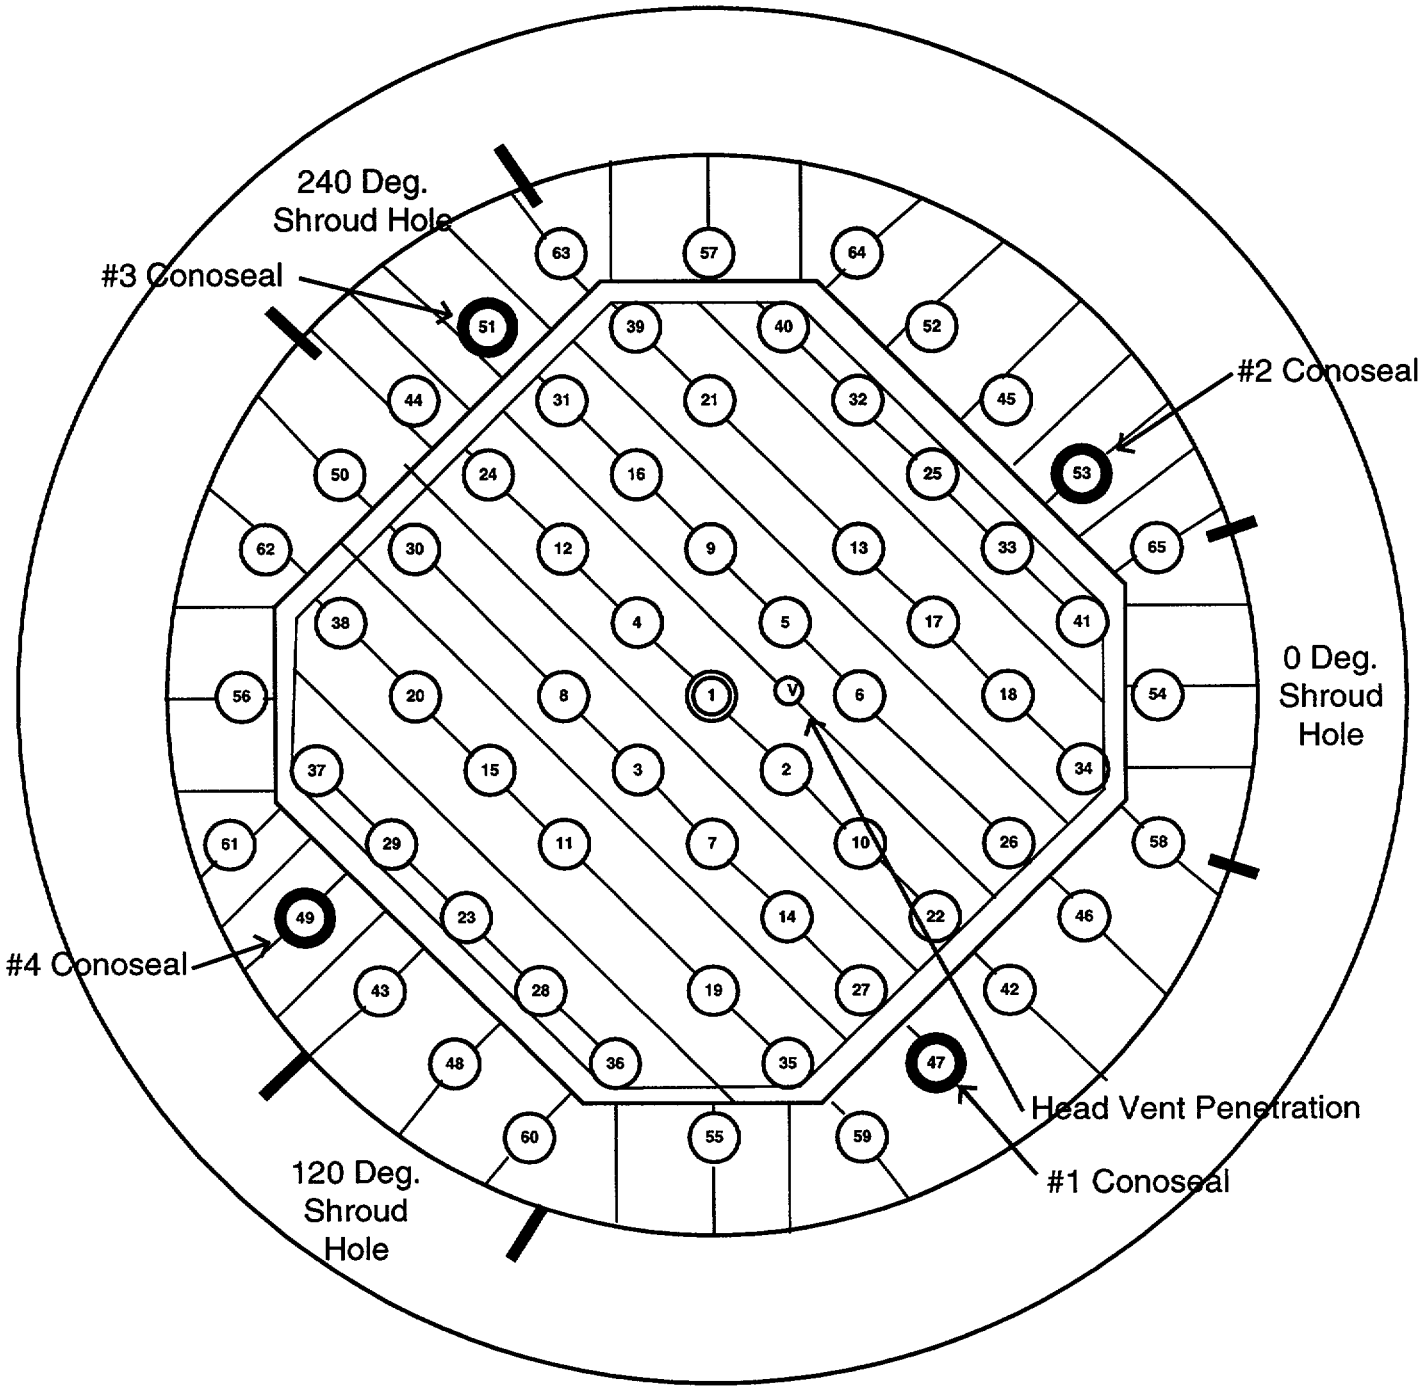
Figure 7

BV-1 Basic Insulation
Panel Orientation
