Davis-Besse Nuclear Power Station
5501 North State Route 2
Oak Harbor, Ohio 43449-9760

Serial Number 2735

October 17, 2001

Subject: Supplemental Information in Response to NRC Bulletin 2001-01, "Circumferential Cracking of Reactor Pressure Vessel Head Penetration Nozzles"

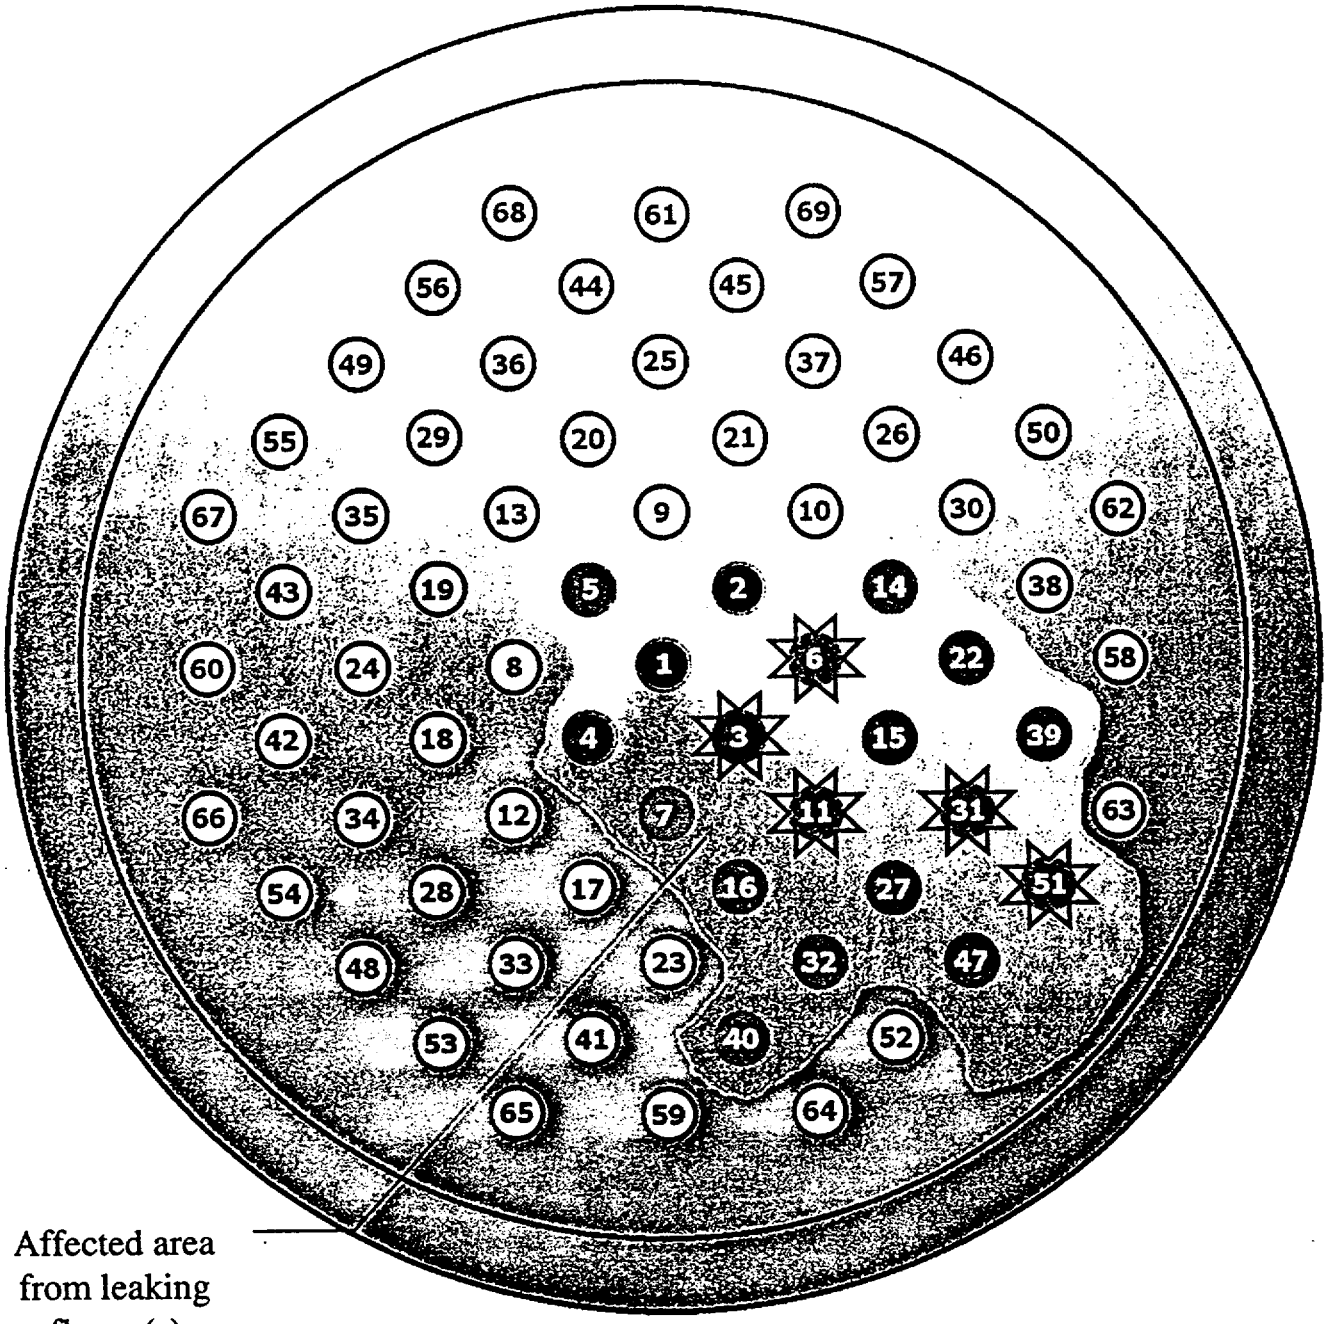
# RPV Head 11 RFO Inspection Results

Affected area from leaking flange(s)

(61) - No leakage identified

(4) - Evaluated not to have sufficient gap to exhibit leakage

(3) - Insufficient gap with leaking flange

(6) - Nozzle obscured by boron with leaking flange

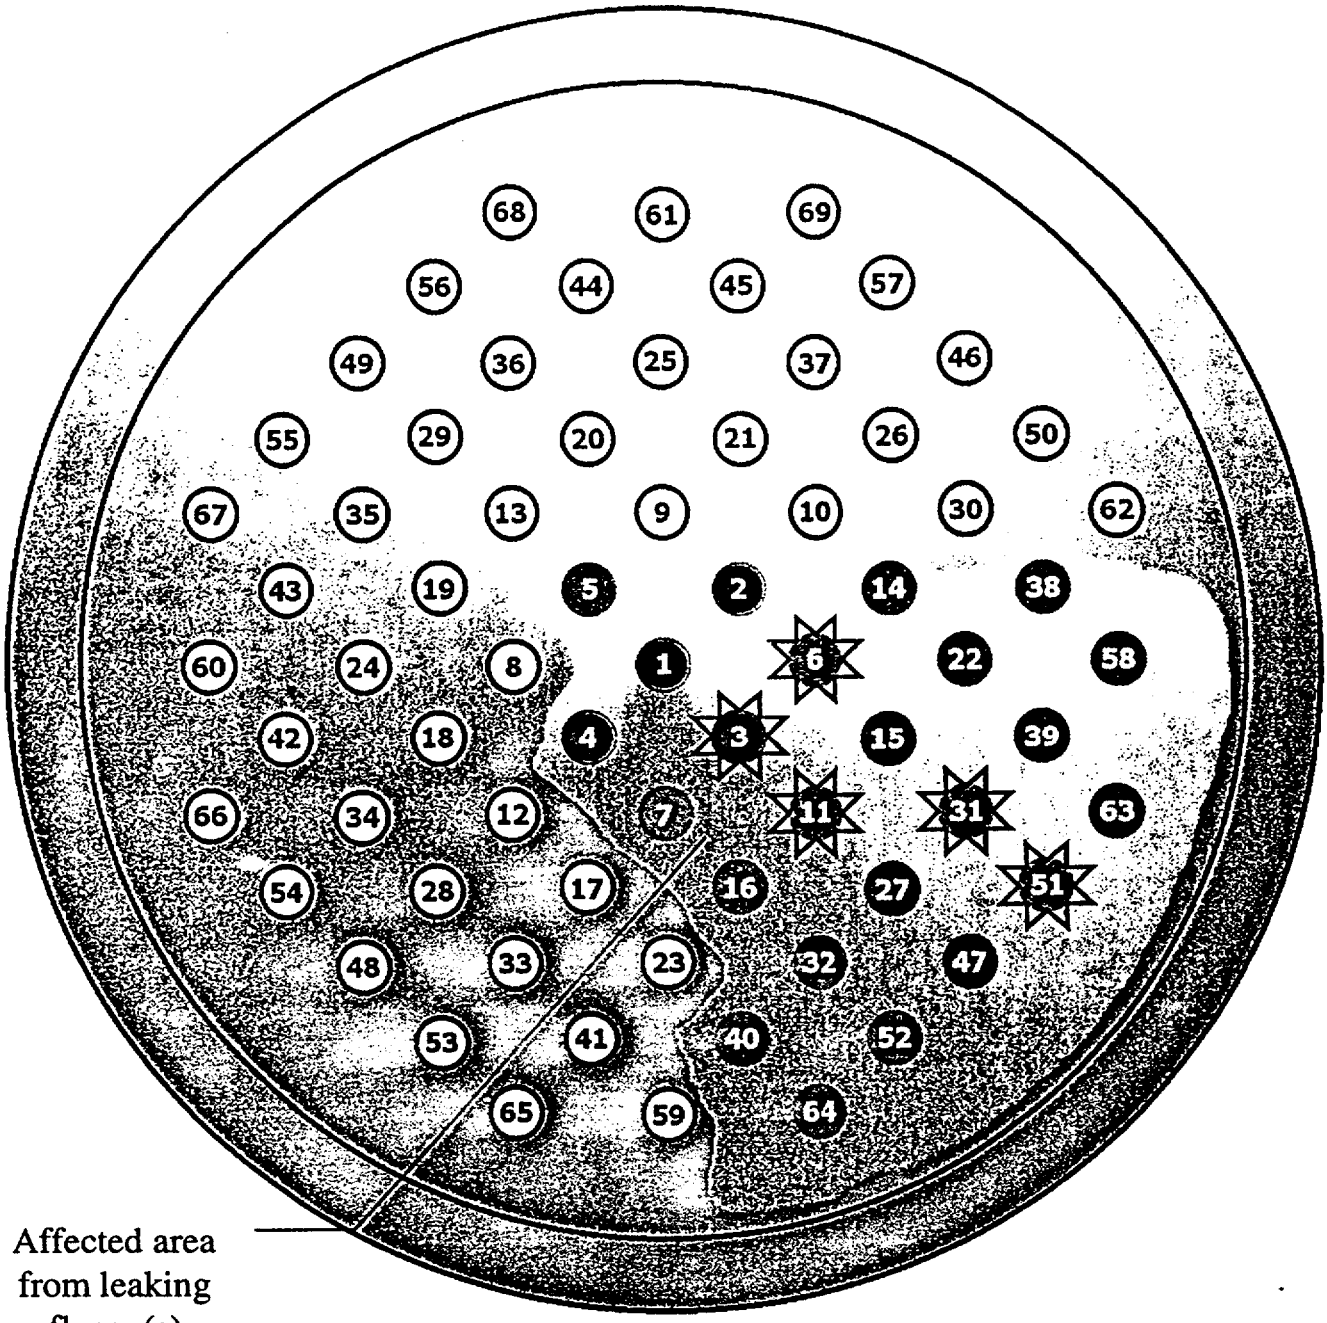
# RPV Head 12 RFO Inspection Results

Affected area from leaking flange(s)

61 - No leakage identified

4 - Evaluated not to have sufficient gap to exhibit leakage

3 - Insufficient gap with leaking flange

6 - Nozzle obscured by boron with leaking flange

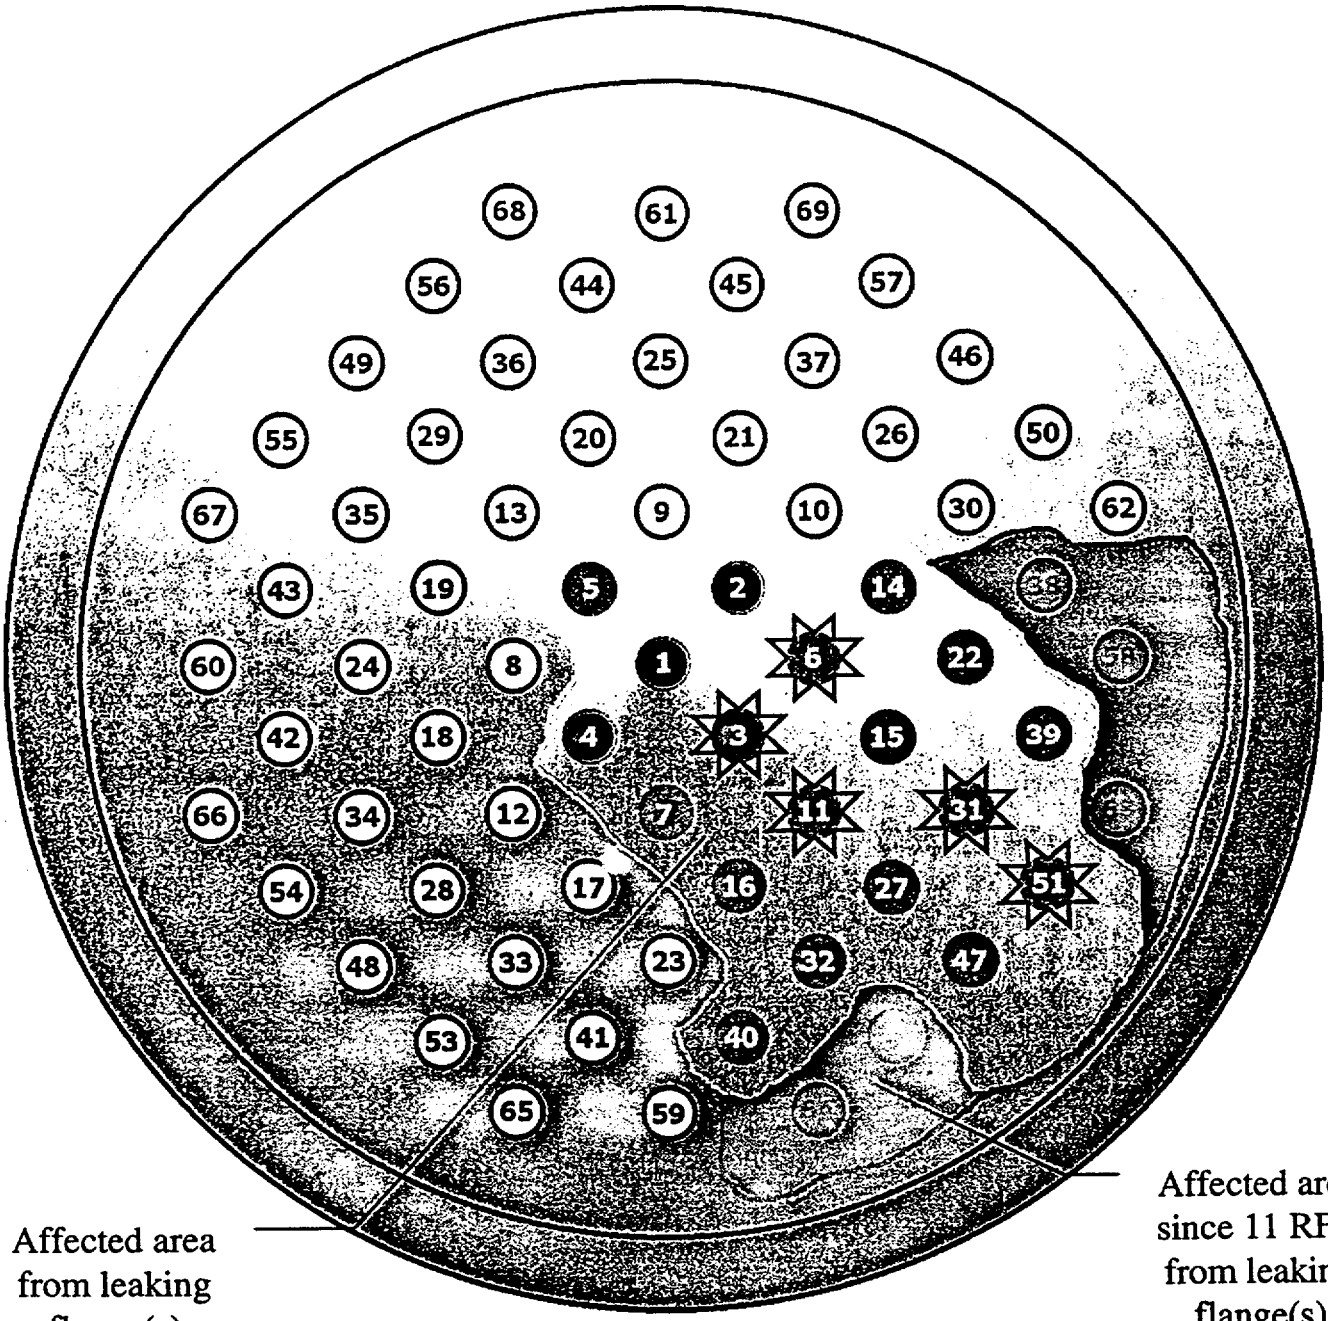
# RPV Head 11 & 12 RFO Inspection Results

Affected area from leaking flange(s)

Affected area since 11 RFO from leaking flange(s)

(61) - No leakage identified

(4) - Evaluated not to have sufficient gap to exhibit leakage

(3) - Insufficient gap with leaking flange

(6) - Nozzle obscured by boron with leaking flange

● - Newly affected, since 11 RFO, by leaking flange(s)

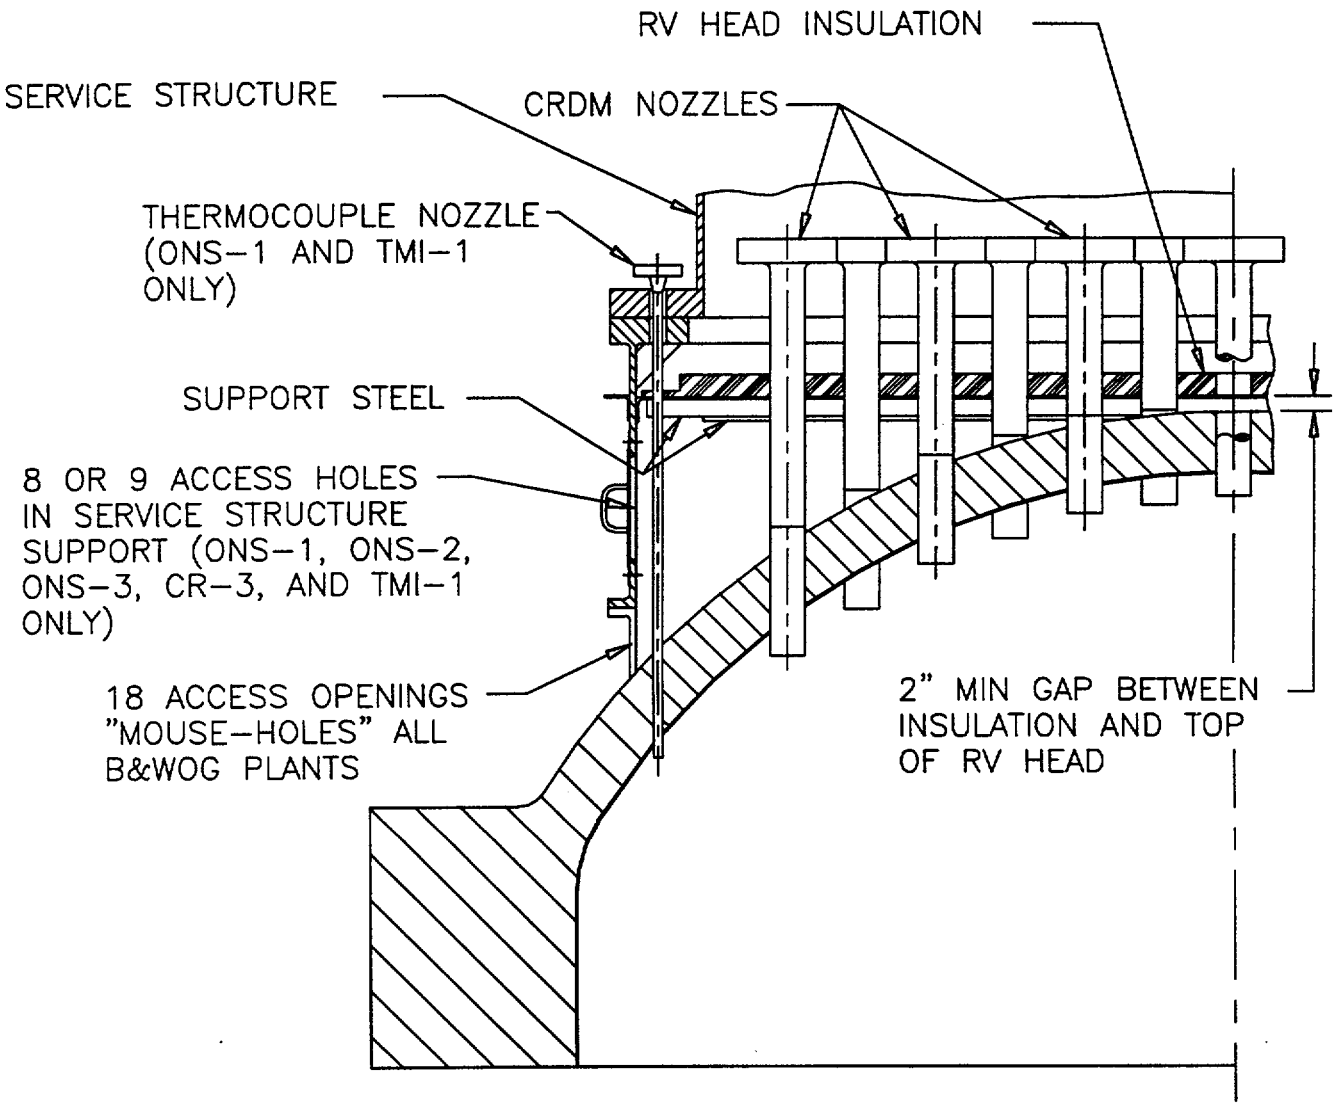
**Figure 1. Side View Schematic of B&W-Design Reactor Vessel Head, CRDM Nozzles, Thermocouple Nozzles, and Insulation.**

Note: The thermocouple nozzles were removed from ONS-1 at EOC-19.

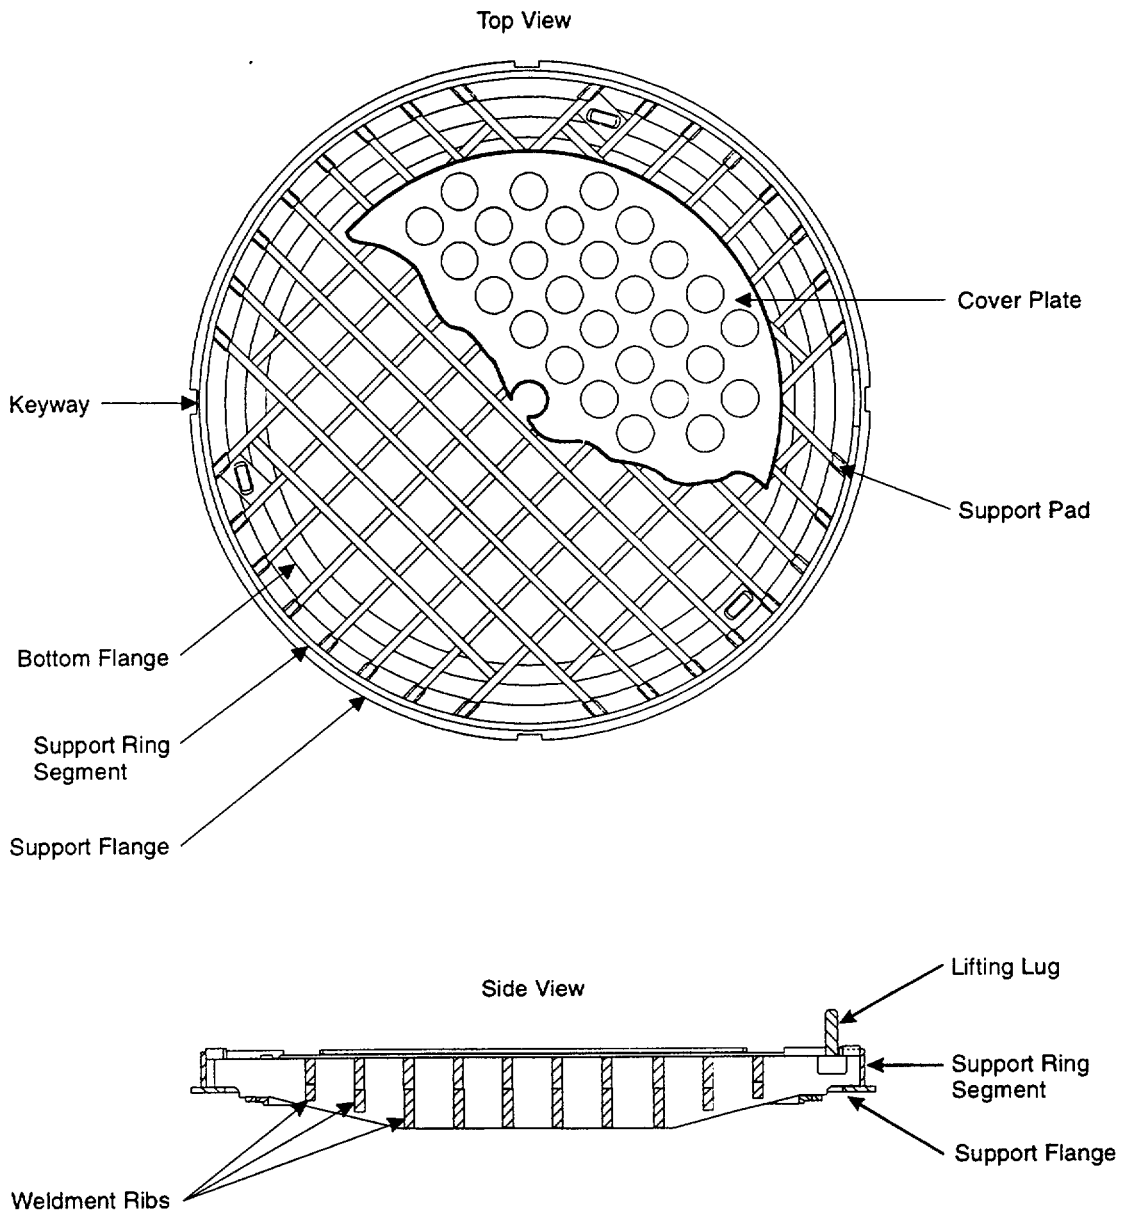
**Figure 2. Plenum Cover Assembly.**

safety or operational issue in the plant (see Figure 2). The second location is through the gaps around the periphery of the plenum cover and would likely end up in the steam generator, potentially damaging the tubes or tube welds. A fragment lodged within a single tube could, as a result of motion induced by the flow through the tube, cause wear of the tube at the point of contact with the inside surface. Although unlikely, this could eventually result in a small through-wall flaw in the tube, causing a primary-to-secondary leak, which can be detected by monitoring procedures already in place at the plant. Once detected, the plant operators would follow the technical specification action statements to shut down if the leak became significant. This does not introduce any new or unanalyzed event. While this location may cause equipment damage, it is not a safety concern. The third possibility, which could be a safety concern, is that the pieces could enter any one of the 69 column weldments through which the control rod spiders descend (see Figures 5 and 6). It has been calculated that there is a 25% chance or greater for a loose piece to enter one of the column weldments. This is simply based on an area ratio of the column weldments in the upper head and the fact that low cross flow velocities in this region would tend to allow debris to fall vertically. In addition, the leadscrews could tend to guide the debris such that the probability of entering the column weldment may be much higher than 25%. If fragments enter the column weldments, they will likely be stopped on one of the control rod guide tube brazements where relatively small fragments (< ¾ inch) would be capable of precluding complete control rod insertion.

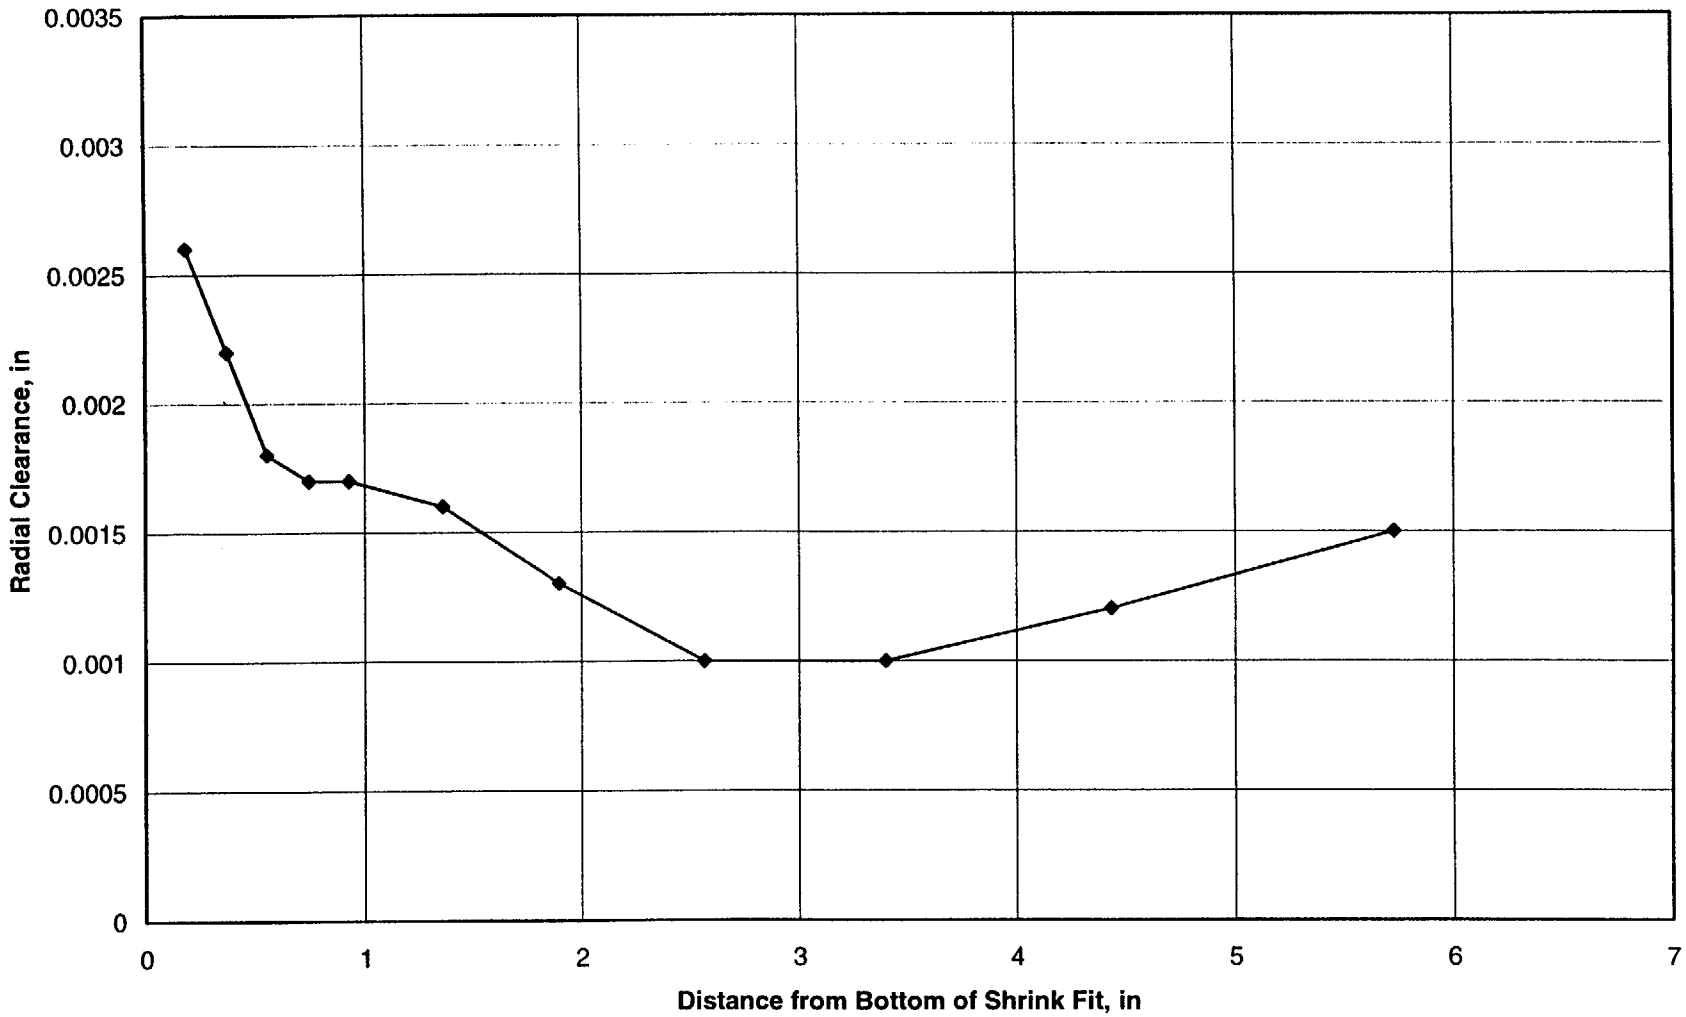
**Figure A-1. Radial Clearance for Center Nozzle**

The crack lengths required to achieve the leak detection capability rate of 1 gpm were determined for annulus clearances of 0.0016 inches and 0.002 inches. These annulus clearances correspond to the average radial gaps during steady state normal operating conditions for the center and outermost CRDM nozzles, respectively. It was determined that a crack length of 7.5 inches in the center nozzle (annulus of 0.0016 inch) is required to achieve a 1 gpm leak rate. Similarly, it was determined that a crack length of 5.0 inches in the outermost nozzle (annulus of 0.002 inch) is required to achieve a 1 gpm leak rate.
