REVIEW OF SOME ASPECTS OF RADIOLOGICAL INTEREST DURING THE ESTABLISHMENT OF THE SAFE ENCLOSURE OF THE THTR 300 PLANT

W. STRATMANN
STEAG Kernenergie GmbH, Essen

M. BÄCHLER
Noell-KRC Energie- and Umwelttechnik GmbH, Würzburg

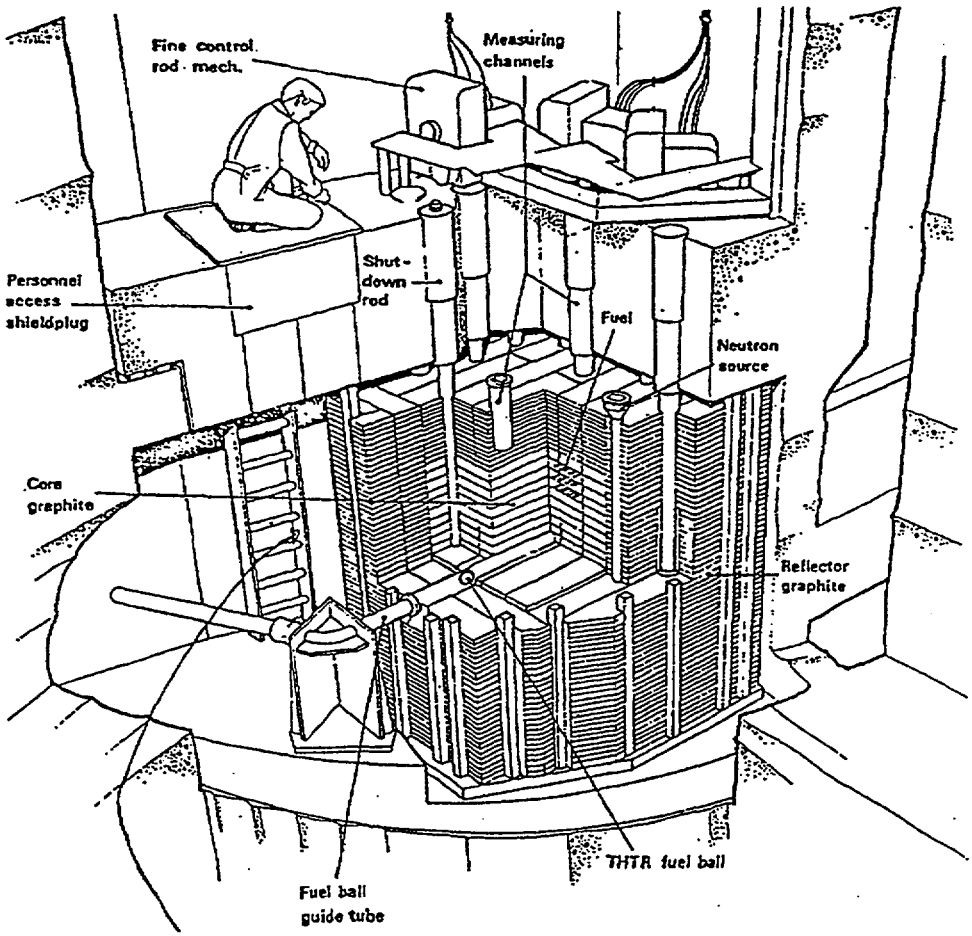
FIG. 1. Installation of the burnup measuring reactor

The burnup measuring reactor was a graphite moderated thermal reactor with a rated output of 500 W, arranged in the reactor hall below the prestressed concrete reactor vessel. The reactor core (1.0 m · 1.2 m · 1.1 m) consisted of various graphite plates provided with grooves for accommodation of the 767 strip-shaped fuel elements. The fuel elements have a rectangular cross-section (15 mm · 1.1 mm) and a length of between 89 and 711 mm. They contain 93% enriched uranium in a U-Al alloy (20% uranium, 80% aluminum). Total uranium content of the core was 3.9 kg.

The core was enclosed by a graphite reflector consisting of plates similar to those of the core. Outside dimensions of the SMR were thus 1.8 m · 2.0 m · 2.0 m. The operating element guide tube, used to guide the operating elements rolling through the core by gravitation, passed through the center of the reactor core. The entire reactor composed of graphite plates was mounted on a steel slab anchored to the floor and was supported by a steel structure installed around the reactor. Reactor instrumentation, absorber rods and the neutron source were arranged in twelve vertical drill holes through the reactor core. Figure 1 gives a general idea of the burnup measuring reactor.

The initial radiological situation was determined by a burnup of approx. 3.1 MW·h/kg U after unloading of the THTR reactor core. Overall activity, originating mainly from the fission products, totaled $2 \cdot 10^{12}$ Bq/kg U. The measured dose rate in the room of installation of the SMR ranged from 500 to 800 µSv/h as regards gamma radiation and was below 1 µSv/h as regards neutron radiation. Values ranging from 1.5 to 20 Bq/cm² were determined for non-fixed contamination. When dismantling work was initiated, indoor air activity concentration was below 40 Bq/m³.

The burnup measuring reactor had to be dismantled only to the extent necessary for removal of the nuclear fuel.

The activities in the THTR 300 plant - from preparation via removal of fuel elements, loading into shielding device and until transfer to the THTR fuel element storage facility - were carried out by a staff of approx. ten persons in one shift over 30 work days. The collective dose for the personnel was only approx. 10% of the maximum value of 200 mSv stated in the application that had been filed for the licensing procedure under nuclear law, and approx. 20% of the dose expected according to the initial step sequence plans.
