UNITED STATES
NUCLEAR REGULATORY COMMISSION
OFFICE OF NUCLEAR REACTOR REGULATION
WASHINGTON, D.C. 20555-0001

July 17, 2002

NRC INFORMATION NOTICE 2002-02, Supplement 1: RECENT EXPERIENCE WITH PLUGGED STEAM GENERATOR TUBES

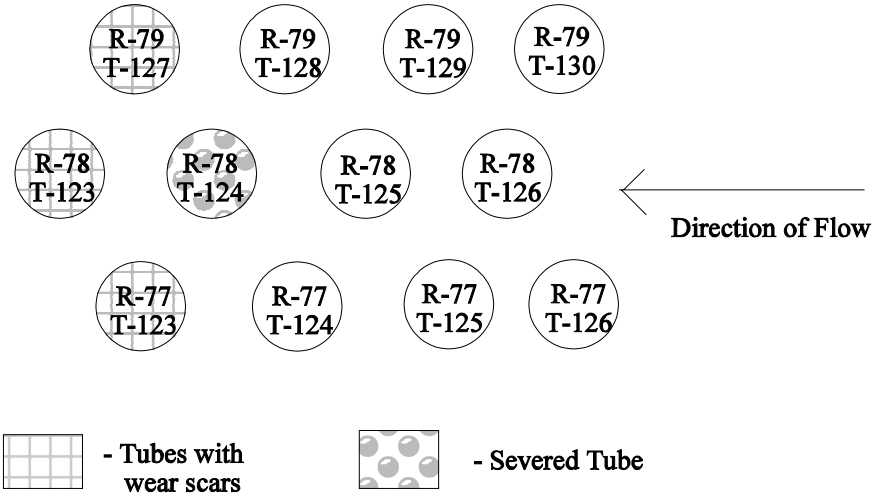
OCONEE NUCLEAR STATION UNIT 1
STEAM GENERATOR B TUBESHEET PATTERN
FIGURE 1

While inspecting a deplugged tube in the B steam generator, row 77 tube 123 (B77-123), the licensee identified signs of wear on the outside tube surface near the secondary face of the lower tubesheet. The wear scar on the tube began at the lower tubesheet secondary face and extended up approximately 6.4 inches and was approximately 28 percent through wall. This wear scar was not detected when the tube was plugged in 1991. An explosive plug in the lower tubesheet of Tube B78-124, which is adjacent to Tube B77-123 (see Figure 1), could not be removed. Therefore, in accordance with the inspection program, the lower tubesheet explosive plug was inspected. It was found to have defects and, per the program, the tube was required to be captured/caged (i.e., surrounded by tubes that were plugged and stabilized). Since previously plugged tube B78-123 was required to be a capture location for tube B78-124, it was deplugged and inspected with eddy current probes. This tube also showed wear in the span near the lower tubesheet area. Tube B78-123 had been plugged in 1999 for volumetric indications in the lower span which could be traced back to 1995. The licensee compared the 2002 inspection data to the 1999 data. The indications appeared to be similar in size. The licensee now believes the volumetric indications were wear indications due to impact from an adjacent tube.

The circumferential location of the wear on these two tubes indicated that the wear was most likely due to impact from an adjacent tube, B78-124. Subsequent visual inspection from the secondary side of the steam generator indicated that tube B78-124 was completely severed at the secondary side (i.e., top) of the lower tubesheet. Based on the flow direction and velocity in the lower tubesheet region, the severed tube would be expected to impact three tubes (B77-123, B78-123, and B79-127). Tube B79-127 was visually inspected from the secondary side and a small wear mark was visible. Based on the location and preliminary characterization of the severed tube's degradation, the licensee concluded it potentially represented a new damage mechanism for once-through steam generators. The NRC obtained this information from the licensee via several conference calls, summaries of which are being prepared and will be made available on the docket.
