NRC 2002-0056

Docket Number 50-301
Point Beach Nuclear Plant, Units 2
Licensee Event Report 301/2002-002-00
Pressurizer Safety Valve Failed to Lift at Test Pressure

TITLE (4)
PRESSURIZER SAFETY VALVE FAILED TO LIFT AT TEST PRESSURE

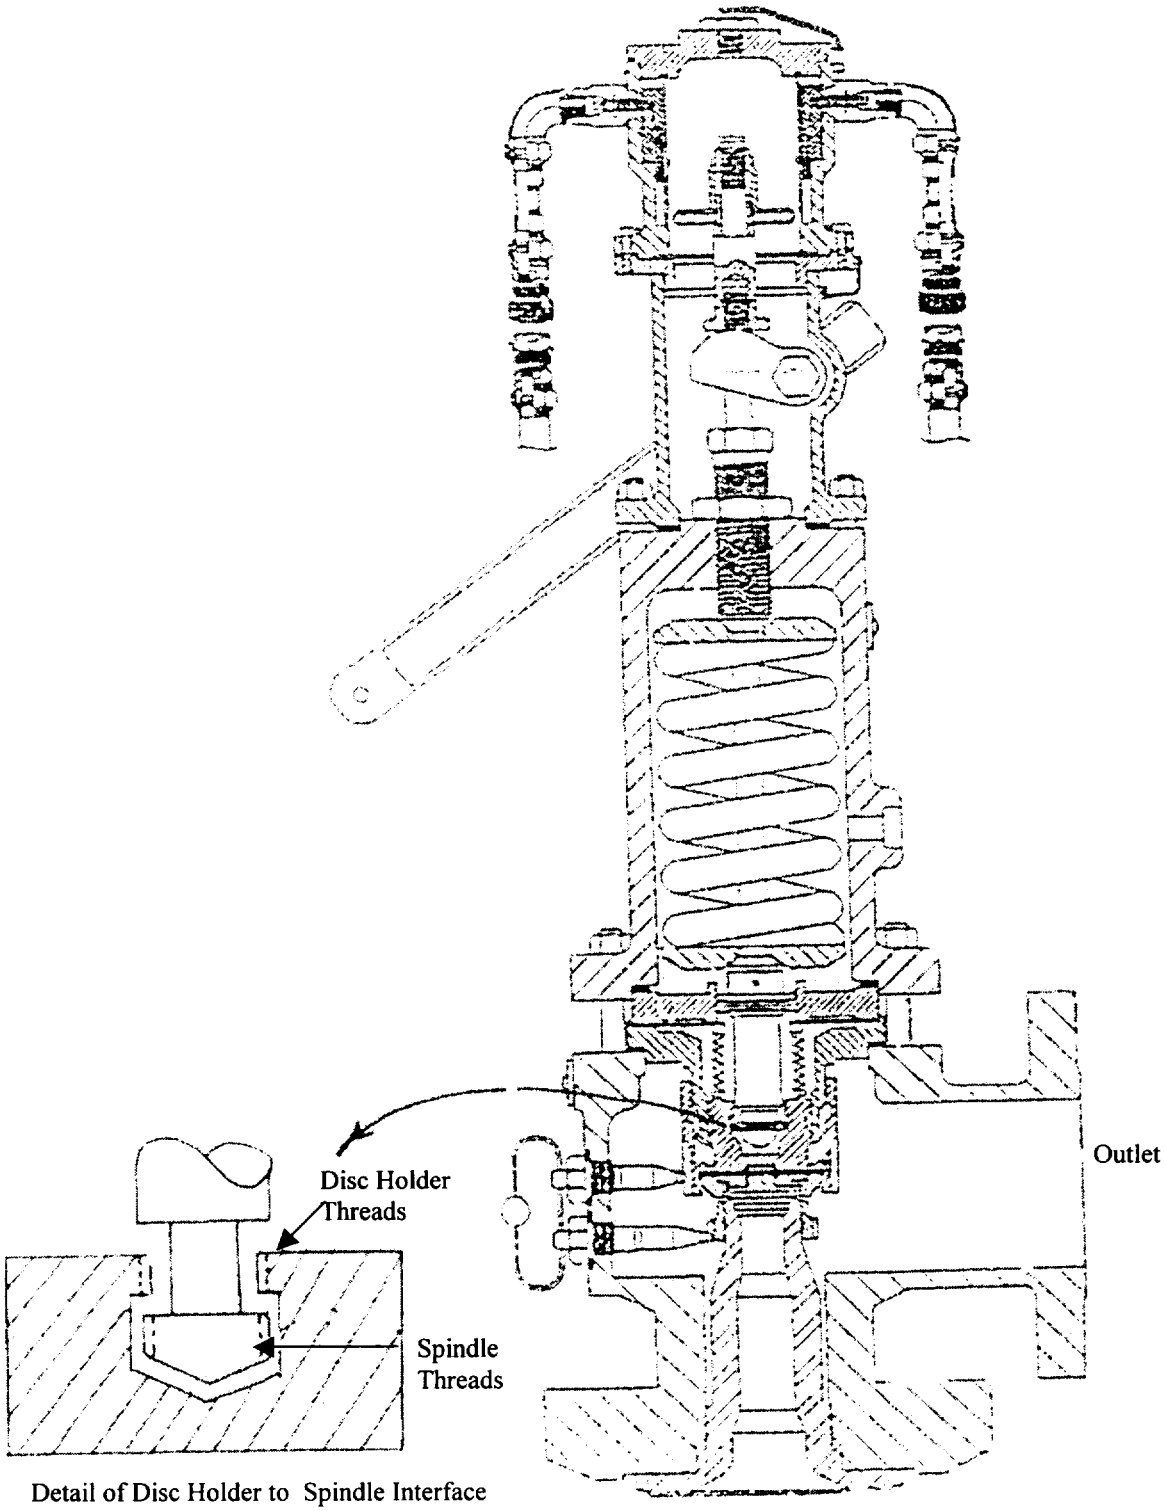
PRESSURIZER SAFETY VALVE - FOR INFORMATION ONLY

The vendor has determined that the cause of this failure of a pressurizer safety valve to lift at the appropriate test pressure was due to improper reassembly of the valve following the previous valve testing in November 2000. Following as-left set point testing of the valve, the valve is tested for seat leakage at 90% of test pressure. If the valve fails this leak test, the valve disc and nozzle are typically lapped, or polished, to remove any slight steam cutting of the valve which can occur during the lift point testing. The valve is then reassembled and leak tested again to ensure that the valve will remain leak tight following reinstallation in the plant. The lapping requires partial disassembly of the valve to separate the valve body from the bonnet. This can be accomplished without affecting the spring setting or lift set point of the valve. However, during the reassembly of the valve following the lapping in November 2000, the technician failed to ensure that the spindle and disc holder were fully engaged, leaving the spindle threads engaged in the disc holder threads (See drawing attached). This caused the actual lift point of the safety valve to exceed the allowable limits. No measurements or testing was conducted following the reassembly to ensure the valve set point was unaffected by the disassembly. The valve manufacturer has estimated that the actual lift point of the misassembled valve would have exceeded 3000 psig, rendering the valve inoperable during the past operating cycle.

Detail of Disc Holder to Spindle Interface
(Shown Fully Inserted)
Incomplete Assembly is with Threads
Engaged

Following the identification of the cause of this valve failure to lift within its prescribed set-point range, Crane has revised their testing and overhaul procedures to require a dimensional check of the valve before and after any disassembly to perform valve lapping. The dimensional check, taken from the top of the valve spindle to the top of the adjusting nut, provides a verification that the valve has been correctly reassembled, and that the spindle threads are not engaged in the disc holder, and the spring setting adjustment bolt, which sets the valve lift point, has not been disturbed.
