SUMMARY OF VESSEL HEAD AND VESSEL BOTTOM PHONE CALLS

BULLETIN 2002-02

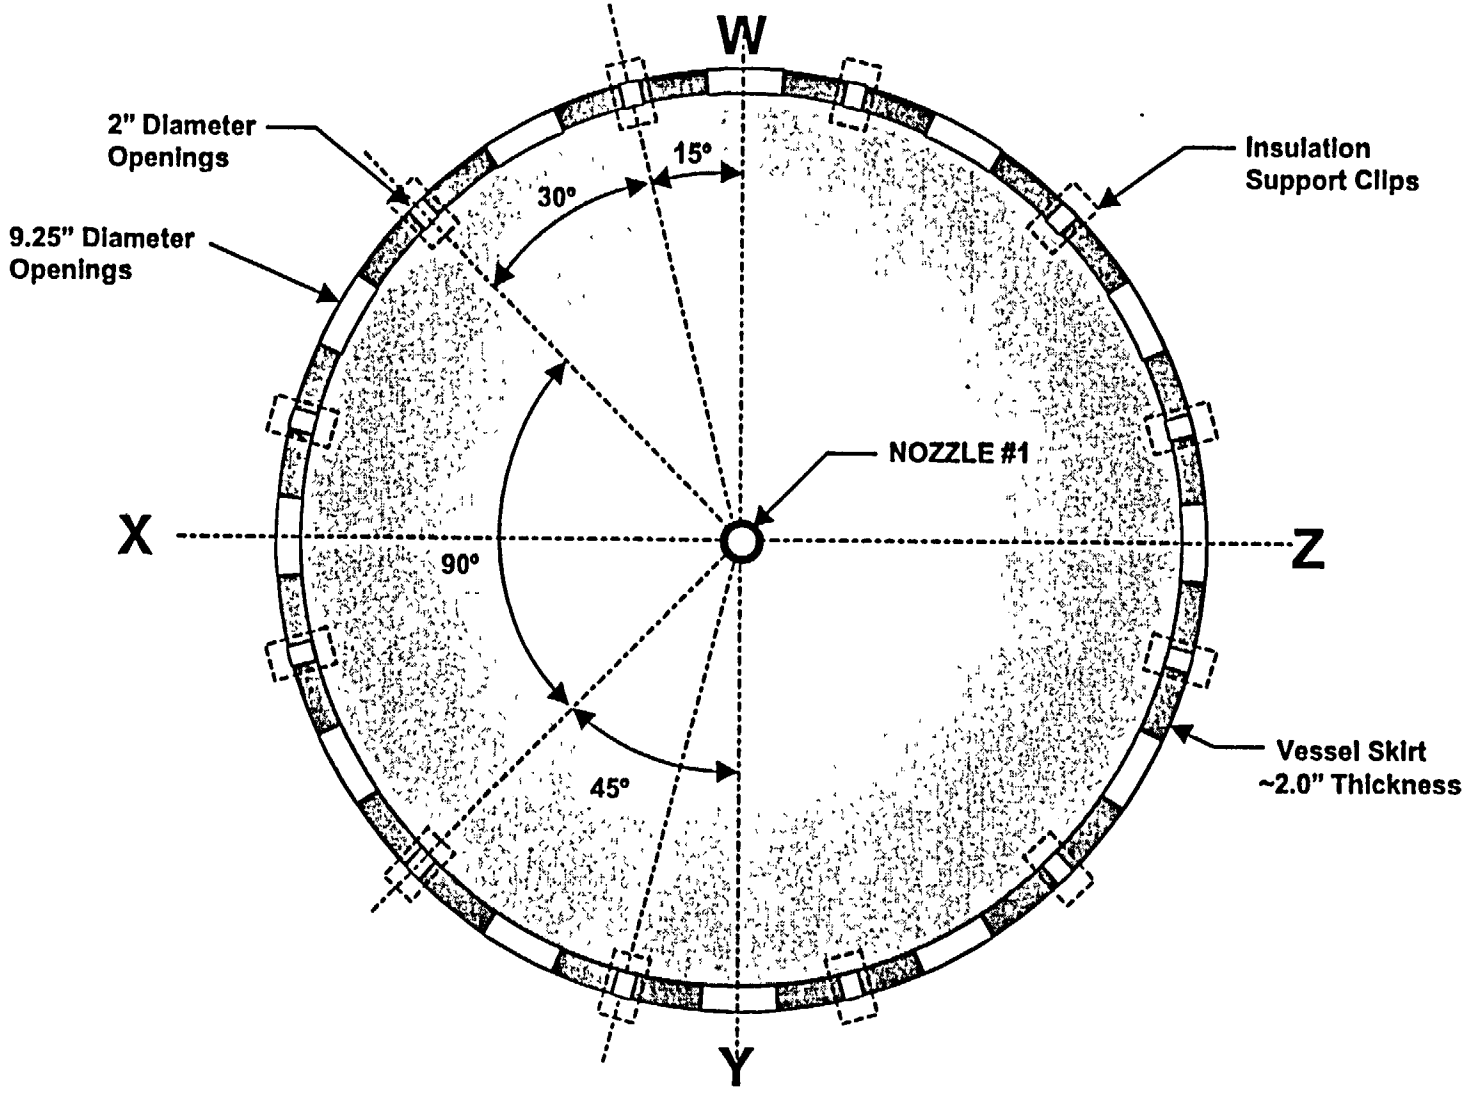
Reactor Vessel Skirt Openings and Locations
Plan View – Looking UP

Attachment 1 (Diagrams of penetrations through vessel skirt, nozzle layout, and description) identifies the nozzles that were inspected using a boroscope and the results. The four nozzles inspected by a boroscope were the only incore tubes that had staining below the insulation. The purpose of the boroscope inspection was to determine whether these nozzles had any evidence of leakage at the vessel interface. Attachment 2 provides a scale composite drawing showing the dimensions of the reactor vessel, support skirt, insulation details, and nozzle 1 and 30.

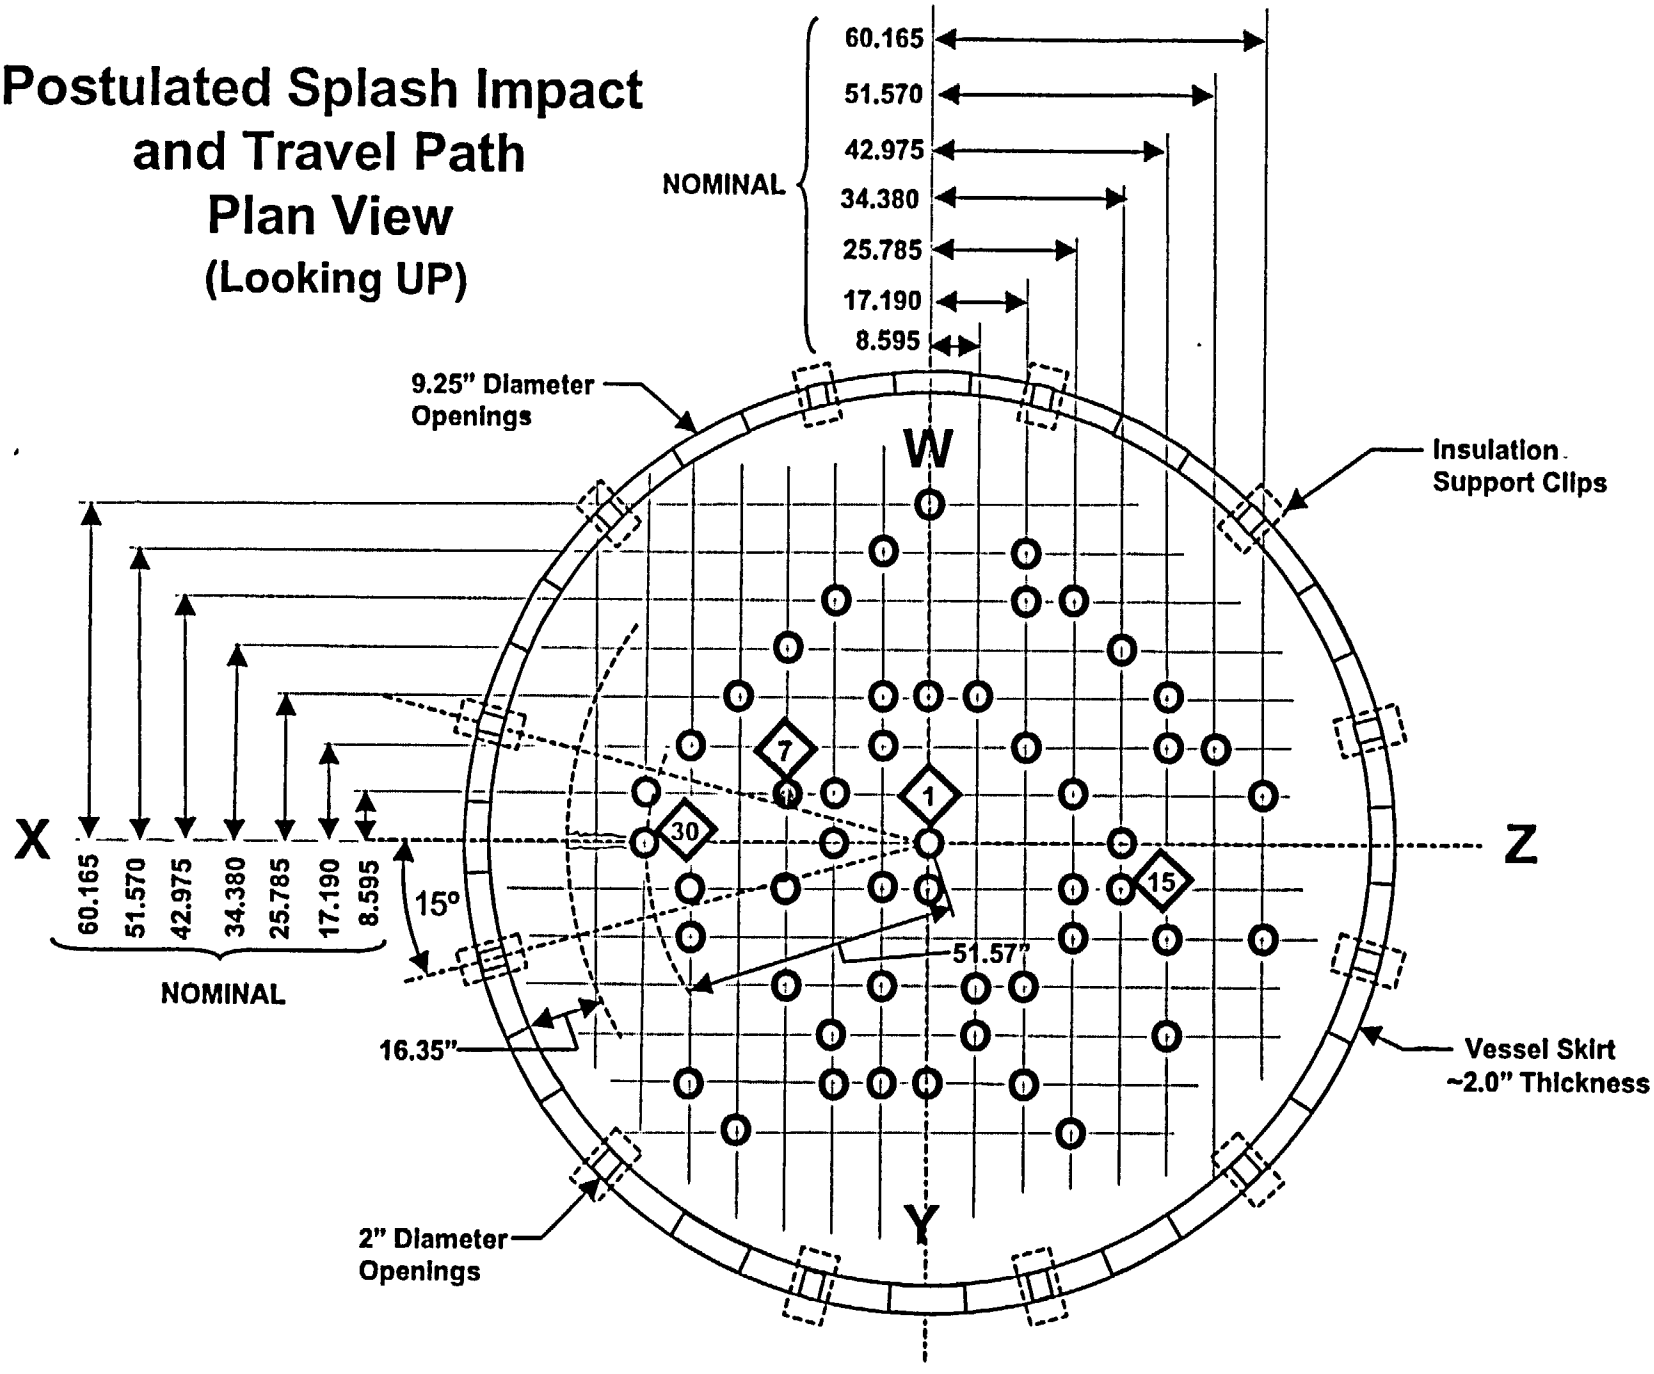
Postulated Splash Impact and Travel Path Plan View (Looking UP)

Based on discussions with site personnel (refueling team, operations, maintenance staff) that were familiar with past activities and issues in the reactor vessel area, instances of cavity seal plate leakage were identified as likely sources for the staining identified in the general area under the vessel. In order to understand the relationship of the vessel, the insulation, the concrete structure, and the drainage path for cavity seal plate leakage, the composite drawing previously identified was developed for this area. Additionally, it was determined that decontamination efforts of the transfer canal near the vessel flange area during the 1980's and early 1990's included rinsing fluid into the cavity seal plate area when the plate was not installed. During this time frame, cavity seal plate leakage was a fairly common occurrence as well as CRDM flange and RVLMS flange leakage decontamination efforts with the cavity seal plate removed. Also an overflow of the incore tank (R-8) that occurred in September 1999 was identified as a source for some of the boron residue identified on the floor in the area under the reactor vessel. Based on these reviews, probable flow paths have been identified that correspond to the indications seen. Documented inspections of the area under the vessel from the previous two outages to the present do not indicate any change in condition to this area.

The reactor cavity seal plate leakage would traverse the annulus area between the vessel and the mirror insulation to reach the undervessel area. The ability to perform additional inspections of the vertical annulus area between the vessel and the mirror insulation has been evaluated. To provide direct visual evidence of the path of borated water through the 2 inch holes in the support skirt above the undervessel insulation, access to the annulus would have to be gained. Possible access routes to inspect the area are limited to access from the top of the reactor vessel and access from below the vessel. There are no access locations between the top and bottom of the vessel because of the primary shield wall. The only openings through the shield wall are around the reactor vessel nozzles and these are too tight a fit to permit access. Access from the top of the vessel to the annulus between the shield wall and the reactor vessel is restricted by the reactor shield blocks. They consist of concrete filled, steel lined blocks. The shield blocks are located below the permanent seal ring at the top of the vessel and above the reactor vessel nozzles. These shield blocks provide a radiation shield in the annulus between the top of the reactor vessel and the floor of the refueling canal. There is no access through these blocks without removing them from above. This can only be accomplished by removing portions of the permanent seal plate.

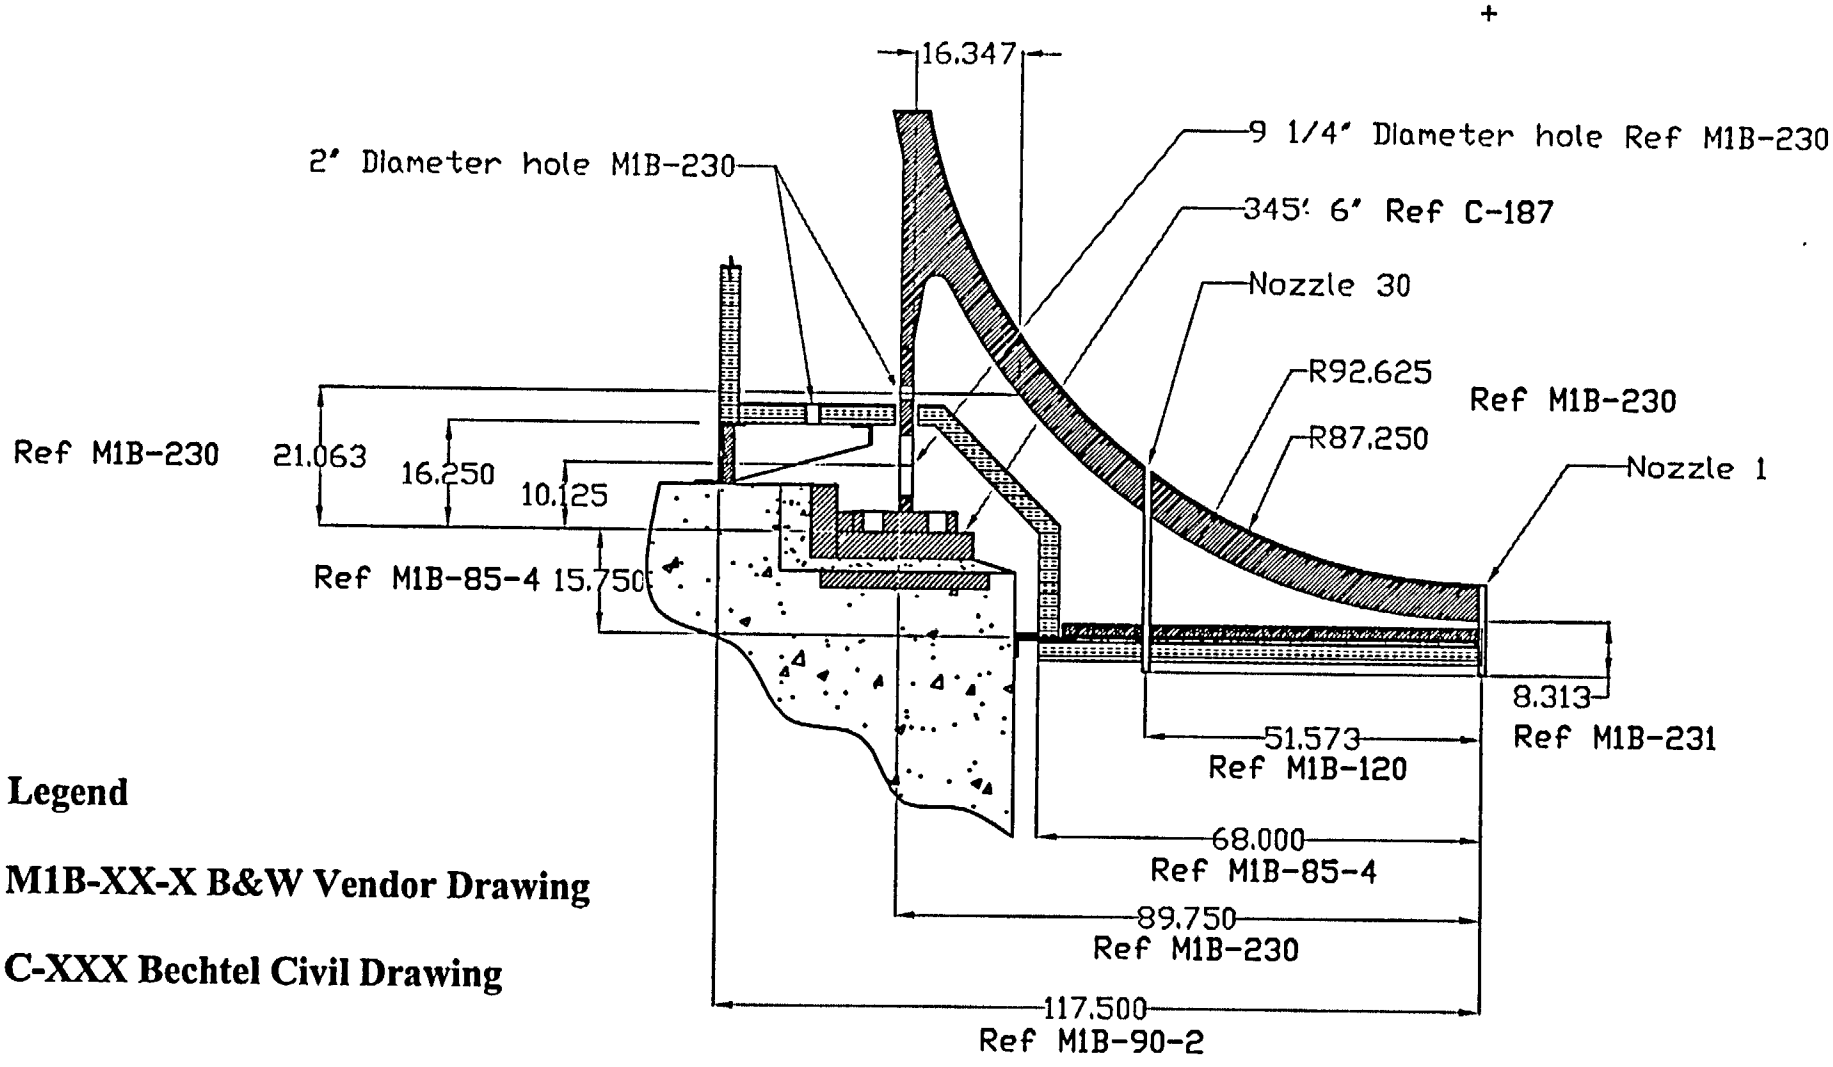
Faint white staining is visible on the nozzle piping extending from the vessel down through the insulation to below the insulation. The stain ranges in width from ¼ to ½ the circumference of the nozzle pipe. Some barely noticeable brown staining is visible on the nozzle piping (approximately 1 pencil width wide. A 360-degree close-up inspection of the nozzle shows no indication of boron originating from the annulus.
