Byron Nuclear Power Station, Unit 2
Facility Operating License NPF-66
NRC Docket No. 50-455

Subject: Byron Station Unit 2 Steam Generator Inservice Inspection Summary Report

STEAM GENERATOR EDDY CURRENT INSPECTION REPORT

CYCLE 10 REFUELING OUTAGE (B2R10)

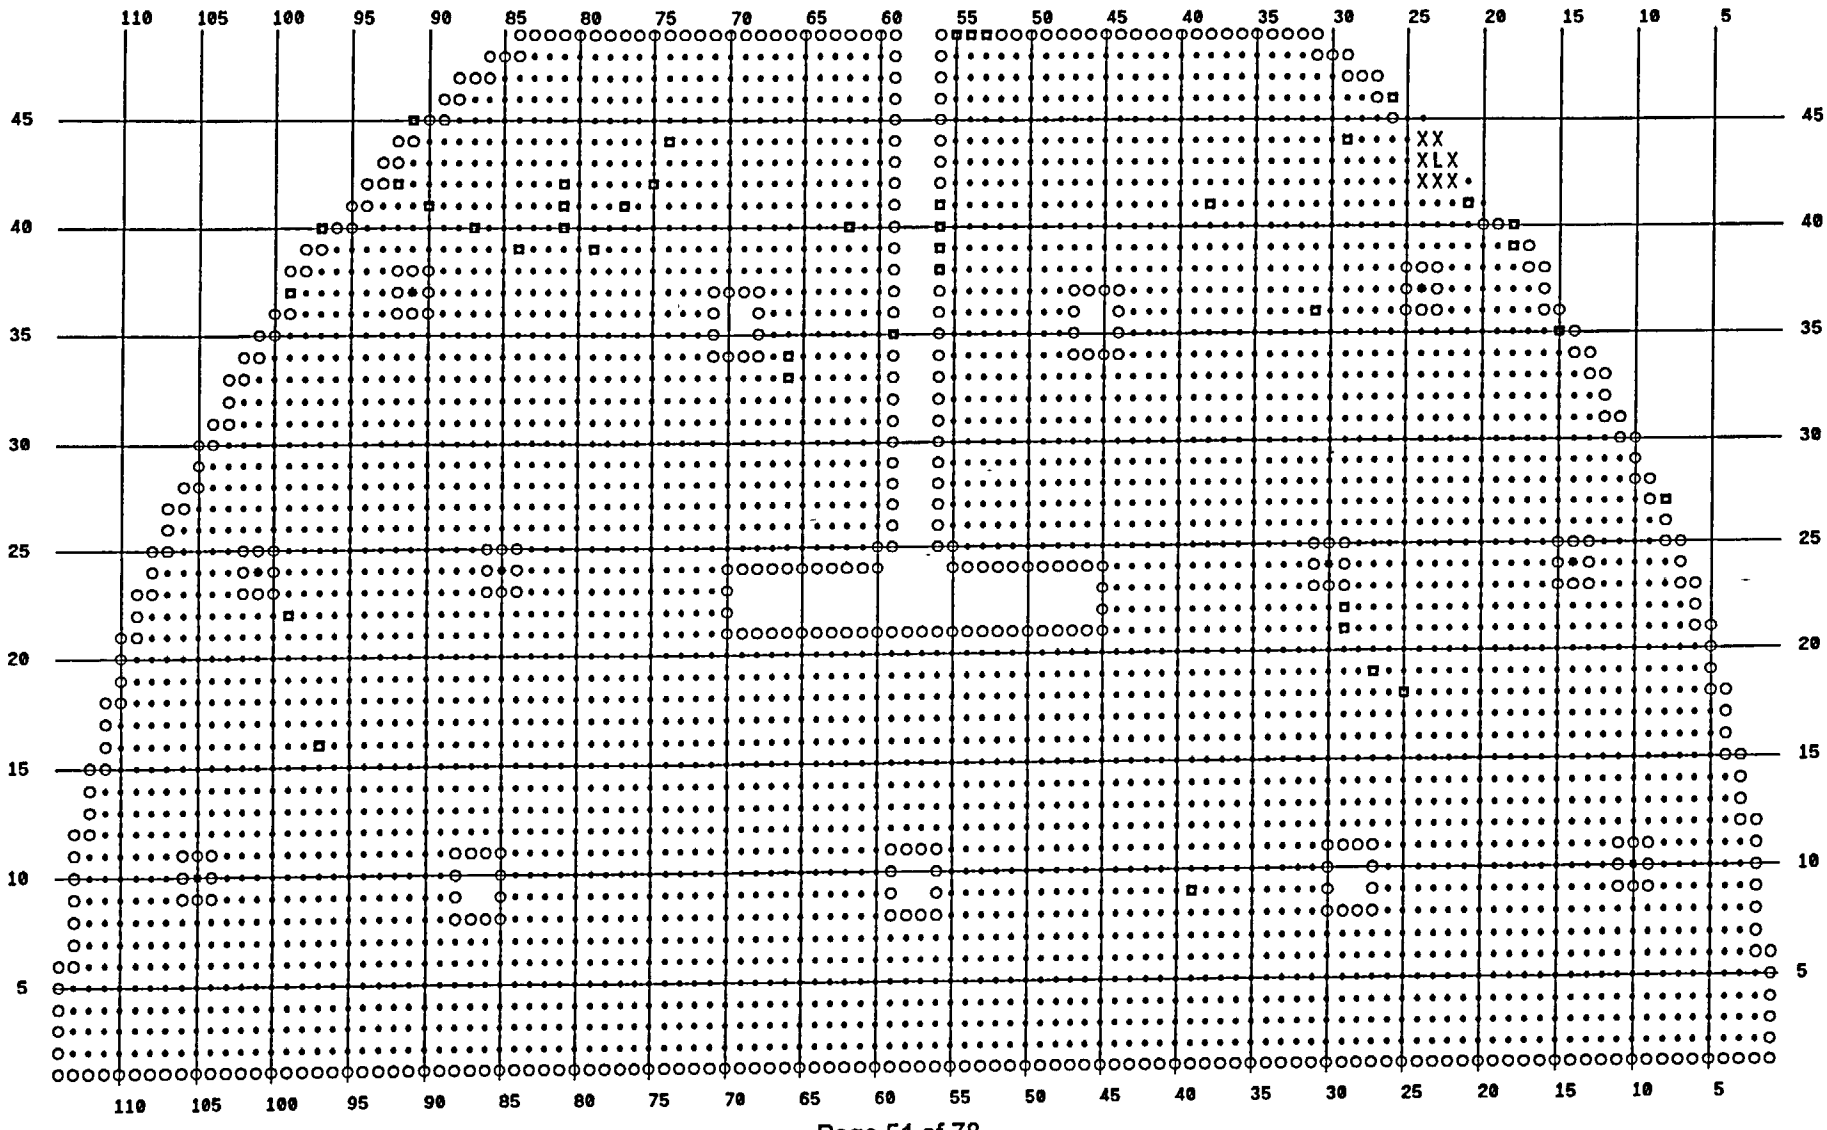
Figure A.33 B2F23 SG C Bobbin Coil Inspection Scope

A forced outage B2F23 was a result of a 75 gallon per day primary to secondary leakage in the 2C SG. Pressure testing and eddy current identified the leak source as foreign object wear in tube R43-C23 at the second TSP on the cold leg side (TSP 02C). Subsequent eddy current examinations identified two additional adjacent tubes that contained foreign object wear. The foreign object that caused this damage was removed from the SG during B2R10. Table 5.1.2b provides a summary of the tubes that contained foreign object wear during B2F23.

L 1 TEST FULL LENGTH (TEH - TEC)

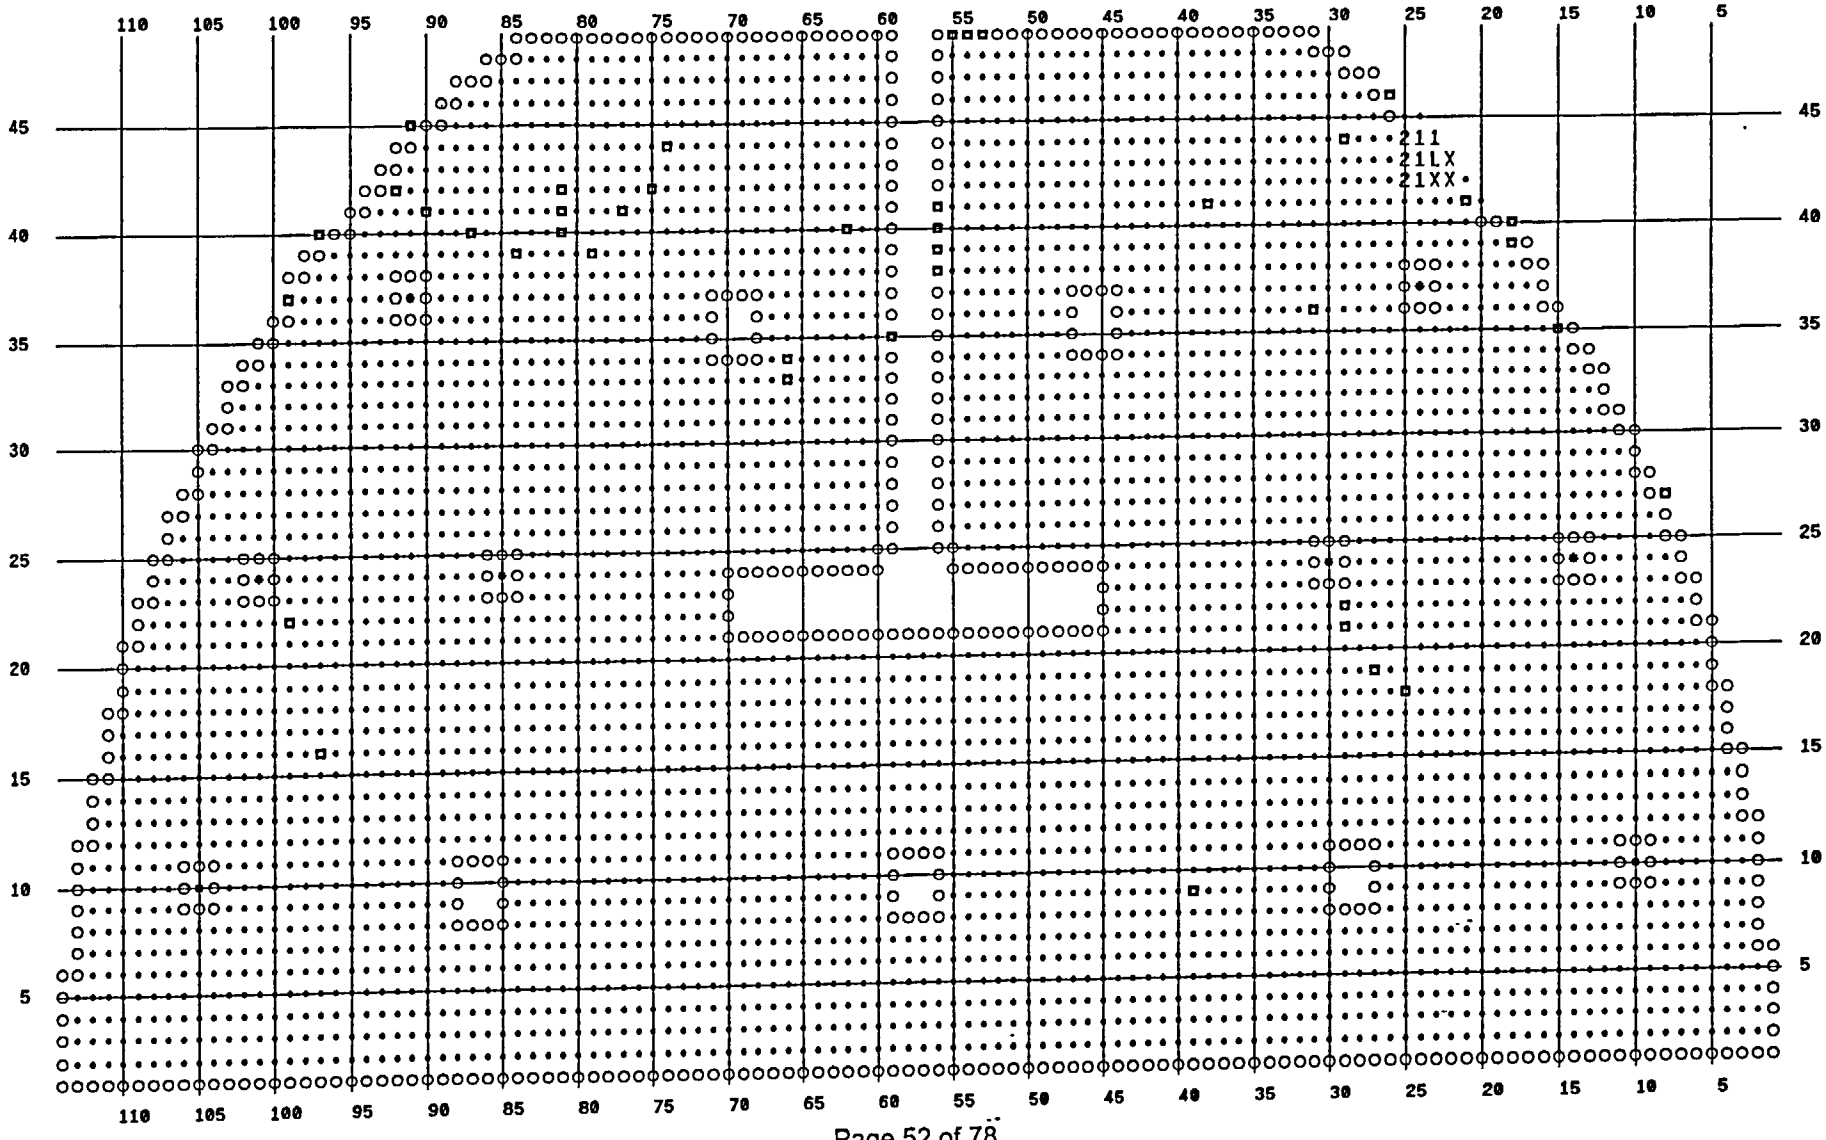
Figure A.34 B2F23 SG C Special Interest Plus-Point Inspection Scope

L 1 TEST 2C and 3C
