Subject: Beaver Valley Power Station, Unit No. 1 and No. 2
BV-1 Docket No. 50-334, License No. DPR-66
BV-2 Docket No. 50-412, License No. NPF-73
Reply to Request for Additional Information Regarding Proposed Alternative Repair Methods for Reactor Vessel Head Penetrations (Relief Request No. BV3-RV-04)

Responses to NRC Questions
Beaver Valley Power Station (BVPS) Unit 1 & 2
Additional Information Regarding Proposed Alternative Repair Methods for Reactor Vessel Head Penetrations (Relief Request No. BV3-RV-04)

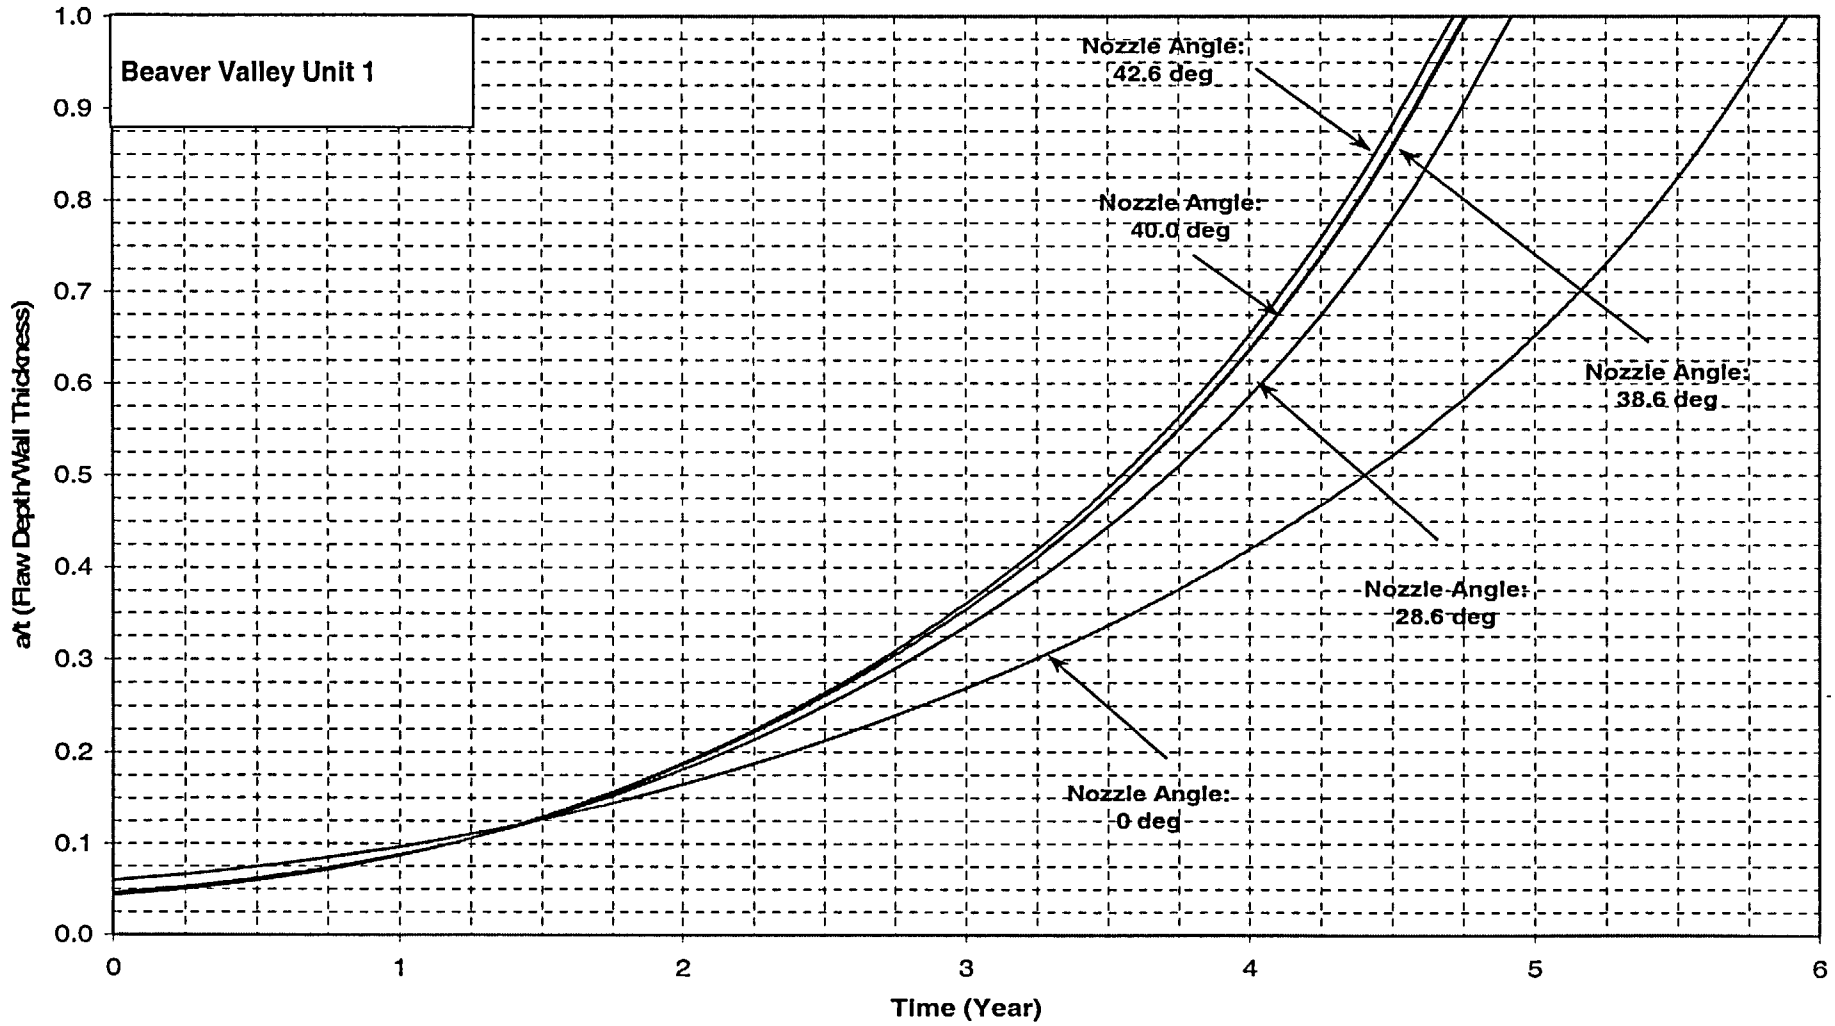
Figure 1
Beaver Valley Unit 1 Stress Corrosion Crack Prediction for 0.5" Below Weld (Nozzle Uphill)
Longitudinal Inside Surface (Aspect Ratio = 6:1)

The crack growth calculations shown here used a methodology consistent with the recently approved Section XI flaw evaluation approach, with a PWSCC crack growth law that is consistent with the MRP-55 report. Figure 1 shows the results for an axial flaw on the uphill side of the nozzle. Curves were developed for a range of nozzle angles, but the governing case for Unit 1 is for an angle of 38.6 degrees, which corresponds to the angle of the tubes in which indications were found. It can be seen that at least 4.25 years are required to grow a flaw from the threshold for initiation at 9MPA sq-rt-m to a depth of 75 percent of the wall thickness. This is a very conservative calculation because the inspection has shown that there are no flaws of any depth on the inside surface of the penetration, and because no benefit was taken for the compressive residual stresses induced by the weld repair.

Another measure of the conservatism is to look at the size flaw that would grow to the ASME limit of 75% of the wall thickness in one fuel cycle. From Figure 1, it can be seen that a flaw depth of over 30% of the wall would be required to have such growth.

A more general approach would be to consider all the tubes, regardless of where indications might be found. The most limiting penetration in Figure 1 is the 42.6 degree penetration, and for this case at least 4.2 years would be required to grow a flaw to the allowable depth of 75 percent of the wall thickness.

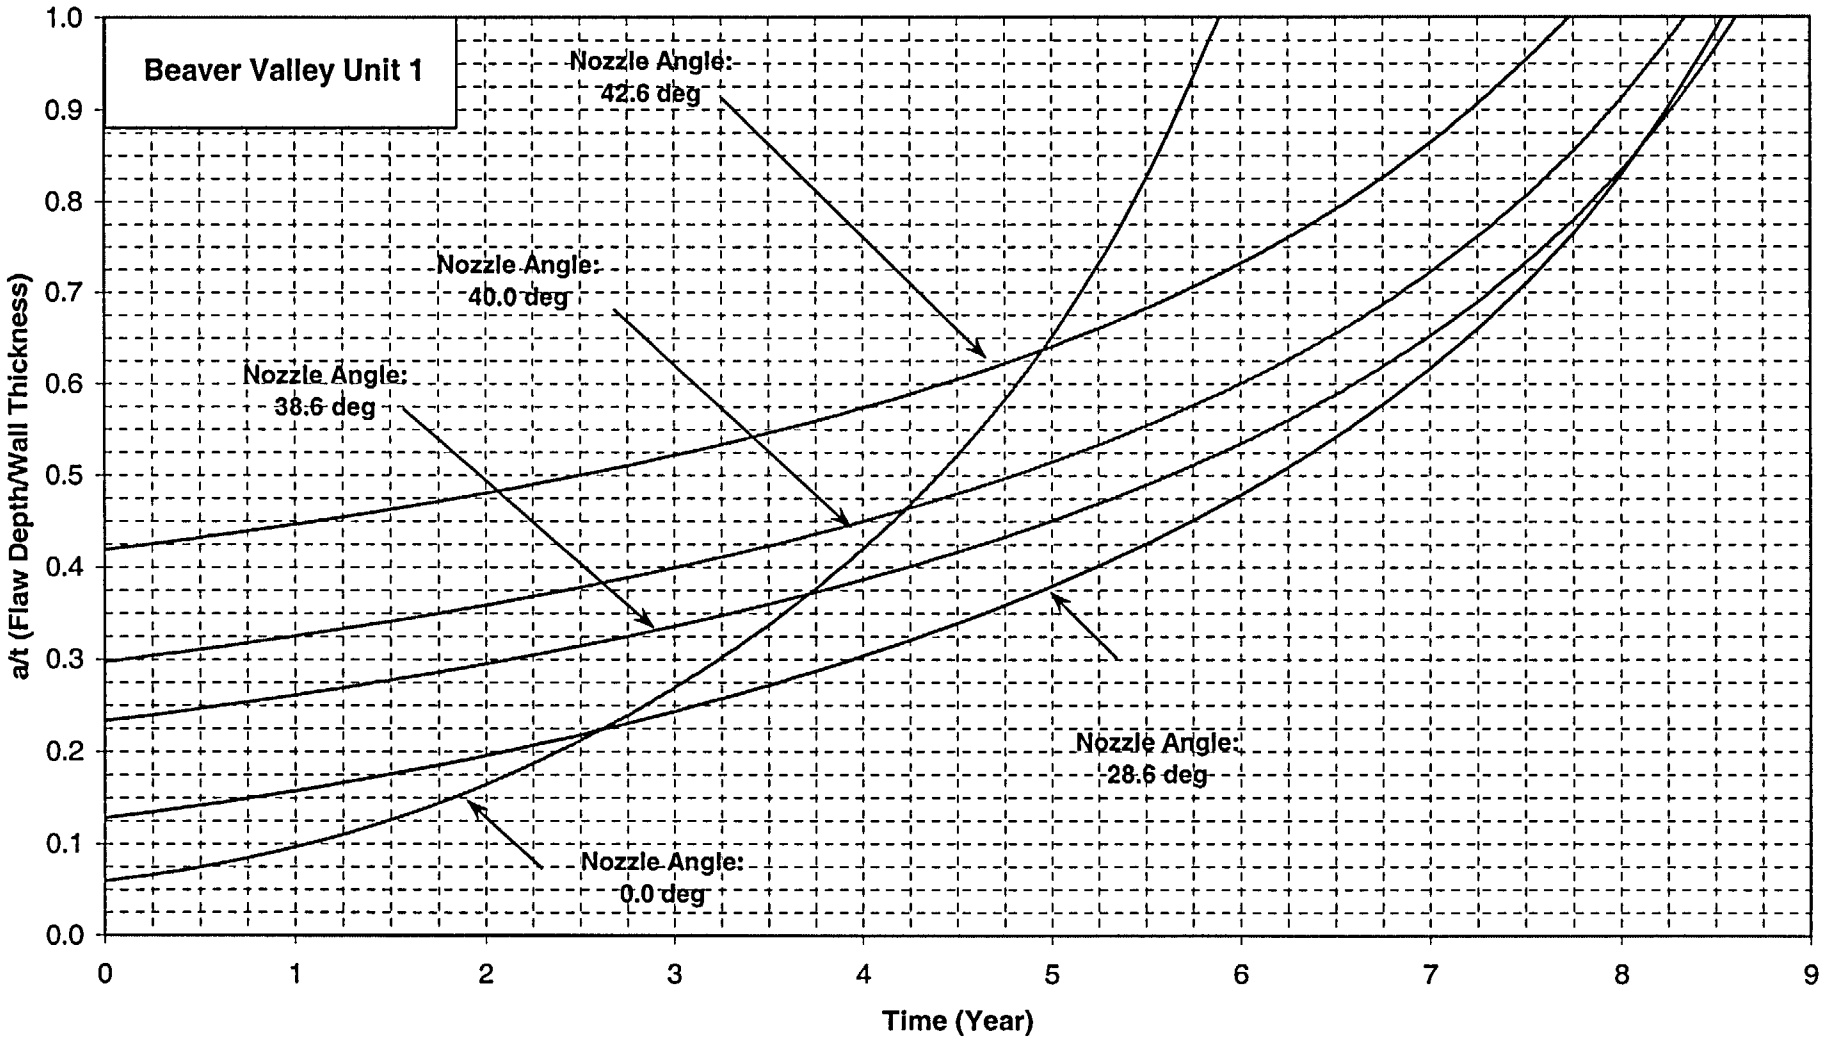
Figure 2
Beaver Valley Unit 1 Stress Corrosion Crack Prediction for 0.5" Below Weld (Nozzle Downhill)
Longitudinal Inside Surface (Aspect Ratio = 6:1)

Figure 2 shows similar results for the downhill side of the nozzle, where the stresses are lower. Again, the governing case is for a 38.6 degree angle, and the time required to grow a flaw from the threshold for crack growth to a depth of 75% of the wall thickness is shown to be approximately 7.2 years. Note that the initial flaw size for this case is rather large, because the stresses are low in this region, and a large flaw must be postulated to reach the threshold for crack growth.

Again, a more general approach would be to consider all the tubes, regardless of where indications might be found. The most limiting penetration in Figure 2 is the zero degree penetration, and for this case at least 5.8 years would be required to grow a flaw to the allowable depth of 75 percent of the wall thickness.
