SUBJECT: Calvert Cliffs Nuclear Power Plant
Unit Nos. 1 & 2; Docket Nos. 50-317 & 50-318
Supplemental Data for Request for Relaxation from Certain Inspection Requirements in NRC Order (EA-03-009) for Reactor Pressure Vessel Head Penetration Nozzles (TAC Nos. MB7752 and MB7753)

RESPONSE TO REQUEST FOR ADDITIONAL INFORMATION AND REACTOR PRESSURE VESSEL HEAD UT EXAMINATION RESULTS

ADDITIONAL RELAXATION REQUEST

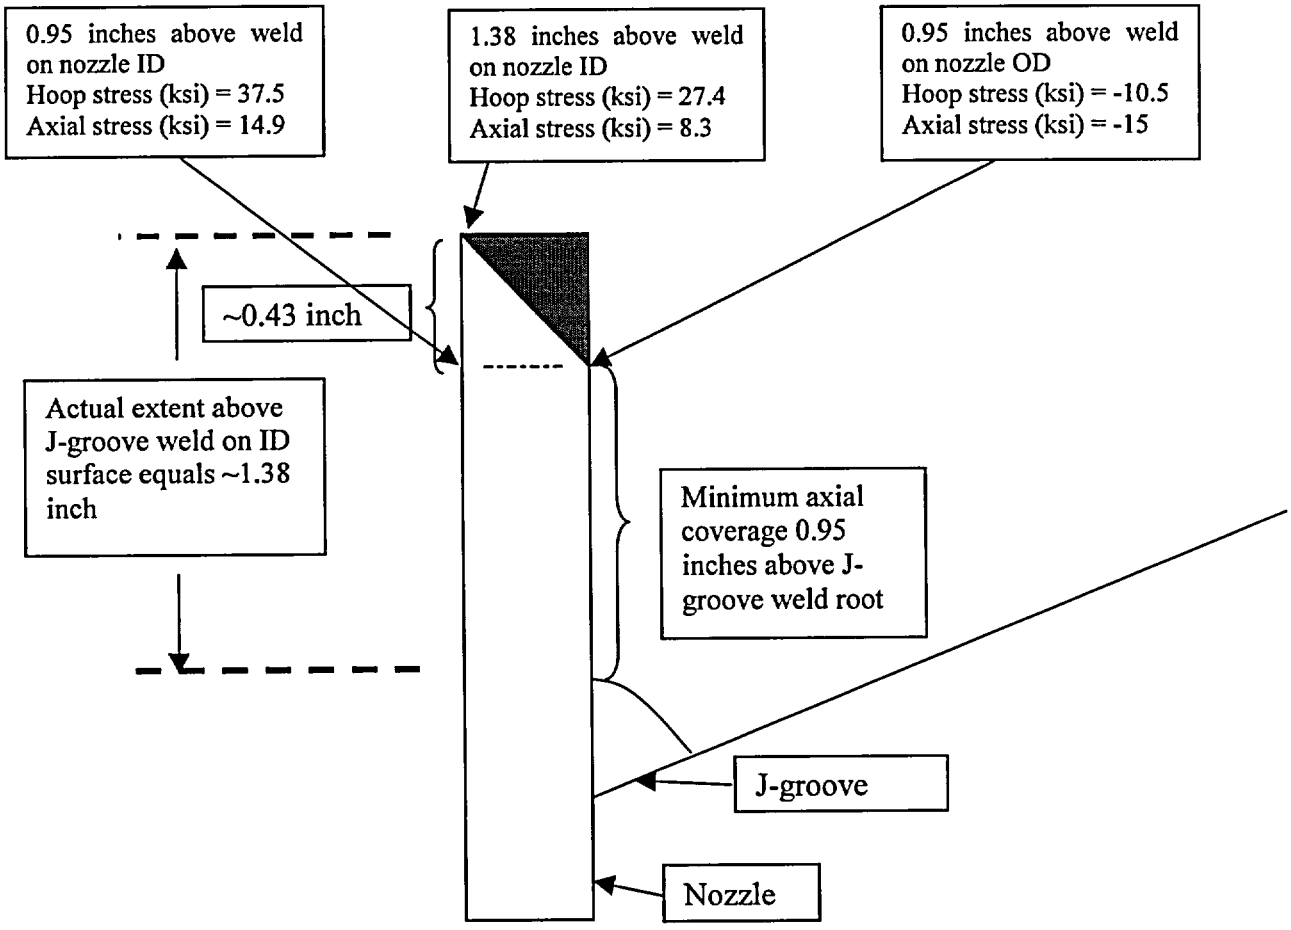
FIGURE 1

The requested information is provided on Figure 1 below. The bounding value is located on Nozzle 43 which had coverage to 0.95 inches above the root of the J-groove weld. Nozzle 43 has a 38.5 degree angle with the head. Calculated stresses are reported for a 42.5 degree nozzle, which bounds a 38.5 degree nozzle. Stresses are provided at three locations: on the outside diameter (OD) at the elevation of highest coverage, on the inside diameter (ID) at the same elevation, and on the ID at the elevation of highest coverage. Coverage elevations above the J-groove weld have been reported for coverage on the OD. In all cases coverage on the ID is higher. This is due to the configuration of the transducers in the blade probe and is analogous to the situation at the bottom of the nozzle (see Figure 1 in Attachment 2). Further discussion on the configuration of the transducers in the blade is contained in Attachment (2).

Bounding hoop and axial stresses at elevation of minimum coverage extent above the root of the J-groove weld occurs on Nozzle 43

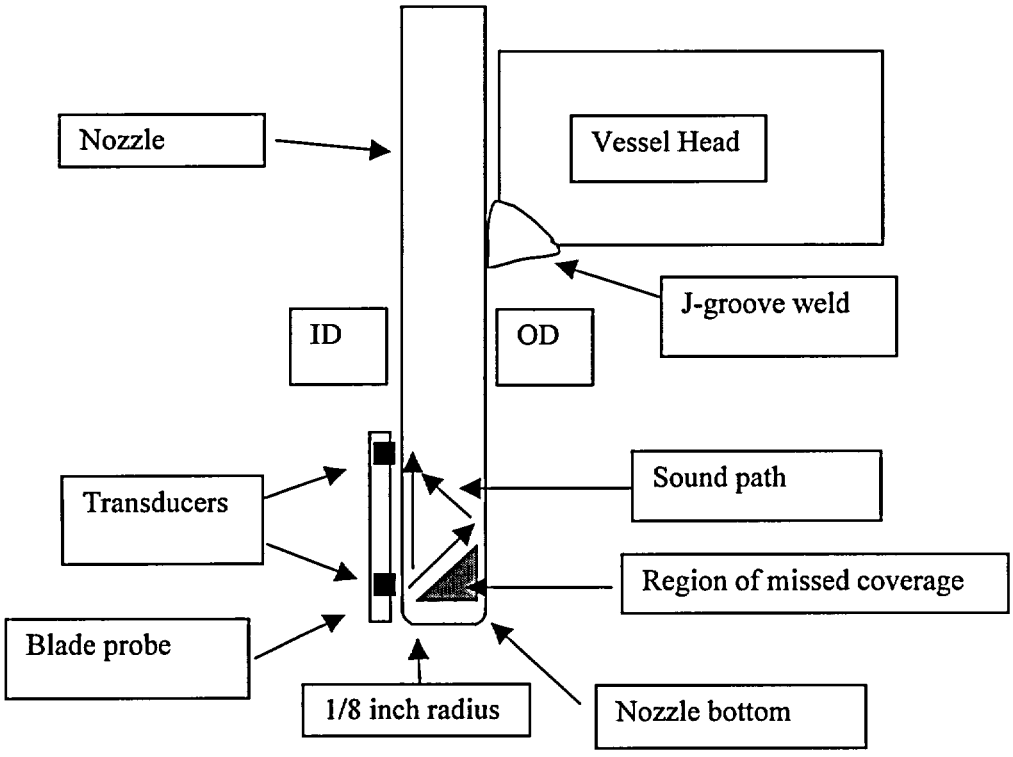
FIGURE 1

This relaxation request applies to all Calvert Cliffs Nuclear Power Plant Unit 2 CEDM penetrations 1 through 65. The un-interrogated area at the bottom end of the CEDM nozzles is due to the configuration of the ultrasonic transducers in the probes used to examine the nozzles. These probes have separate transducers for sending and receiving the ultrasonic signal. The probes, used for detection of the most significant type of cracks, circumferential cracks, have the two transducers arranged one above the other. The transducers used in the CE-type circumferential blade probe are located nominally 0.86-inch apart. With this configuration, the lower transducer will not contact the inside wall on the nozzle until the upper transducer is inserted greater than approximately 0.86-inch into the nozzle. Since the scanning process requires that both transducers be in contact with the surface, the probe cannot scan a small portion of the bottom of the nozzle. Based on the geometry involved in the transducer location and nozzle configuration, the portion that cannot be scanned is the portion extending from the bottom of the nozzle upward for a distance of approximately 0.56-inch. The value is half the distance between the two transducers plus a 1/8-inch radius at the bottom corner of the nozzle. The actual volume of unobtainable coverage is triangular in cross-section. The inside diameter of the nozzle receives relatively complete coverage (with a lateral wave), while the UT angle defines a triangle hypotenuse extending from the nozzle inside diameter lower end, to a spot on the nozzle outside diameter, located approximately 0.56-inch above the bottom of the nozzle. The other legs of the triangle are the lower portion of the nozzle outside diameter and the bottom surface of the nozzle. Figure 1 illustrates the un-interrogated area.

Illustration of the Un-interrogated Area at the Bottom of the CEDM Nozzles
