Root Cause Analysis of the Reactor Pressure Vessel Head Degradation at the Davis-Besse Nuclear Power Station

May 7, 2002

FENOC

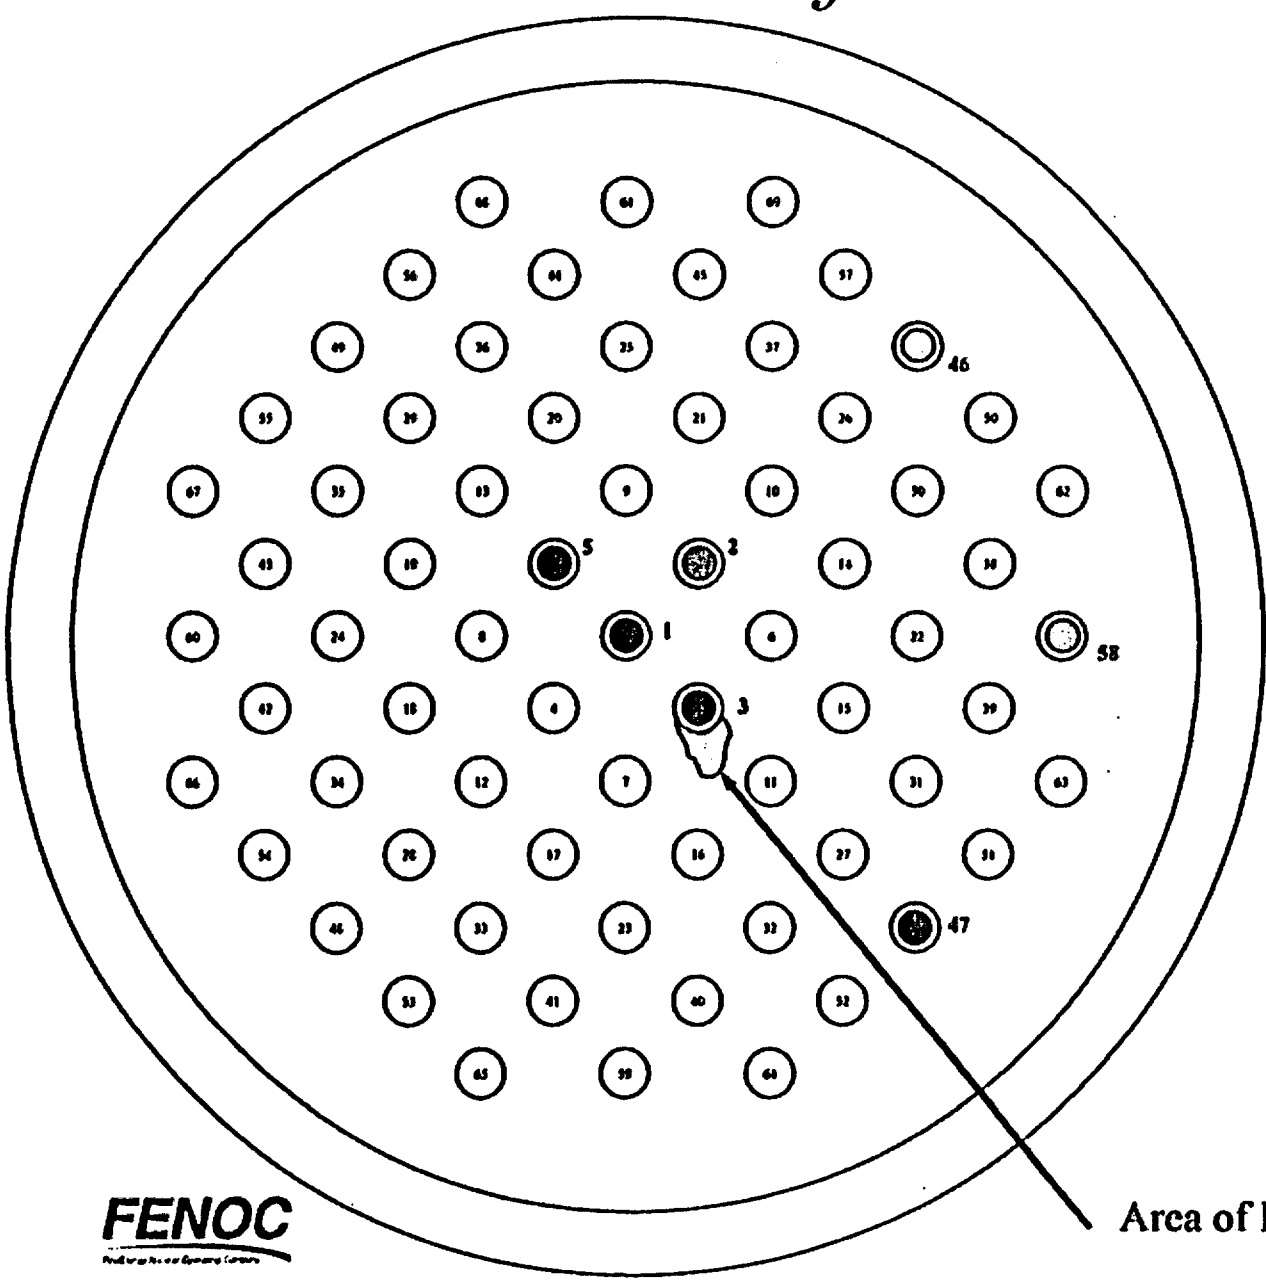
Facts of Discovery

Nozzle #	Summary of Results
1*	9 Axial Flaws, 2 through-wall (TW)
2*	8 Axial Flaws, 1 Circumferential Flaw, 6 TW
3*	4 Axial Flaws, 2 TW
5*	1 Axial Flaw
46	No Flaw Indication
47	1 Axial Flaw
58	No Recordable Indications

Nozzle with Axial Indication -

Nozzle with Axial and Circumferential Indication –

No flaw indication - ○

Area of Degradation

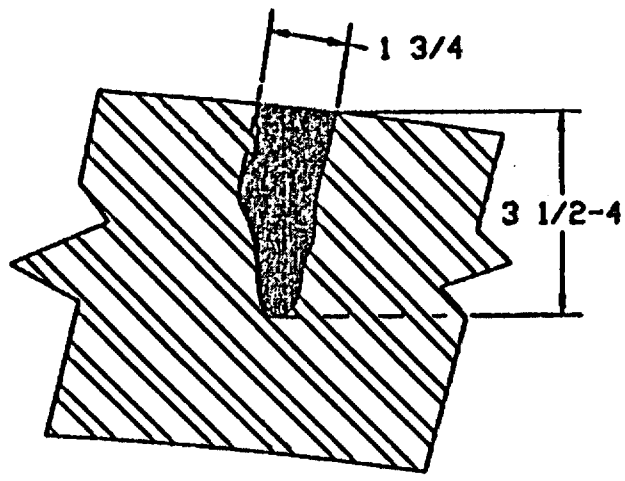
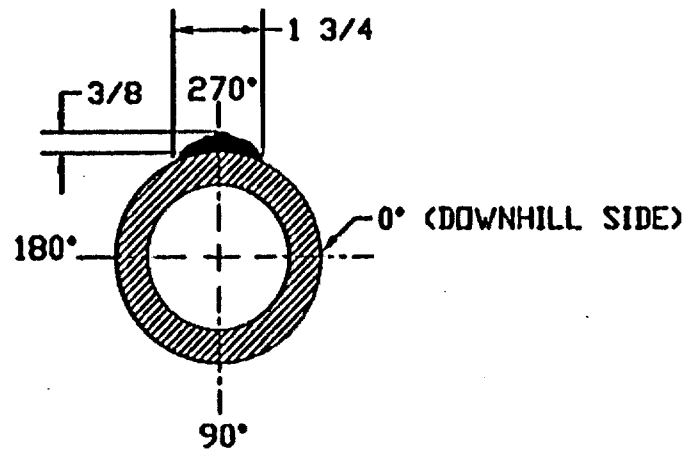
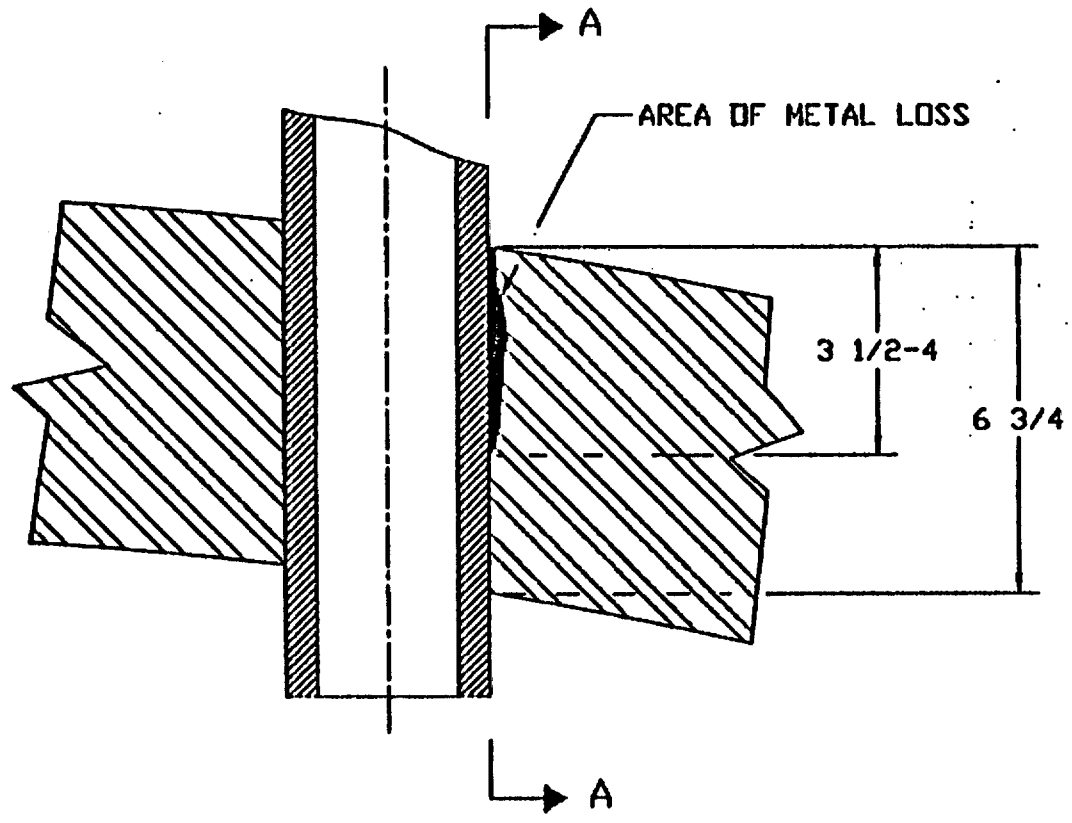
Nozzle 2 Corrosion Profile

- Oxygen penetration in annulus increased due to decreasing velocity and differential pressure in annulus
- Preferential corrosion occurred in the vicinity of crack (consistent with EPRI-6 test)
- Exiting steam mass flow from annulus region not sufficient to wet surrounding areas
- Nozzle 2 progressed through this stage [redacted]

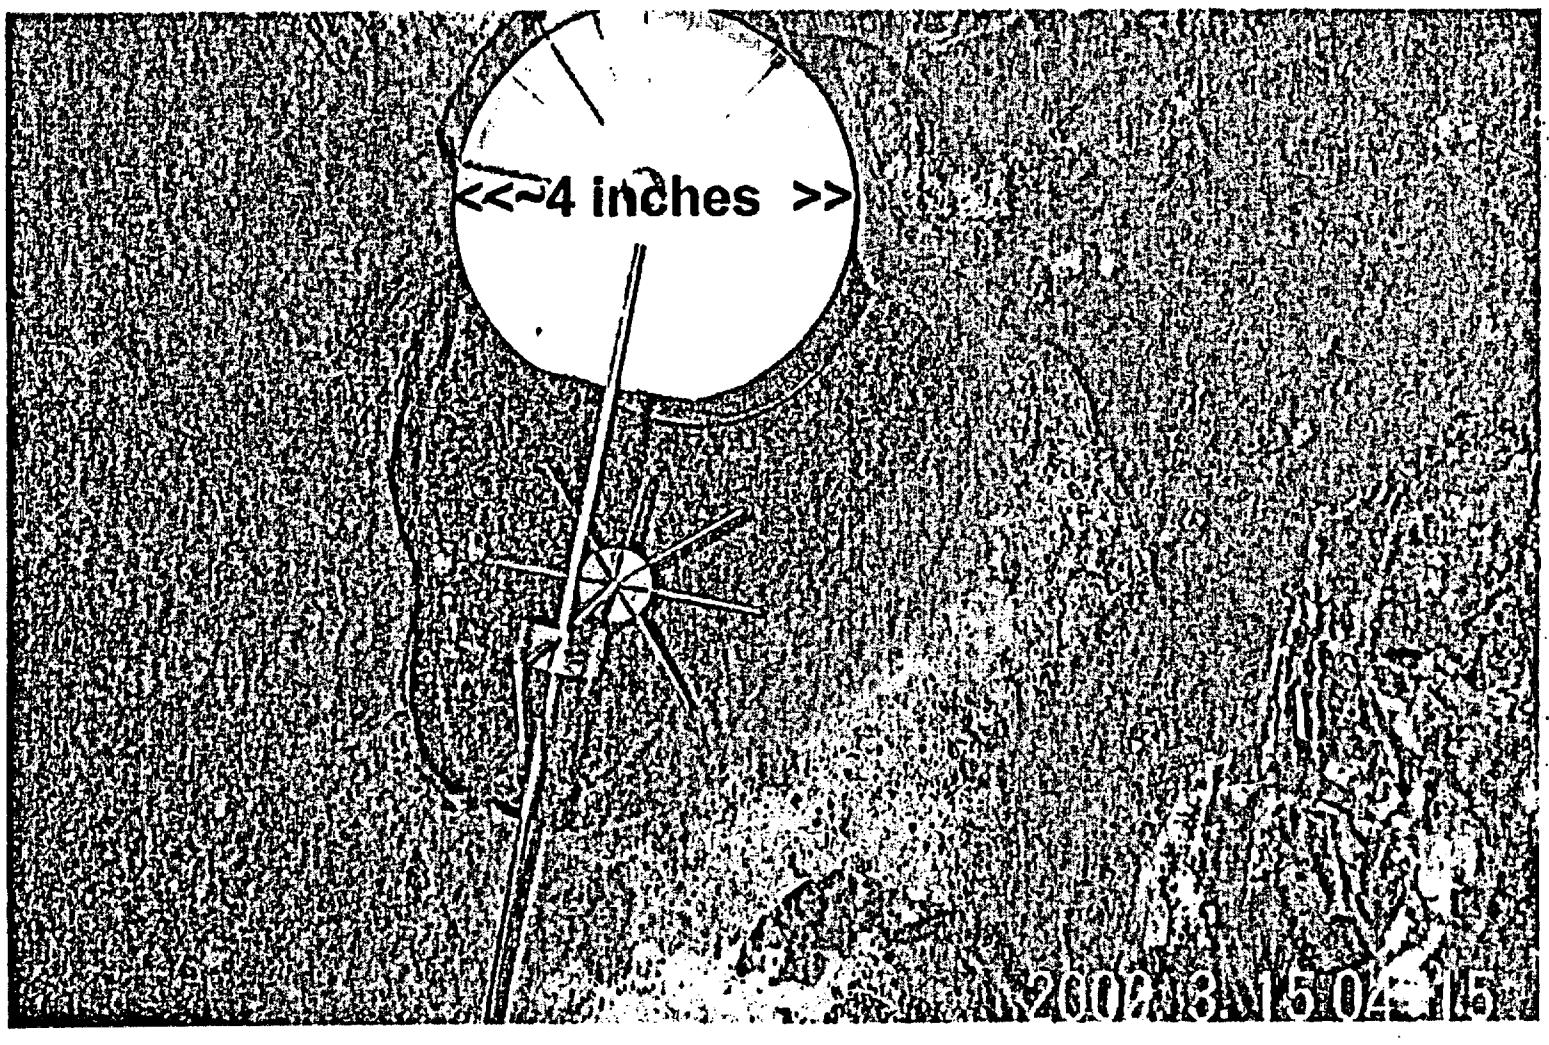
Nozzle 3 Cavity

- 4 years of stage 4 corrosion
- Maximum radial progression ~7 inches
- Average rate ~2 inches per year
- Lateral direction corrosion rate ~1/2 that of axial direction
- Consistent with EPRI Boric Acid Corrosion Guidebook

- 1990 (+/- 3yrs) Nozzle 3 cracking initiated
- 1994-1996 Nozzle 3 cracking propagates through-wall
- 1998 and 2000 Nozzle leak not identified
- 2002 Corrosion discovered at nozzle 3, minor degradation at nozzle 2

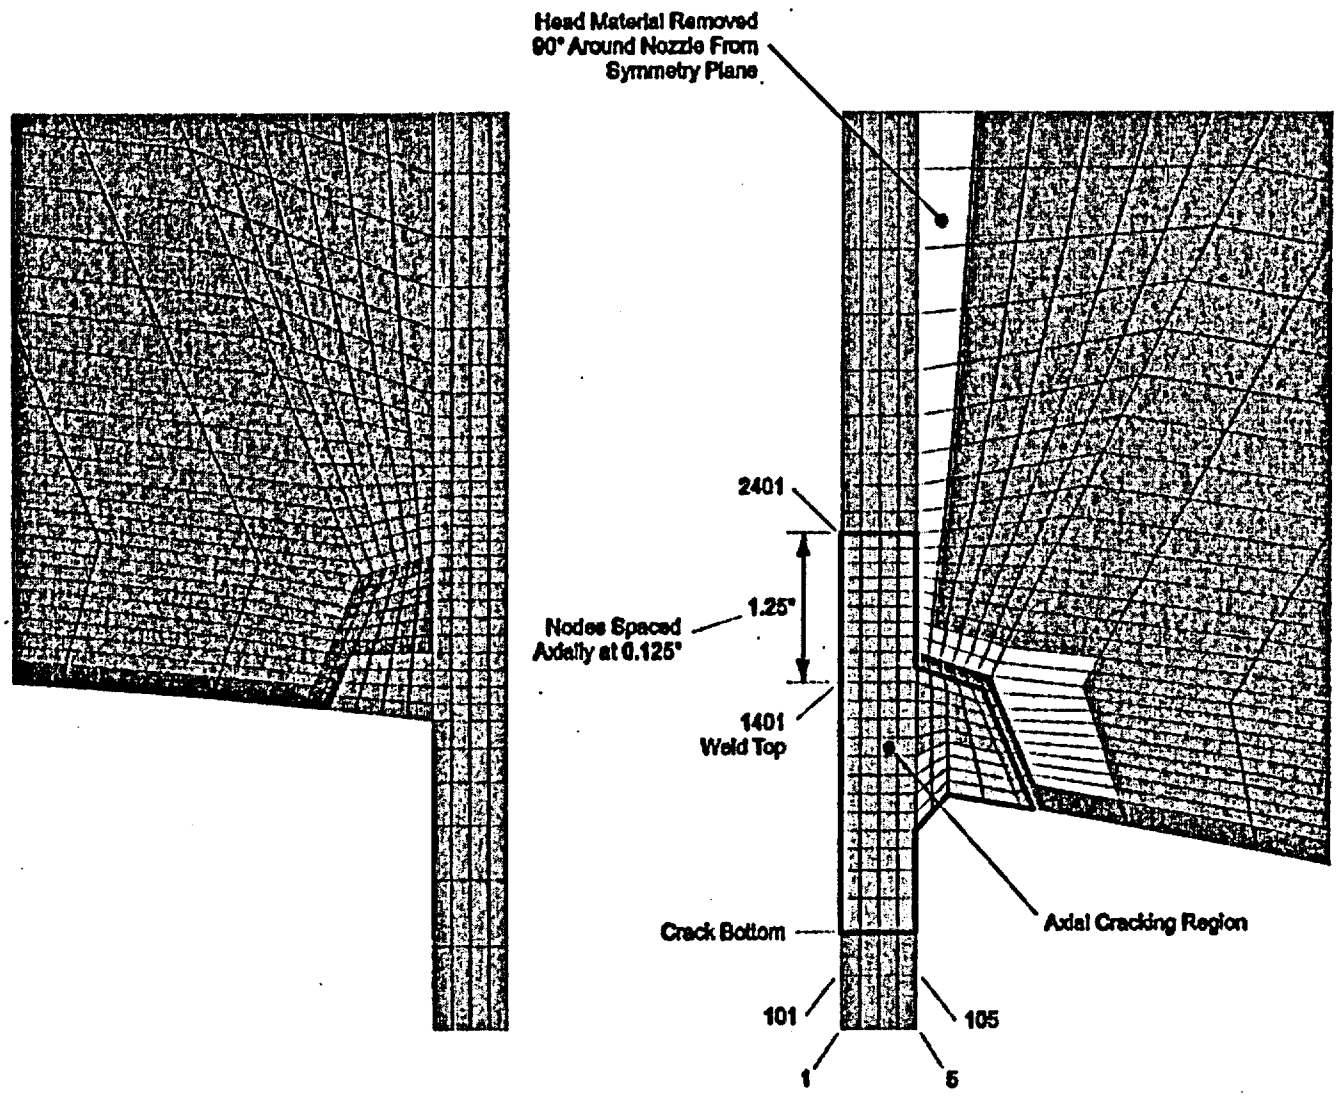
Nozzle 3 Crack Finite Element Model

- Davis-Besse axial cracks above weld were longer than reported from other plants (1.1 inches for nozzle 2 and 1.2 inches for nozzle 3)
- Analytical leakage predictions yield wide range of results (.025 to >1 gpm) depending on method and assumed geometry used
- Estimated leak rate based on boric acid deposits and unidentified leakage are in the range of 0.04 to 0.2 gpm

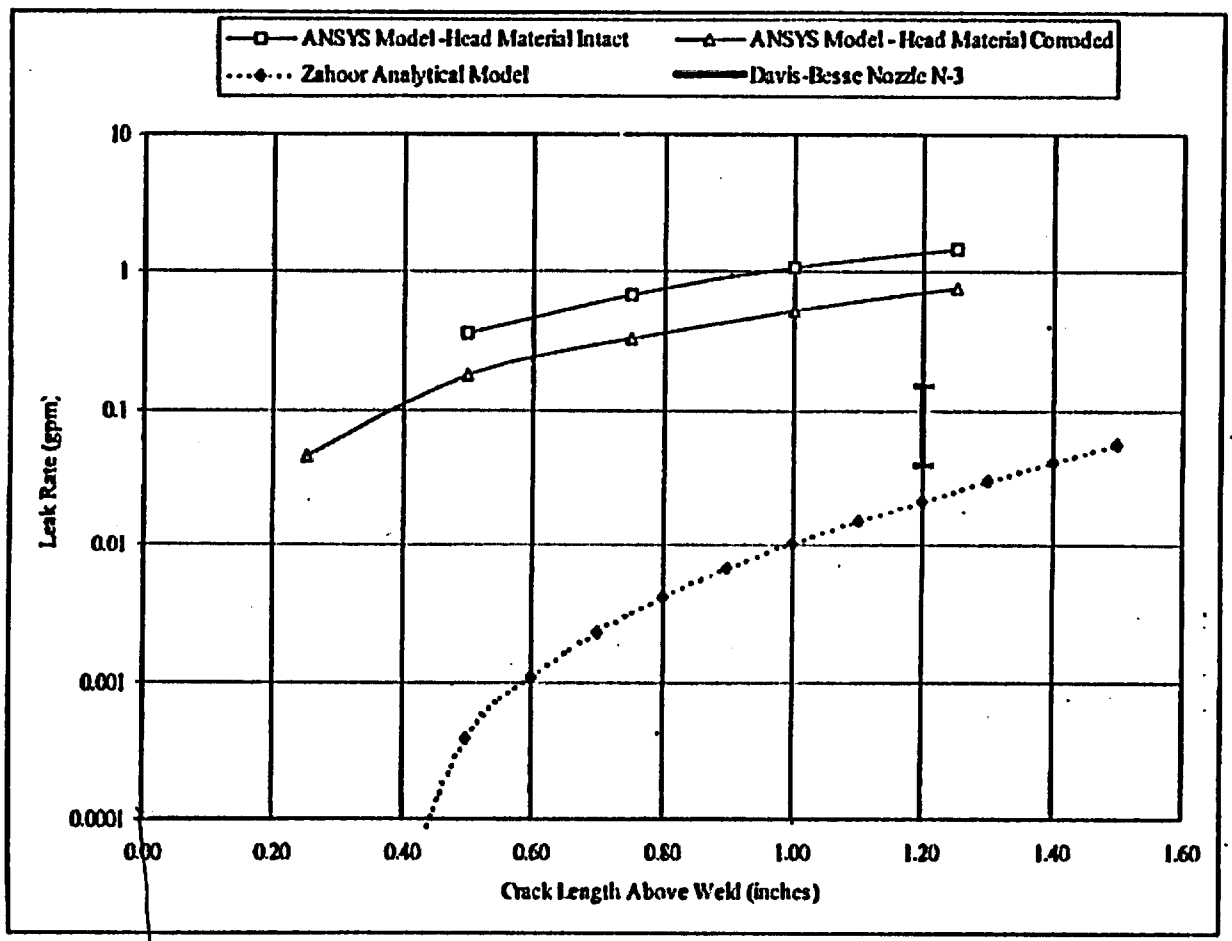
Analytically Predicted Leak Rates

Leak Rate versus Crack Length

Estimated leakage rate from nozzle 3 crack is consistent with analytical predictions
