UNITED STATES
NUCLEAR REGULATORY COMMISSION
WASHINGTON, D. C. 20555

June 15, 1990

SUBJECT: GUIDANCE FOR PERFORMING TEMPORARY NON-CODE REPAIR OF ASME CODE CLASS 1, 2, AND 3 PIPING (GENERIC LETTER 90-05)

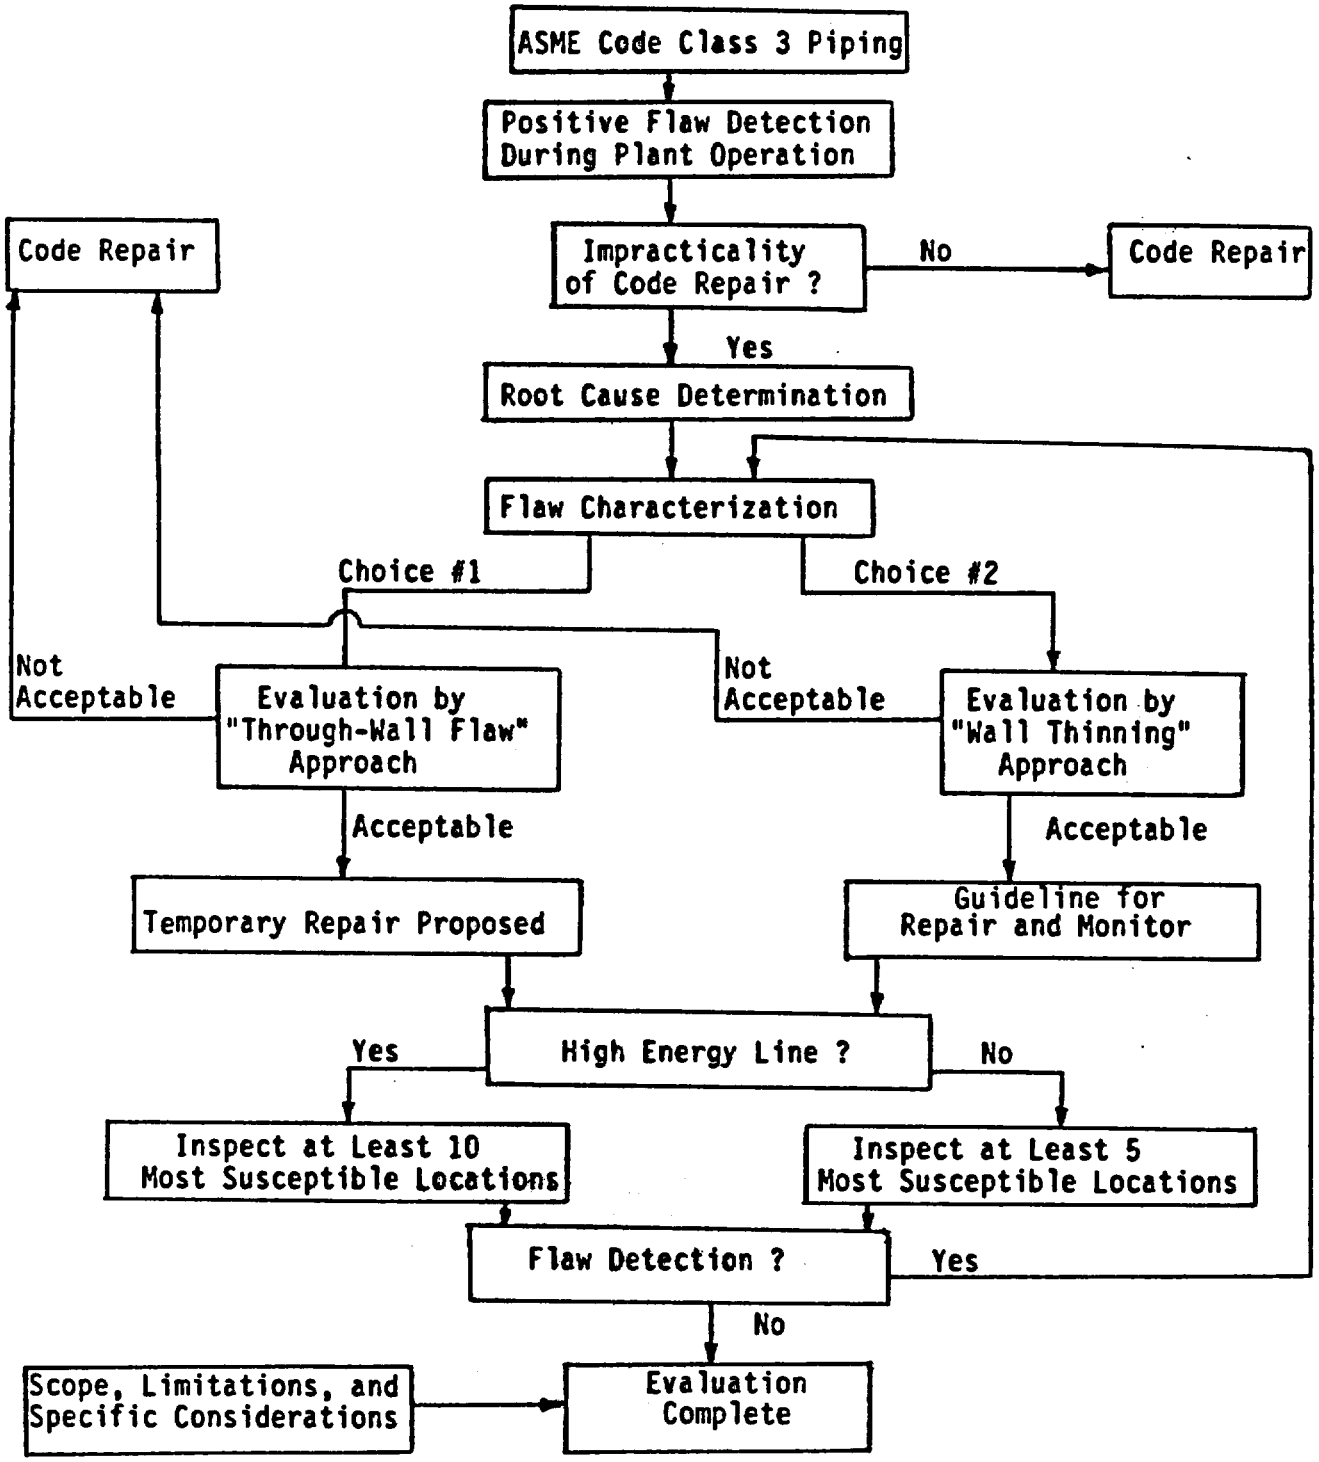
Figure 1 shows a flow chart for the staff evaluation guideline on temporary non-code repairs of code Class 3 piping. The flow chart consists of (1) flaw detection during plant operation and impracticality determination, (2) root cause determination and flaw characterization, (3) flaw evaluation, and (4) augmented inspection.

Fig. 1 Flow chart of staff guidance in evaluating relief requests for temporary non-code repair of ASME Code Class 3 piping.

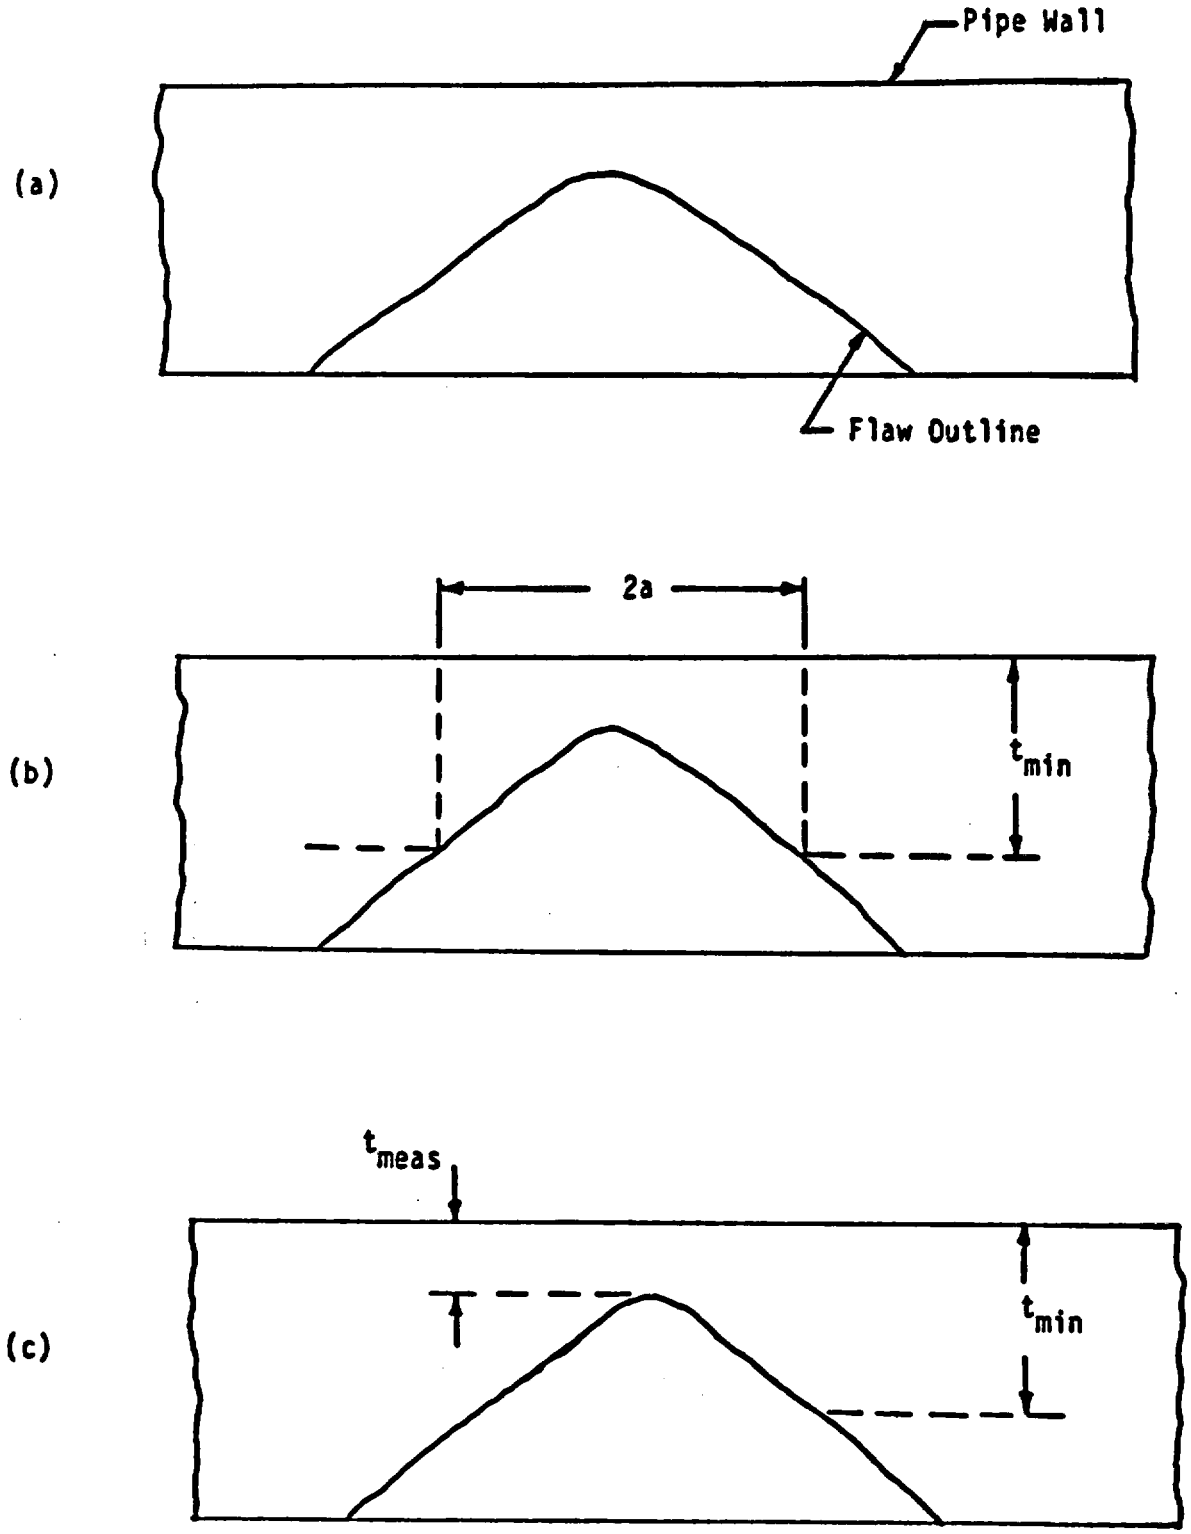
This approach assumes a through-wall flaw and evaluates the flaw stability by a linear elastic fracture mechanics methodology. Figure 2b shows some geometric parameters used in the evaluation. The code-required minimum wall thickness "$t_{min}$" should be determined. The maximum length of the portion of the flaw that extends beyond "$t_{min}$", independent of orientation with respect to the pipe, is the through-wall flaw length "2a". As shown in Figure 2b, the flaw does not have to be through-wall for the application of this approach. The length "2a" can be determined according to Figure 2b for a flaw that may or may not be through-wall.

Figure 2c shows some geometric parameters used in the evaluation. The code-required minimum wall thickness "$t_{min}$" should be determined. The minimum measured wall thickness "$t_{meas}$" should be determined by NDE. Based on an estimated wall thinning rate and "$t_{meas}$", the minimum predicted wall thickness "$t_p$" projected to the next inservice examination should be determined. ASME Code Case N-480 provides rules for determining the allowable local wall thickness "$t_{aloc}$" for the measured length of the flaw. Local wall thinning is acceptable if "$t_p$" exceeds "$t_{aloc}$".

Fig. 2 Schematic of (a) generalized flaw, (b) parameters in "through-wall flaw" approach, and (c) parameters in "wall thinning" approach.

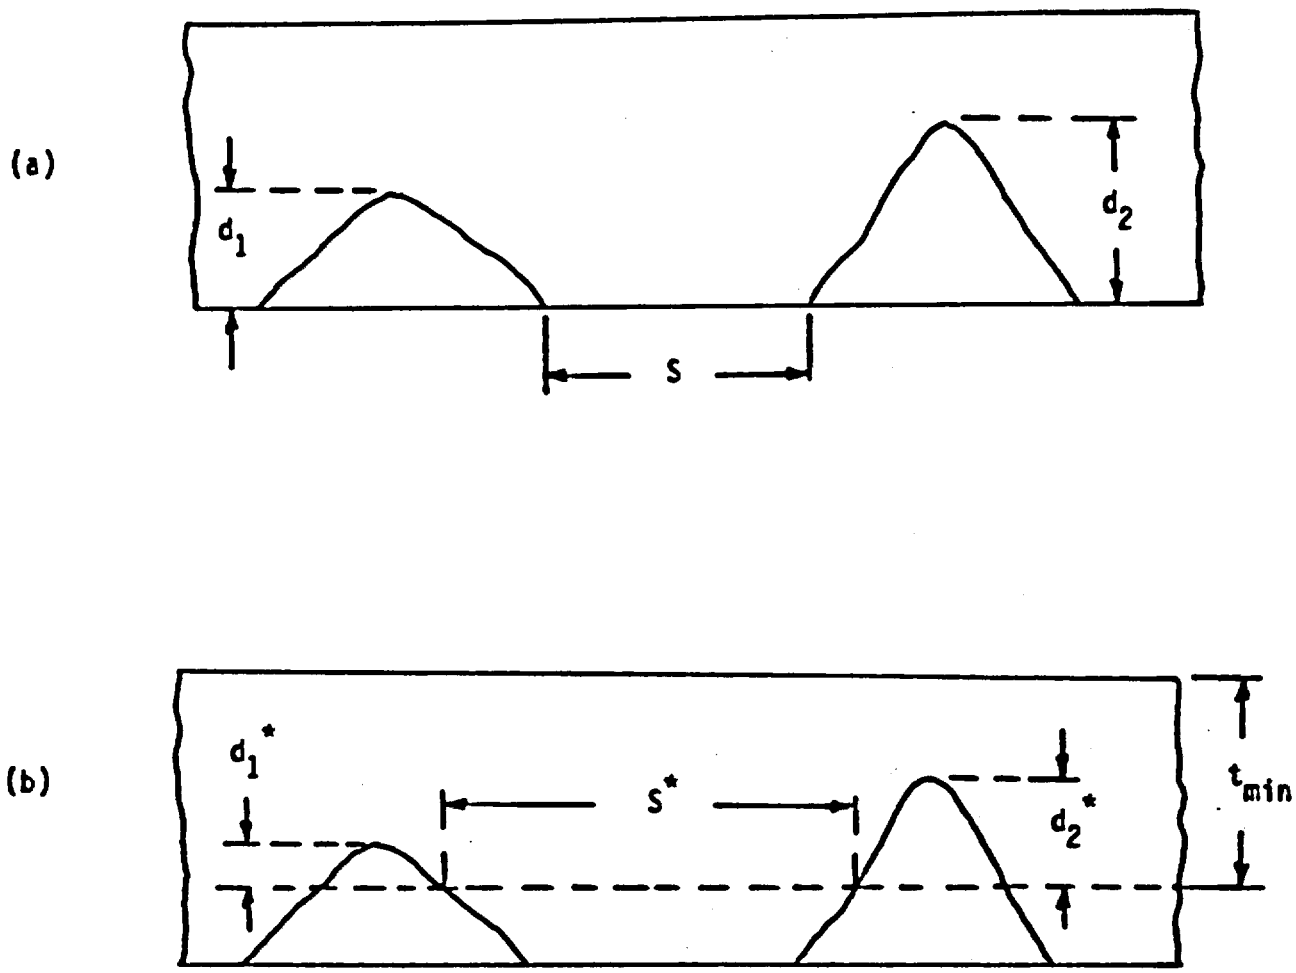
Figure 3a shows the geometric parameters used in the evaluation for the "wall thinning" approach. The minimum spacing "S", independent of orientation relative to the pipe, between two flaws of depths "$d_1$" and "$d_2$" are shown. For "$d_2$" larger than "$d_1$", the two flaws should be treated as a single flaw if "S" is less than or equal to two times "$d_2$".

Figure 3b shows the geometric parameters used in the evaluation for the "through-wall flaw" approach. The difference between Figure 3a and Figure 3b is that the parameters are measured from "$t_{min}$" in Figure 3b. The minimum spacing "$S^*$", independent of orientation relative to the pipe, between two flaws of depths "$d_1^*$" and "$d_2^*$" is shown. For "$d_2^*$" larger than "$d_1^*$", the two flaws should be treated as a single flaw if "$S^*$" is less than or equal to two times "$d_2^*$".

Fig. 3 Schematic indicating parameters in determining single versus multiple flaws for (a) "wall thinning" approach and (b)"through-wall flaw" approach.
