Name of Proceeding: Advisory Committee on Reactor Safeguards Materials and Metallurgy & Plant Operations Joint Subcommittee Meeting

ADVISORY COMMITTEE ON REACTOR SAFEGUARDS
MATERIALS & METALLURGY AND PLANT OPERATIONS SUBCOMMITTEES
VHP CRACKING AND RPV HEAD DEGRADATION
COMMISSIONERS' CONFERENCE ROOM (O-1G16)
11545 ROCKVILLE PIKE, ROCKVILLE, MARYLAND

April 23, 2003

REACTOR VESSEL HEAD INSPECTIONS

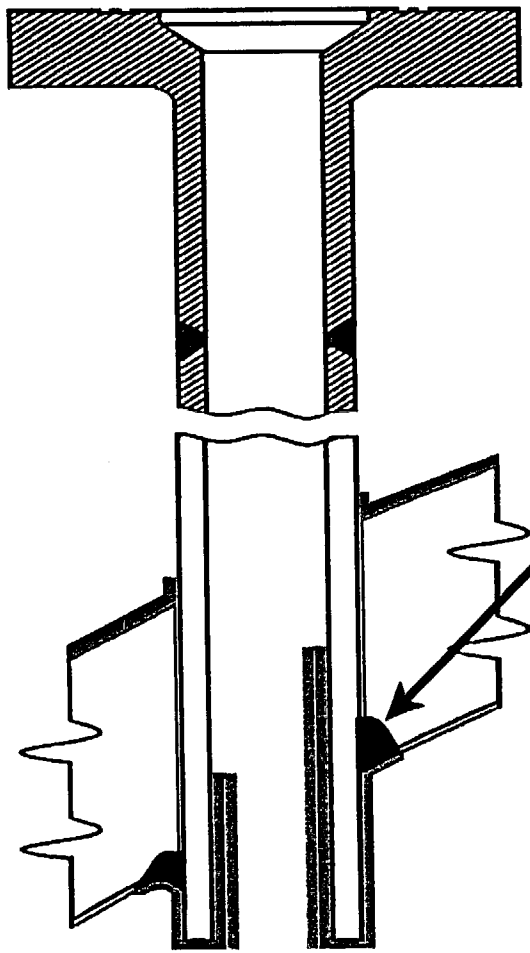
Order EA-03-009
Required Inspection Surfaces

Bare Metal Visual Inspection Area

Ultrasonic Inspection Area

Wetted Surface Inspection Area

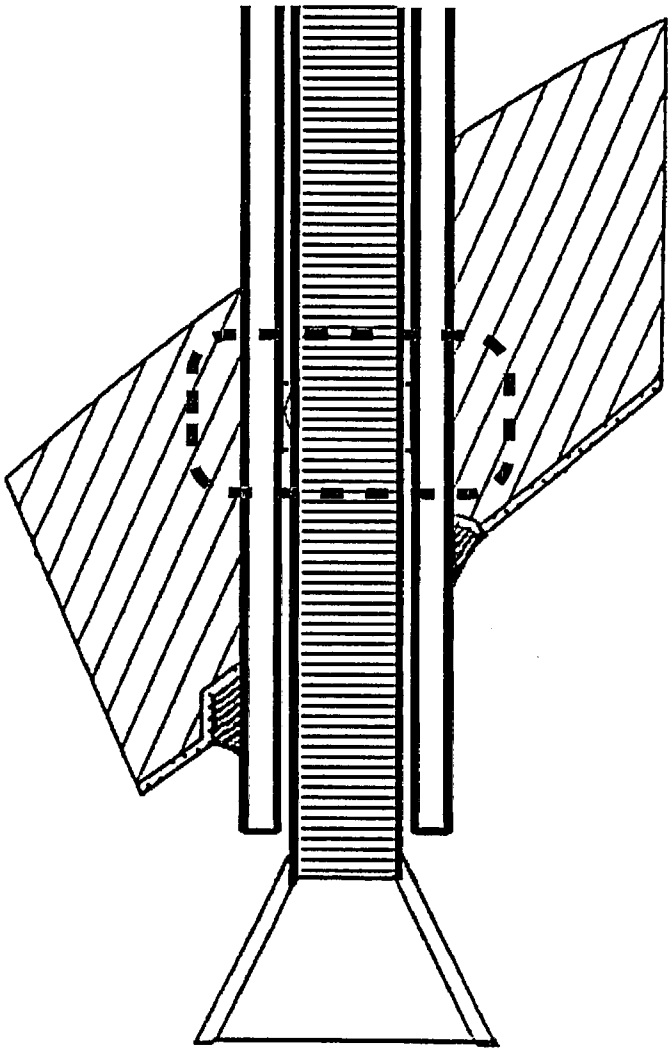
Calvert Cliffs
Order Inspection Limitations

Thermal/Guide Sleeve

Sleeve Expansion Points

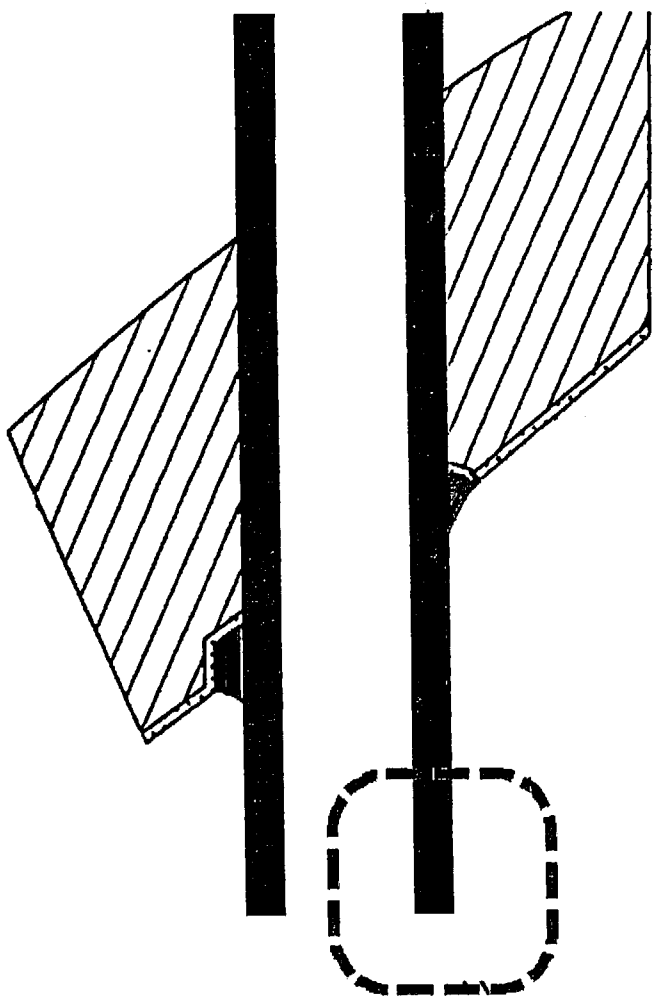
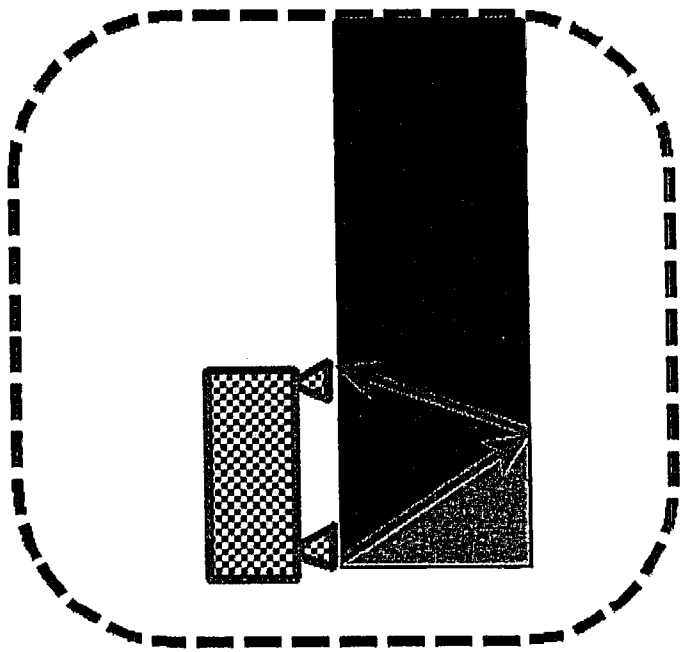
TOFD Transducer Coupling Limitations

Area of Nozzle
Inspection Limitation

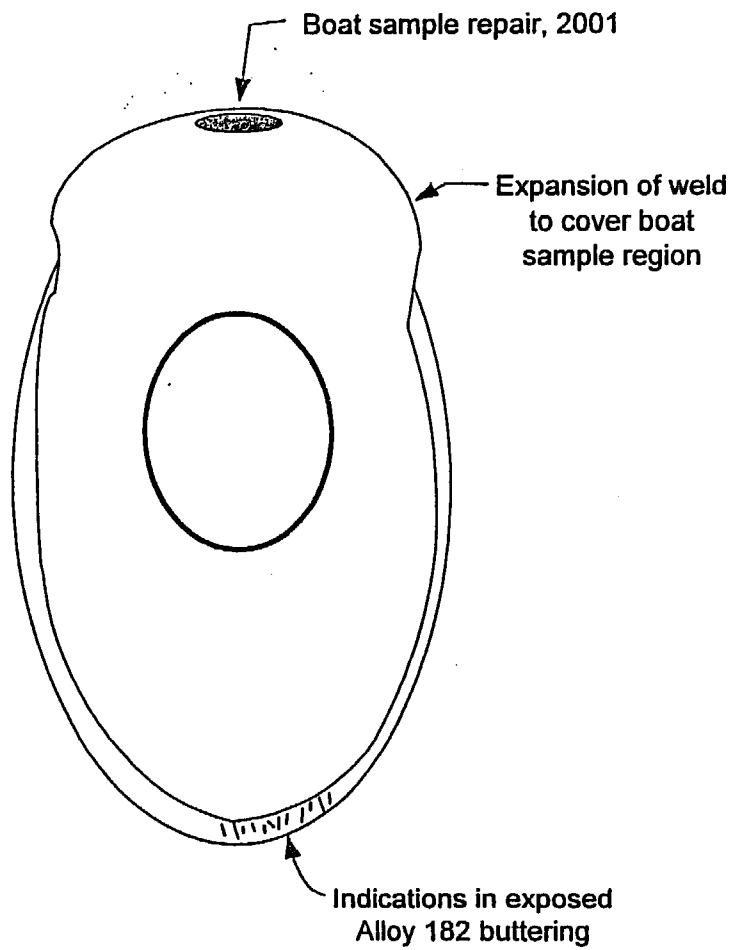
Sketch of Weld Repair, Penetration 62, Shows the Extension to Cover Buttering

- Several leaks identified on the RPV head
- Repairs implemented in fall 2001 did not adequately cover original Alloy 182 buttering
- Numerous welds with indications
- RPV head replaced with new head (Alloy 690 nozzles)

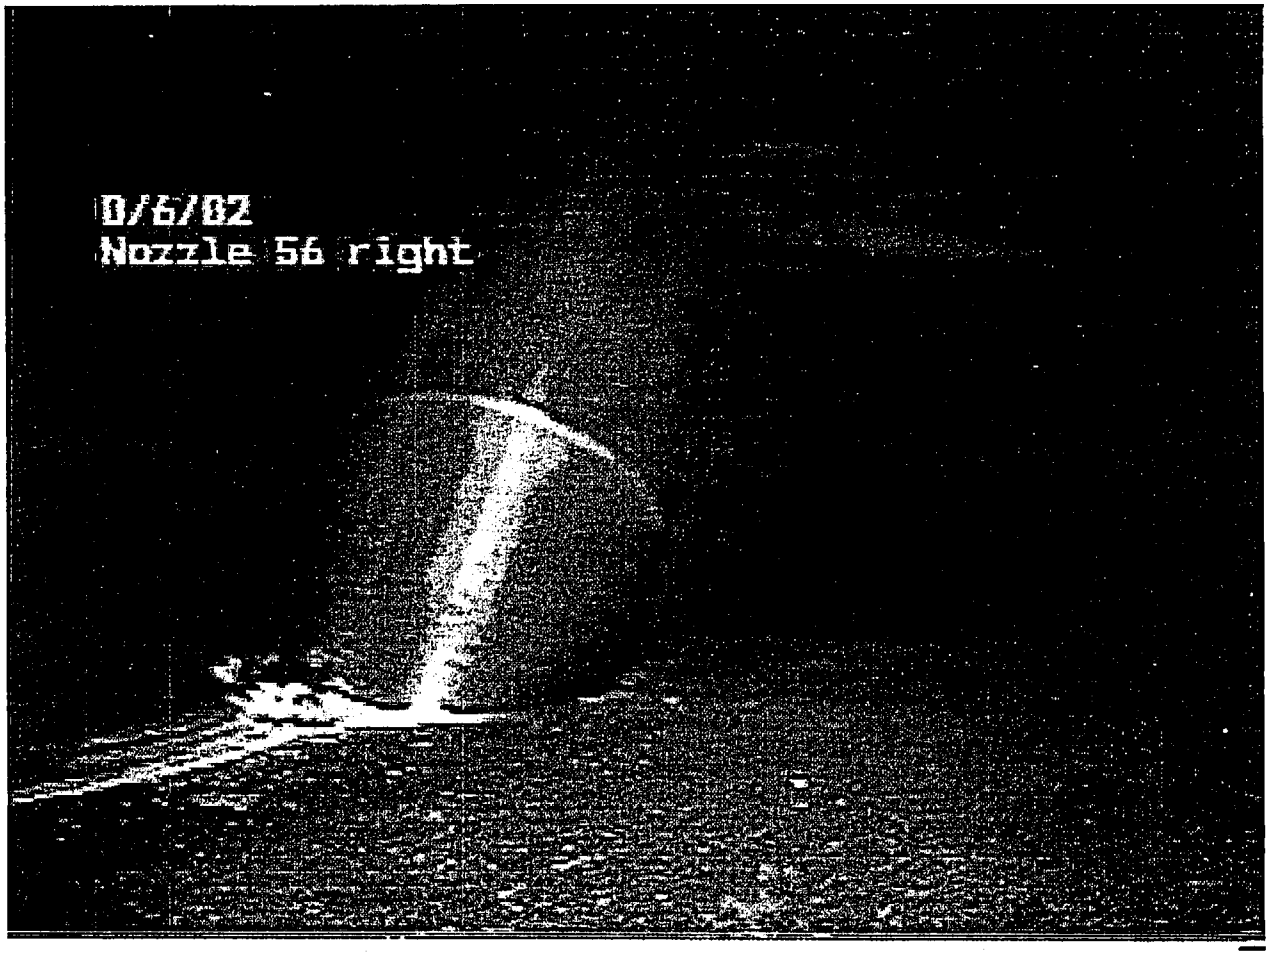
1R17 Nozzle 56 Boric Acid

- Leak identified on the RPV head at repaired nozzle
- Repair implemented in spring 2001 left original Alloy 182 exposed
- Revised repair implemented

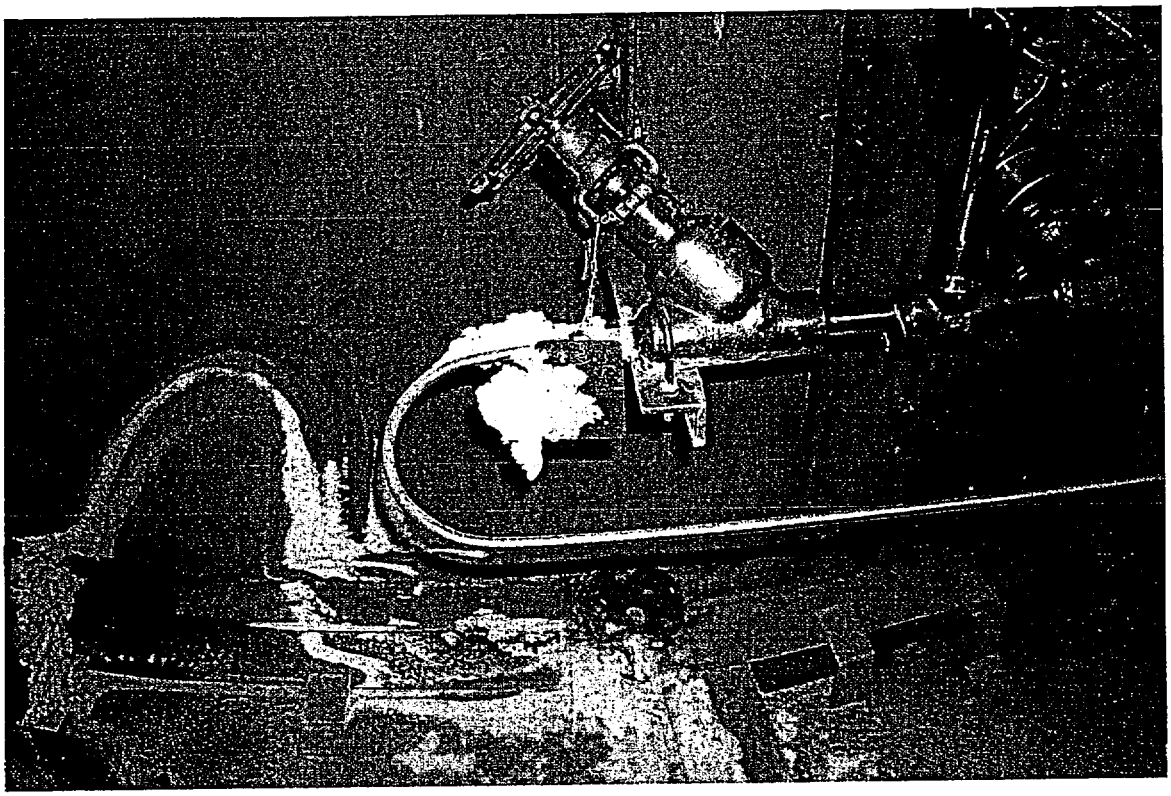
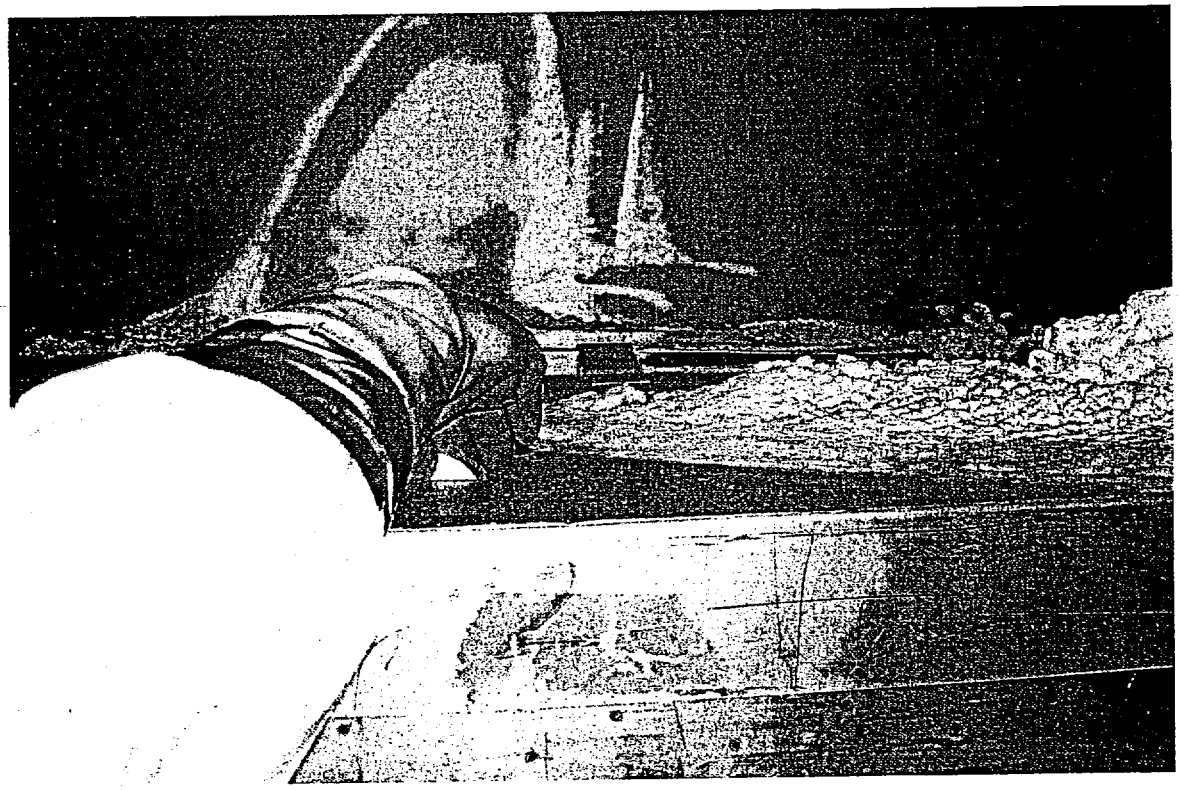
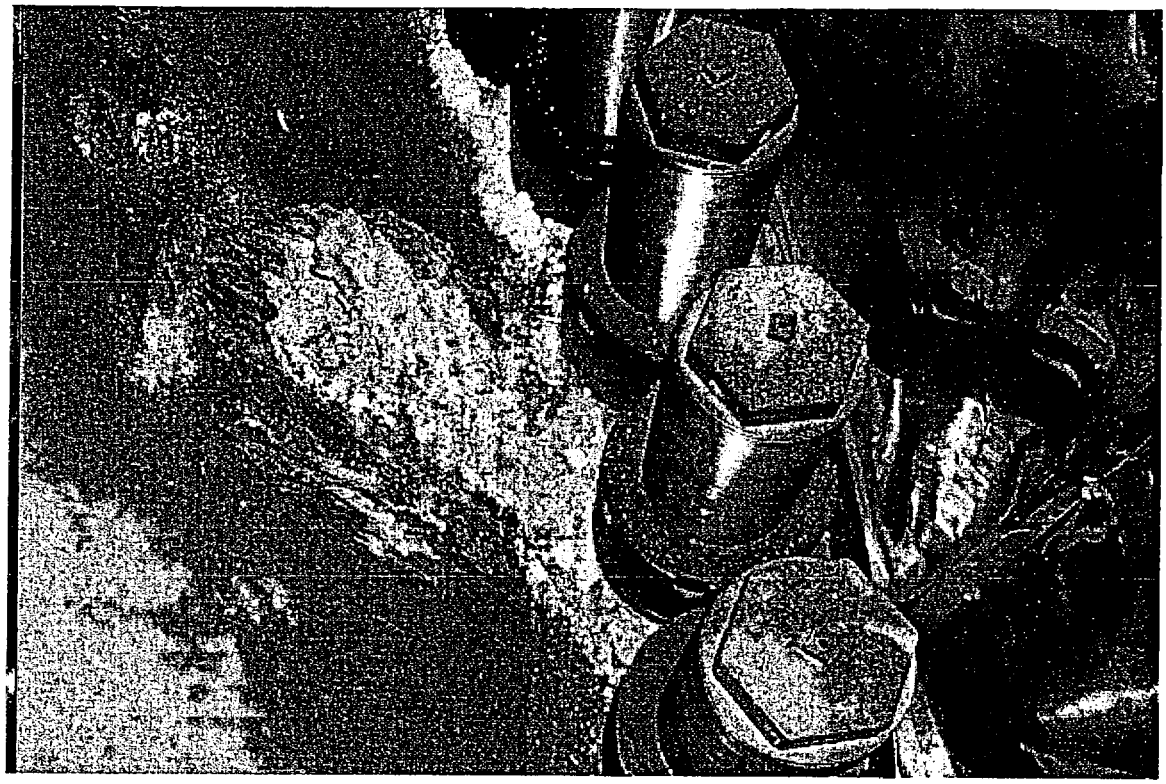
SEQUOYAH 2 - RVLIS LEAK (FALL 2002)

- Leak from RVLIS valve
- Impacted insulation and fell through a seam and onto the RPV head
- Area cleaned up
- Corrosion area of 5 in. long x 5/16-in. wide x 1/8-in. max depth

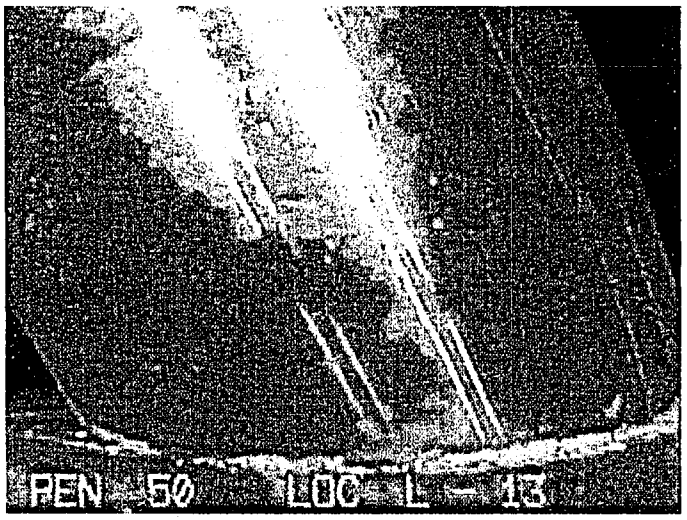
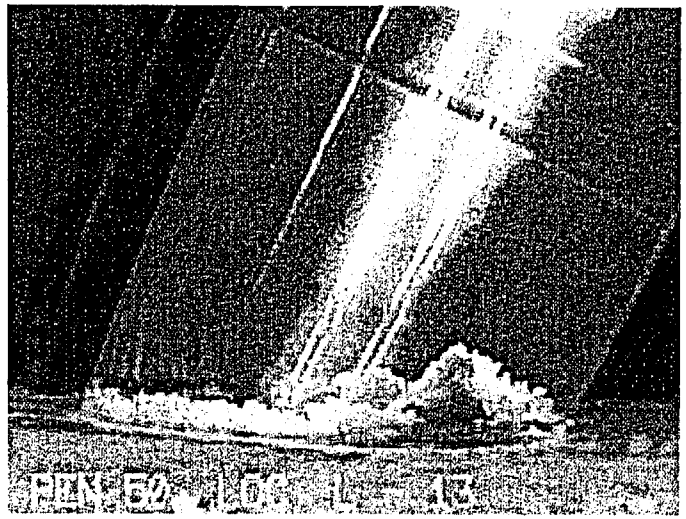
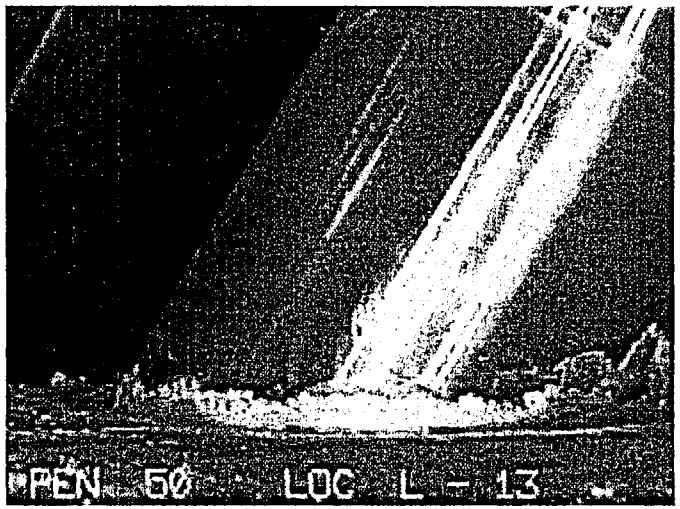
NORTH ANNA UNIT 1 - FALL 2001
(NOZZLE #50)

- Popcorn deposit on Nozzle #50 - only a limited bare metal visual
- Nozzle identified as suspect at fall 2001 outage - first plant inspected after issuance of Bulletin 2001-01
  - Clean ultrasonic record in fall 2001
  - PT indications "in the cladding"
- RPV head replaced

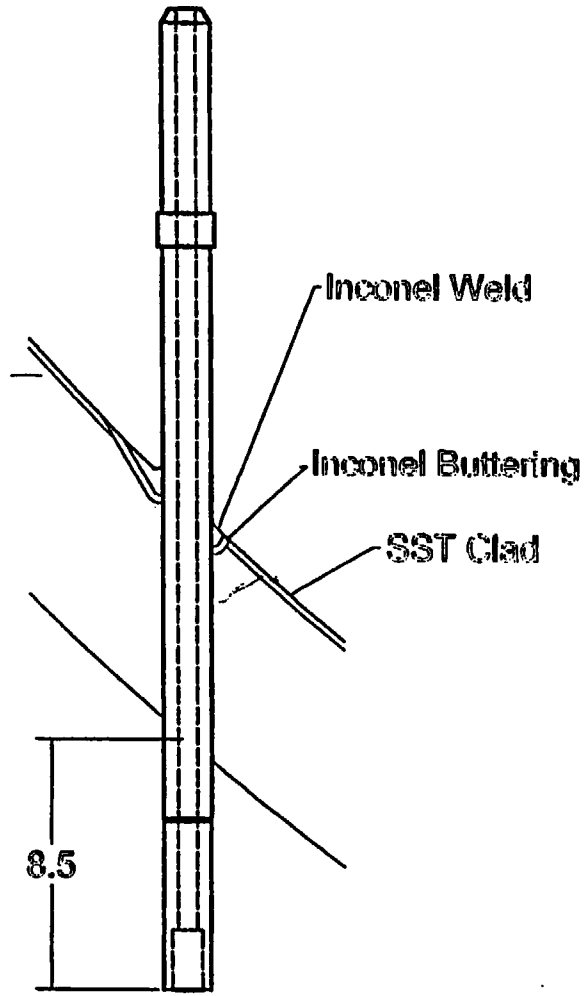
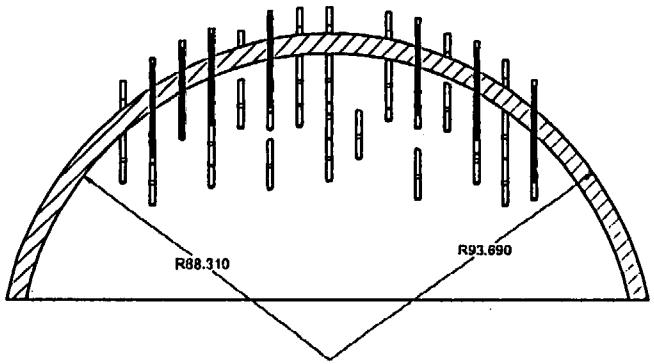
SECTION A-A
SCALE 1 / 25

- Lower head examination identifies 2 nozzles with deposits - #1 and #46 - upper head is clean
- EDY of upper head is 4.5-6.3 (recent bypass flow conversion)
- EDY of lower head ~2.1 (operating temperature 561°F)
- Licensee planning characterization activities, including flaw identification (nozzle base material or J-groove weld?), root cause (fabrication-related, fatigue or PWSCC?) and repair - restart late summer

Inconel Weld
Inconel Buttering
SST Clad
8.5

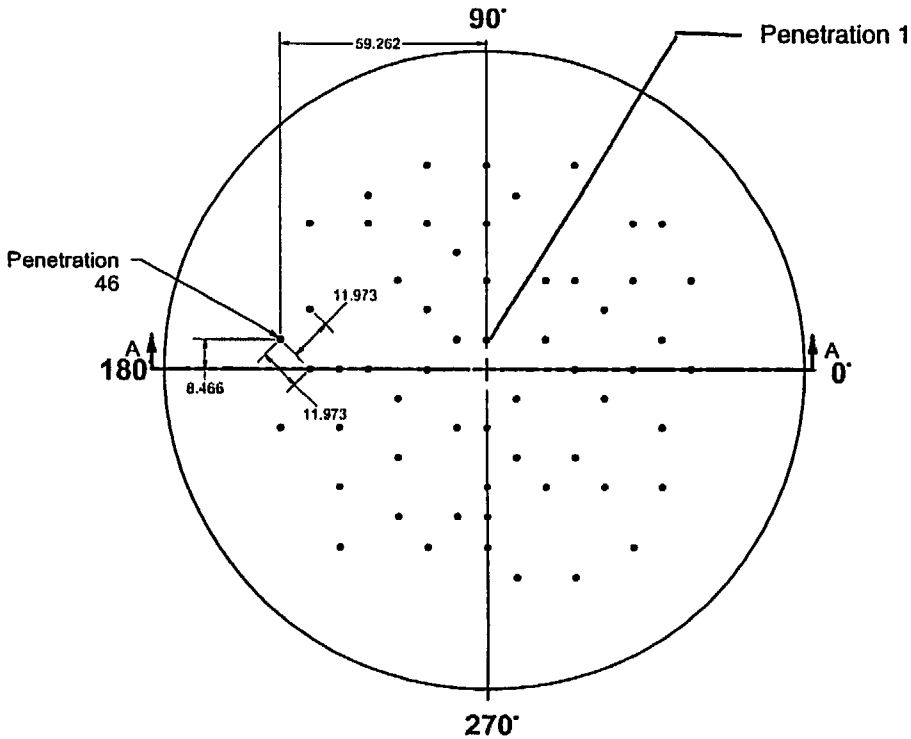
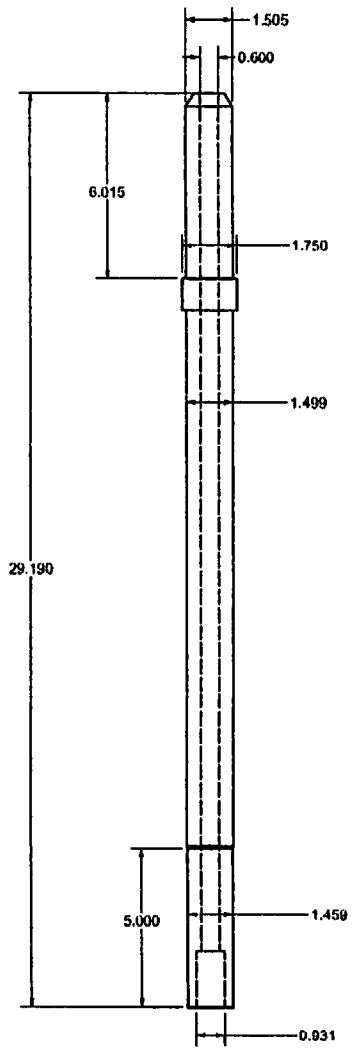
Penetration 46
BMI Tube
Mtl. = SB-166

Viewed From
Outside Head
