Re: St. Lucie Unit 2
Docket No. 50-389
Order (EA-03-009) Interim RPVH Inspection Requirements
Revised Relaxation Requests 1 and 2 - Supplement 4

ST. LUCIE UNIT 2 RELAXATION REQUEST NO. 1 REVISION 2 FROM US NRC ORDER EA-03-009

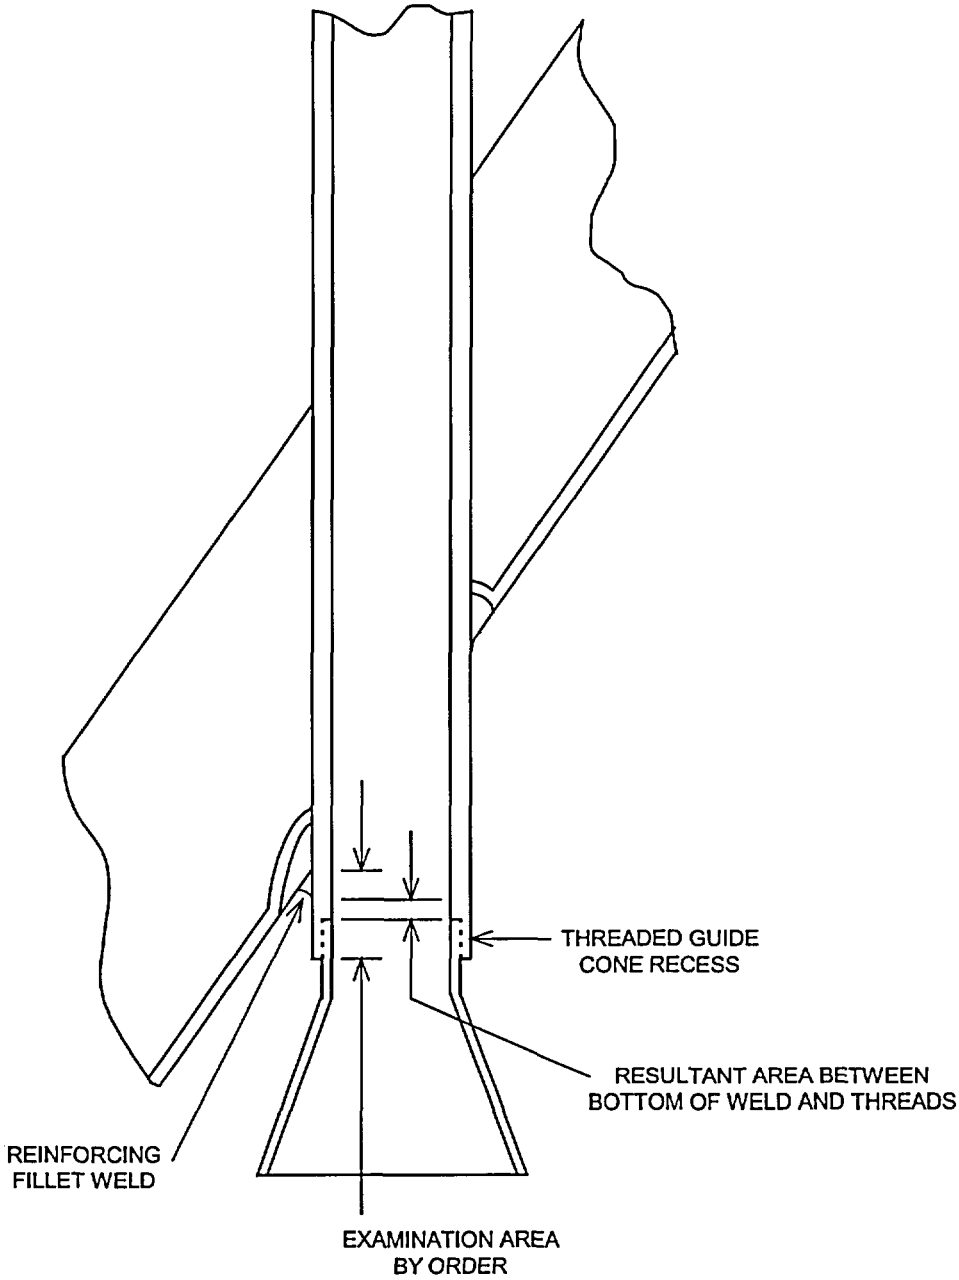
Figure 1
Typical St. Lucie Unit 2 CEDM Nozzle Configuration

- The distance between the bottom of the weld and the top of the threads is smaller than anticipated. The fillet weld associated with the partial penetration J-groove weld extends near the top of the threads. This condition may be caused by the combination of a shorter length of the penetration nozzle extending below the bottom head surface and the tolerances associated with the fillet weld leg size.

The configuration described above does not allow for inspection of a minimum of 1 inch below the weld, as proposed in Revision 0 of Relaxation Request 1.[3,4] A typical example of the internally threaded nozzle, including the externally threaded guide funnel, at a high hillside angle is shown in Figure 1.

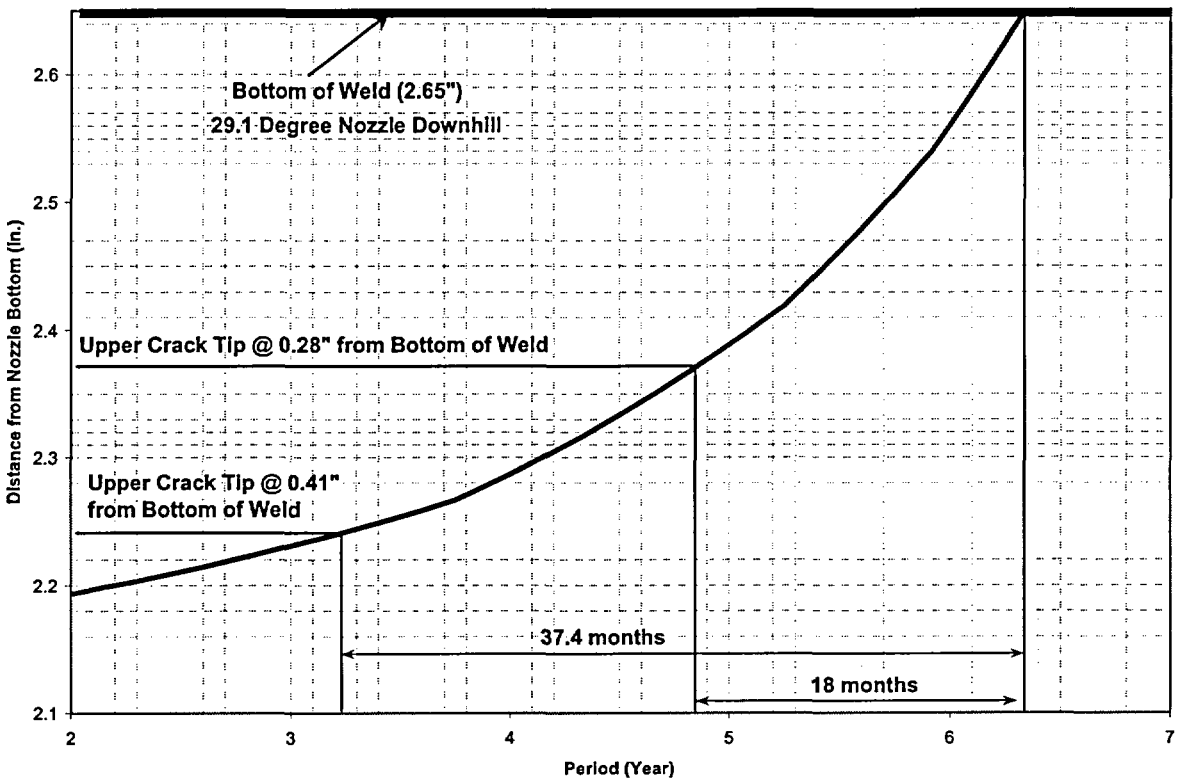
Figure 2: Graphical Determination of Minimum Inspection Coverage Distance Below the Weld to Support an Additional 18-Month Operation Period, and Additional Margin at a UT Inspection Coverage Distance of 0.41 Inches (exploded section from Figure 6-16 of WCAP-16038-P).

Figure 2 provides a check of the determination in Table 1, using the 29.1° nozzle example.

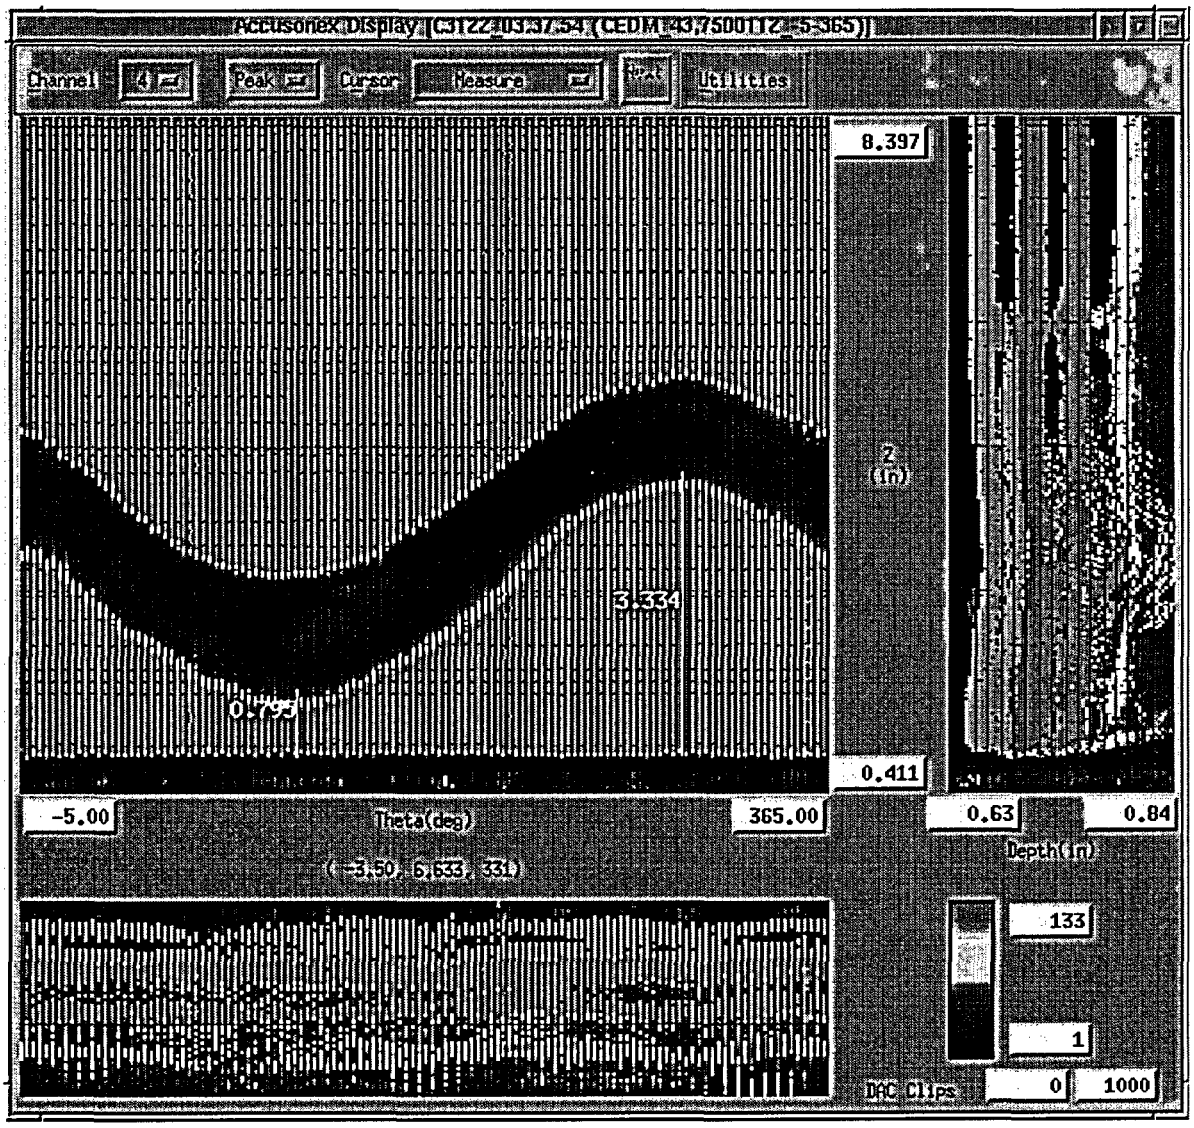
Figure 3: Typical UT "C" Scan of Nozzle 43 Showing Minimum and Maximum Coverage Area Below the Weld

The UT coverage for a typical CEDM nozzle is shown in Figure 3. Since all of the 91 CEDM penetrations are unobstructed on the ID, 100% scan coverage can be obtained above the threaded area. This includes 100% of the area adjacent to the interference fit region between the nozzle and the head, for assessment of a potential "leak path." In the example below, the extent of UT coverage below the weld ranges from 0.79 inches at the downhill side to a maximum of 3.33 inches on the uphill side.

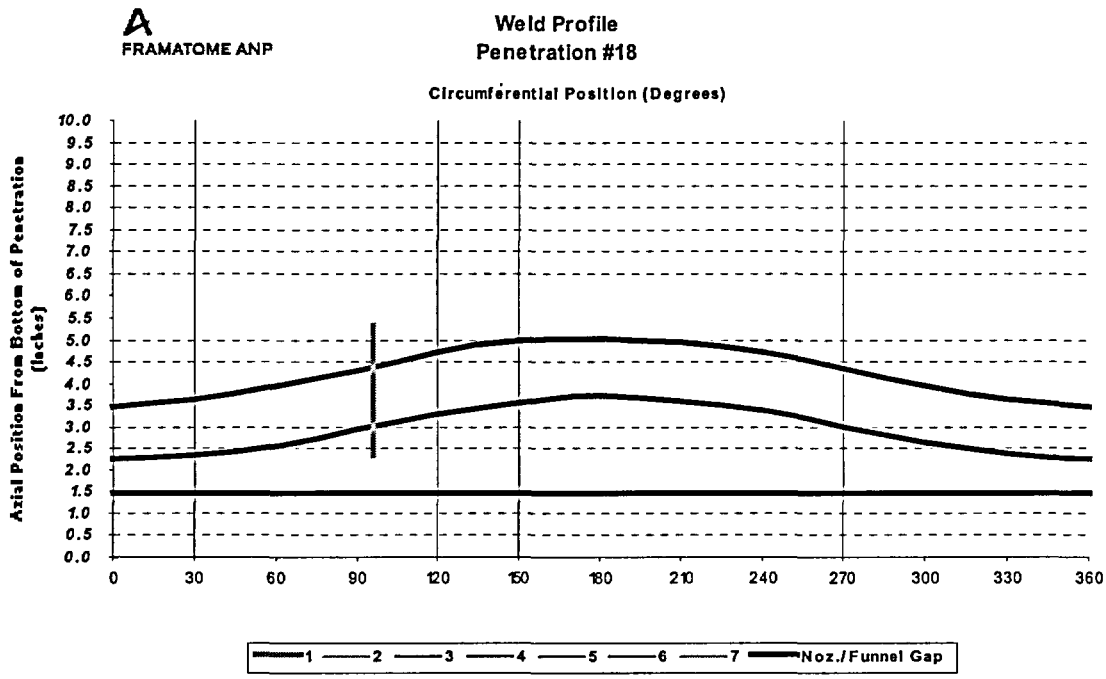
FPL Response to Question 3: A single flaw was identified in Nozzle Nos. 18 and 72 at St. Lucie Unit 2. The details of each are provided in the table below. A graphical weld profile and flaw orientation is also provided. The 0° is identified as lowest downhill position of the weld.

Nozzle #	Flaw Location /Type	Azimuthal Location	Flaw Length	Flaw Depth	Distance Below Weld
18	OD Axial	96°	2.98"	0.26"	0.71"
72	OD Axial	354°	0.96"	0.28"	0.35"
