Florida Power & Light Company, 6501 S. Ocean Drive, Jensen Beach, FL 34957

L-2003-129
EA-03-009(IV)(F)(2)

Re: St. Lucie Unit 2
Docket No. 50-389
Order (EA-03-009) Interim RPVH Inspection Requirements
Revised Relaxation Requests 1 and 2 - Supplement 4

ST. LUCIE UNIT 2 RELAXATION REQUEST NO. 1 REVISION 2 FROM US NRC ORDER EA-03-009

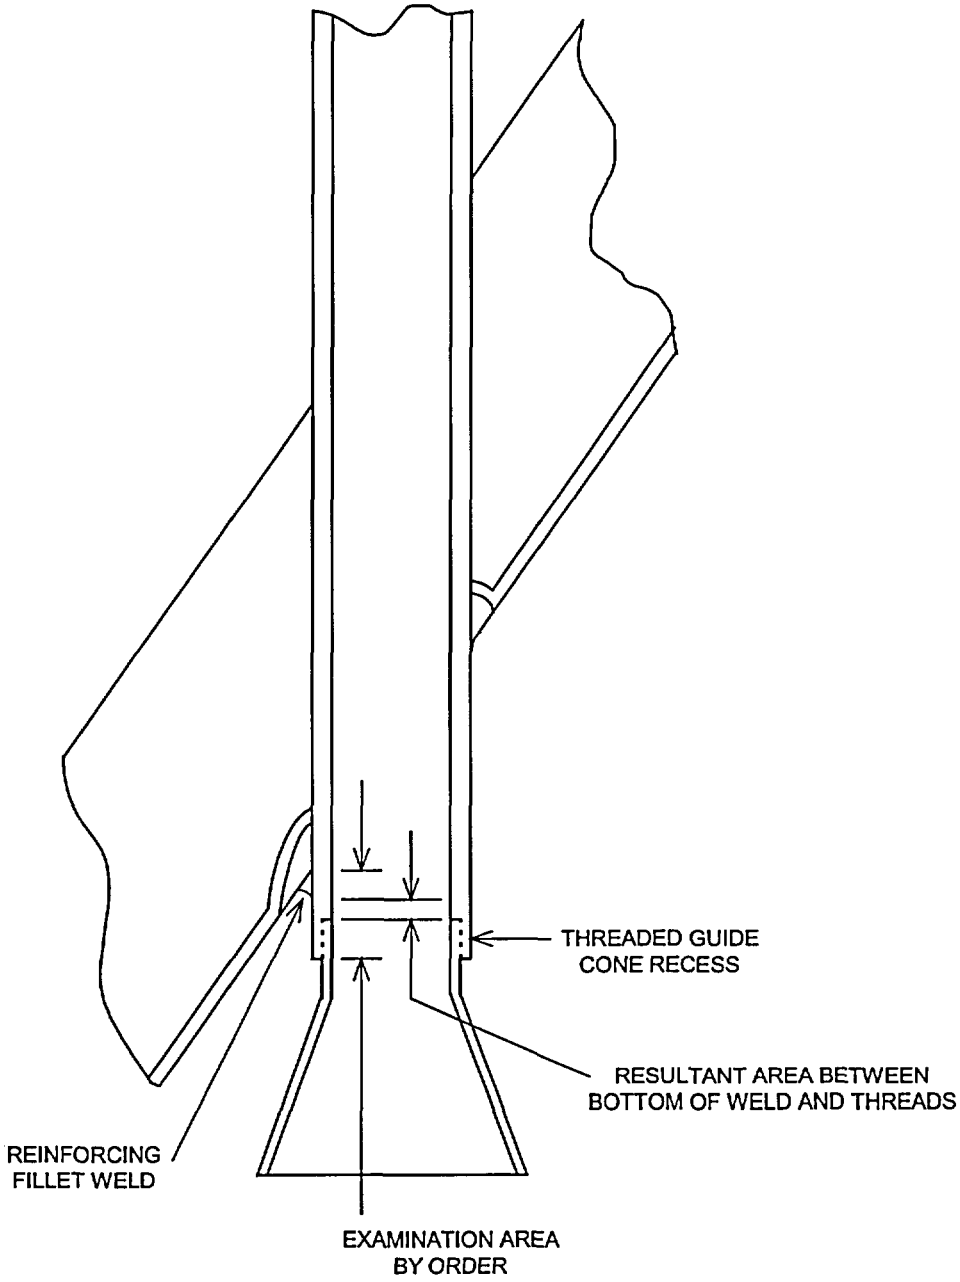
Figure 1
Typical St. Lucie Unit 2 CEDM Nozzle Configuration

- The distance between the bottom of the weld and the top of the threads is smaller than anticipated. The fillet weld associated with the partial penetration J-groove weld extends near the top of the threads. This condition may be caused by the combination of a shorter length of the penetration nozzle extending below the bottom head surface and the tolerances associated with the fillet weld leg size.

The configuration described above does not allow for inspection of a minimum of 1 inch below the weld, as proposed in Revision 0 of Relaxation Request 1.[3,4] A typical example of the internally threaded nozzle, including the externally threaded guide funnel, at a high hillside angle is shown in Figure 1.

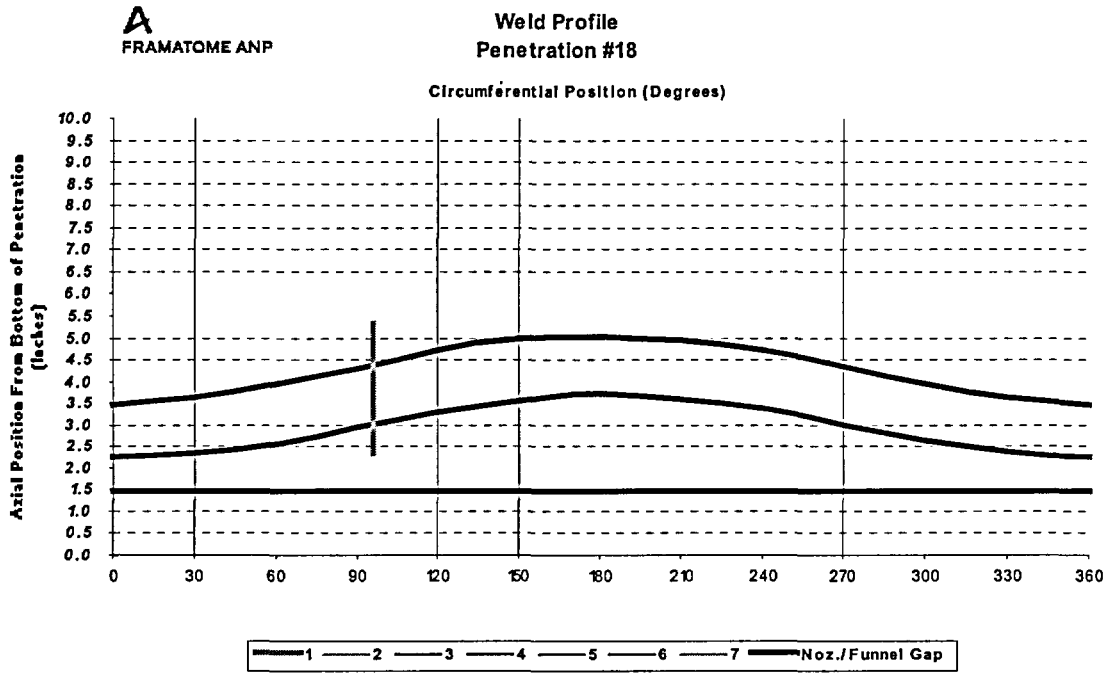
FPL Response to Question 3: A single flaw was identified in Nozzle Nos. 18 and 72 at St. Lucie Unit 2. The details of each are provided in the table below. A graphical weld profile and flaw orientation is also provided. The 0° is identified as lowest downhill position of the weld.

Nozzle #	Flaw Location /Type	Azimuthal Location	Flaw Length	Flaw Depth	Distance Below Weld
18	OD Axial	96°	2.98"	0.26"	0.71"
72	OD Axial	354°	0.96"	0.28"	0.35"

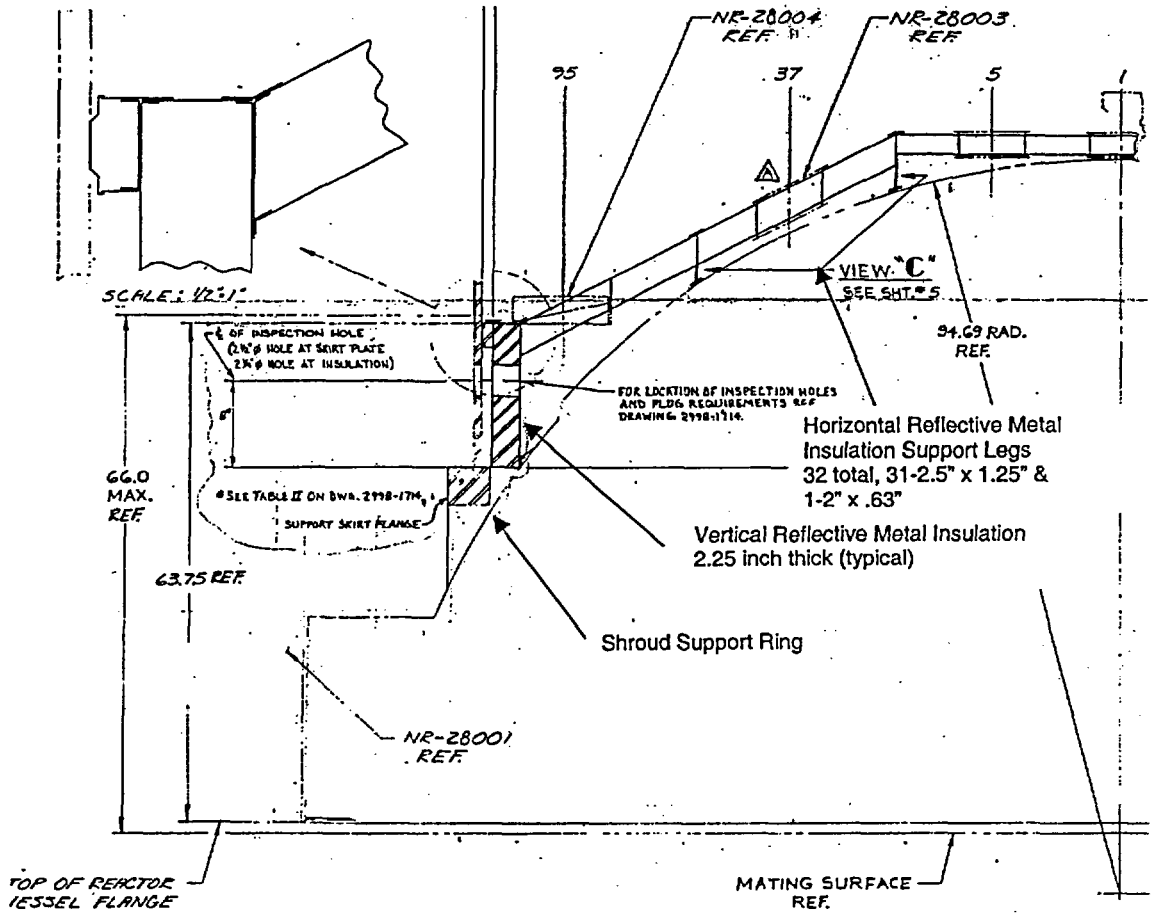
Figure 2: RPV Head Side View Showing Horizontal Insulation Support Leg Location

- The visual examination performed during SL2-14 of the base material adjacent to the 102 penetration nozzle-to-top-of-head interface region (360° coverage was obtained) identified no evidence of leakage.
- The visual examination performed during SL2-14 of the RPV head base material with the exception of the areas under the vertical insulation panels at the 12 shroud lug locations, and horizontal RMI panel legs identified no evidence of wastage of the head base material or staining leading into the inaccessible areas.
- The visual examination performed during SL2-14 of the RPV head base material, with the exception of the areas under the vertical panels at the 12 shroud lug locations and horizontal RMI panel legs, identified no evidence of corrosive products on the head base material.
