Nuclear Operating Company
South Texas Project Electric Generating Station P.O. Box 289 Wadsworth, Texas 77483

May 12, 2003
NOC-AE-03001528
10CFR50

South Texas Project
Units 1 & 2
Docket Nos. STN 50-498, STN 50-499
Responses to NRC Questions Regarding
Bottom Mounted Instrumentation Penetration Indications

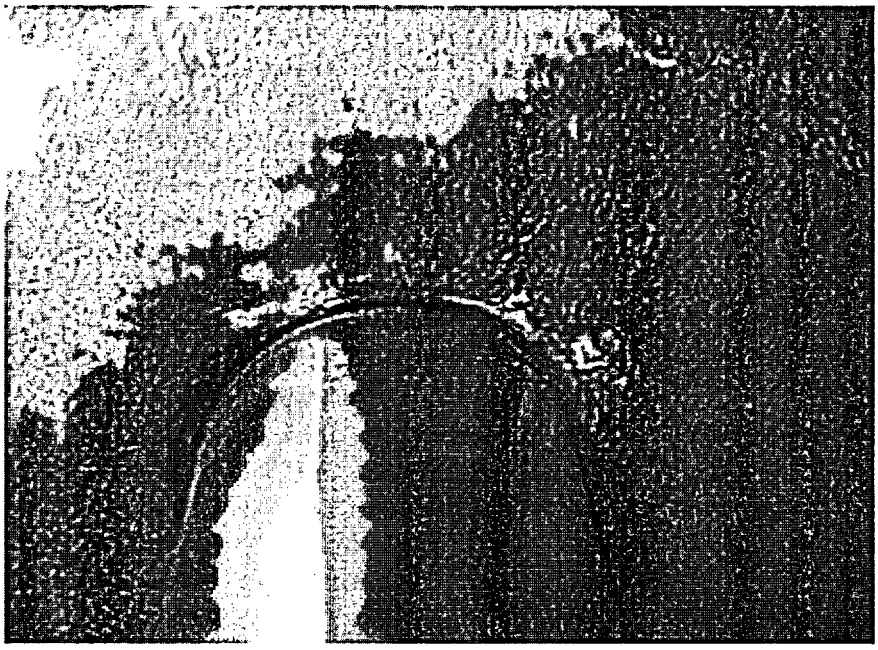
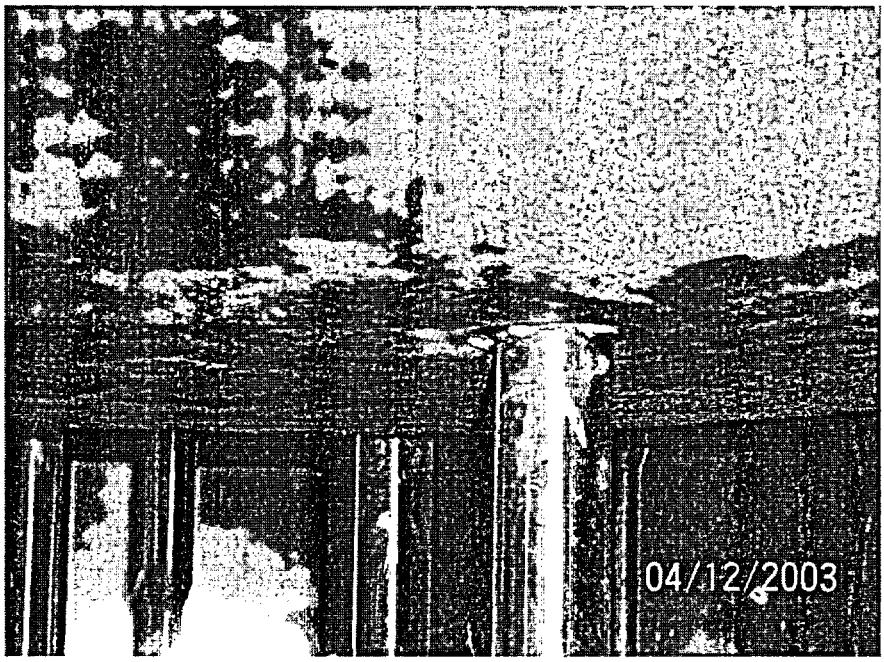
9. Please explain the apparent groove or gap in the photograph of Penetration 1.

There is no groove or gap. A closeup photo from a video taken after the residue was removed shows a better view of Penetration 1. The penetration openings are chamfered. This photograph shows that the chamfer is still clearly defined. A photograph of Penetration 1 prior to cleaning is provided for comparison.

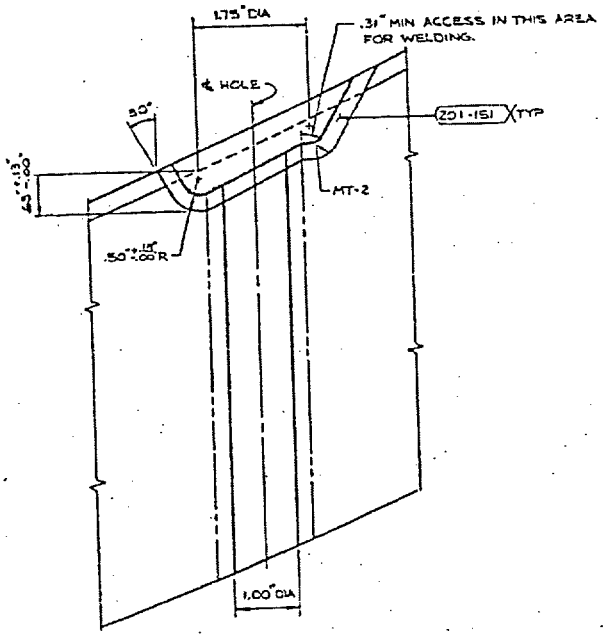
STP BMI Generic J-Groove Configuration

STP BMI J-groove weld dimensions from Question 11.
