NUREG-0619-REV-1

BWR FEEDWATER NOZZLE AND CONTROL ROD DRIVE RETURN LINE NOZZLE CRACKING: RESOLUTION OF GENERIC TECHNICAL ACTIVITY A-10 (TECHNICAL REPORT)

Nuclear Regulatory Commission
Washington, D. C.

NOV 80

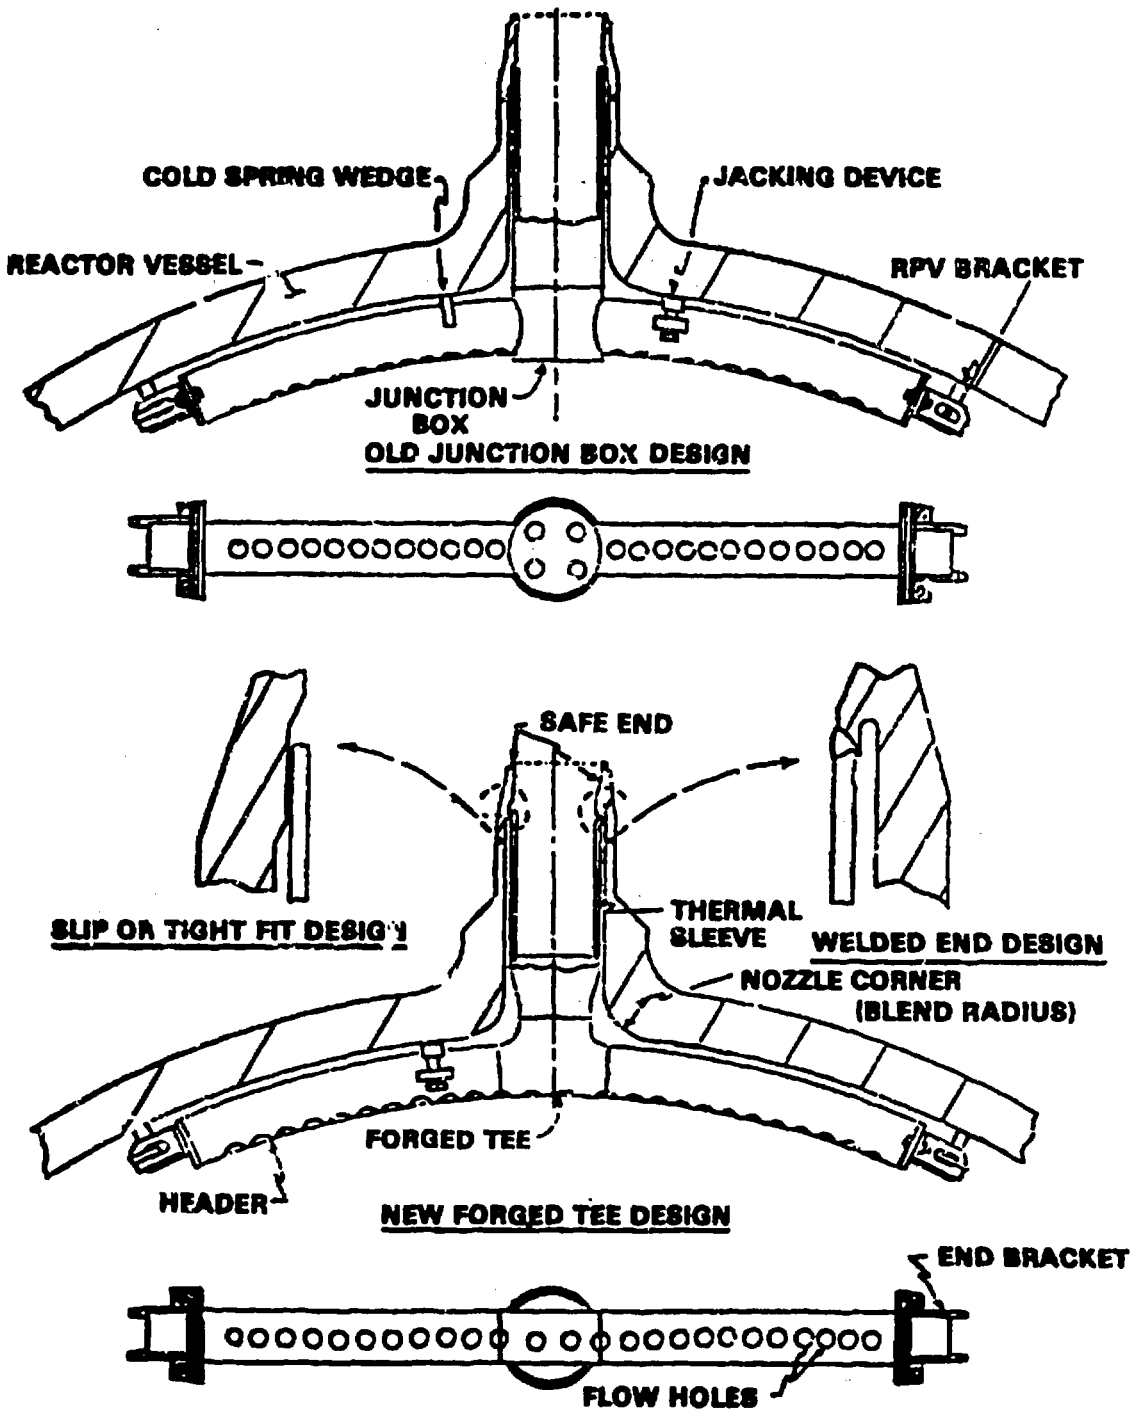
Figure 4. Feedwater spargers showing old and new designs.

Figure 4 shows the old sparger design and some of the designs that replaced it. The tight-fit, forged-tee design is used predominantly today as an interim measure until the installation of the modified triple-sleeve spargers or other acceptable designs. The triple-sleeve sparger design is depicted in the proprietary General Electric (GE) document NEDE-21821-A. Several plants have the welded thermal sleeve design.

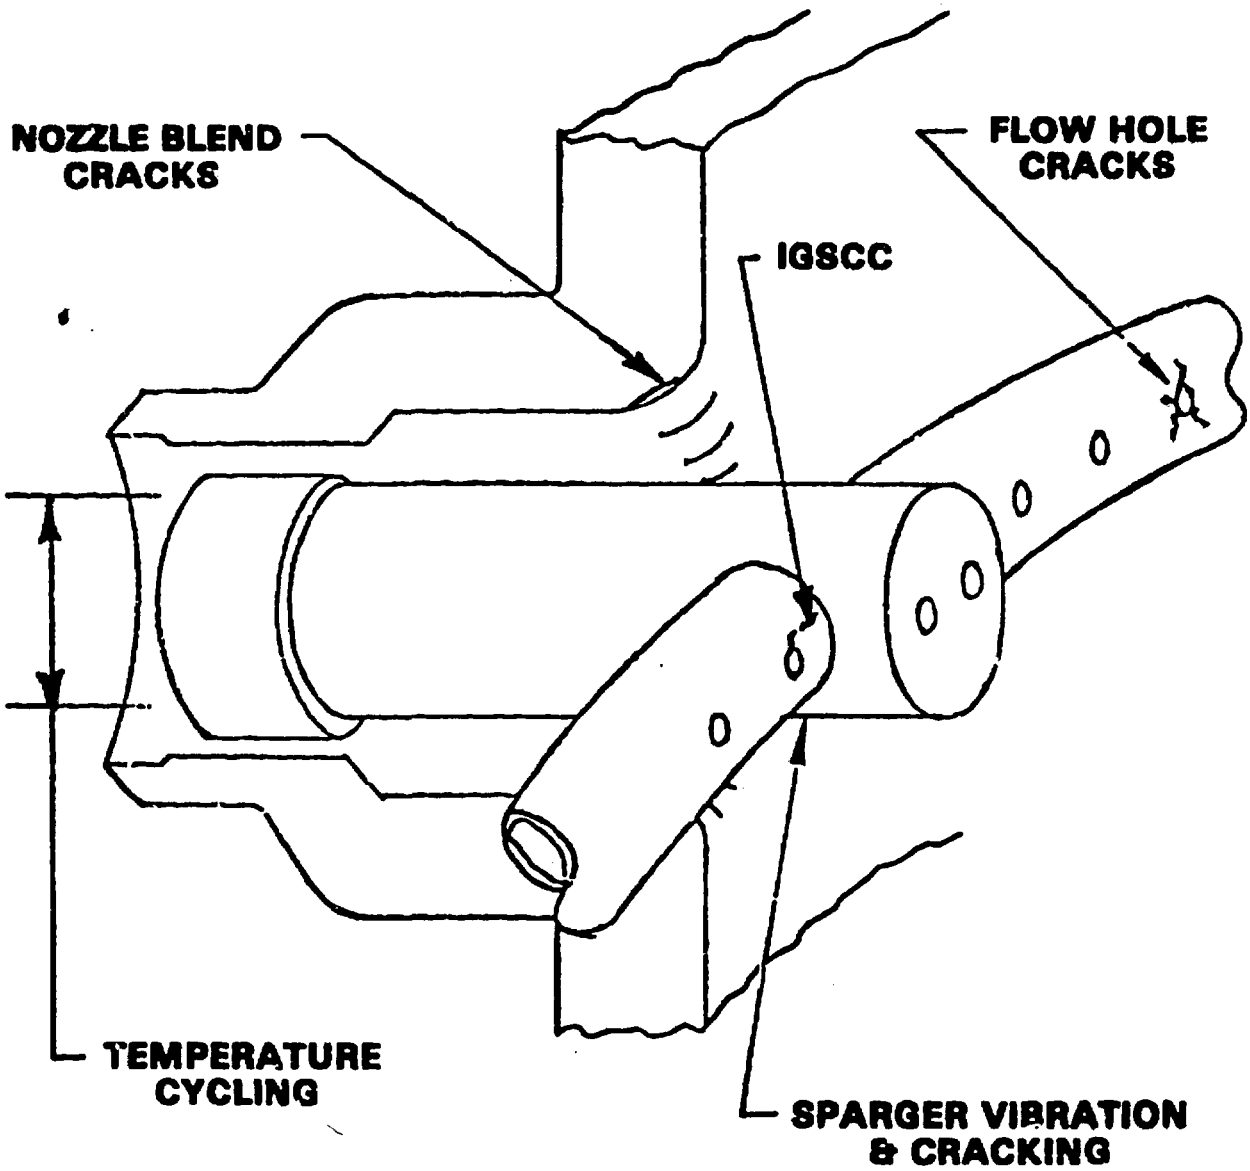
Figure 5. Loose-fit sparger problems.

Figure 5 illustrates the problems that have resulted from the loose fit of the thermal sleeve. The staff believes the new designs provide a substantial and acceptable improvement over previous designs and should resolve these problems.

Cracking at the junction of the sparger arms and thermal sleeve was discovered during inspection of the loose-fit design and was attributed to vibration induced by water flowing through the gap between the thermal sleeve and the nozzle safe end. Section 4.1 of Appendix C contains the NRC staff's conclusion that the GE triple-sleeve sparger design has acceptably resolved the vibration problem.

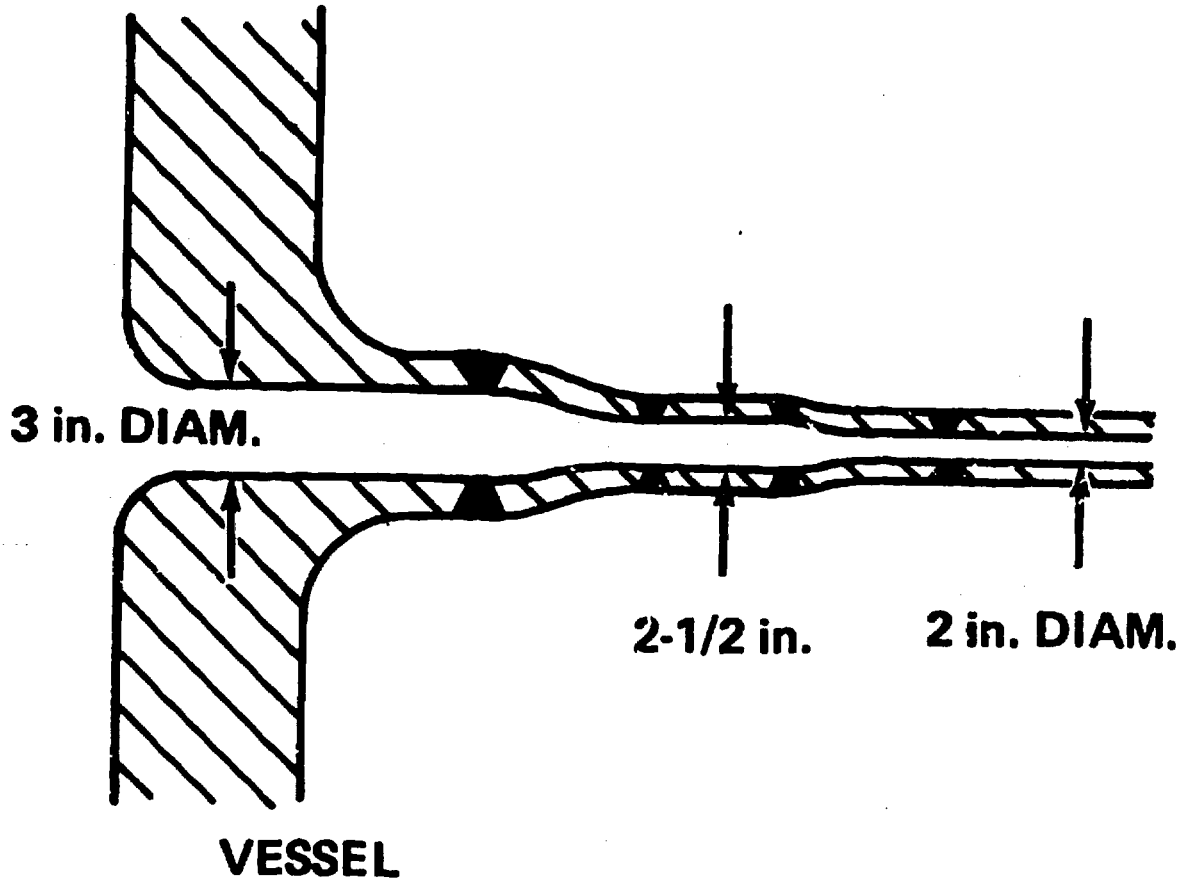
Twenty-two of the 23 operating BWR reactor vessels in the United States with feedwater nozzle/sparger systems also have control rod drive return line (CRDRL) nozzles. Each vessel has one such nozzle, typically 3-4 inches in diameter, and generally located 68-100 inches above the top of the active fuel. A typical nozzle is illustrated in Figure 6.

Figure 6. Typical BWR CRD hydraulic return line nozzle (does not show thermal sleeve/flow shroud).

Also unlike the feedwater nozzle, cracks have been observed on the vessel wall directly beneath the CRDRL nozzle in an area extending downward 6-8 inches from the nozzle blend radius. The cracks on the vessel wall are mainly circumferential. They are believed to result from high-cycle thermal stresses related to stratified flow of cold water along the bottom of the nozzle and down the vessel wall as it mixes with the downflow of reactor water.
