Bottom Mounted Instrument Guide Tube Condition

Enclosure 1

5/1/03

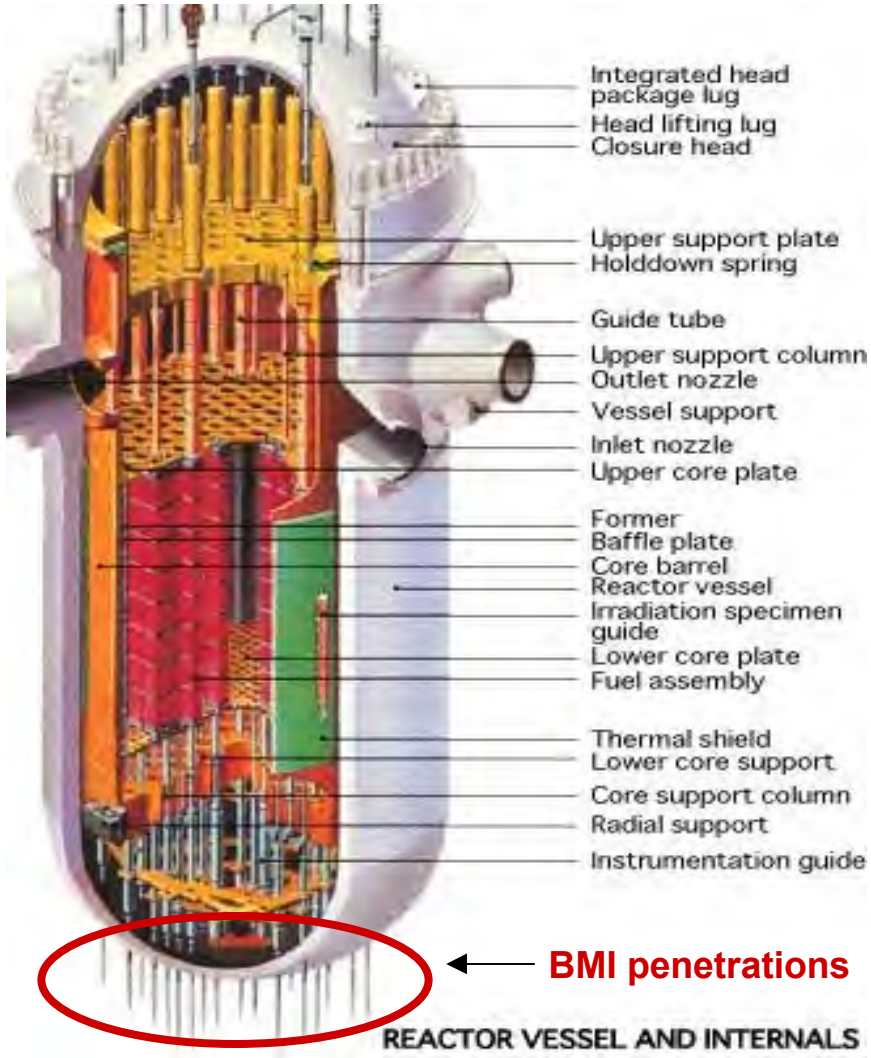
April 12 - residue found on two of the 58 Bottom Mounted Instrumentation (BMI) penetrations.

A small amount of residue had accumulated approximately 90 degrees around the guide tubes at vessel Penetrations #1 and #46.

The quantity of residue found on Penetration #1 is equivalent to about half of an aspirin (approximately 150 mg).

Penetration #46 had about 3 milligrams of residue.

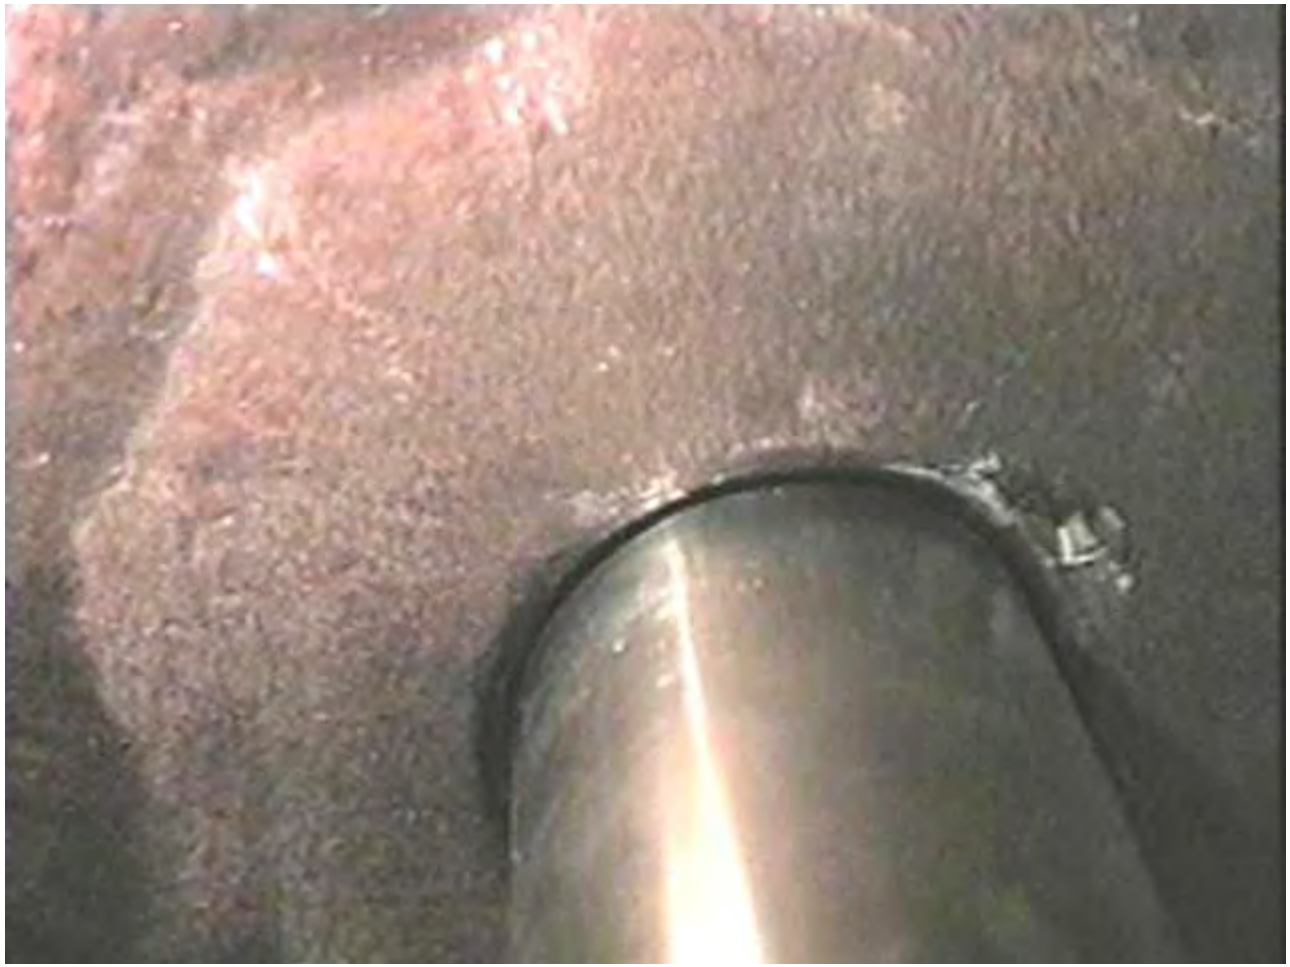
Penetration #1 After Cleaning

Penetration #1

Penetration #46
