SPECIAL REPORT 03-02

W* ALTERNATE REPAIR CRITERIA 90 DAY REPORT

DIABLO CANYON POWER PLANT UNIT 2 ELEVENTH REFUELING OUTAGE

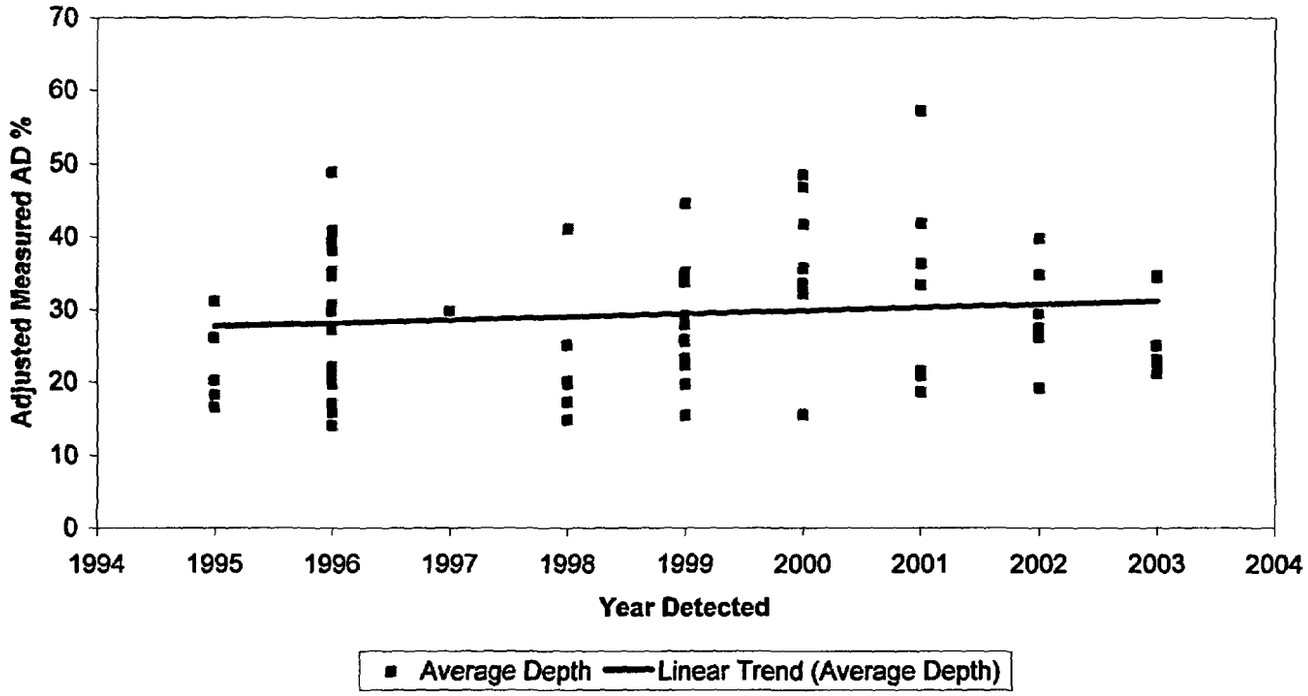
Figure 7

Circumferential Average Depth Trending

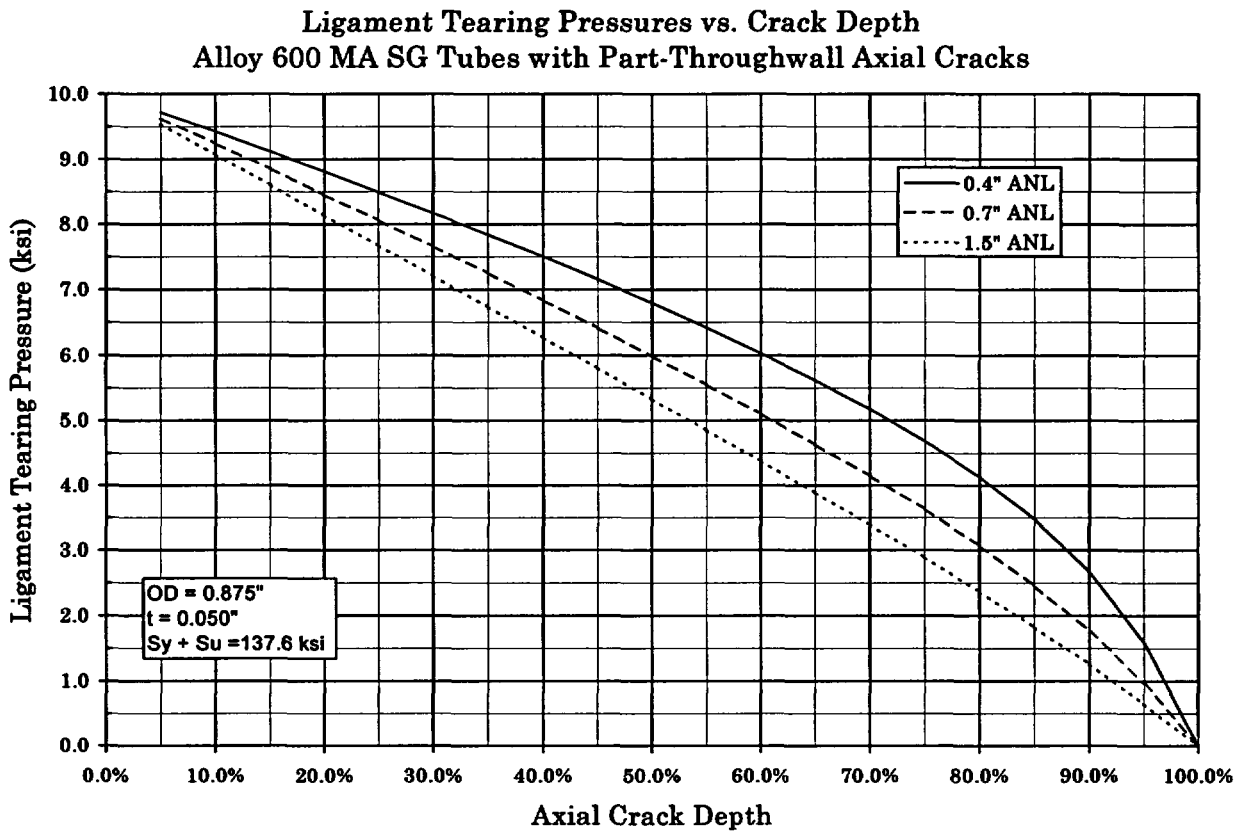
Figure 3: Ligament Tearing Pressure vs. Crack Length, Reference 2

The limit of m_p as h goes to 1, i.e., corresponding to a throughwall crack, is infinity, and the ligament tearing pressure is then zero. Results obtained from the model for three different crack lengths are illustrated on Figure 3. For very long cracks, say greater than 1.5", the model is linear between the non-degraded burst pressure for zero depth and zero tearing pressure for 100% depth. For shorter cracks the shape of the curve becomes more and more convex as shown on Figure 3. As the length of the crack approaches zero, the location of the maximum rate of change of the

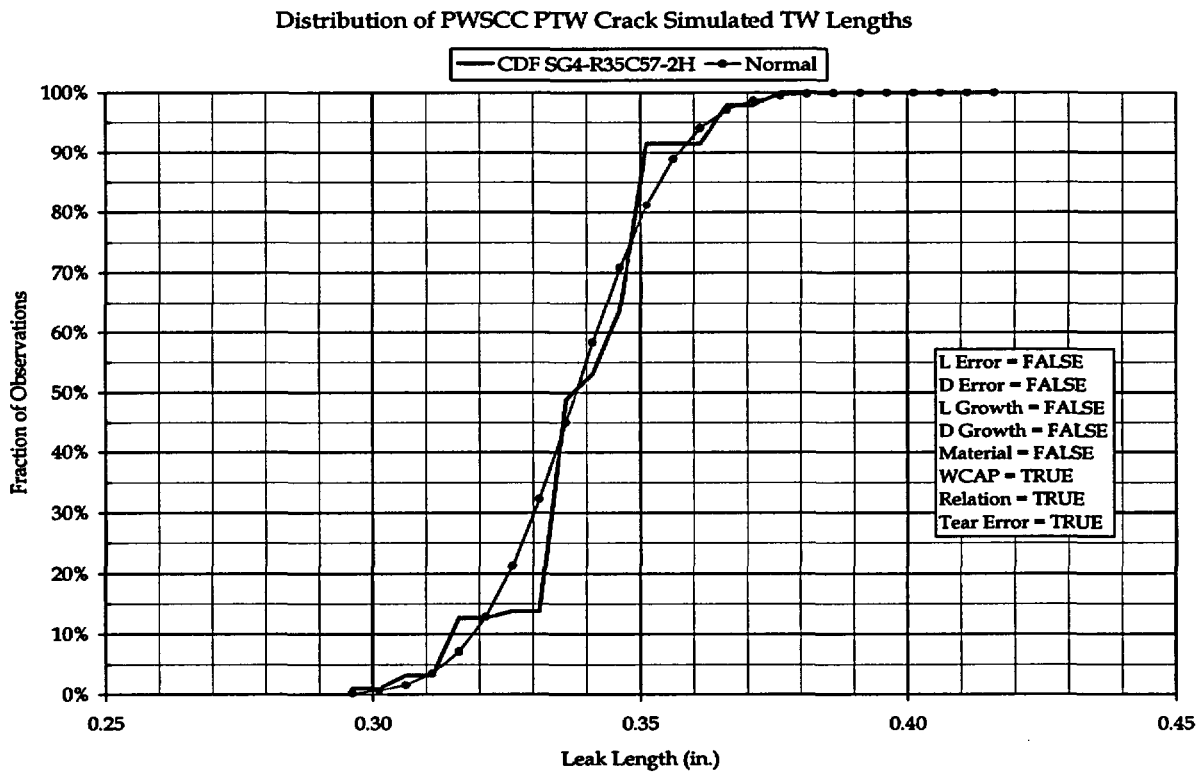
Figure 6: Distribution of R35C57 Torn Lengths

The profile obtained from the destructive examination of the R35C57 cracked tube section is illustrated on Figure 5. There was no ductile tearing in the radial, axial, or circumferential directions under SLB conditions; the only tearing occurred in the axial direction during the burst testing of the tube section. The initial throughwall portion of the crack was 0.217 inch long. The distribution of torn lengths resulting from the analysis using the ligament tearing model for the destructive examination profile is shown on Figure 6. The average of the simulated torn lengths was 0.338 inch even though no tearing occurred during the actual test of the tube section. The measured leak rate at a test pressure of 2750 psi at 70°F was found to be 0.0368 GPM. The adjusted value for the ODSCC ARC database was calculated to be 0.0023 GPM at a differential pressure of 2405 psi at 600°F when condensed to ambient conditions. The results from a simulation of ligament tearing and leak rate are shown on Figure 6 for the crack lengths and Figure 7 for the leak rates. The median, average, and 95th percentile leak rate values from the model of Reference 2 were 0.026, 0.060 and 0.204 GPM respectively.

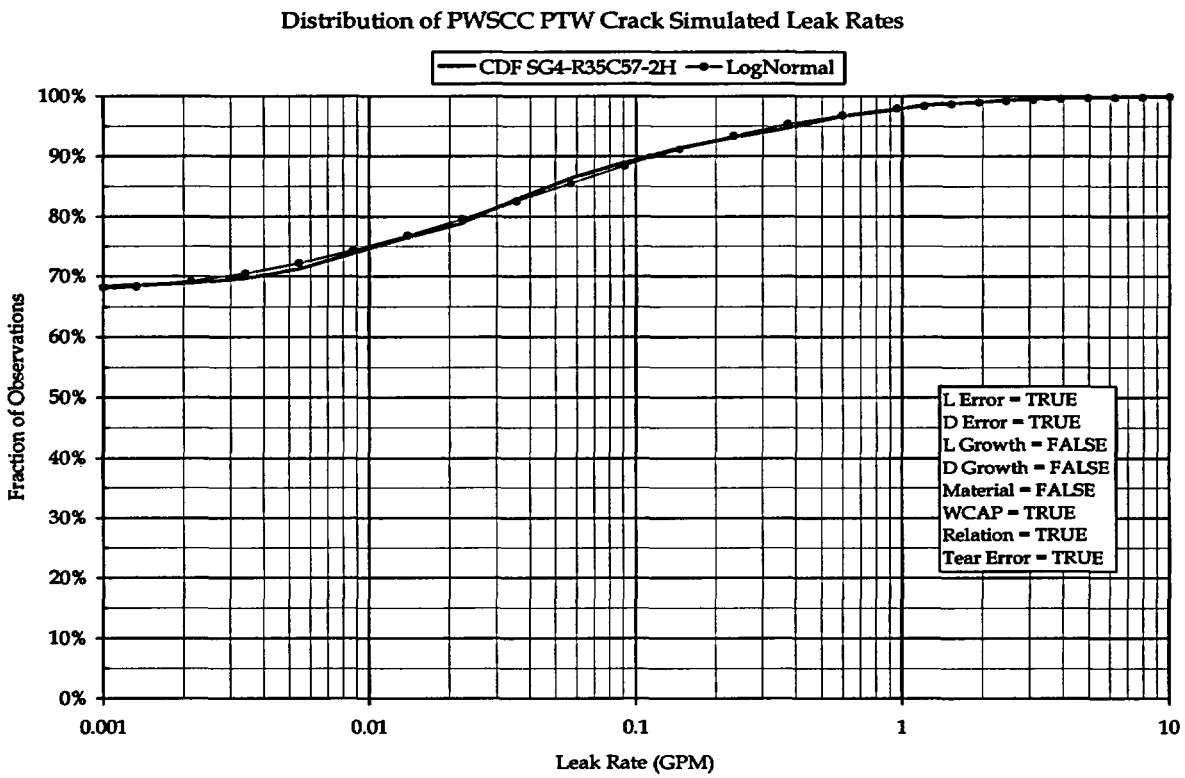
Figure 9: NDE Profile Distribution of R435C57 Torn Lengths

The analysis was repeated using the profiles based on amplitude sizing of the information from the eddy current inspection. The NDE uncertainty values from Reference 2 were used for the simulations even though the cracks were ODSCC. There is a lack of ODSCC amplitude sizing information and the intent of the analysis was to simulate the level of uncertainty that would be associated with the application of the PWSCC ARC. A consequence of using the NDE uncertainties is that most of the simulations resulted in predicting that tearing of the remaining ligament would not occur. The intercept of the correlation of true depth to NDE depth is at about -1% and the slope of the regression line is 0.94. This means that the depth of the 100% portion of the profile will be ≤ 93% for 50% of the simulations. Because the associated lengths of the deepest portion of the profile are relatively short, ligament tearing is not predicted to occur for most of the simulations at a differential pressure of 2405 psi. One of the random simulated profiles is illustrated on Figure 8, a case that did not exhibit tearing at 2405 psi. However, the average torn length of the random indications that were predicted to exhibit tearing was calculated to be 0.402 inch. The simulated median, average and 95th percentile leak rates were 0.000, 0.087 and 0.400 GPM respectively. The distribution of torn lengths is illustrated on Figure 9 and the distribution of predicted SLB leak rates is shown on Figure 10. In summary, the leak rate used in the condition monitoring evaluation of the flaw, i.e., the 95th percentile leak rate from the NDE profile, was estimated to be 174 times greater than found from the destructive examination.

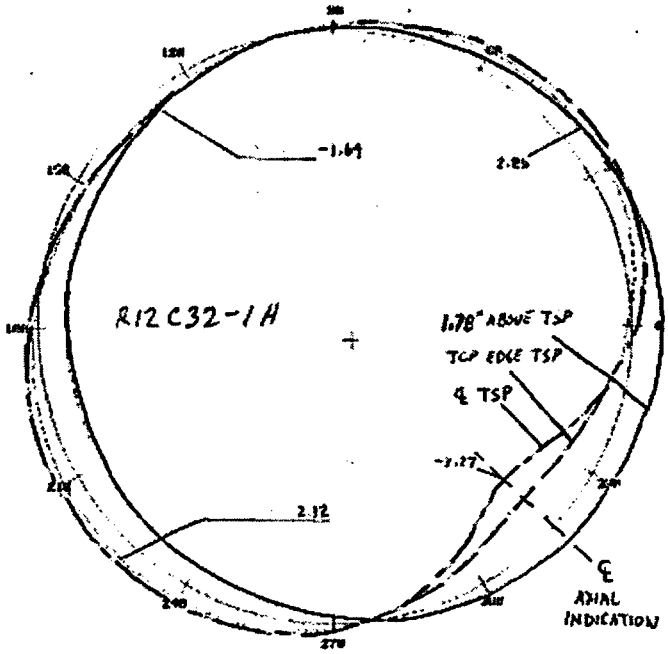
Figure 1
Field UT Circumferential Dent Profile for Pulled Tube R12C32

Figure 1 shows the UT circumferential dent profile for DCPP Unit 1 1R7 pulled tube R12C32-1H, which had a dent voltage of 1.1 volts. The UT profile indicates a maximum dent indentation of about 7.3 mils, which is large for a 1.1 volt dent. The maximum OD hoop stress resulting from the local dent deformation would occur at the point of maximum OD curvature. From Figure 1, this occurs at about 45° to 50° (absolute angle of about 265° in Figure 1) from the centerline of the PWSCC crack. Other UT profiles from Diablo Canyon pulled tubes show similar dent shapes and angles between the PWSCC crack and maximum OD curvature ranging from about 40° to 90° where the larger value occurred for pulled tube R10C22-2H (Figure 2). For

Axial PWSCC is found at one or two locations at dented TSP intersections. When two cracks occur, the cracks are separated by about 180° (Figure 3) and occur at the minor axis of the ovalized tube such as for the dent shapes of Figures 1 to 3. At the minor axis, the ID hoop stresses are the largest and the crack locations are consistent with the maximum ID hoop stress locations as also shown in the figures. The typical dent has a local deformation superimposed on the ovalized tube as seen in the figures. The PWSCC indications are dominantly within the TSP although a few occurrences of cracks outside the TSP are found in the inspections and can be reasonably expected when significant ovalization extends to the axial length outside the TSP.

(minimum of 34°), which exceed crack separation distances required to prevent interaction between axial cracks. The UT profiles of Figures 1 to 3 show expected crack separation distances of 45° and 90° based on locations of maximum OD curvature. Consequently, axial PWSCC and ODSCC indications resulting from dent stresses have a negligible potential for reductions in burst pressure or increased leakage above that of the individual indications evaluated as isolated cracks.

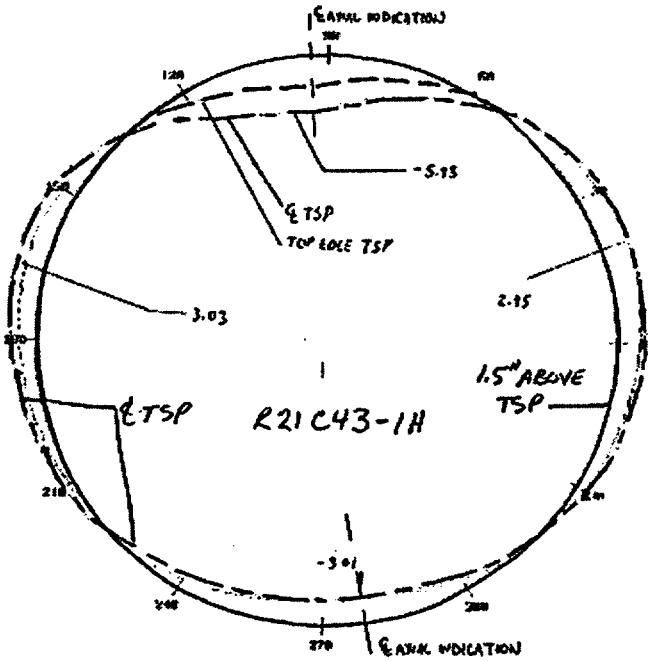
Figure 3
Field UT Circumferential Dent Profile for Pulled Tube R21C43

R10C22, the major diameter (5.9 mil diameter increase) of the strongly ovalized tube had the greatest OD curvature. For R21C43 as shown in Figure 3, the location of maximum OD curvature is about 70° left of vertical (between absolute angles of 150° and 180°) from the upper axial crack near 90°. The DCPP Units 1 and 2 PWSCC to ODSCC crack separation angles are consistent with the expected range of crack separation based on the Diablo Canyon dent profiles. The DCPP crack separation distances and the expected distances based on the dent profiles exceed the required hoop direction ligament thickness of 0.1 inch. Therefore, the DCPP ID/OD flaws can be evaluated independently for burst and structural integrity under their respective ARCs. Further development of this conclusion is provided in the following sections.

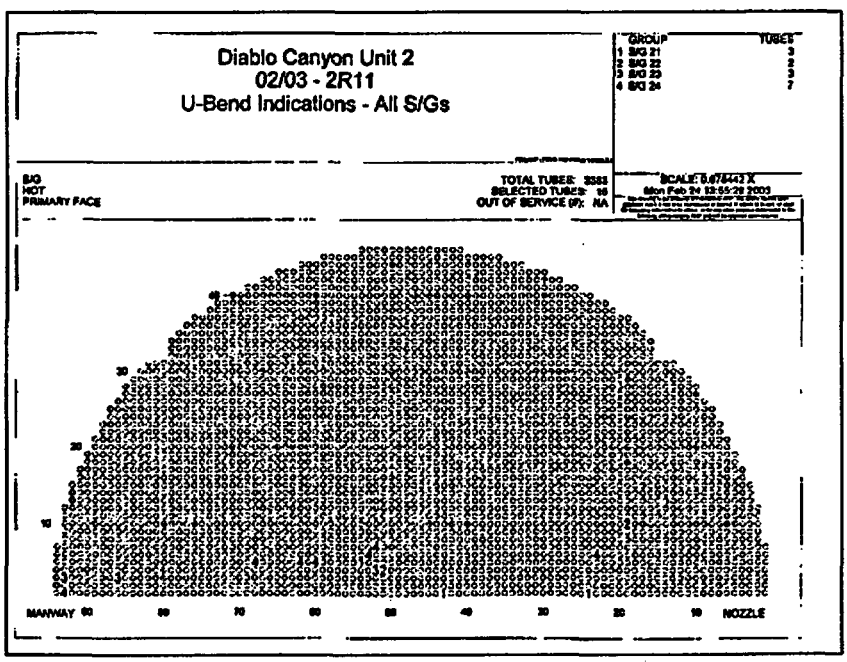
FIGURE 2 – MAP OF U-BEND INDICATIONS IN ALL STEAM GENERATORS

The tubesheet map in the following figure shows the coordinates of the tubes with U-bend indications. The affected tubes are distinguished by label (refer to the legend for an explanation) for each steam generator to promote a visual reference for the condition in a particular steam generator as well as all four combined. It can be noted that a number of the tubes with indications have similar tube coordinates (neighboring tubes) and are grouped in a few basic areas in the steam generator.

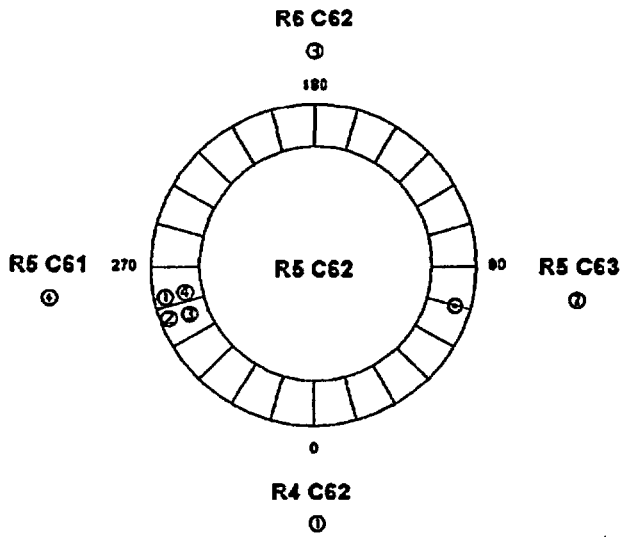
FIGURE 3 – INDICATION LOCATIONS BASED ON MAGNETIC INDEXING PROBE

The angular position of the indications in tube SG 24 R5-C62 was verified using a magnetic indexing reference probe. This probe consists of a long sheath with a high strength magnet at its tip. The probe is inserted into a tube immediately adjacent to a flawed tube and the magnet is positioned near the flaw of interest. The flawed tube is then scanned with a rotating eddy current probe in order to image the flaw and magnet response in one scan. For this test the magnet was positioned 6 inches into the bend region of 4 tubes adjacent to R5-C62, one at a time, and tube R5-C62 was scanned each time with a rotating +Point probe. The signal response from the magnet was related to the flaw response in order to determine the angular position of the flaw. The result of this test is shown below and the view presented is from the hot leg of the steam generator. This test was repeated with a rotating pancake probe later for different application.

①②③④	Angular position of the same indication as obtained by 4 acquisitions from neighboring tubes using a magnet. 10° ccw from R5-C61 80° cw from R4-C62 160° cw from R5-C63 255° cw from R6-C62
⊙	Angular position of the sole indication on the opposite side of the tube measured from the magnets and from the larger indication.

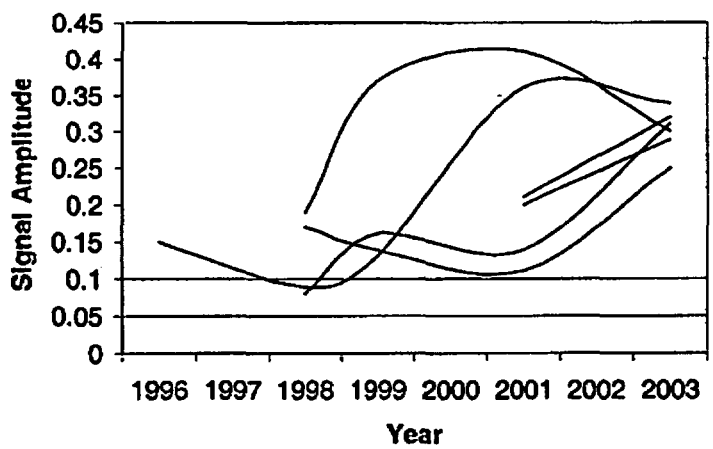
FIGURE 5 - VOLTAGE GROWTH

Elevation	Feb 2003		May 2001		Sept 1999		Feb 1998		April 1996	
Above 7H	Volts	%TW	Volts	%TW	Volts	%TW	Volts	%TW	Volts	%TW
4.56	0.42	97								
11.01	0.30	51	0.41	22	0.37	21	0.19	50		
12.64	0.30	93								
12.99	0.31	99	0.14	59	0.16	96	0.08	50		
13.26	0.25	89	0.11	91	0.14	59	0.17	21		
14.55	0.34	86	0.36	86	0.13	95	0.09	37	0.15	44
14.81	0.15	94								
16.03	0.29	95	0.20	96						
16.45	0.27	69								
17.72	0.11	76								
19.63	0.32	84	0.21	92						
23.19	0.11	84								
25.87	0.22	83

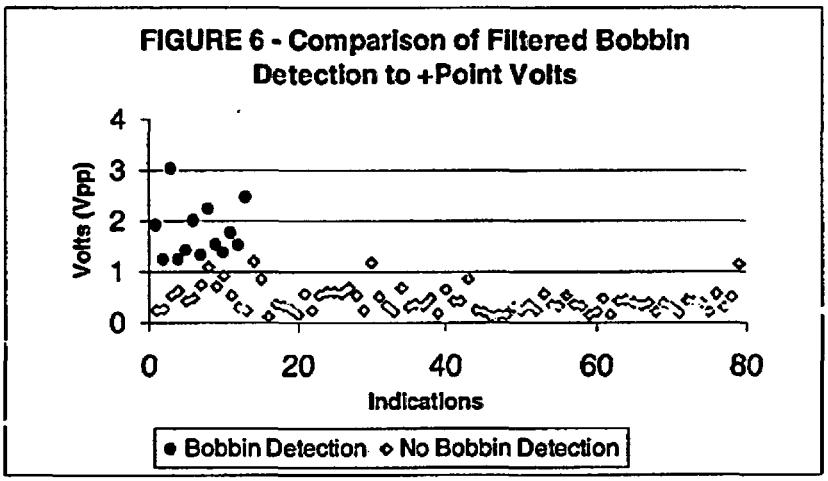
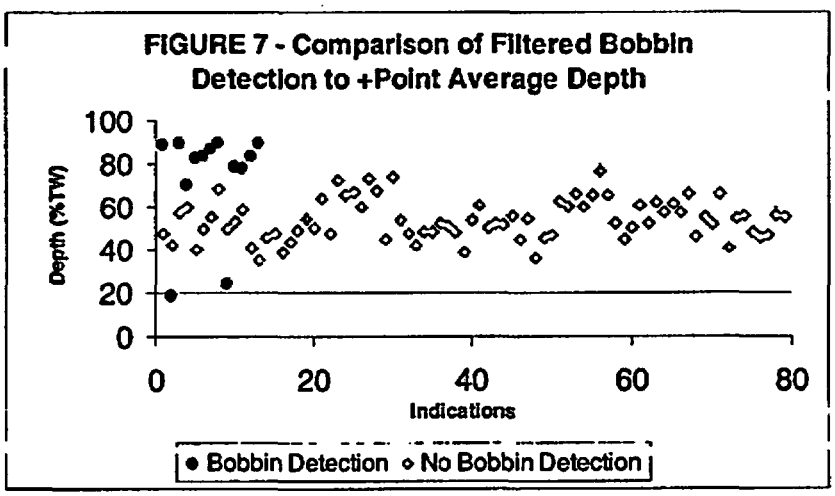
Figure 6 shows the correlation between the +Point max voltage for each indication and the detection of the bandpass filtered bobbin data channel. There were a total of 92 +Point indications in the 12 affected tubes of which 13 were detectable in the bobbin data with pre-knowledge of the +Point results. Nine were detectable without pre-knowledge and produced clear Lissajous signals for analysis. The results show that bobbin detection is well correlated to +Point volts. The lowest +Point voltage detected was 1.23 Vpp and the highest voltage not detected was 1.21 Vpp. The Bandpass filter was applied to the 200 kHz differential channel with a low cut of 33, a high cut of 171 and a sharpness of 23. The +Point voltage was measured from the 300 kHz channel normalized to 20 Vpp on the 100% Circumferential EDM in the Axial Lissajous window. Figure 7 shows the correlation between bobbin detection and +Point average depth, calculated from the line-by-line sizing.

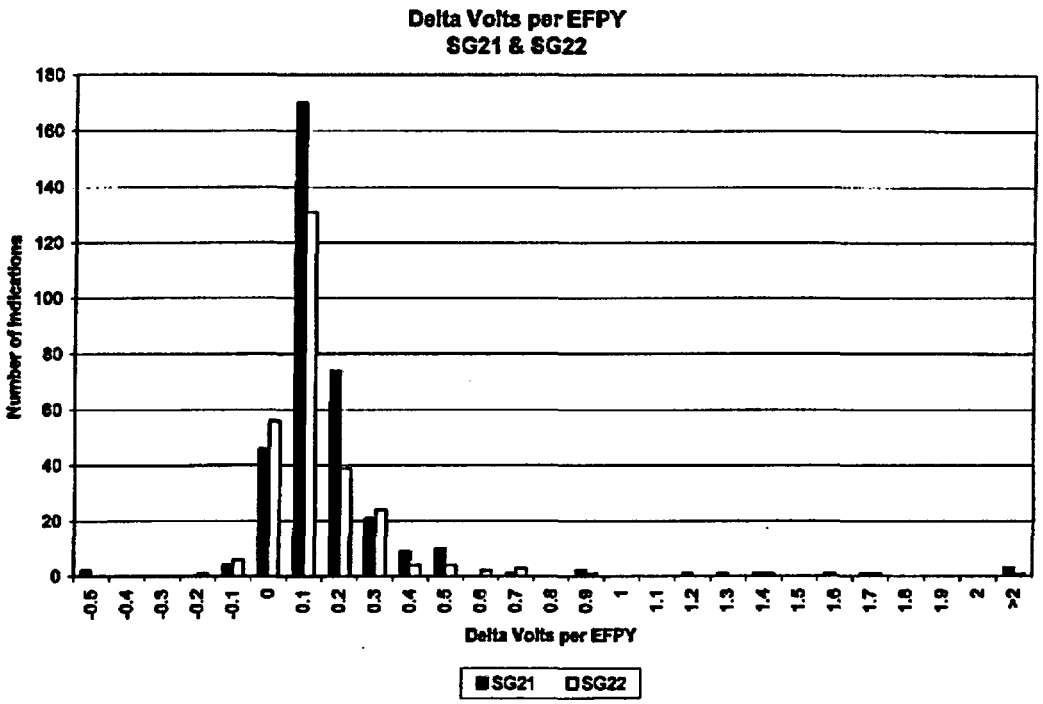
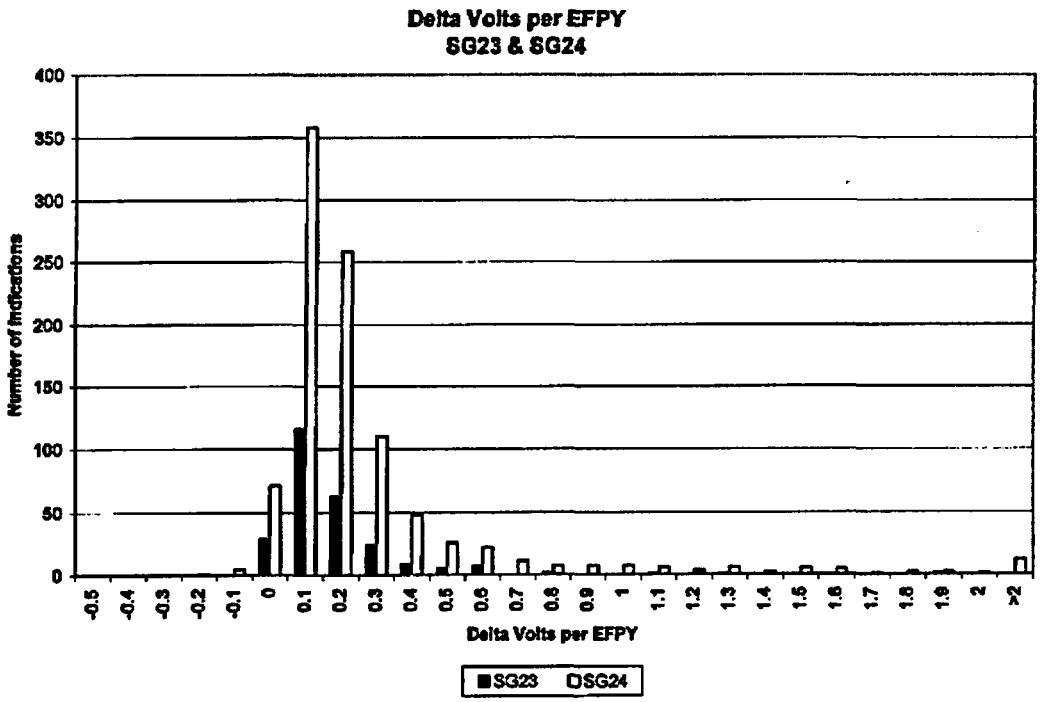
decrease in average BOC voltage, reflecting the impact of a large number of new low voltage indications detected in 2R11. Table 3-7 shows the voltage independent growth distributions for each SG and the composite for all four SGs. The cumulative probability distribution function is also provided here. Figures 3-8 and 3-9 show the voltage growth distributions depicted in bar charts. The negative growth values were included as zero growth rates, as required by Generic Letter 95-05. Reviewing the average and maximum voltage growth for all indications for each SG as well as the number of new indications in each SG shows that the ODSCC mechanism is most active in SG 2-4. This phenomenon of a leading SG in plants affected by ODSCC is common in the industry. Reviewing Table 3-6 and Figures 3-8 and 3-9 also supports this conclusion. As shown in the table and figures, the largest growth rates occurred in SG 2-4. Cycles 10 and 11 voltage independent growth rates for each SG are provided in Figure 3-30, and Figure 31, respectively.

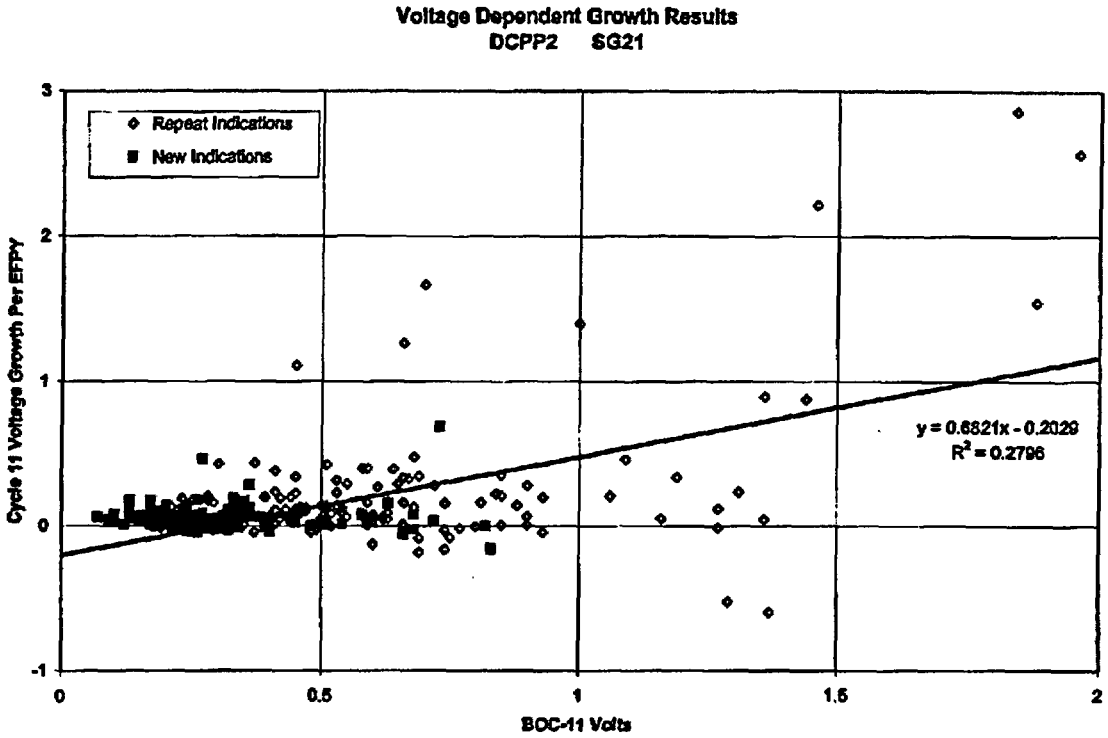
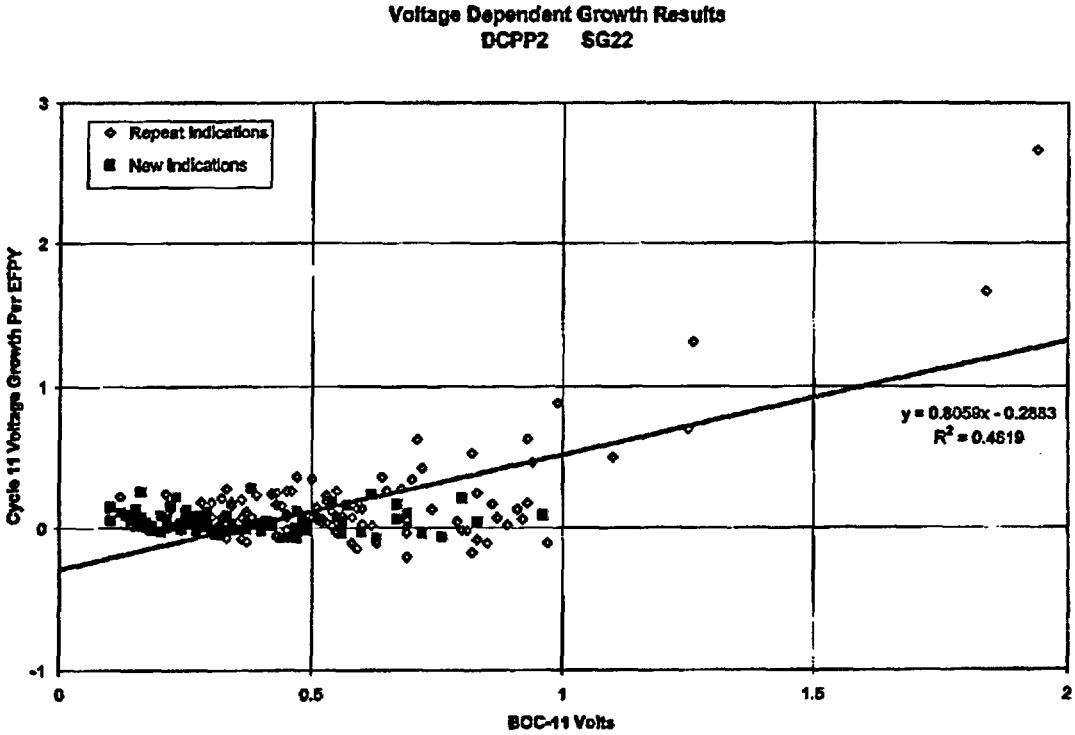
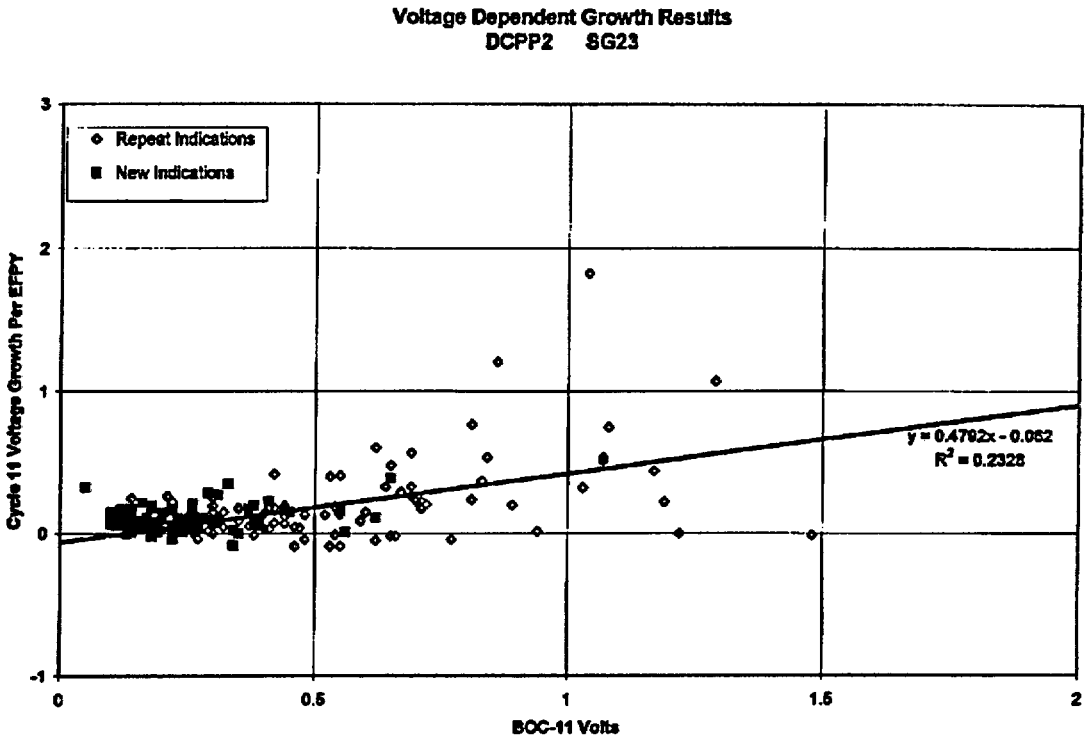
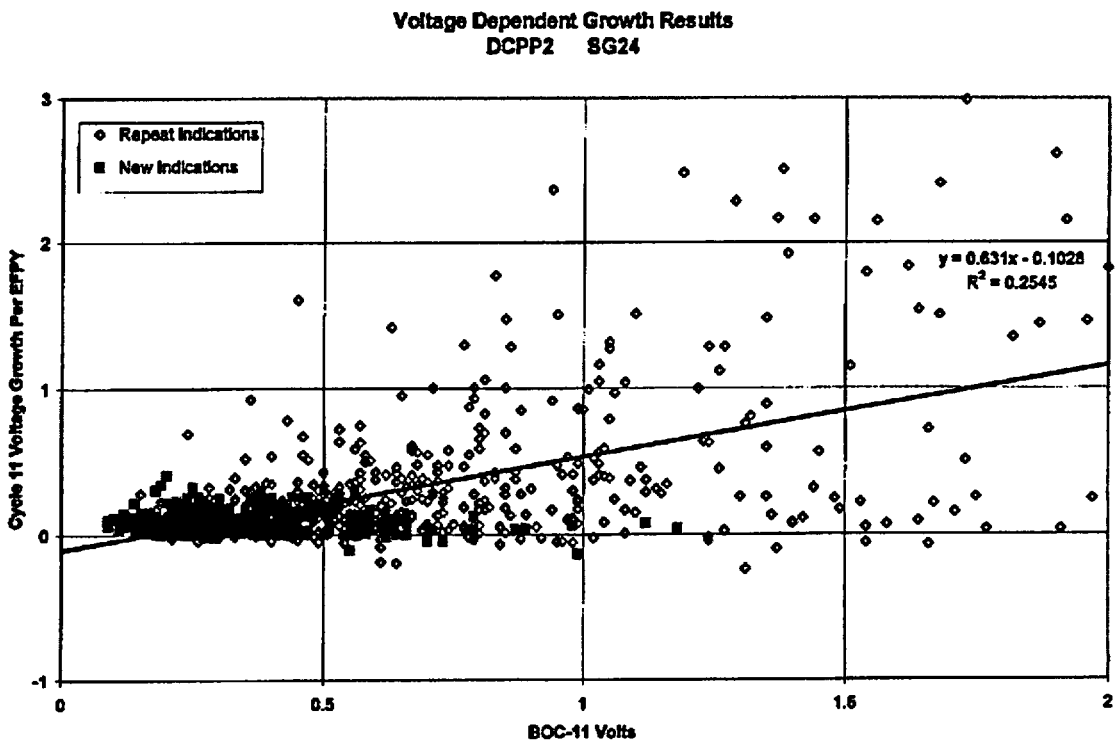
For Cycle 11, growth rates were plotted against the BOC voltage for all steam generators. Their data are shown in Figures 3-10 through 3-13. As is demonstrated by the figures, a positive slope exists in all SGs, indicating that voltage growth at DCPP-2 is in fact a function of the BOC voltage. This phenomenon is known as voltage dependent growth (VDG) and the initiation of it was previously observed in the Cycle 10 data for SGs 2-3 and 2-4, as documented in the 2R10 90-day report. Another observation is that the new indications are not exhibiting as much VDG as repeat indications. Figure 3-14 depicts all of the Cycle 11 data for SG 2-4, including R44C45 that grew from 2.0 volts to 21.5 during Cycle 11. This graph supports the conclusion that the growth rate of this indication is not indicative of the remaining population of the indications at DCPP-2, and is a separate growth issue confined to this indication. A cause assessment of the high growth rate of this indication is provided in Section 4 of this report. A VDG strategy was employed for the previous cycle 90-day report analyses for SGs 2-3 and 2-4, and to evaluate the similarities between the two cycles, the Cycle 10 growth data is provided with the Cycle 11 data in Figures 3-15 through 3-18. VDG is not a new concept, and has been documented by the European SGs affected by ODSCC. Because of their higher repair limits, their data encompasses a much broader and higher range of data than at DCPP and the US plants and provides significant basis for the VDG approach.

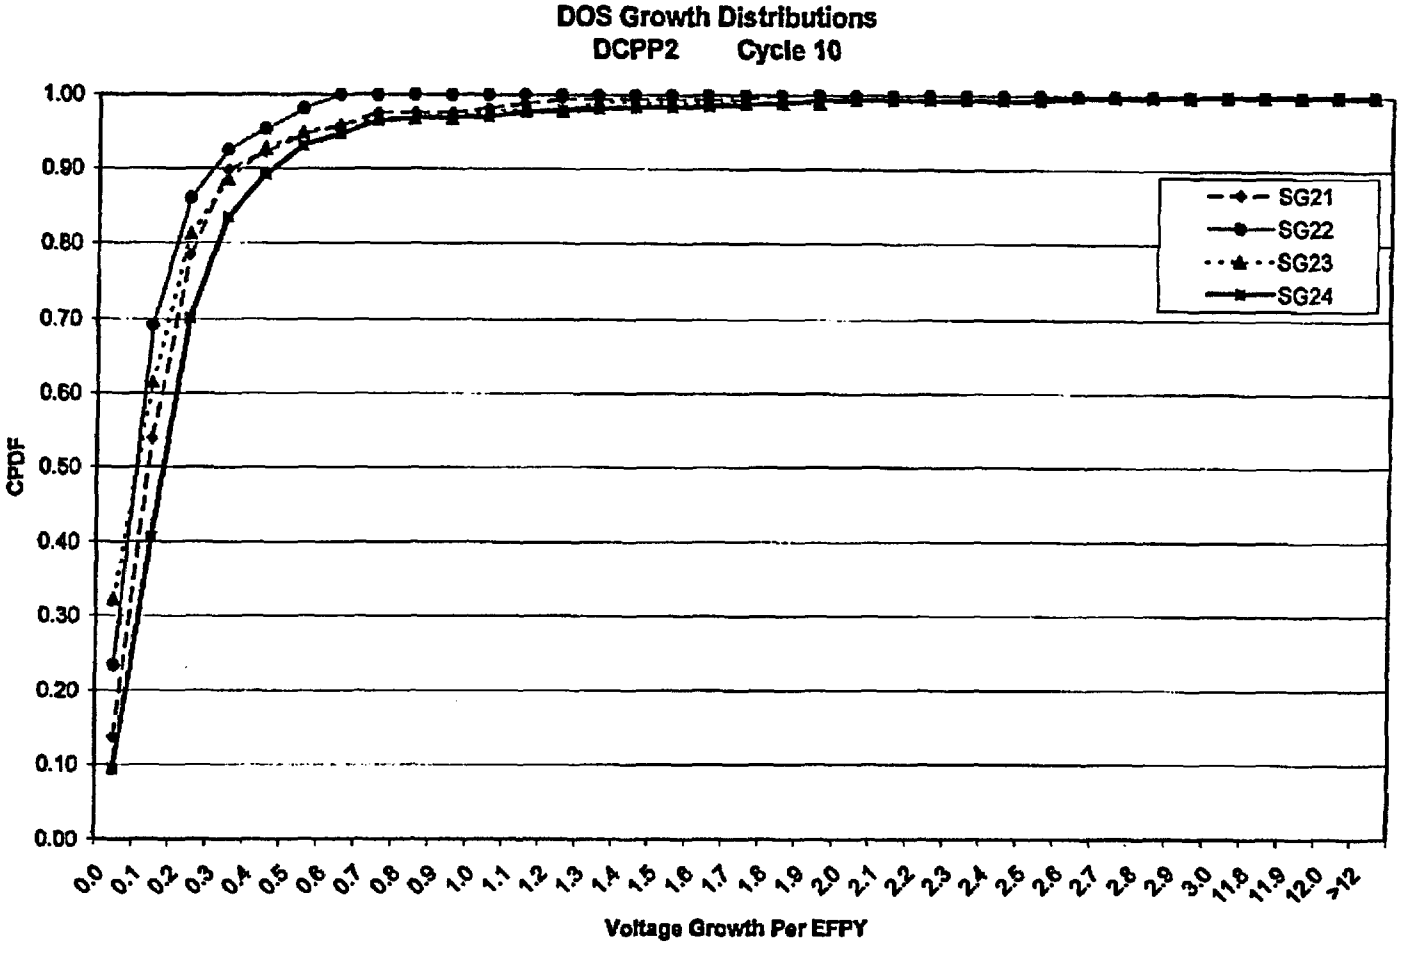
Figure 3-30: Cycle 10 Independent Growth Curves All SGs

Growth data for Cycle 11, independent of BOC-11 voltage, is contained in Table 3-7 for each SG. These results are presented graphically in Figure 3-31. The Cycle 10 SG-specific growth rates are shown in Figure 3-30. GL 95-05 requires that the most limiting of the two growth distributions from the previous two cycles should be used. Comparing these distributions against these requirements, it was determined that the Cycle 11 data was more conservative than Cycle 10 data. Therefore, for EOC-12 projections, Cycle 11 data should be used. Additionally, it was determined that SG 2-4 had the most conservative growth rates during Cycle 11. Therefore a composite curve for all SGs was developed and determined to be more conservative than the SG specific curves for SGs 2-1, 2-2 and 2-3. Therefore, for Cycle 12 projections, a composite curve was utilized for these SGs, and the SG specific curve was used for SG 2-4. Table 3-11 presents the data that was used in the Cycle 12 OA calculations that utilized a voltage independent growth approach.

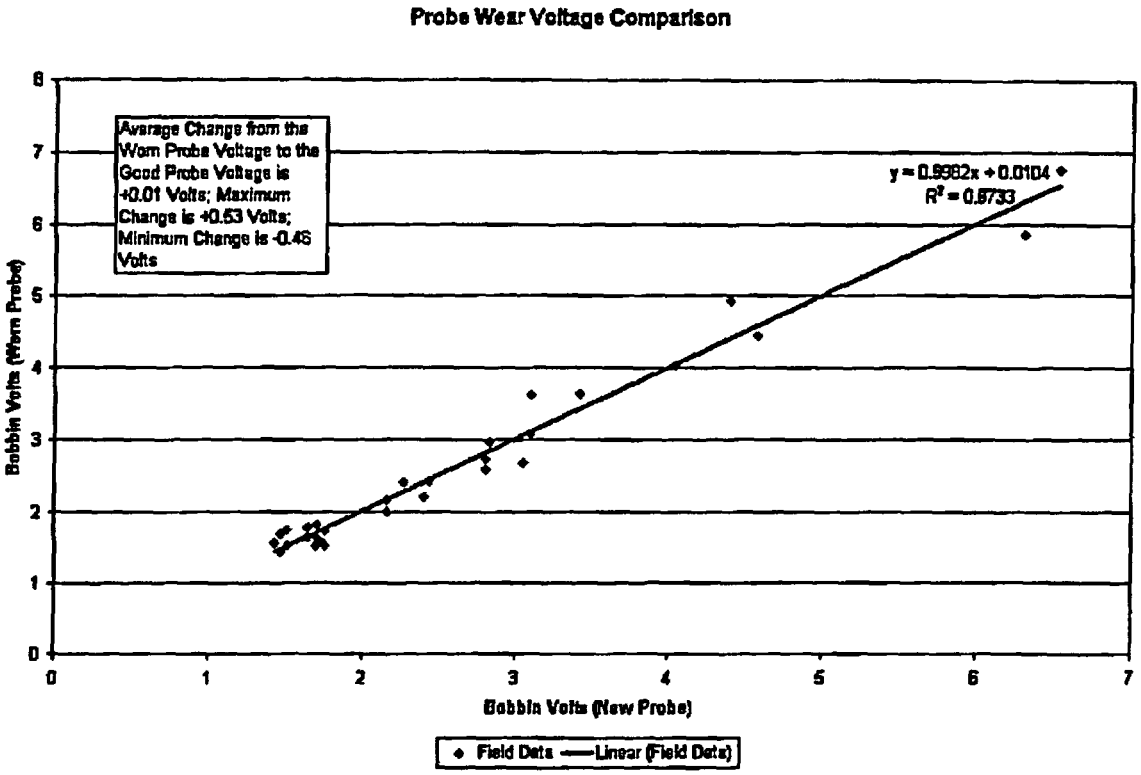
Figure 3-32: 2R11 Probe Wear Voltage Comparison

The 2R11 eddy current inspection resulted in 30 bobbin indications greater than or equal to 1.5 volts that were inspected with a worn probe. These indications are shown in Table 3-13. The RSS and DOS voltage variation was tabulated for each worn probe inspection. The retest voltage values compare reasonably with the final acceptable DOS voltage, generally within about ±8.5%) of the RSS voltage. Figure 3-32 shows a comparison of the worn probe and good probe voltages. This figure shows that the voltages do not change significantly between the

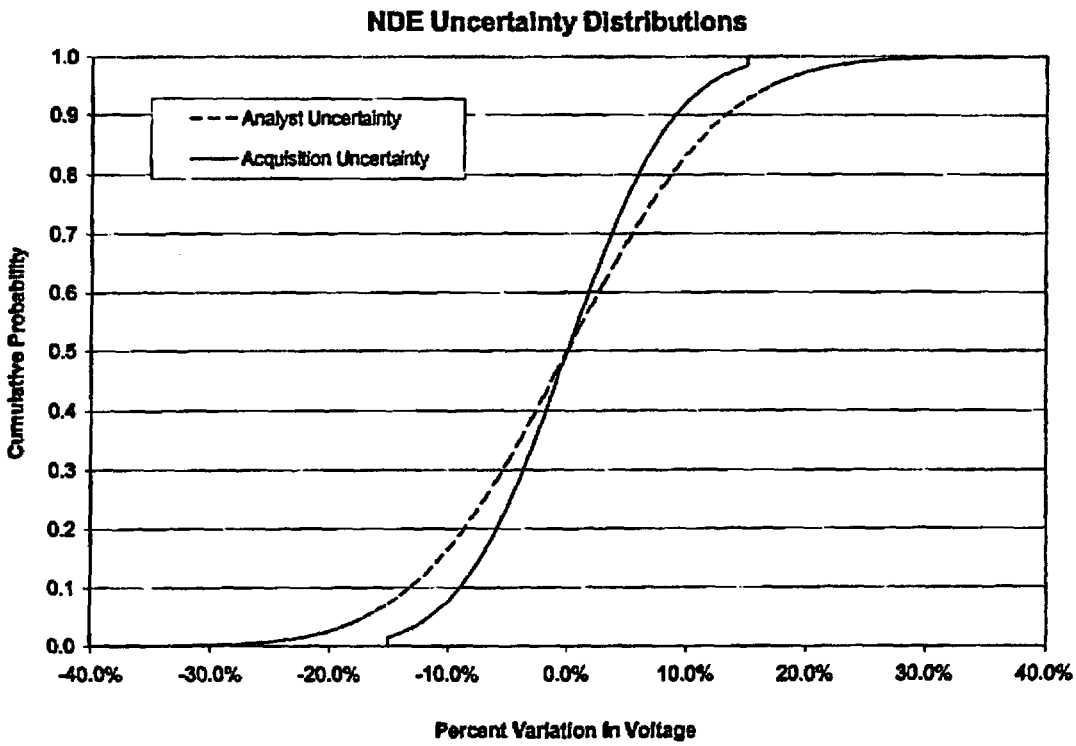
Figure 3-33: Bobbin Voltage Uncertainty Distributions

NDE uncertainties must be taken into account when projecting the end-of-cycle voltages for the next operating cycle. The NDE uncertainties used in the calculations of the EOC-12 voltages are described in Ref. 6. The acquisition uncertainty was sampled from a normal distribution with a mean of zero, a standard deviation of 7%, and a cutoff limit of 15% based on the use of the probe wear standard. The analyst uncertainty was sampled from a normal distribution with a mean of zero, a standard deviation of 10.3%, and no cutoff limit. These uncertainty distributions are shown in Table 3-17 and Figure 3-33.

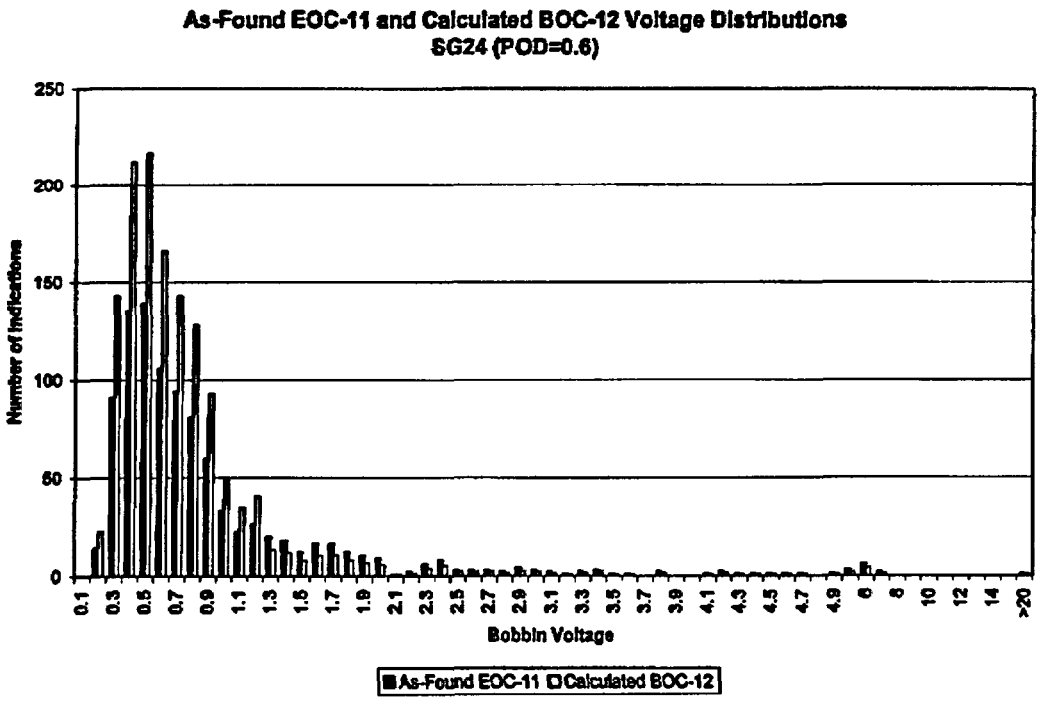
Figure 6-4: As-found SG 2-4 and BOC-12 Voltage Distributions (POD 0.6/1.0 for R44C45)
