SPECIAL REPORT 03-02

W* ALTERNATE REPAIR CRITERIA 90 DAY REPORT

DIABLO CANYON POWER PLANT UNIT 2 ELEVENTH REFUELING OUTAGE

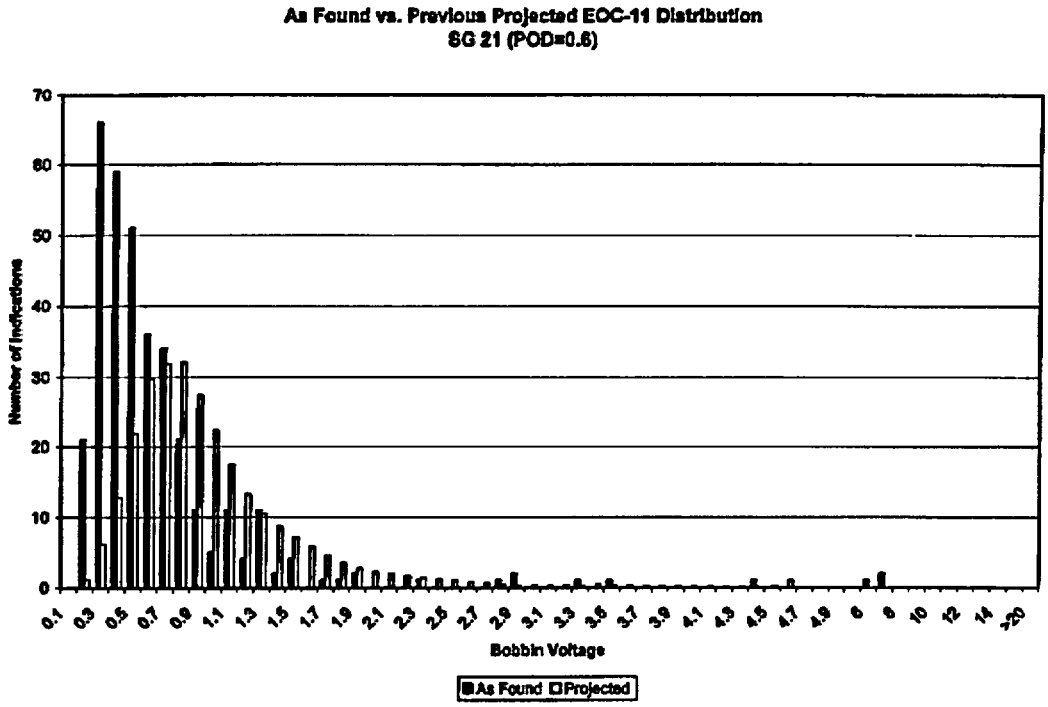
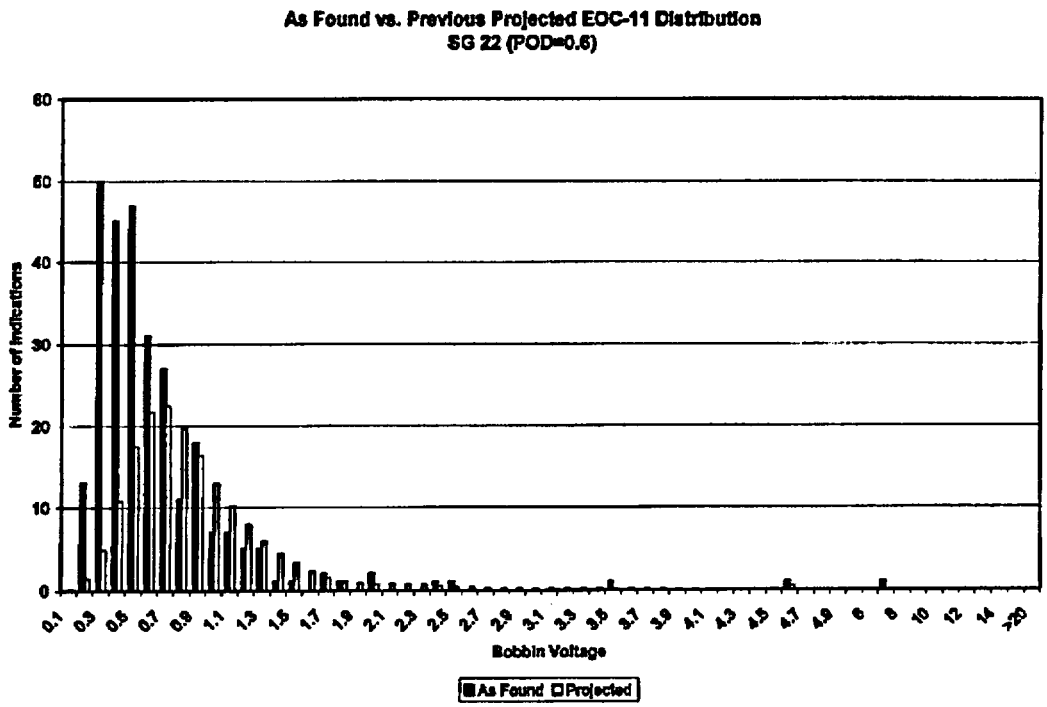
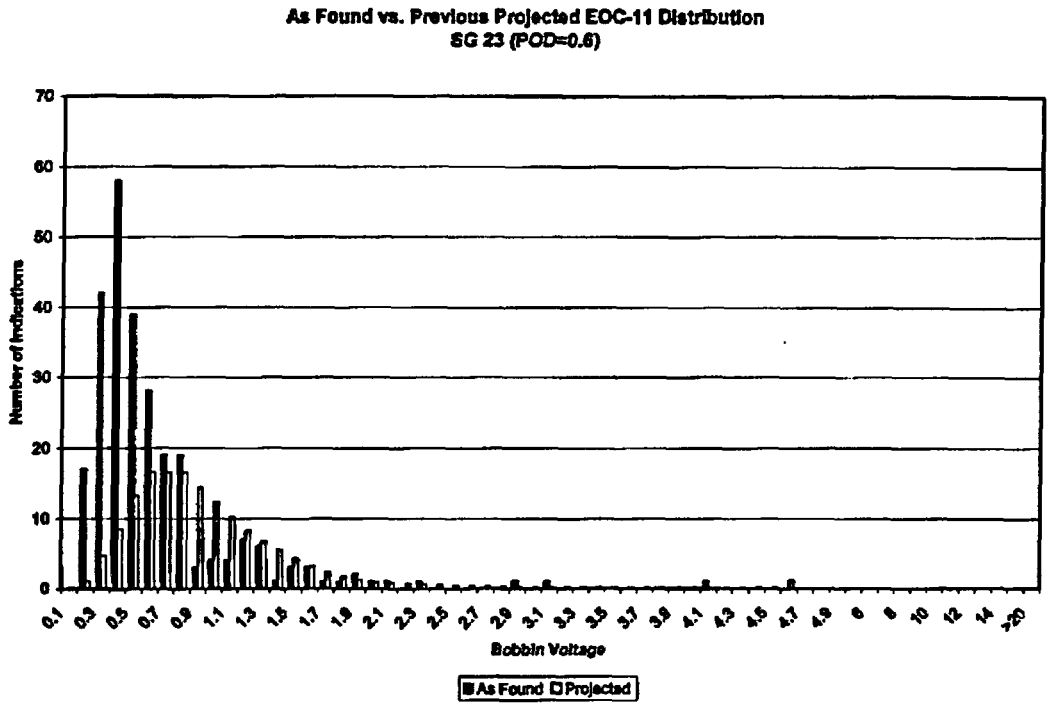
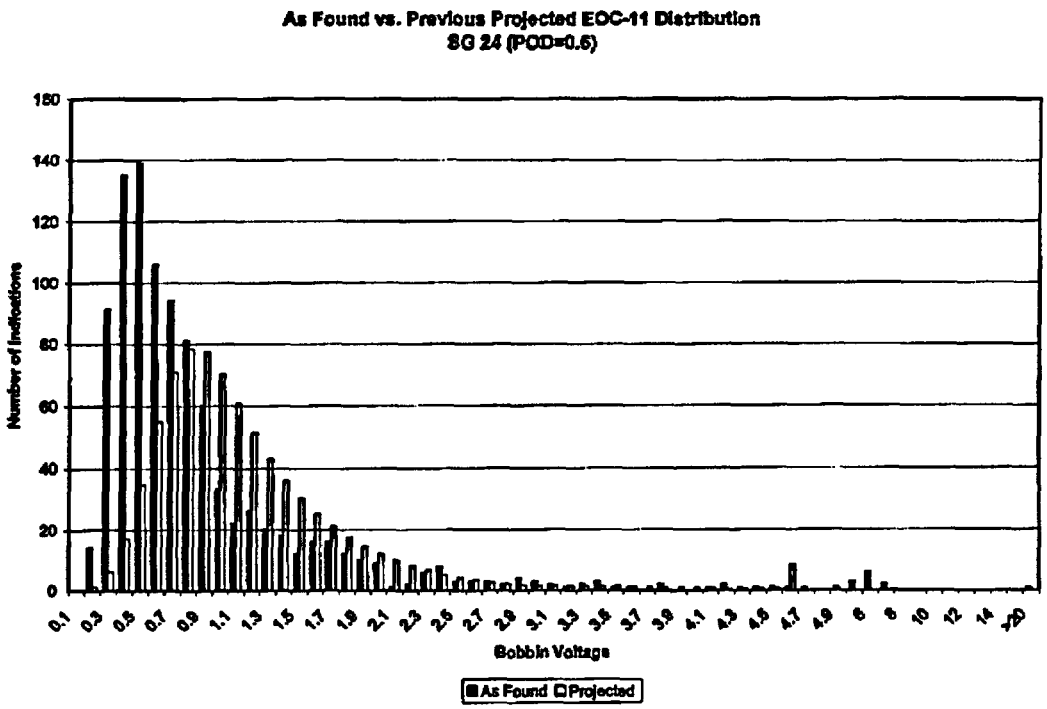
The as-found EOC-11 bobbin voltage distributions and the predicted distributions from the previous 90-day report using a POD of 0.6 and a voltage independent growth for all SGs are compared in Table 6-7. Figures 6-5 through 6-8 depict the projected population at EOC-11 using a POD of 0.6 and independent growth from Ref. 7, versus the as-found EOC-11 conditions. As shown in Table 6-7, the number of indications was under-predicted using the 0.6 POD for all steam generators. Figures 6-5 through 6-8 show that the under predictions generally occurred in voltage bins less than about 0.8 volts. For bins exceeding 0.8 volts, the predictions generally exceed the as-found voltages except for the tail of the distribution for all four SGs. SG 2-1 and 2-2 had several indications over 6 volts that were not projected at 2R10. The EOC-11 results for SG 2-4 projected there would be 8 indications at 4.6 volts. There were fourteen indications found during 2R11 that exceeded 4.6 volts. The results of these comparisons demonstrate that the voltage independent growth rate method in conjunction with the 0.6 POD was not adequate to predict EOC-11 conditions. VDG calculations were also performed at EOC-10 for SGs 2-3 and 2-4, using both POD of 0.6 and EPRI Addendum 4 POPCD. Table 6-8 compares both of the projected distributions to the EOC-11 as-found conditions for these SGs. The projections both under predicted the number of indications compared to the as-found conditions. The POD of 0.6 did predict a higher number of large voltage indications, however, this is expected since a much larger fraction of the repaired indications are returned to service, compared to application of POPCD which has a much higher POD in the high voltage ranges. The shortcoming of the 2R10 90-day report VDG+POPCD projections are attributed to the growth rate differences between the cycles and the bins that were chosen in the analysis (one breakpoint at 1 volt based on Addendum 4 recommendations for 50 indications in the upper voltage bin).

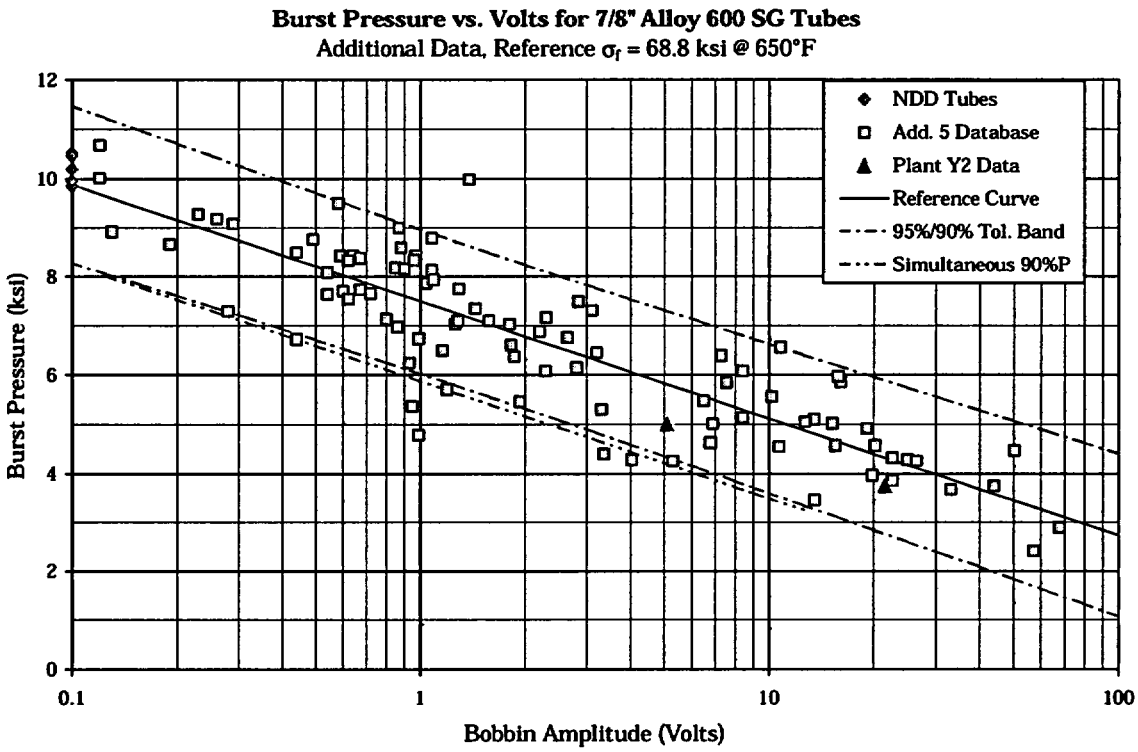
The results of the leak and burst testing are listed in Table 5-2 below. Based on the evaluation of the leak and burst results and their ultimate inclusion in the Ref. 8 database (see comparisons in Table 5-3, 5-4, 5-5), the pulled tubes from 2R11 were prototypical of those contained in the database and justify the use of the voltage-based ARC for DCPP Unit 2. The detailed evaluation of the pulled tubes on the ODSCC ARC database is submitted by PG&E as a separate attachment to the 90 day report.

Figure 1: Comparison of additional test data to database tolerance bounds.

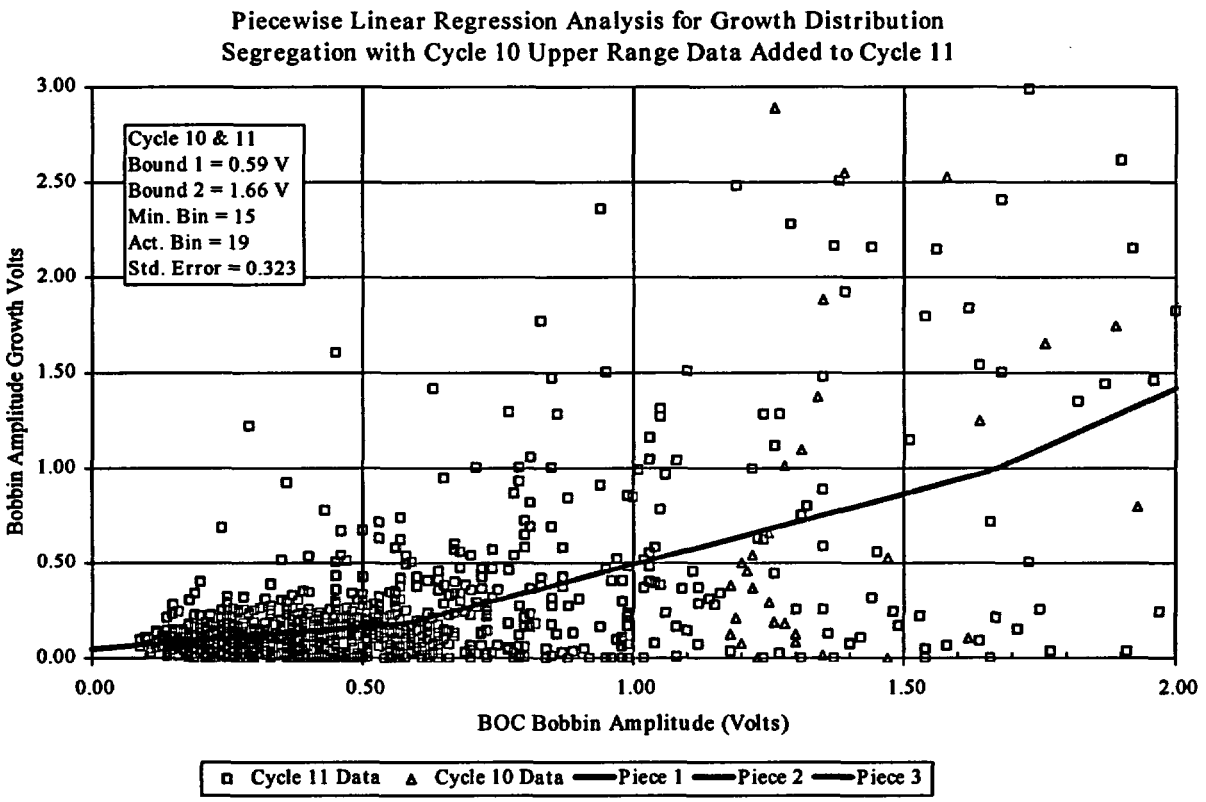
Figure 9: Trilinear regression lines for SG 2-4 Cycle 11 growth data

where V_{B1} and V_{B2} are the two breakpoints needed in the analysis. The solution is independently illustrated on Figure 9. The trilinear regression analysis illustrated is for a different data set than used for the bilinear regression, upper range values from the growth during Cycle 10 were included to increase the probability of experiencing some of the larger growth values. The sum of squares of the errors is greater for the trilinear regression than for the bilinear because of the difference in the data sets. However, the improvement, measured by decreasing the SSE, obtained by increasing the complexity of the model was marginal at best. Although the SSE was only marginally improved, the use of the trilinear regression was and is recommended where practical. Recall that the purpose of the analysis is not to fit useable functions to the data, but only to find locations where there is evidence that the growth may be changing. The results are readily apparent from an examination of the information presented on Figure 7. An additional breakpoint is found at location 1.66 Volts which results in greater predicted growth for the larger values. This is a desirable feature to include in the operational assessment. There are 19 data pair included in the solution for the upper bin, indicating that the solution was not converging to the remaining single highest growth value. Had the single extreme growth value been included in these analyses, the solution would have converged to whatever limit was in place for the upper bin, e.g., 15 in this case.

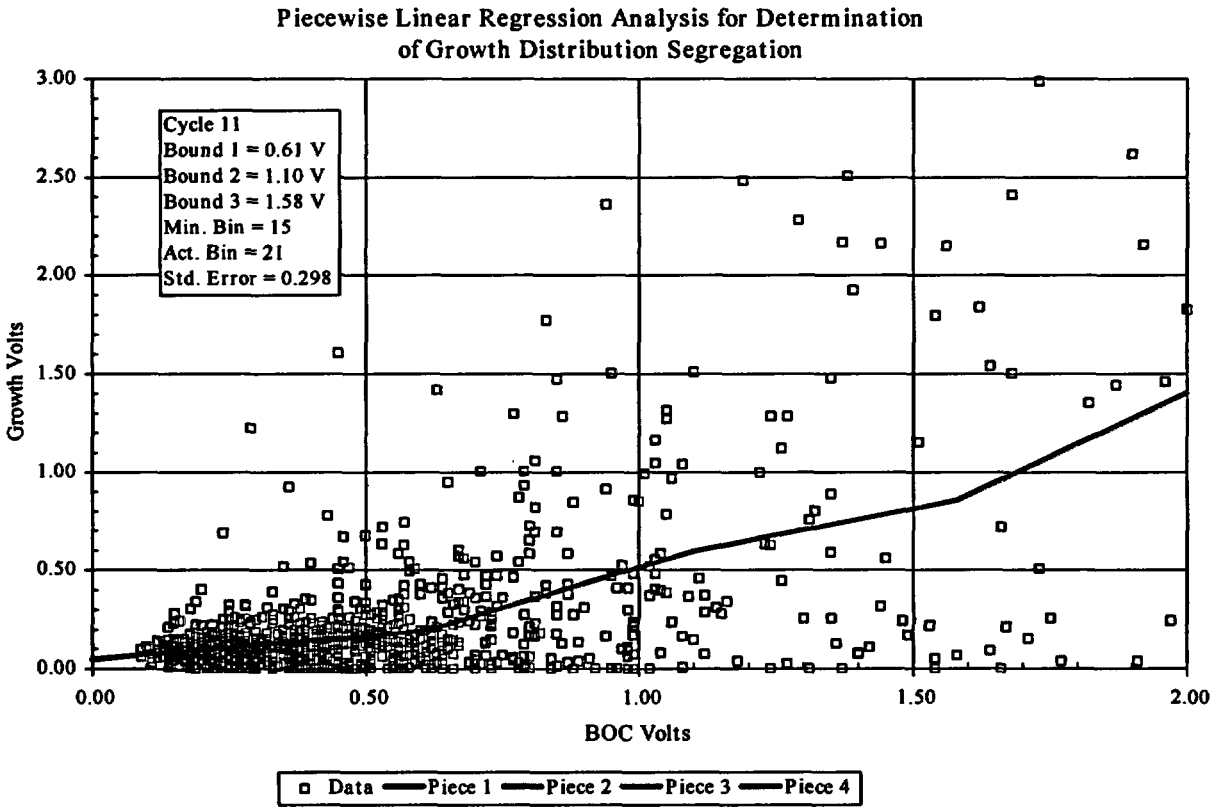
Figure 12: Quadrilinear regression of SG 2-4 Cycle 11 growth data

where V_{B1}, V_{B2} and V_{B3} are the three breakpoints to be calculated. The results of extending the model to consider four regression lines are illustrated on Figure 12. An undesirable consequence,

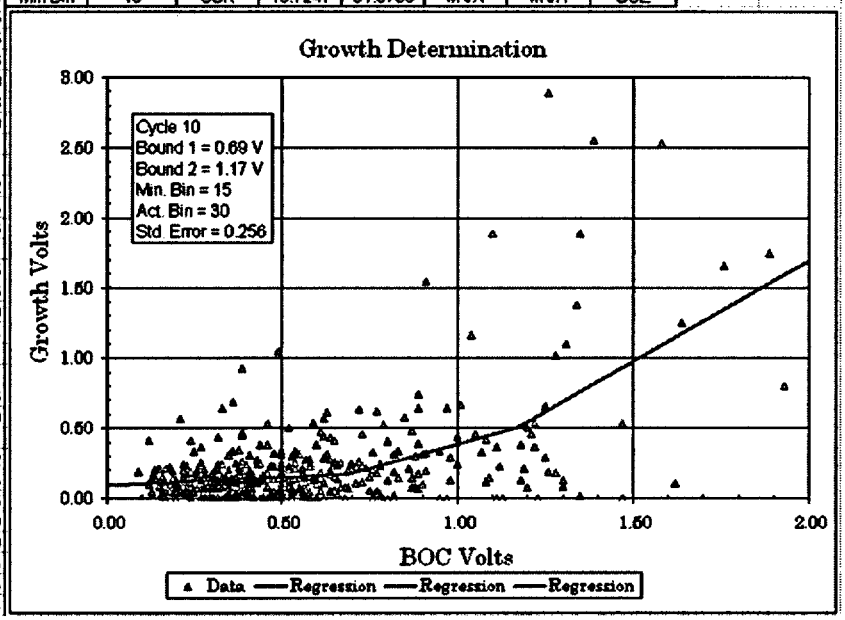
Figure 13: Excel screen for SG 2-4 Cycle 10 growth data

The growth data from Cycle 10 for SG 2-4, a total of 488 indications, were analyzed using the same techniques to find breakpoints in the growth that would minimize the corrected sum of squares of deviations from the piecewise regression predictions. The Excel screen for the analysis is shown of Figure 13. The results of the analysis indicate that breakpoints of 0.69 and 1.17 Volts should be used for analyses employing the Cycle 10 growth data. The dependence of growth on BOC amplitude is significant above the second breakpoint where it is apparent that the change in slope is somewhat dramatic. The results are illustrated in larger scale on Figure 14.

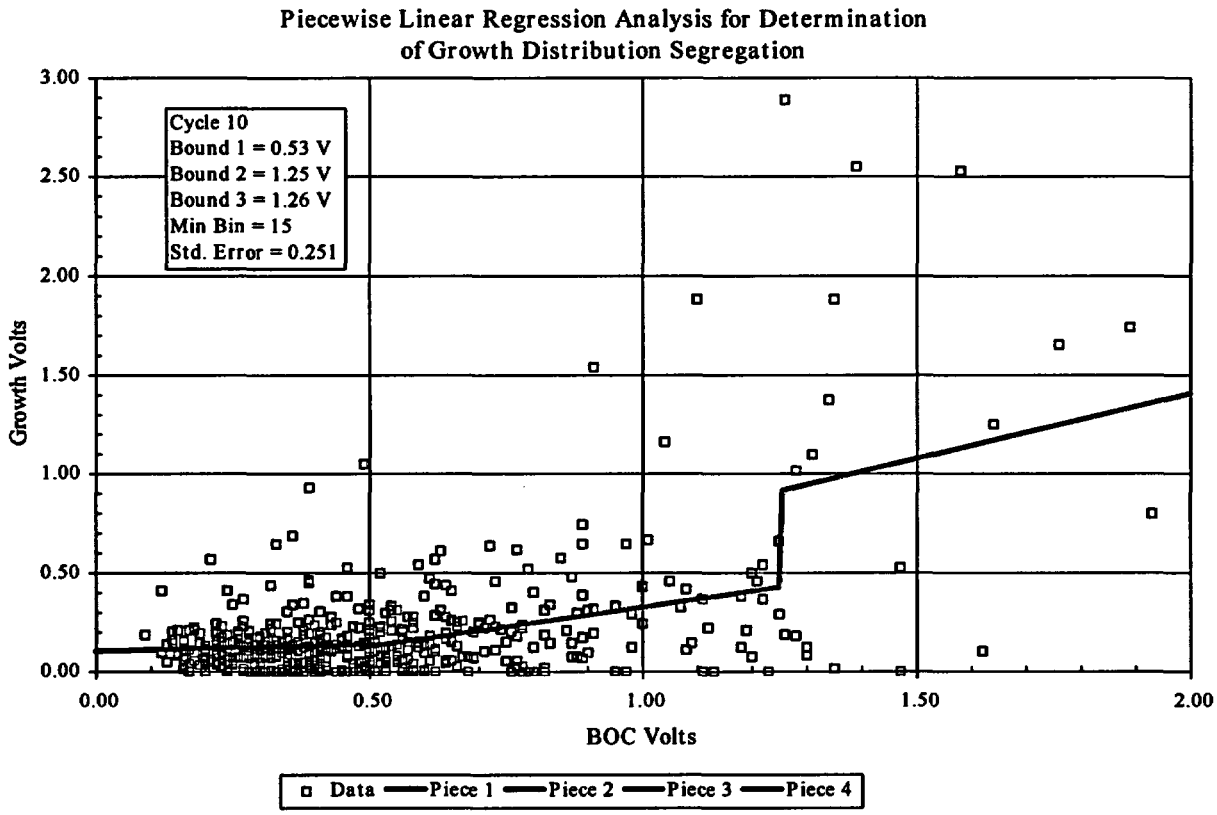
Figure 15: Quadrilinear regression w/o a data limit on Piece 3

The Cycle 10 data also provide an illustration a potential drawback in using quadrilinear regression without a restriction on the minimum number of data that may be used for the third segment or piece of the curve. A near step function results as illustrated on Figure 15. This results from the influence of the large growth value at about 1.25 volts, i.e., minimization of the standard error of the regression is achieved by having a step at that value, with a smaller slope for the fourth segment of the curve. The noted point, and two others, is also influential in the determination of the slope of the third segment for the trilinear regression. A comparison of the two curves shows

Illustration of an unsatisfactory analysis result.

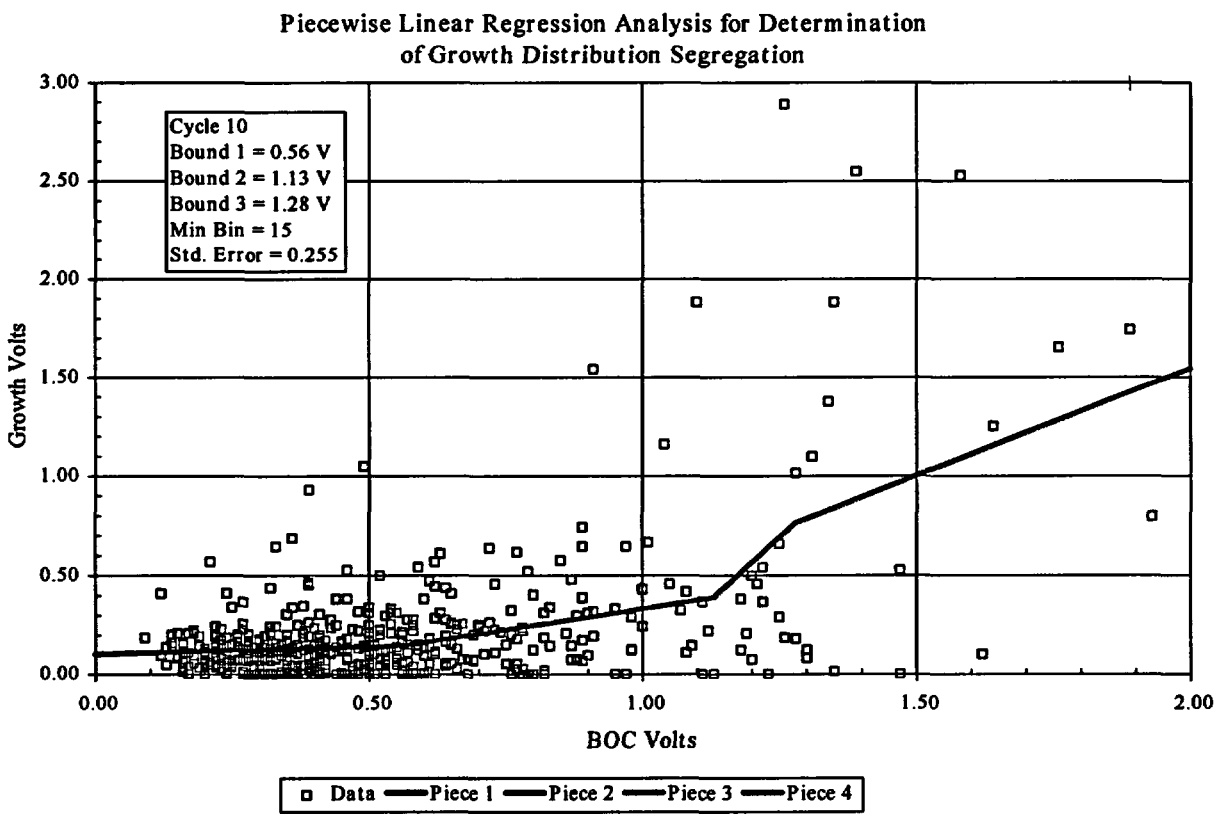
Figure 16: Quadrilinear regression of SG 2-4 Cycle 10 growth data

that the growth in the range of less than 1.2 Volts is less than if the trilinear curve is used, in the range of 1.2 to 1.5 Volts the growth is greater if the quadrilinear curve is used, and growth for indications greater than 1.5 Volts is greater if the trilinear curve is used. Figure 16 illustrates the solution for the same data if a limitation on the number of data for the third segment is used. In this case the growth rate in the range below about 1.2 Volts is greater for the trilinear curve and slightly lower thereafter to about 1.5 Volts. It should be noted that for the trilinear fit the number of data in the upper bin is 30 even though the specified minimum was 15. For the quadrilinear fit the number of data in the third and fourth bins exactly matches the specified minimum. Thus, the analysis is converging to the specified limits instead of seeking out the natural breakpoint. As for the analysis of the Cycle 11 data, there is no advantage to using a quadrilinear fit to determine the breakpoints.
