Nuclear Operating Company
South Texas Project Electric Generating Station P.O. Box 289 Wadsworth, Texas 77483

July 11, 2003
NOC-AE-03001557
10CFR50

South Texas Project
Units 1 & 2
Docket Nos. STN 50-498, STN 50-499
Additional Information Regarding STP's Commitment to Investigate and Repair
Bottom Mounted Instrumentation Penetration Indications

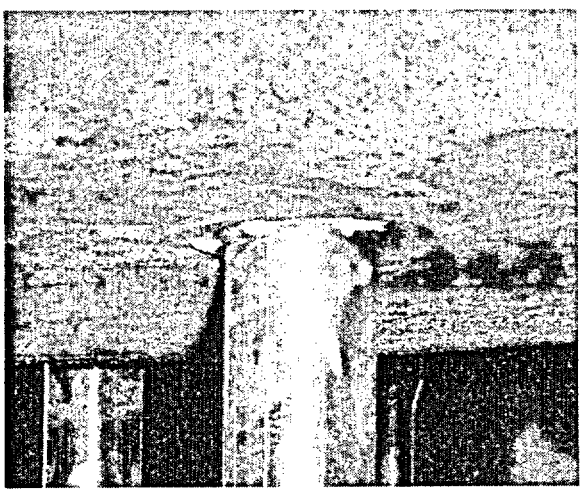
Figure 1 (Nozzle 46)

Nozzle 46 had two cracks and each crack was axially oriented to the J-groove weld. One crack extended above and below the J-groove weld but did not penetrate the inside diameter of the nozzle. The second crack extended for most of the length of the J-groove weld from the outside diameter, did not extend either above or below the J-groove weld, and did not penetrate through to the inside diameter of the nozzle.

The bottom head of the reactor was inspected on April 12, 2003 as a routine part of the station's regular bare metal inspection of the reactor vessel bottom penetrations. The inspection is part of the RCS Pressure Boundary Inspection for Boric Acid Leaks program, 0PGP03-ZE-0033. The bottom head of the reactor is contained in an insulating box structure with no insulation directly in contact with the bottom head. The inspection is accomplished by removing some of the insulation panels forming the box. Three different vantage points are used to inspect all 58 BMI nozzles. The inspection found small amounts (150 milligrams on nozzle 1 and 3 milligrams on nozzle 46) of white residue around Bottom Mounted Instrument (BMI) nozzles number 1 and 46 at the annulus between the nozzle and the bottom head, (Figure 1 and Figure 2).

Nozzle 46 had two cracks. Each crack was axially oriented to the J-groove weld. One crack extended above and below the J-groove weld but did not penetrate the inside diameter of the nozzle. The second crack was smaller, did not extend above or below the J-groove weld, and did not penetrate the inside diameter of the weld.

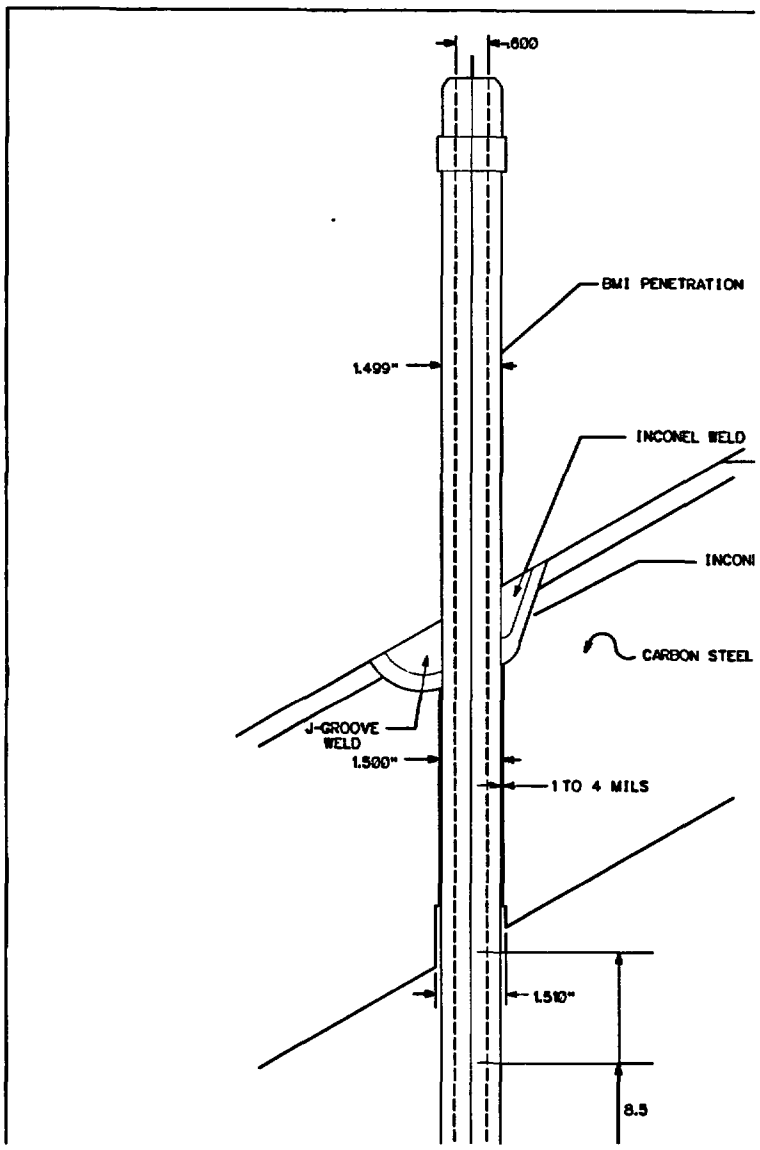
The BMI nozzles are machined from 1.75-inch diameter Alloy 600 bar stock. The nozzles have an outside diameter of 1.499 inches and an inside diameter of 0.60 inches. The BMI nozzles are structurally secured by an interior J-groove weld consisting of Alloy 600 base weld materials designated as 182 with fabrication

weld repairs being made with either 182 or 82 weld material. The vessel itself is 5.38-inch thick low alloy carbon steel with 0.22 inches of stainless steel cladding on the interior surface. Each penetration bore in the reactor bottom head is nominally 1.5 inches in diameter. There is an open annulus between the nozzle and the reactor head below the J-groove weld. Figure 4 provides a simplified view of a typical nozzle configuration

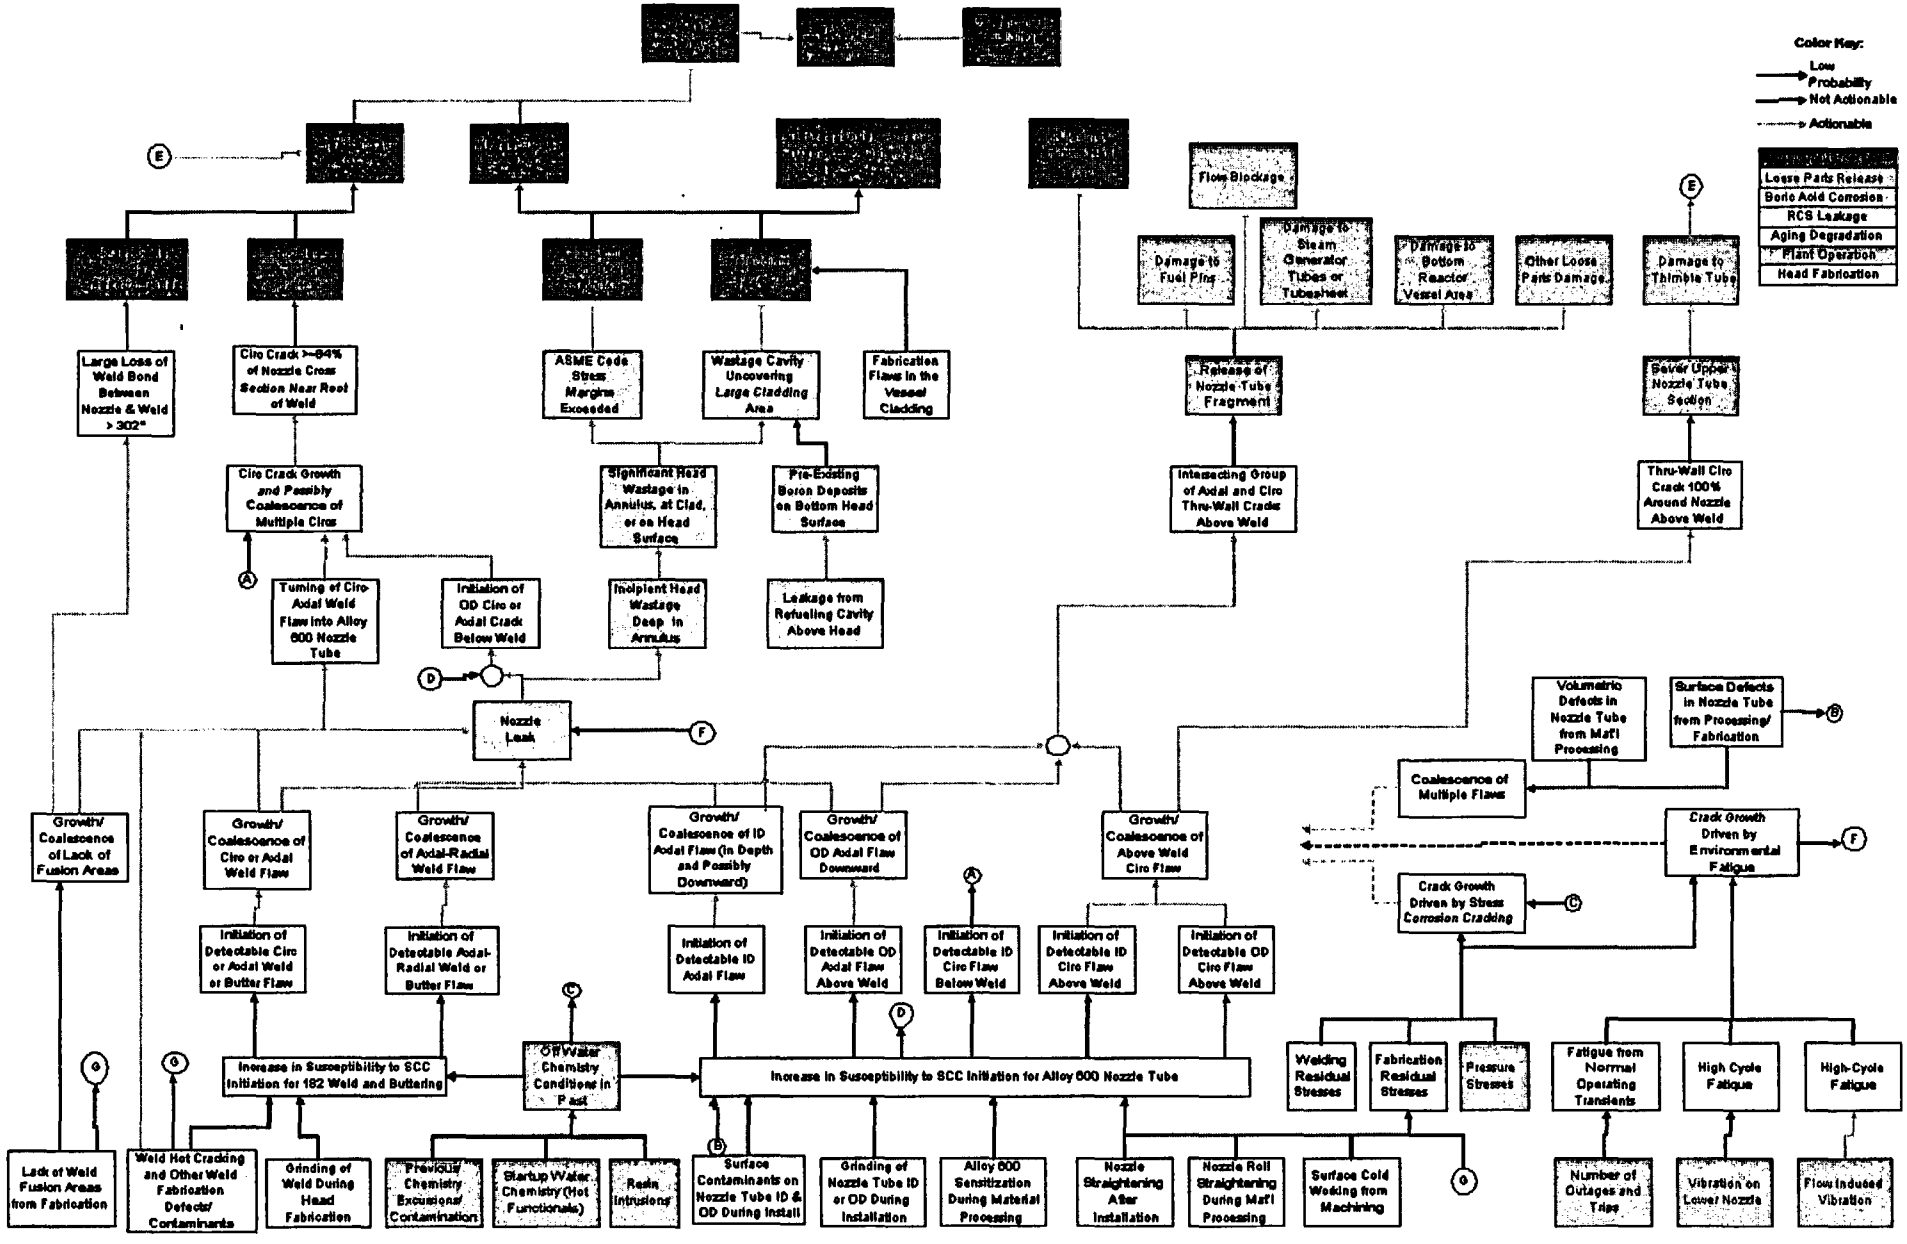
South Texas Project Status Report on Resolving the Unit 1 BMI Issue – Attachment 1
Failure Modes and Effects Analysis Chart

South Texas Project's Failure Modes and Effects Analysis for Bottom Mounted Instrument Nozzle Leakage

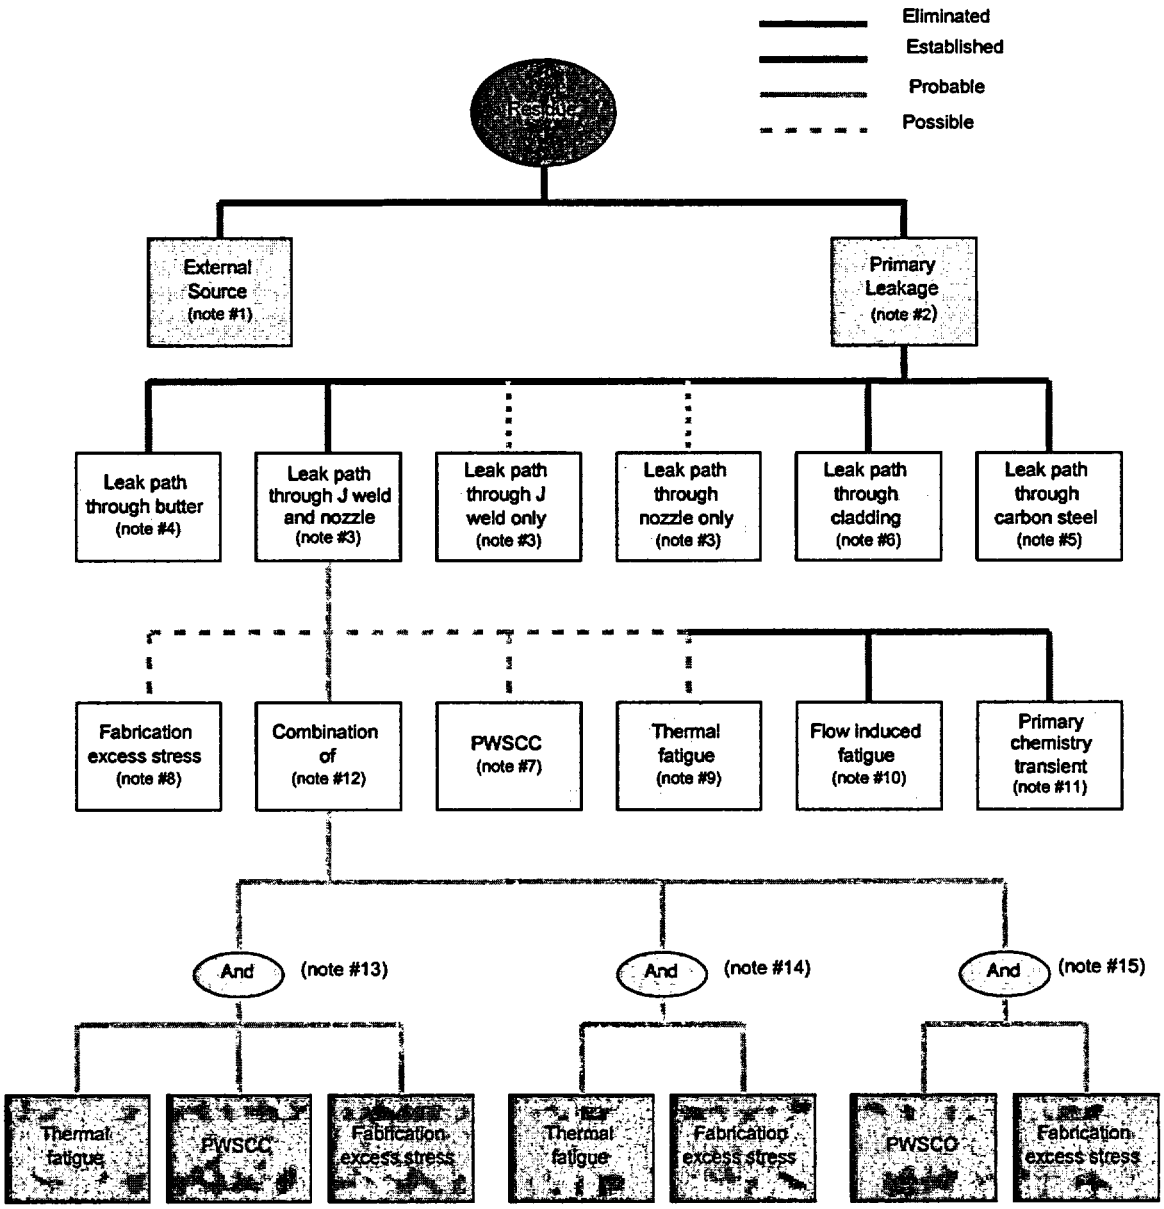
South Texas Project Status Report on Resolving the Unit 1 BMI Issue – Attachment 3 Fault Tree Analysis

Note #1: Swipes and visual inspection of the outside surface of the RPV do not support outside source for the boron residue.

Note #2: Boron, lithium, and cesium content confirm RCS coolant as source of residue.

Note #3: UT examination and the pressure test identified a leak through the weld and nozzle 1. UT examinations suggest the cracks in nozzles 1 and 46 originated at the nozzle weld interface. A crack originating at this location most likely involves both the nozzle and the weld. The investigation path for nozzle, weld and combined nozzle and weld is the same. The boat sample result will be the best opportunity to separate between the nozzle and the weld.

Note #7:PWSCC requires three things; 1) susceptible metal, 2) residual stress, and 3) an aqueous environment. Only two of five nozzle cracks are confirmed to be in contact with primary water. Although these cracks appear to have their origin within the welded zone, it is possible, but unlikely, they could exist by PWSCC alone.

Note #9: This is low cycle fatigue due to temperature and pressure changes. If fatigue alone were responsible for the flaws there should be more flaws in other nozzles. Fatigue is a possible source of the cracks but more likely in combination with pre-existing fabrication defects.

Note #11: There are no records of significant RCS chemical transients. STP experience with the Alloy 600 steam generator tubes, which are much thinner, have not indicated any degradation due to RCS chemical contaminats.

Note #12: Cracks that do not extend beyond the weld zone, (i.e., not in contact with primary water) Are most likely the result of a combination of fabrication flaws

and low-cycle fatigue. However, cracks that are in contact with primary water may be a combination of PWSCC, fabrication flaws, and low-cycle fatigue.

Note #13: Possible for cracks that appear to have their origin within the weld and extend to the point of contact with primary water.

Note #14: Most likely source of cracks totally imbedded in the weld zone but could also be possible for cracks that extend beyond the weld.

Note #15: This postulates a fabrication flaw that was missed by the final PT examination or propagated to the surface during the initial hydro vessel testing and later grew through the weld zone by PWSCC.

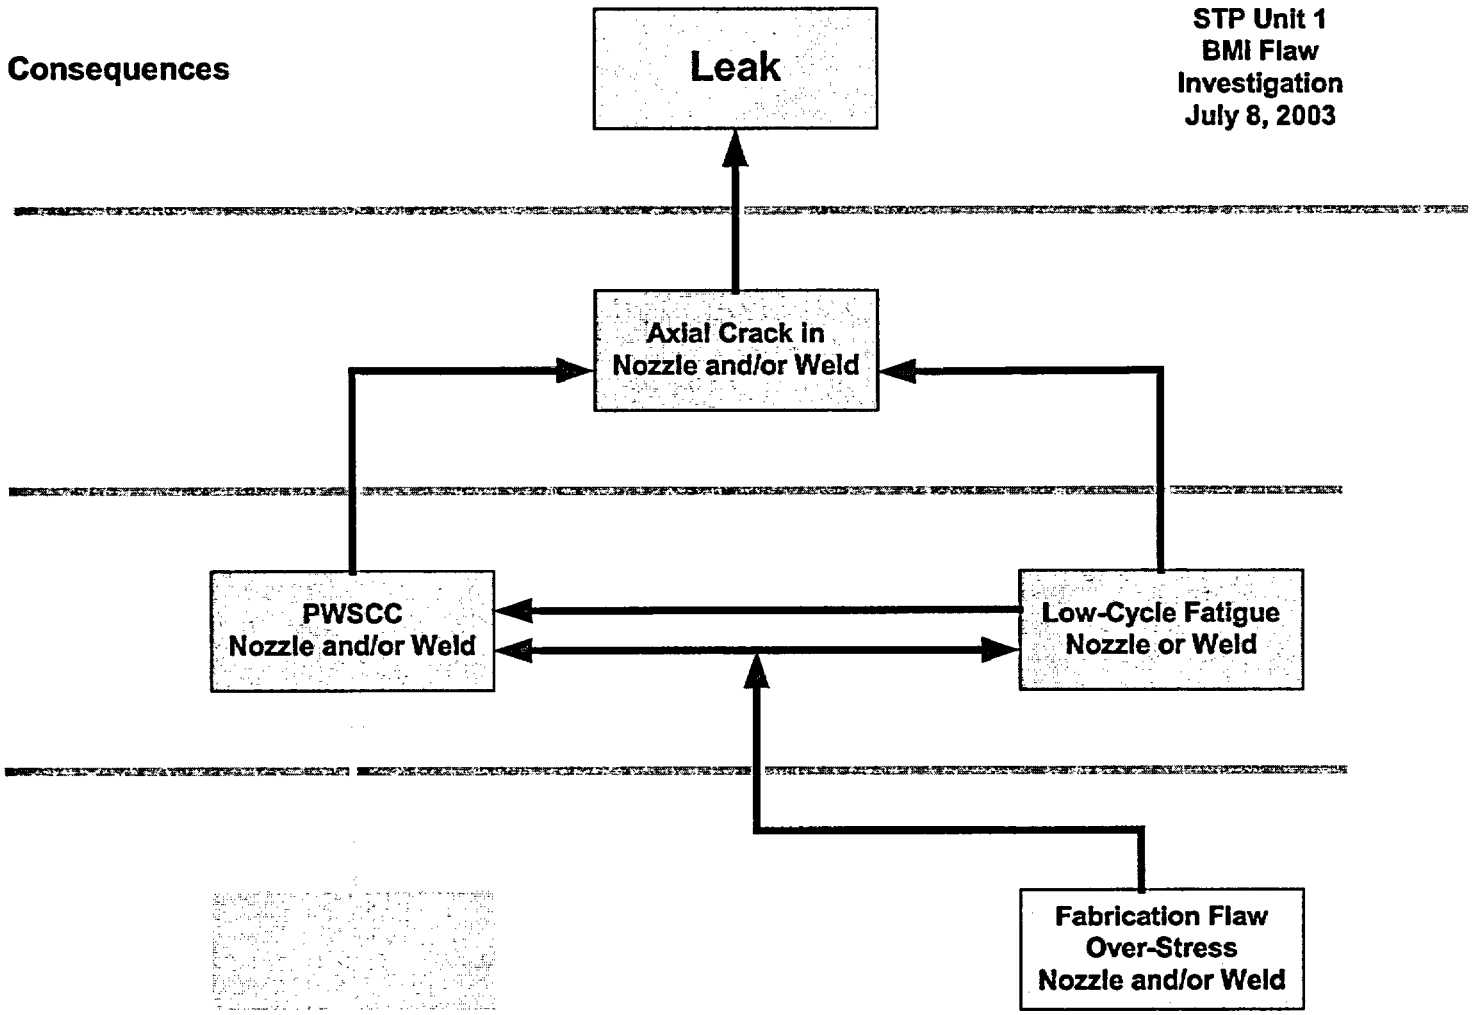
Consequences
Leak
STP Unit 1
BMI Flaw
Investigation
July 8, 2003
Axial Crack in
Nozzle and/or Weld
PWSCC
Nozzle and/or Weld
Low-Cycle Fatigue
Nozzle or Weld
Fabrication Flaw
Over-Stress
Nozzle and/or Weld

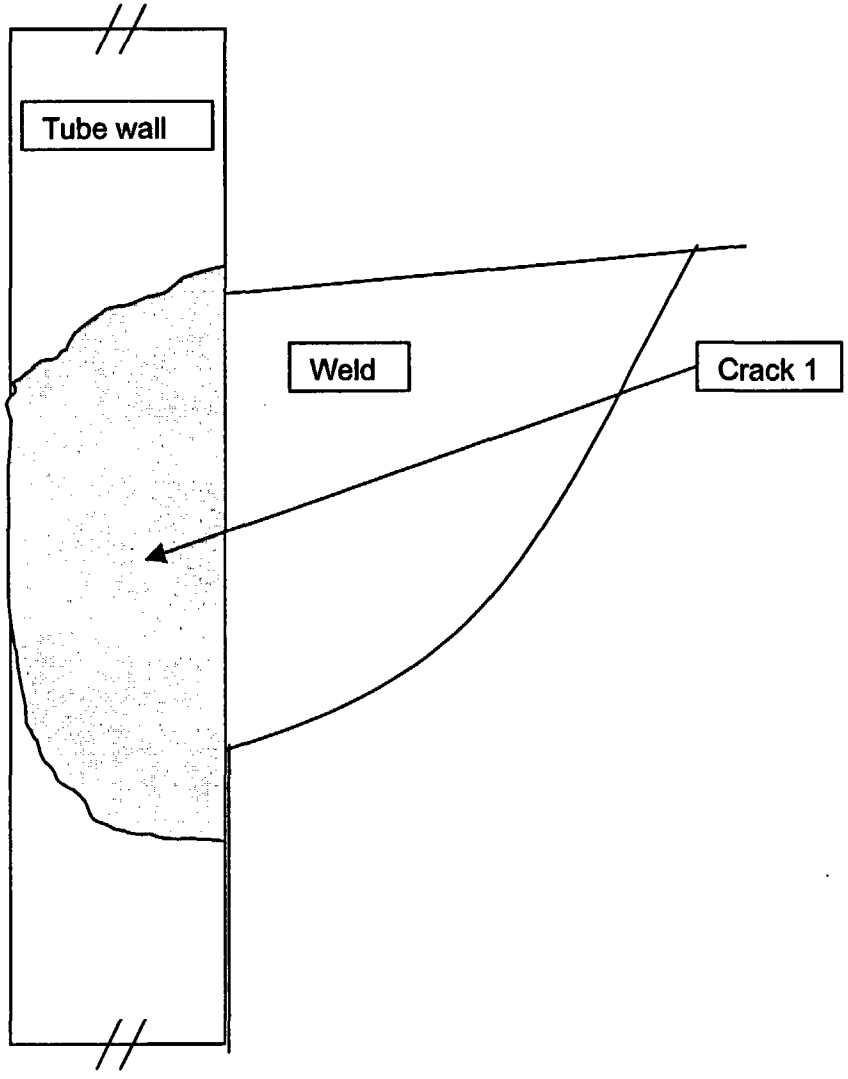
South Texas Project Status Report on Resolving the Unit 1 BMI Issue – Attachment 5 Two Dimensional Representation of Cracks in Nozzle 1

Nozzle 1 had three cracks and each crack was axially oriented to the J-groove weld. One crack extended above and below the J-groove weld and penetrated the inside diameter of the nozzle. The second and third cracks were much smaller and were located on the outside diameter of the nozzle close to the initial root weld passes. The second and third cracks did not extend either above or below the J-groove weld and did not penetrate the inside diameter of the nozzle.

Nozzle 1 had three cracks. Each crack was axially oriented to the J-groove weld. One crack extended above and below the J-groove weld and penetrated the inside diameter of the nozzle. The second and third cracks were much smaller and on the outside diameter of the nozzle close to the initial weld passes. The second and third cracks did not extend above or below the J-groove weld and did not penetrate the inside diameter of the weld.

All three probes confirmed the presence of five cracks, three in nozzle 1 and two in nozzle 46. Attachments 5 and 6 are two-dimensional representations of the cracks. There were no cracks indicated in any of the remaining nozzles, and no circumferential cracks were found. In addition, the UT probes indicated anomalous conditions at the nozzle weld interface in all of the nozzles, possibly indicating lack of weld fusion or some other anomalous weld condition. The possible significance of lack of fusion in the BMI nozzle welds is discussed later in Section V. E. 4. The extensive data derived from the primary UT inspection are electronically recorded for detailed analysis and preserved as a baseline for future UT inspections.
