NRC 2003-0067

July 31, 2003

POINT BEACH NUCLEAR PLANT, UNITS 1 AND 2
DOCKETS 50-266 AND 50-301
REACTOR VESSEL CLOSURE HEAD PENETRATION REPAIR
RELIEF REQUESTS MR 03-018-1 AND MR 02-018-2
SUPPLEMENT 2 AND RESPONSE TO REQUEST FOR ADDITIONAL INFORMATION

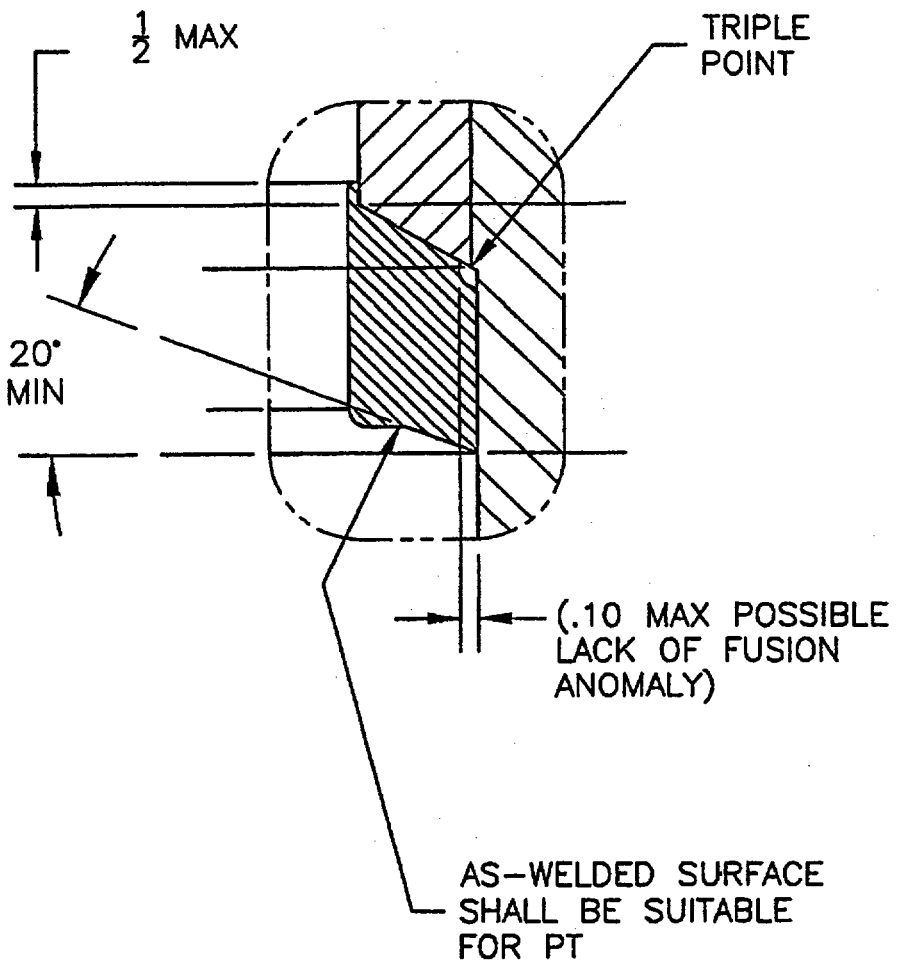
Figure 1. Weld Anomaly in Temper Bead Weld Repair

During the welding process (step 4), a maximum 0.1 inch weld anomaly may be formed due to lack of fusion at the "triple point", as shown in Figure 1. The anomaly is conservatively assumed to be a "crack-like" defect, 360 degrees around the circumference at the "triple point" location. The technical requirements document (Reference 2) provides additional details of the ID temper bead weld repair procedure. The purpose of the present fracture mechanics analysis is to provide justification, in accordance with Section XI of the ASME Code (Reference 3), for operating with the postulated weld anomaly at the triple point. Predictions of fatigue crack growth are based on a design life of 25 years.

2) In the radial plane, the anomaly is assumed to include a quarter-circular "crack-like" defect (see Figure 1). For analytical purposes, a semi-circular flaw is used to represent the radial cross-section of the anomaly.

The anomaly is located in the triple point region as shown in Figure 1 below.

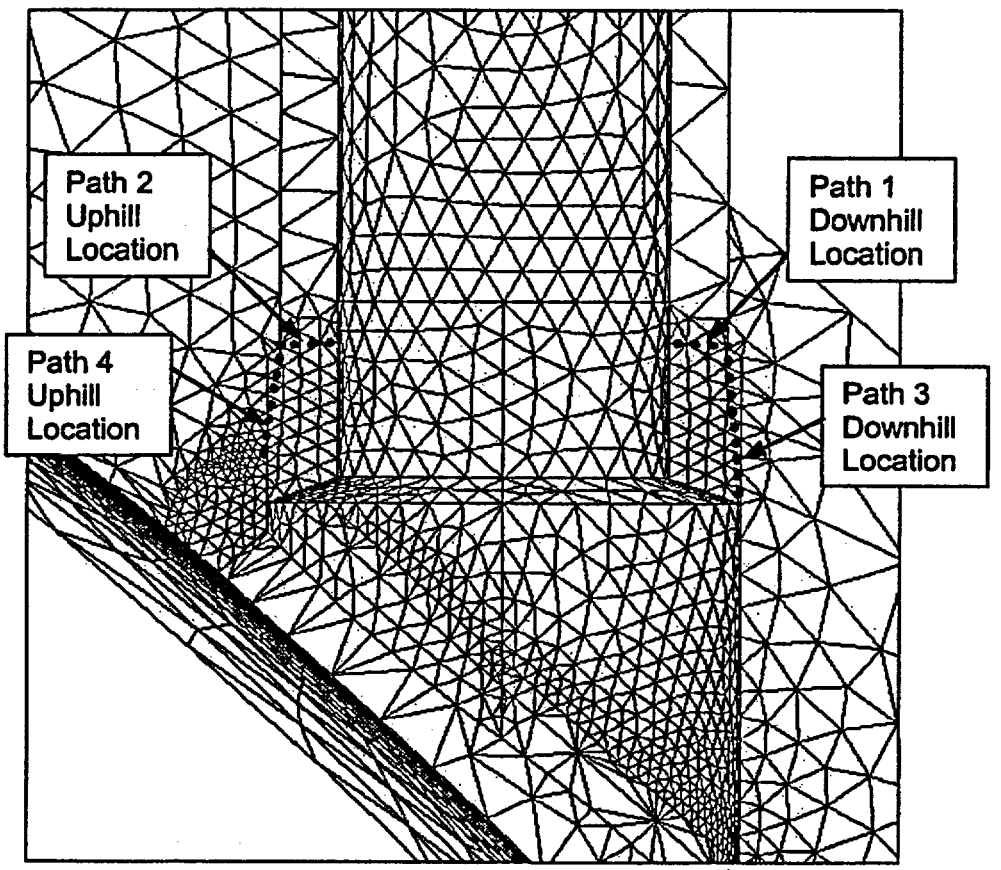
Figure 2. Illustration of Crack Propagation Paths on the Finite Element Stress Model

Stresses are available from Reference 6 for the four crack propagation paths illustrated in Figure 2. Paths 1 and 3 are located on the downhill (0°) side of the nozzle and Paths 2 and 4 are on the uphill (180°) side. Stresses are reported in a cylindrical coordinate system relative to the CRDM nozzle and include the three component directions (axial, hoop and radial) needed to calculate mode I stress intensity factors for the various postulated flaws. Stresses are provided at four uniform increments along each propagation path.

Since stresses are generally higher on the uphill side of the nozzle and the length of Path 4 is less than Path 3 (smaller distance to form a potential leak path), the stresses for Paths 2 and 4 will be used to evaluate postulated flaws at the triple point weld anomaly.

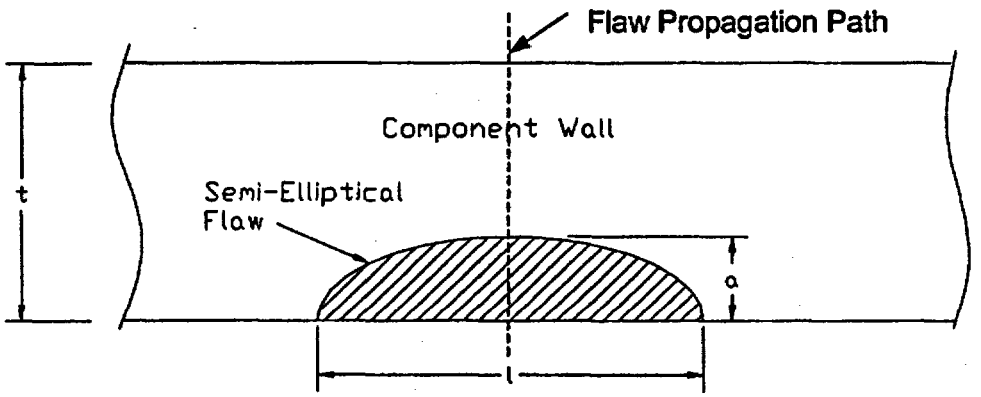
An axially oriented semi-circular OD surface flaw is also considered in the evaluation, as illustrated by the schematic below.

where, a = initial flaw depth = 0.100 inch
l = 2c = flaw length = 0.200 inch
t = wall thickness = 0.591 inch

An axial flaw is considered since the stresses in the CRDM penetration region are primarily due to pressure and therefore the hoop stresses are more significant. The SIF solution by Raju & Newman (Reference 10) for an external surface crack in a cylindrical vessel is used in the evaluation. The fatigue flaw growth analysis for the axial crack is also performed using the austenitic stainless steel properties.

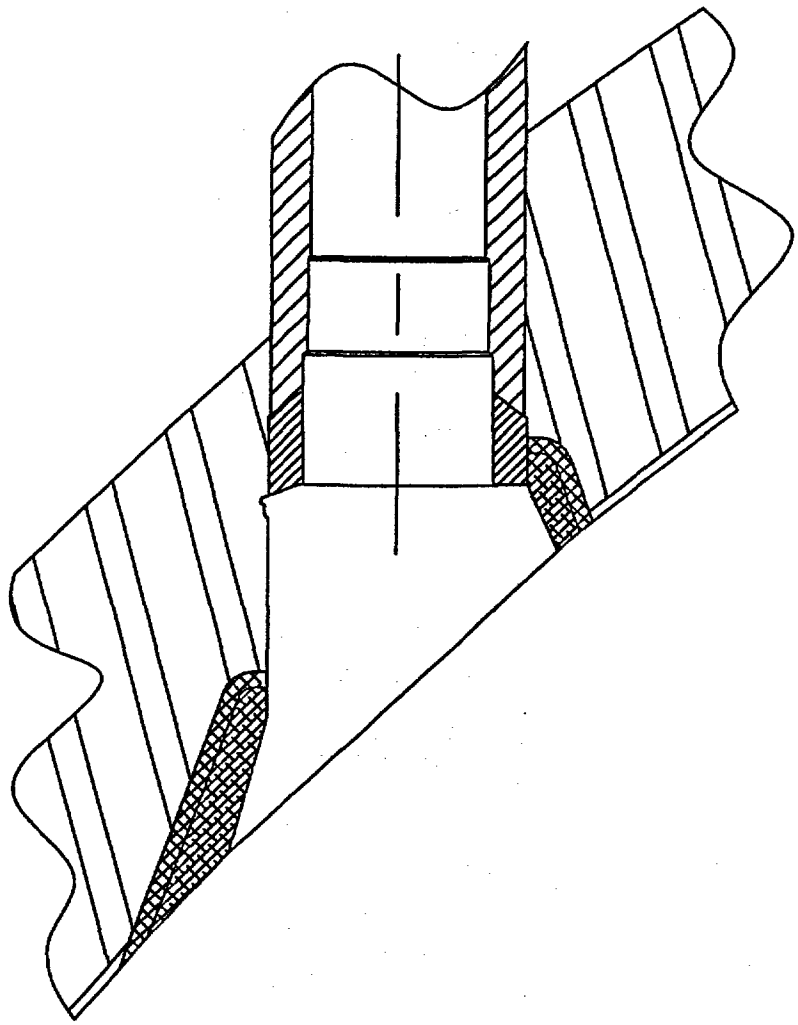
Figure 1. ID Temper Bead Weld Repair

Due to the susceptibility of Alloy 600 partial penetration nozzles to primary water stress corrosion cracking (PWSCC), a repair procedure has been developed for reactor vessel head control rod drive mechanism (CRDM) nozzles at Point Beach Unit 1 (PB-1) wherein the lower portion of a degraded nozzle is removed by a boring procedure and the remaining portion of the nozzle is welded to the low alloy steel reactor vessel head above the original Alloy 182 J-groove attachment weld, as shown in Figure 1. This repair design is more fully described by the design drawing [1] and the technical requirements document [2]. Except for a chamfer at the corner, the original J-groove weld will not be removed. Since a potential flaw in the J-groove weld can not be sized by currently available non-destructive examination techniques, it must be assumed that the "as-left" condition of the remaining J-groove weld includes degraded or cracked weld material extending through the entire J-groove weld and Alloy 182 butter material. The purpose of the present analysis is to determine from a fracture mechanics viewpoint the suitability of leaving degraded J-groove weld material in the vessel following the repair of a CRDM nozzle.

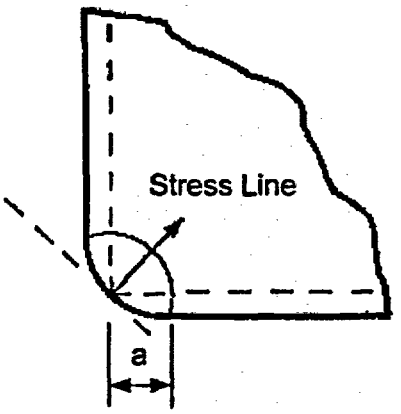
Figure 2. Corner Flaw Model

It is postulated that a radial flaw is present in the low alloy steel head, extending from the chamfered corner of the remaining J-groove weld to the interface between the butter and head. Analytically, this flaw is crudely simulated using the corner flaw model shown below in Figure 2.

The flaw depth, "a", is the radius to the crack front. The stress line shown in the figure above depicts a typical direction for consideration of a one-dimensional variation of stress through the area represented by the corner flaw model.

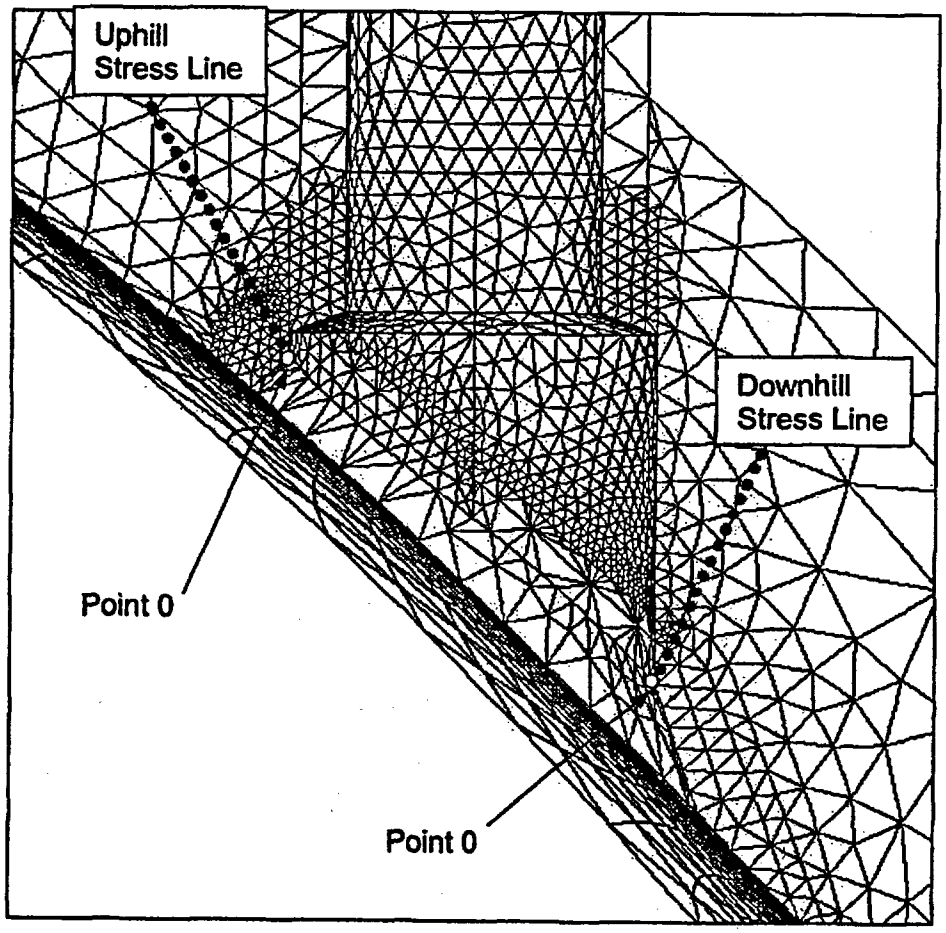
Figure 3. Orientation of Stress Lines

Table 1 presents the maximum and minimum hoop stresses for each transient. Due to the dominating influence of pressure on stress, stresses remain positive for all transient conditions. Stresses are listed in Table 1 for the downhill (0°) location as a function of the radial position along the stress line shown in Figures 2 and 3. Nine positions are used to report stresses along the stress line: the first 4 positions are within the weld material, the fifth position is at the butter/head interface, and the last 4 positions are located in the reactor vessel head base metal.

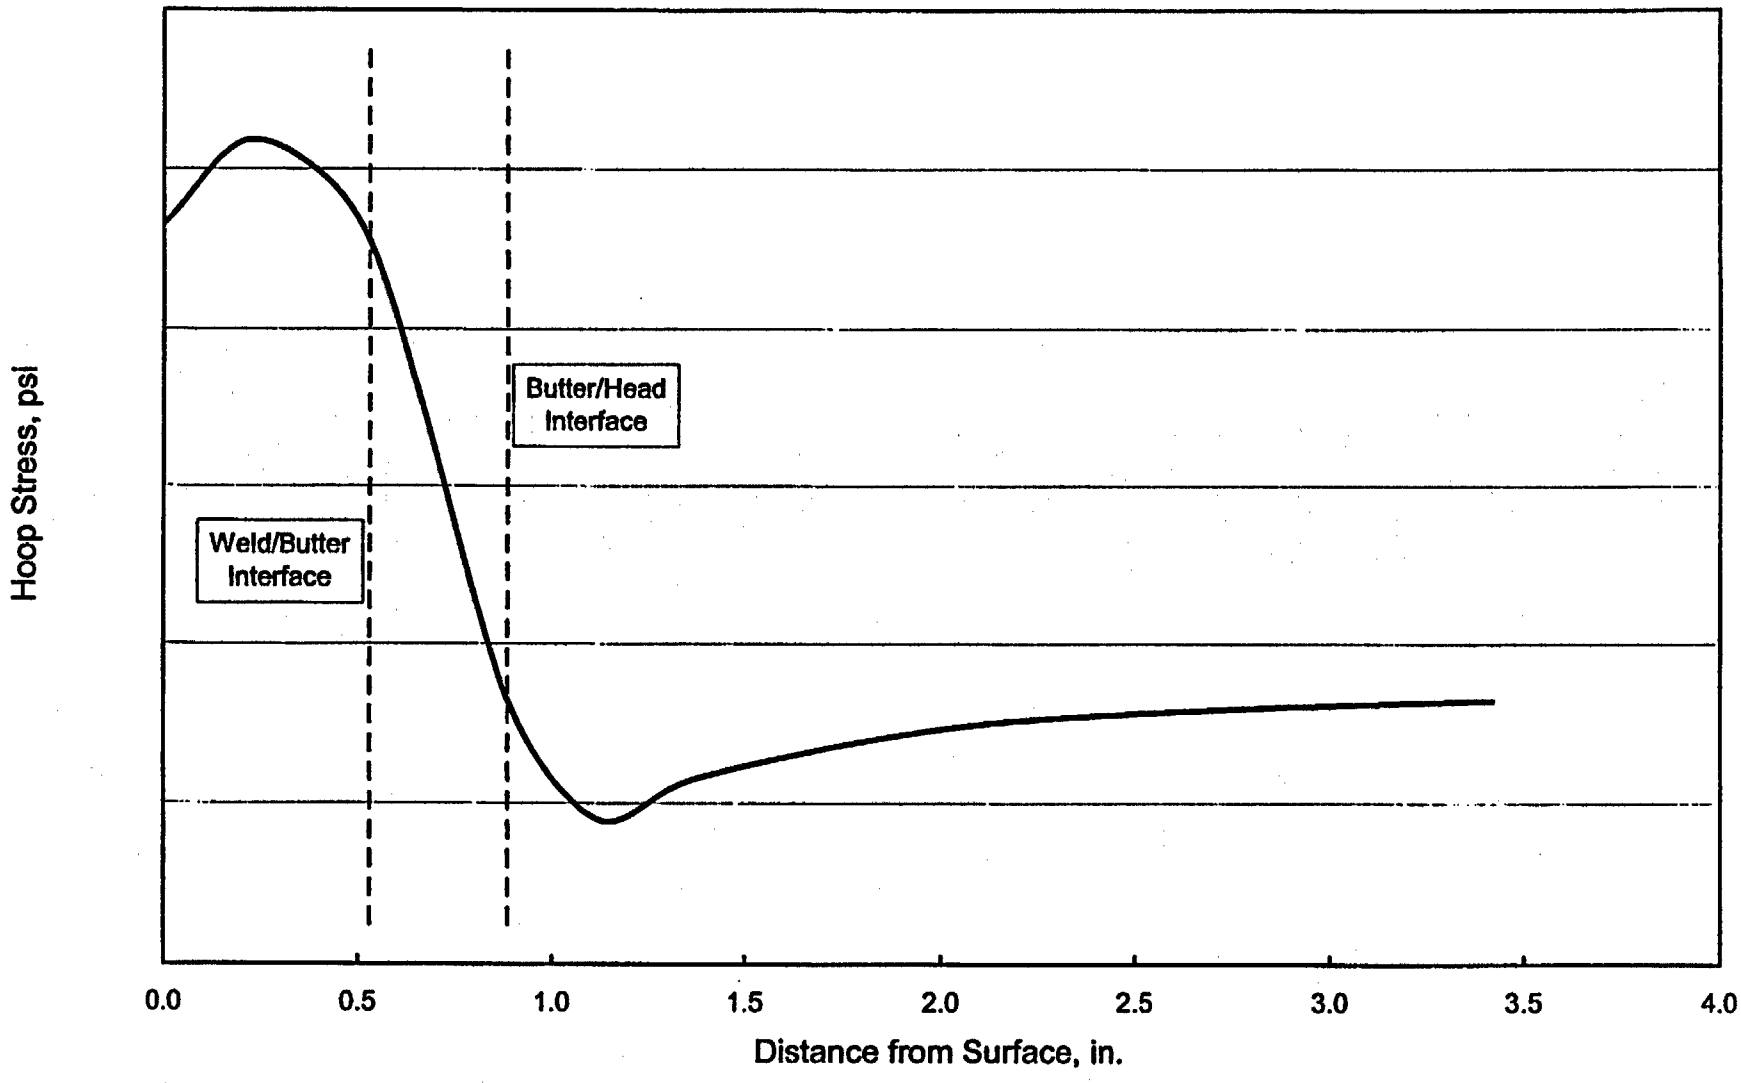
Figure 5. Residual Hoop Stresses After Weld Repair

The residual stresses from the Dominion Engineering analysis are listed in Table 2 and plotted in Figure 5. These stresses are in the original weld, after chamfering. Although the residual hoop stress in the weld region is high, up to about [ ] psi, the stress decreases to zero within the butter region and is compressive in the head. These stresses would be relieved as the crack propagates through the weld, so that only the operating stresses from Table 1 need be considered when evaluating a crack at the butter-to-head interface.
