NUREG/CR-6831
ANL-03/17

Examination of Spent PWR Fuel Rods after 15 Years in Dry Storage

Argonne National Laboratory

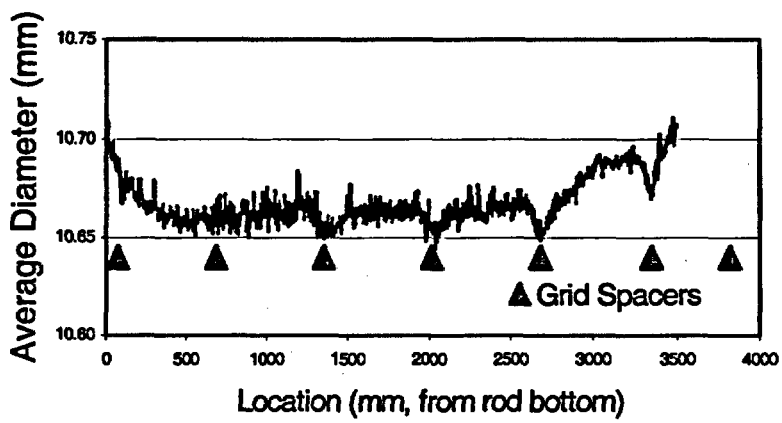
Some of the profiles show an increase in diameter along the upper half of the rod relative to the lower half of the rod. Based on creepdown alone, one would expect the profile of the rod in an as-irradiated state to be reasonably flat in the middle 2.5 m of the fuel column, where the fast fluence is relatively uniform. The diameter increase in the upper half of the rods, measured after storage, is probably due to the increase in oxide layer thickness with axial location.

Fig. 3. Averaged outer-diameter profile of Rod H9 (from Surry-2 Assembly T11) after extensive thermal benchmark testing (≈350- 415°C) and ≈15 years of dry cask storage in He (≈344 → ≈155°C). The nominal as-fabricated cladding outer diameter is 10.71 mm.

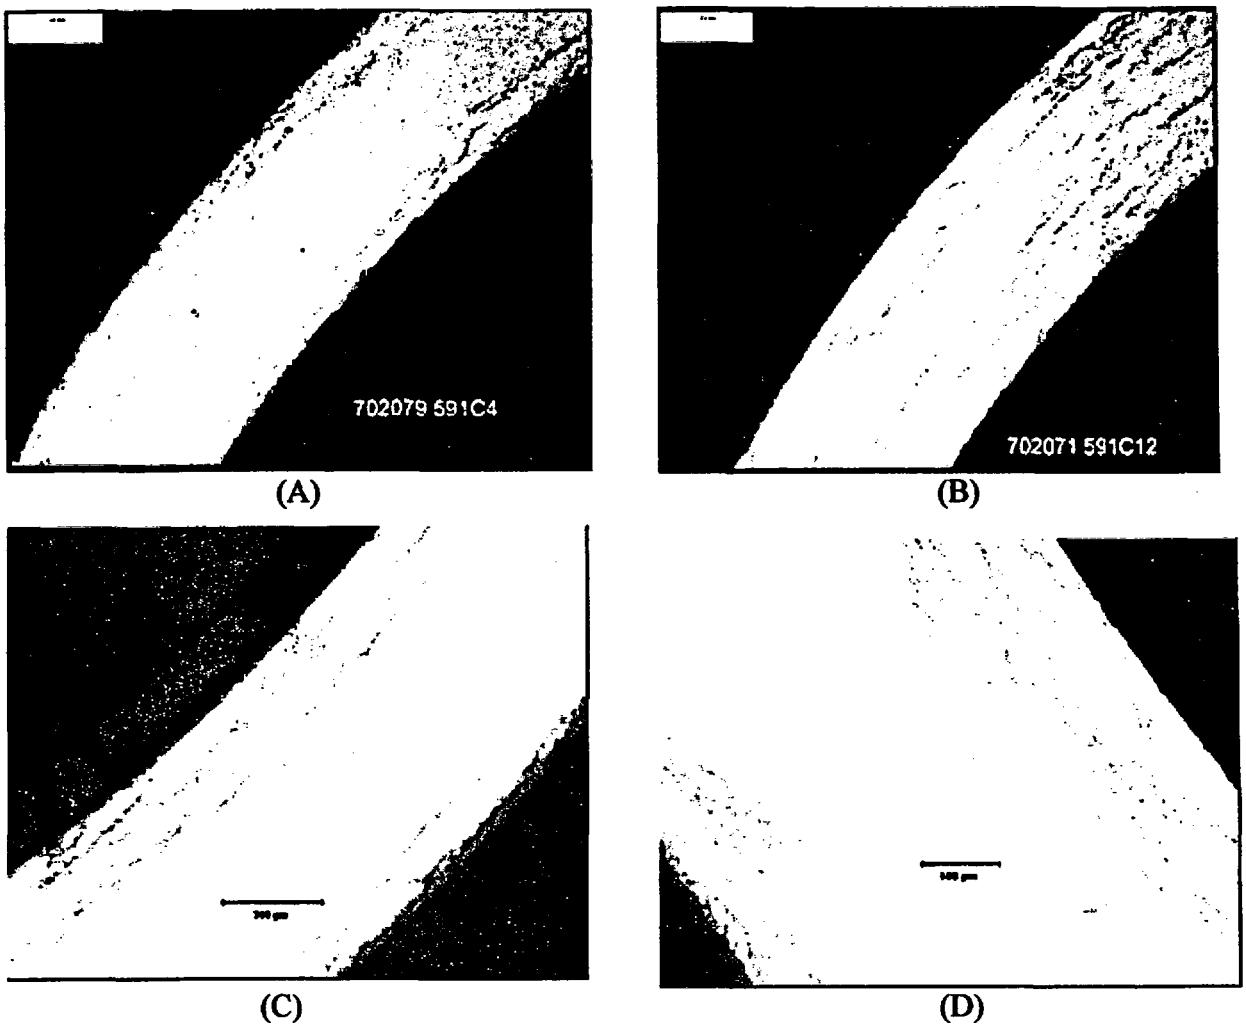
The hydrides are in the form of long circumferential stringers. Although no radial hydrides are observed near the oxide/cladding interface, it is clear that small segments of the hydrides are oriented at angles between 0 and 90° from the cladding radius. This also holds true for the hydrides within the inner cladding region. These are only very small hydrides, and there is no evidence of significant reorientation. At a few of the azimuthal orientations ≈500 mm above the midplane on Rod G6, some of the long hydrides are surrounded by very small, randomly orientated precipitates.

Fig. 6. Hydride structure in fuel rod cladding of Assembly T11 at two elevations:
(A) approximate midplane of Rod H9, (B) ≈500 mm above midplane of Rod H9,
(C) approximate midplane of Rod G6, and (D) ≈500 mm above midplane of Rod G6.

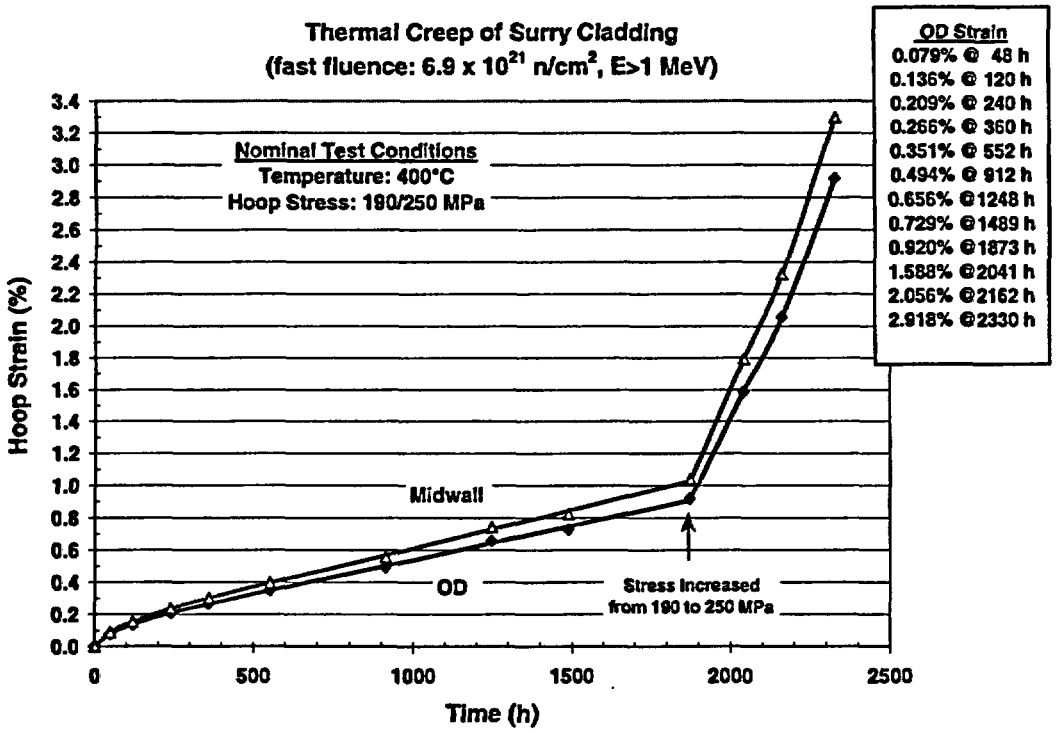
The Surry cladding exhibits a residual creep strain of >1% for thermal creep test temperatures of 380°C (220 MPa) and 400°C (190 MPa). A residual creep strain of ≈6% was achieved in the 400°C sample after raising the stress level to 250 MPa for ≈700 h. Although the creep rate increased during the 700 h because of wall thinning, the deformation was uniform around the circumference of the cladding. Inasmuch as no symmetric or asymmetric bulging of the cladding was observed – a precursor to failure – the residual creep life of the 400°C sample is >6%. Secondary creep rates that span two orders of magnitude were measured for the five creep tests. These data are useful not only for code benchmarking, but also for determining the stress and temperature sensitivity of the creep rate.

Fig. 7. Thermal creep data for irradiated, dry-cask-stored Surry cladding Sample C9 tested at 400°C and 190 MPa hoop stress for 1873 h, followed by 693 h at 250 MPa. Diamonds: OD measurements; triangles: calculated wall-average strain.

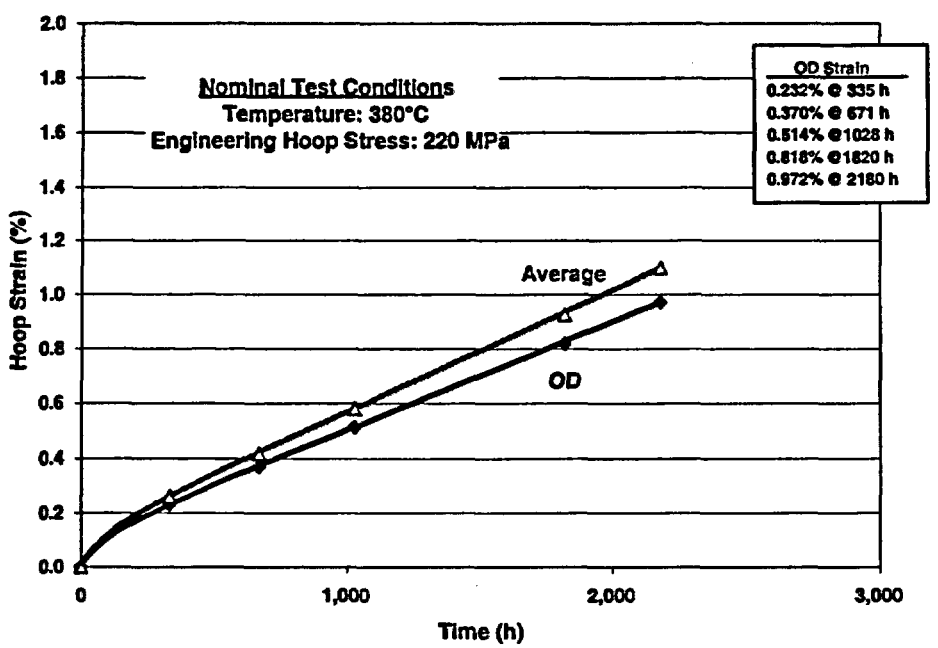
Figure 8 shows the time history of the creep strain for Sample C8 at 380°C and 220 MPa engineering hoop stress. It appears that secondary creep has been obtained. After 2180 h, the wall-averaged hoop creep strain is 1.10% and the secondary creep rate is 4.5×10^{-4} %/h. In comparing the creep strain of C8 with that of C9, (see Figs. 7 and 8) it is noted that the strain histories are similar for the two samples. This similarity suggests that a 20°C drop in temperature is compensated by a 30 MPa increase in hoop stress.

Fig. 8. Thermal creep data for irradiated, dry-cask-stored Surry cladding Sample C8 tested at 380°C and 220 MPa engineering hoop stress for 2180 h. Diamonds: OD measurements; triangles: calculated wall-averaged strain.

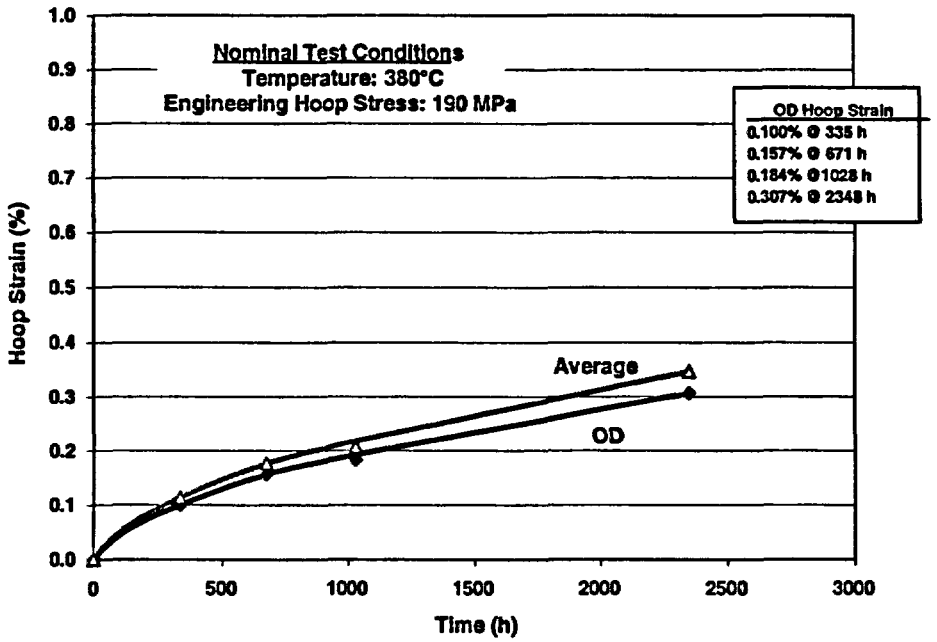
Figure 9 shows the time history of the creep strain for Sample C6 at 380°C and 190 MPa engineering hoop stress. It appears that this sample is also in the secondary creep regime after 2348 h at a wall-averaged hoop strain of 0.35%. The secondary creep rate is 8.8×10^{-5} %/h.

Fig. 9. Thermal creep data for irradiated and dry-cask-stored Surry cladding sample C6 tested at 380°C and 190 MPa engineering hoop stress for 2348 h. Diamonds: OD measurements; triangles: calculated wall-averaged strain.

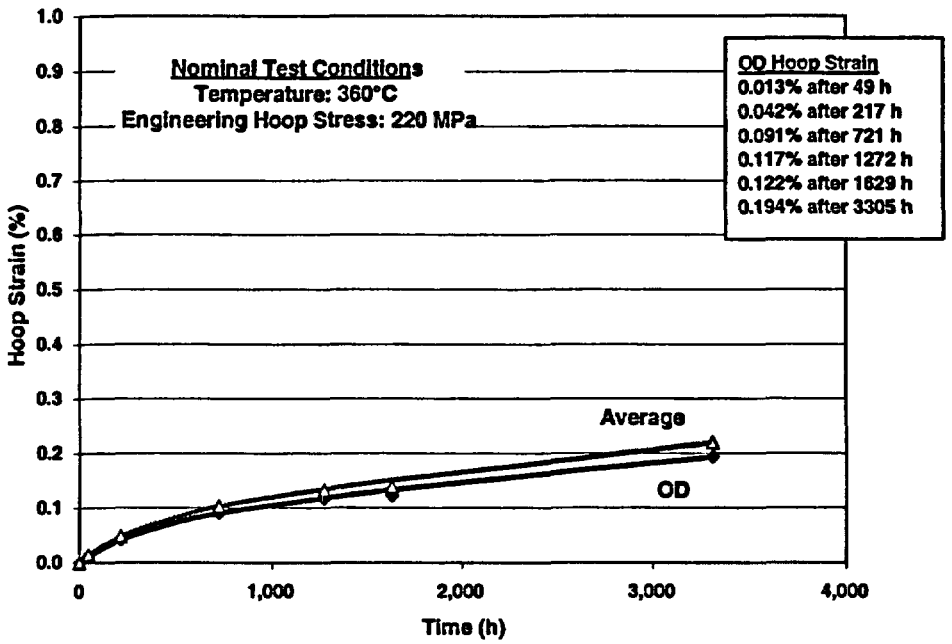
Figure 10 shows the time history of the creep strain for Sample C3 at 360°C and 220-MPa engineering hoop stress. The cladding is very creep resistant at this temperature level. Sample C3 appears to be in secondary creep regime after 3305 h at an average hoop strain of 0.22%. The secondary creep rate is $\leq 4.2 \times 10^{-5}$ %/h.

Fig. 10. Thermal creep data for irradiated, dry-cask-stored Surry cladding sample C3 tested at 360°C and 220 MPa engineering hoop stress for 3305 h. Diamonds: OD measurements; triangles: calculated wall-averaged strain.

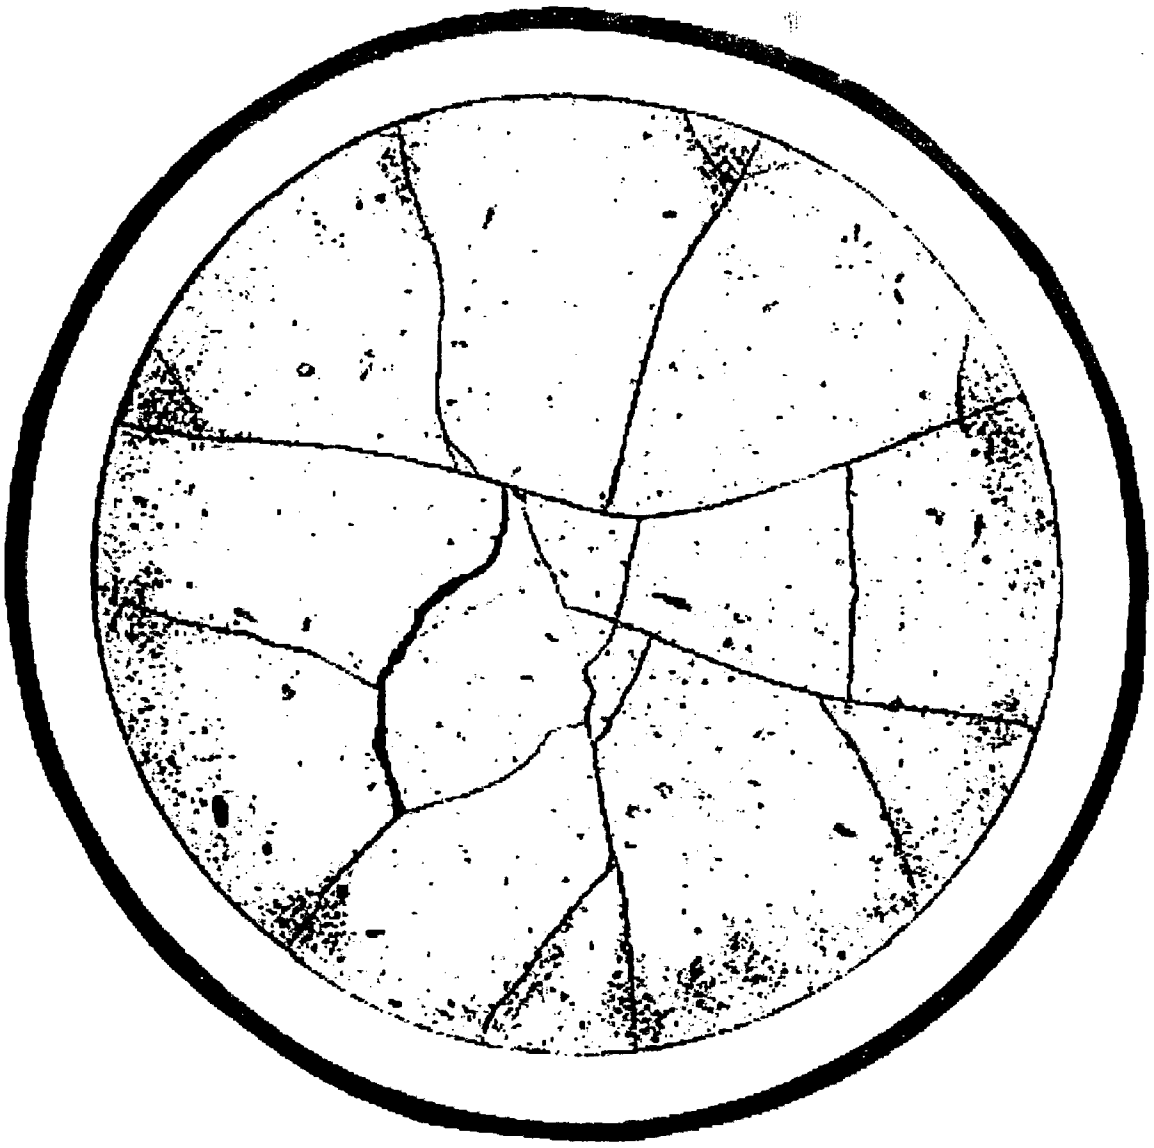
Changes in the condition of the fuel pellets were not expected because there was no cladding breach, and the temperature of the fuel during storage was lower than the temperature of the fuel during reactor operation. Transverse ceramographic samples were taken from Rod H9 at the rod midplane, ≈500 mm above the midplane, and ≈1000 mm above the midplane. Samples were taken from Rod G6 at 0 and 500 mm above the midplane. Cross-sectional mosaics (see Fig. 4) depict a pellet with multiple cracks, which is prototypical of this medium-burnup PWR fuel. Because of the extensive cracking, which occurred during reactor operation, several fuel fragments fell out of the cladding during the sectioning, leaving irregularly shaped voids (dark areas). The central region of the fuel ($r/r_o < 0.5$) at the higher elevation contained a greater density of fission gas bubbles; hence the darker appearance. No such

Fig. D.1 Cross-sectional mosaic of Rod H9 at the approximate fuel midplane.
JPG file = 591C4 Fuel Mosaic.

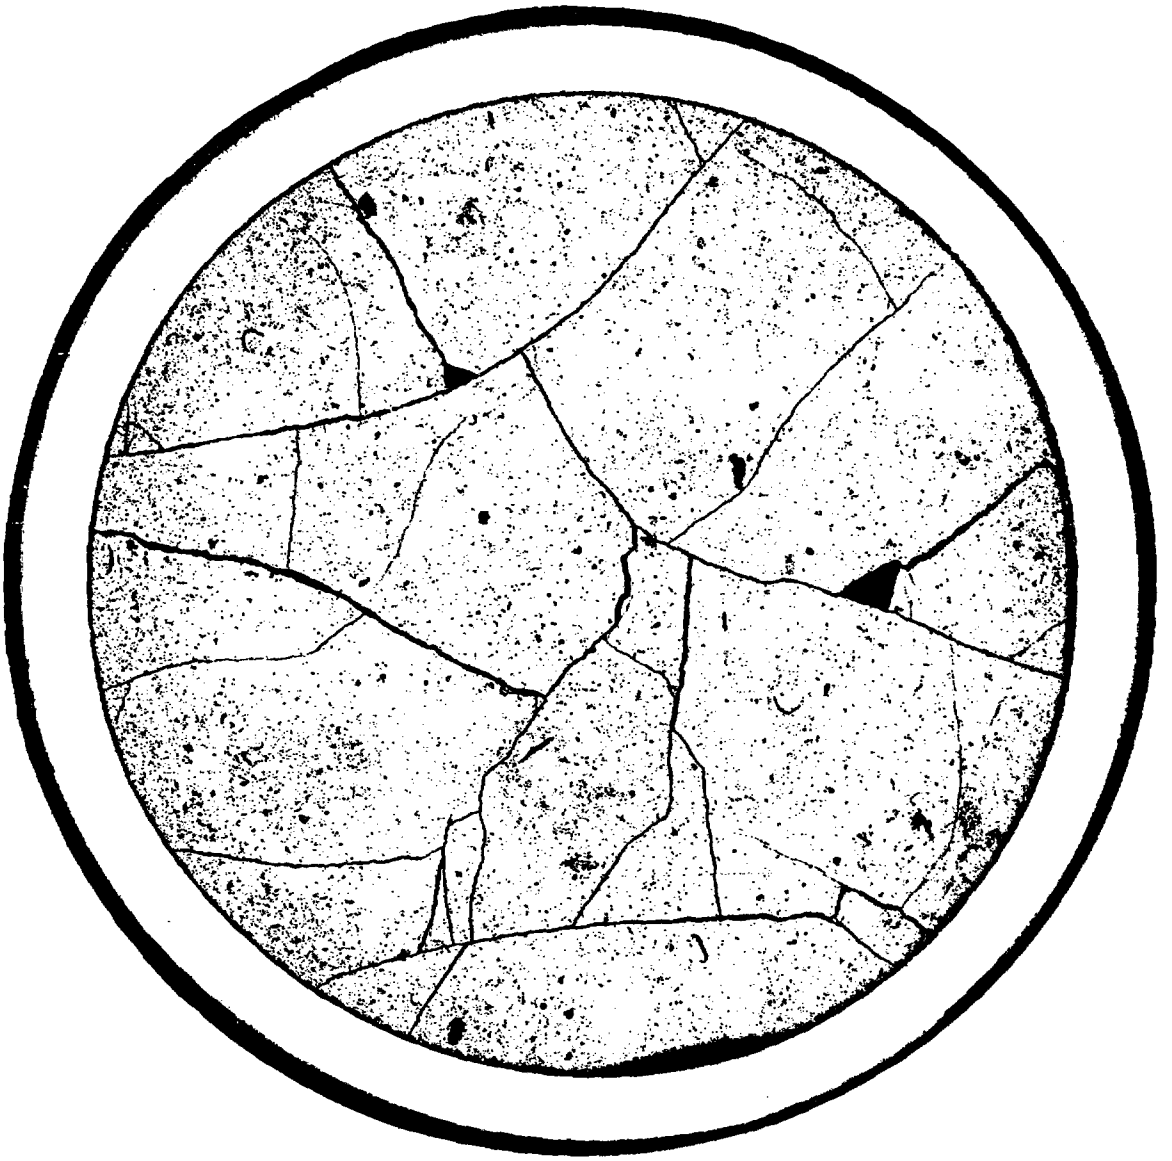
porous central region was apparent in samples from the lower-elevation C4 and C12, possibly because of their lower operating temperatures. The porous region at the higher elevation is nearly centered, indicating a symmetric temperature distribution, which is consistent with the fact that the rod was in the central region of the host assembly during the irradiation. As expected, no appreciable rim effect is observed in this medium-burnup rod.

Fig. D.2 Cross-sectional mosaic of Rod H9 at ≈500 mm above the fuel midplane.
JPG file = 591C12 Fuel Mosaic.

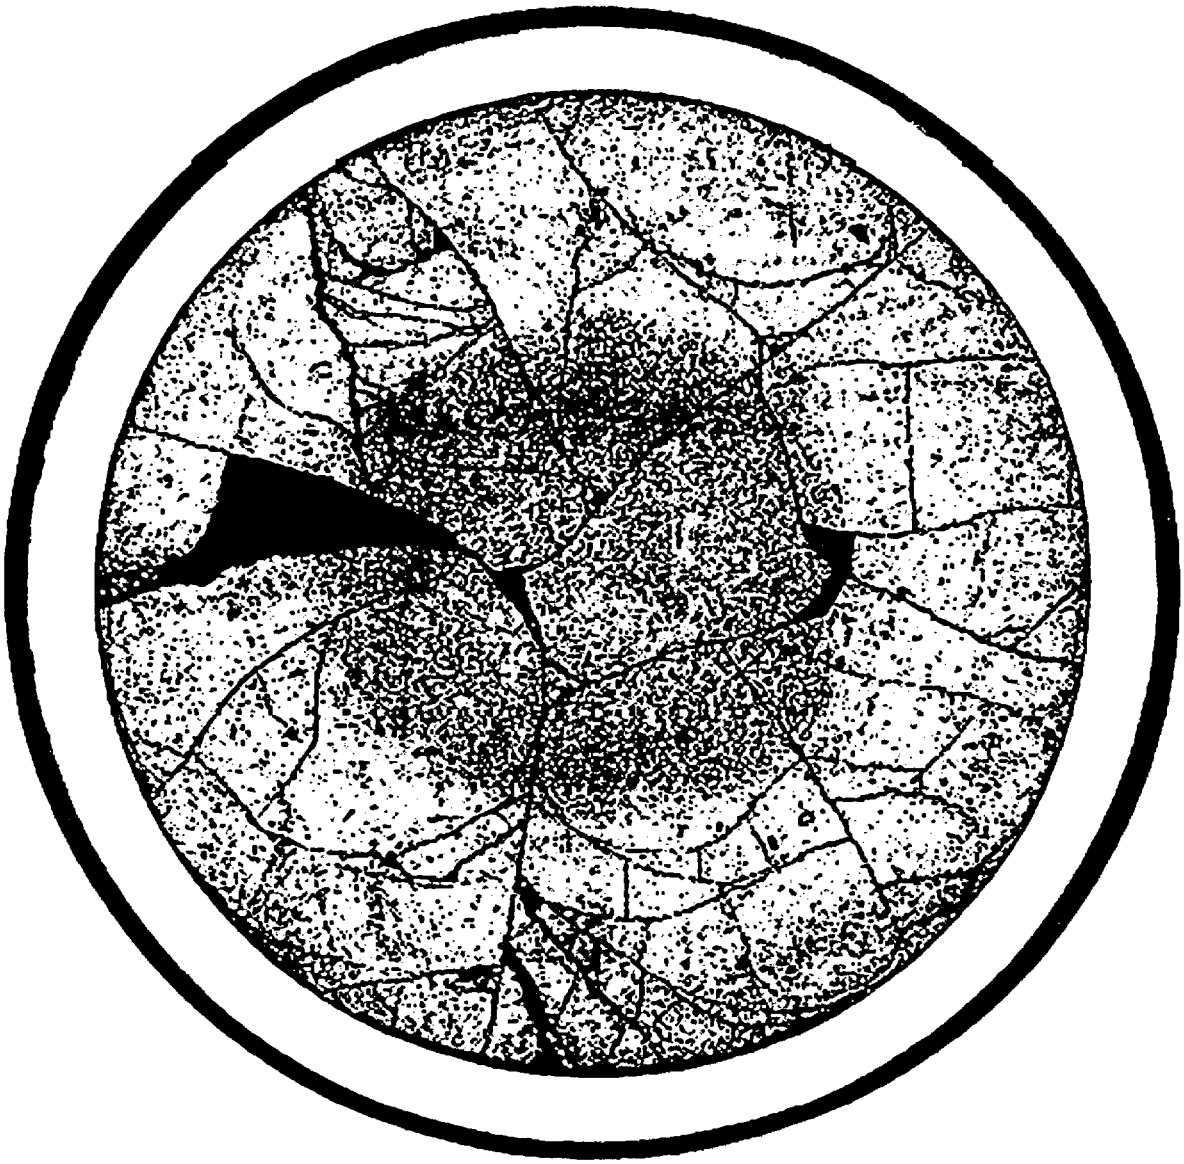
Fig. D.3 Cross-sectional mosaic of Rod H9 at ≈1000 mm above the fuel midplane.
JPG file = 591B2 Fuel Mosaic.

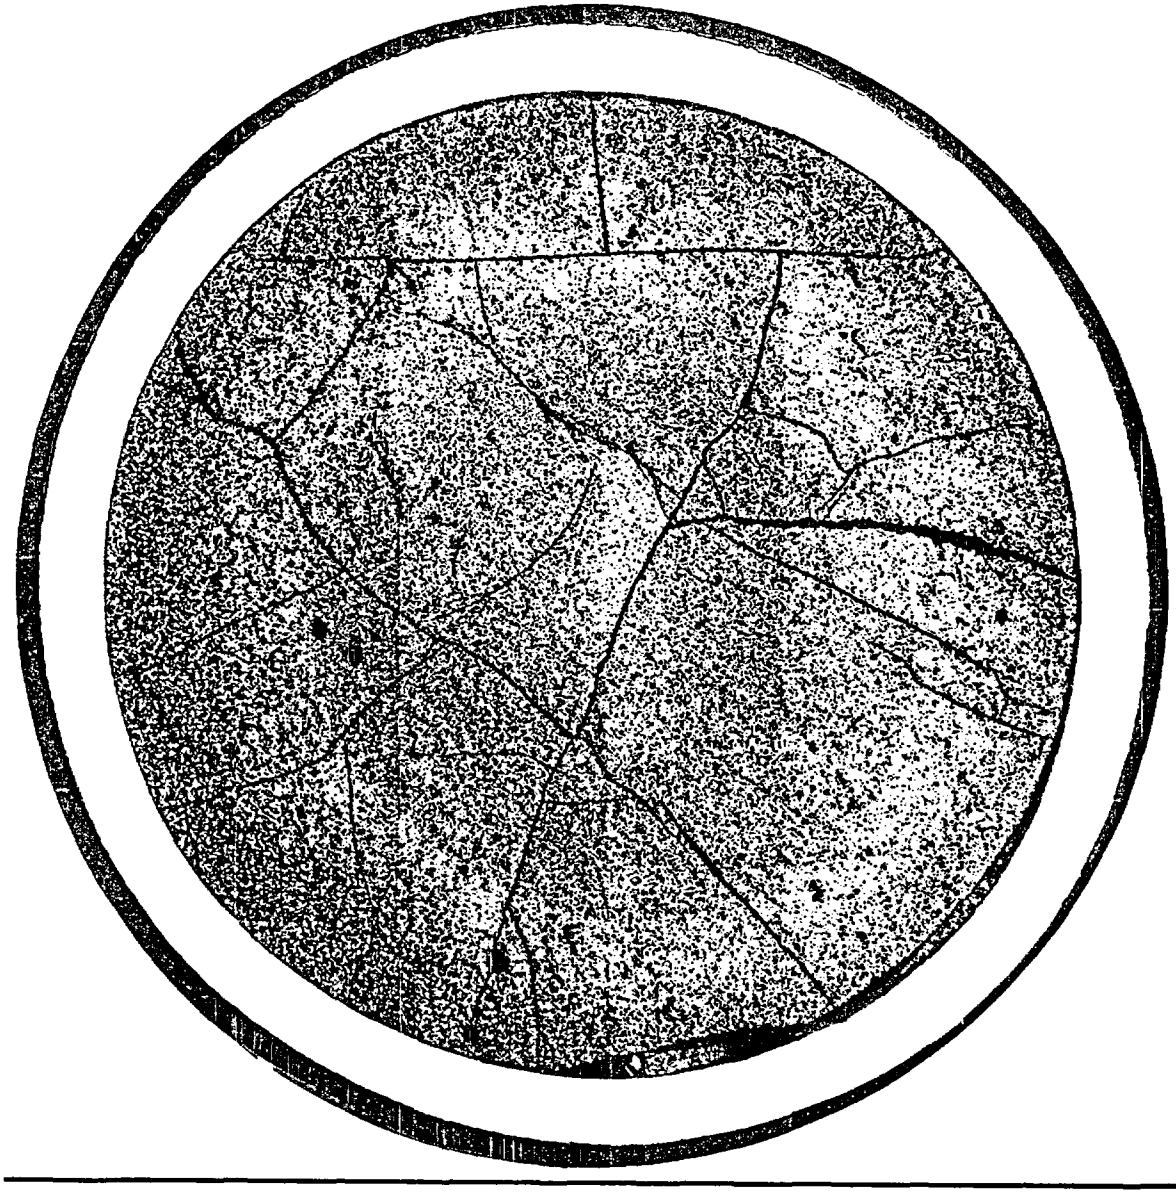
Fig. D.4 Cross-sectional mosaic of Rod G6 at the approximate fuel midplane.
JPG file = 592C4 Fuel Mosaic. 703341

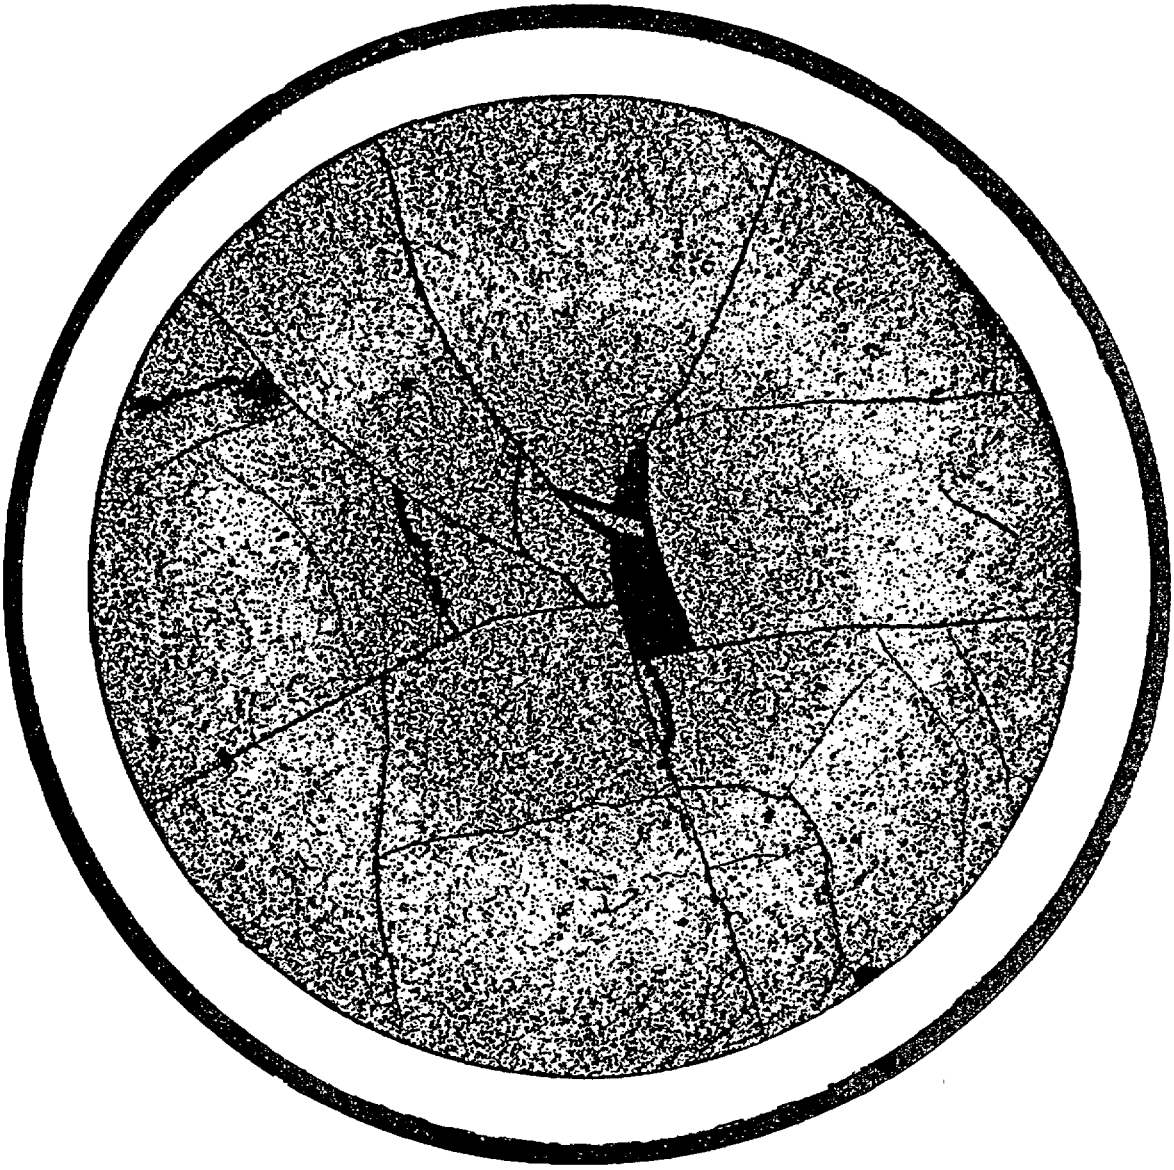
Fig. D.5 Cross-sectional mosaic of Rod G6 at ≈500 mm above the fuel midplane.
JPG file = 592C12 Fuel Mosaic. ET7043342

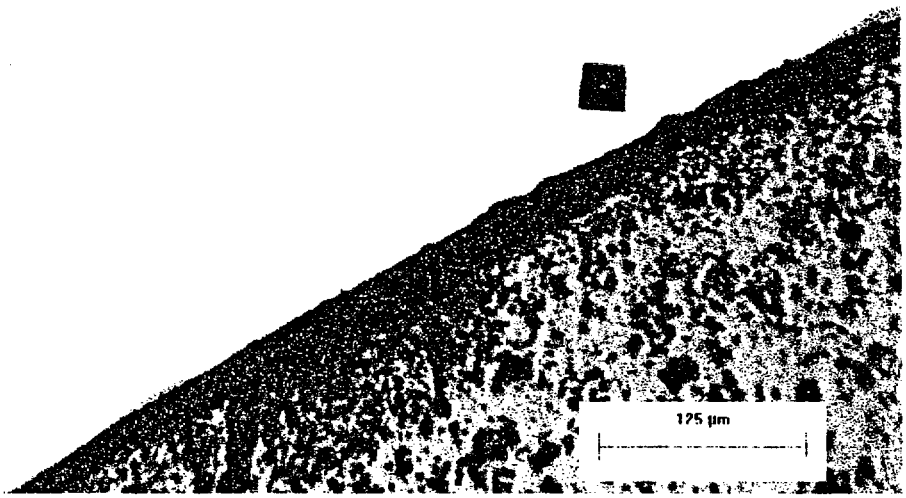
Fig. D.9 Cross-sectional view of Rod H9 fuel-cladding interface at two azimuthal positions ≈1000 mm above the fuel midplane (areas 6, 8). Scale marker = 125 µm. JPG file = 591B2 ID Oxide Areas 6,8. ET702573, ET702574

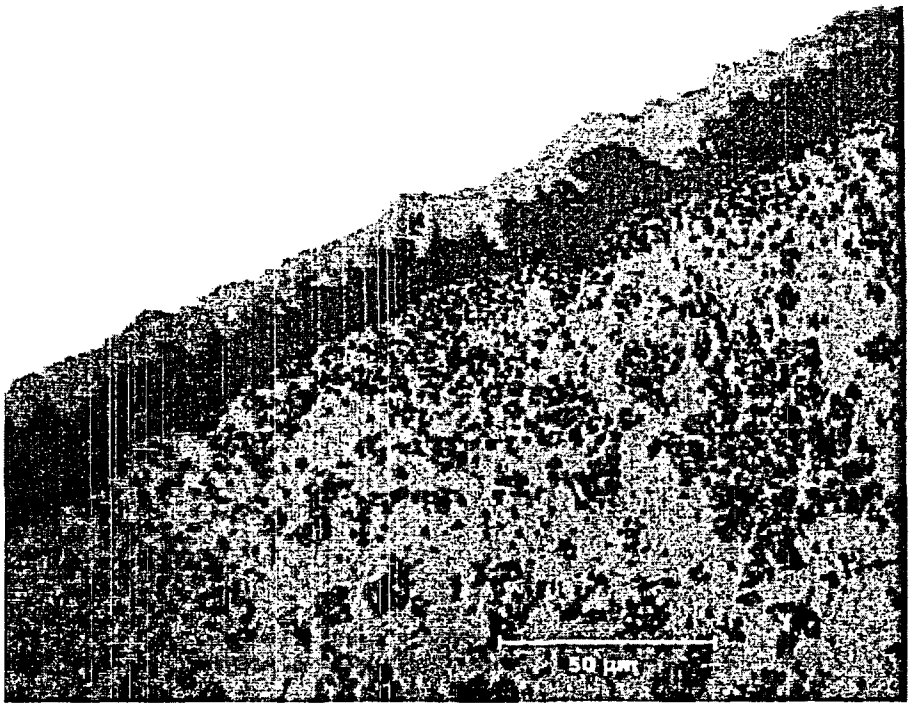
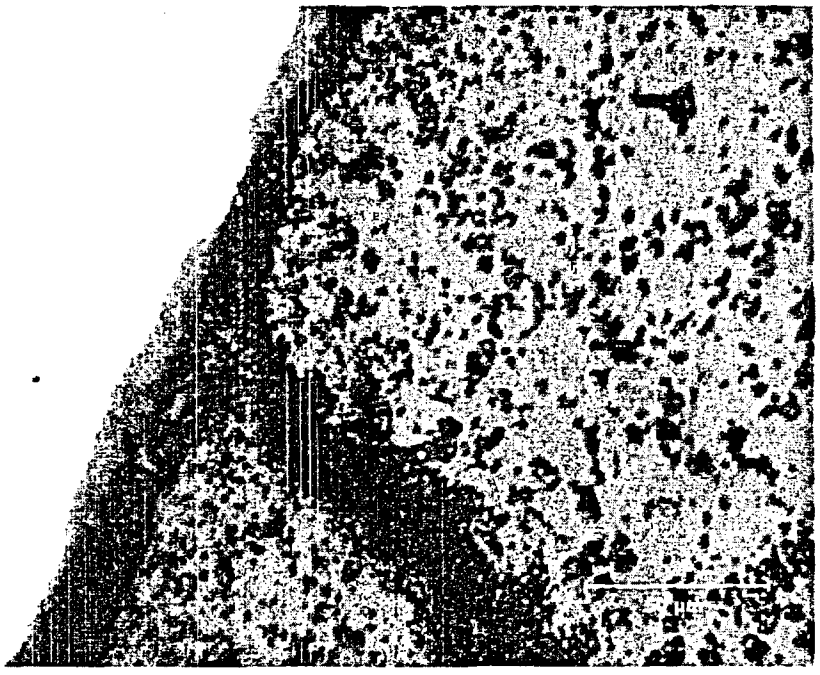
Fig. D.10 Cross-sectional view of Rod G6 fuel-cladding interface and cladding inner-surface oxide layer at two azimuthal positions located at the approximate fuel midplane (areas 1-2). Scale marker = 50 µm.
JPG file = 592C4 ID Oxide Areas 1, 2. ET703240, ET703241

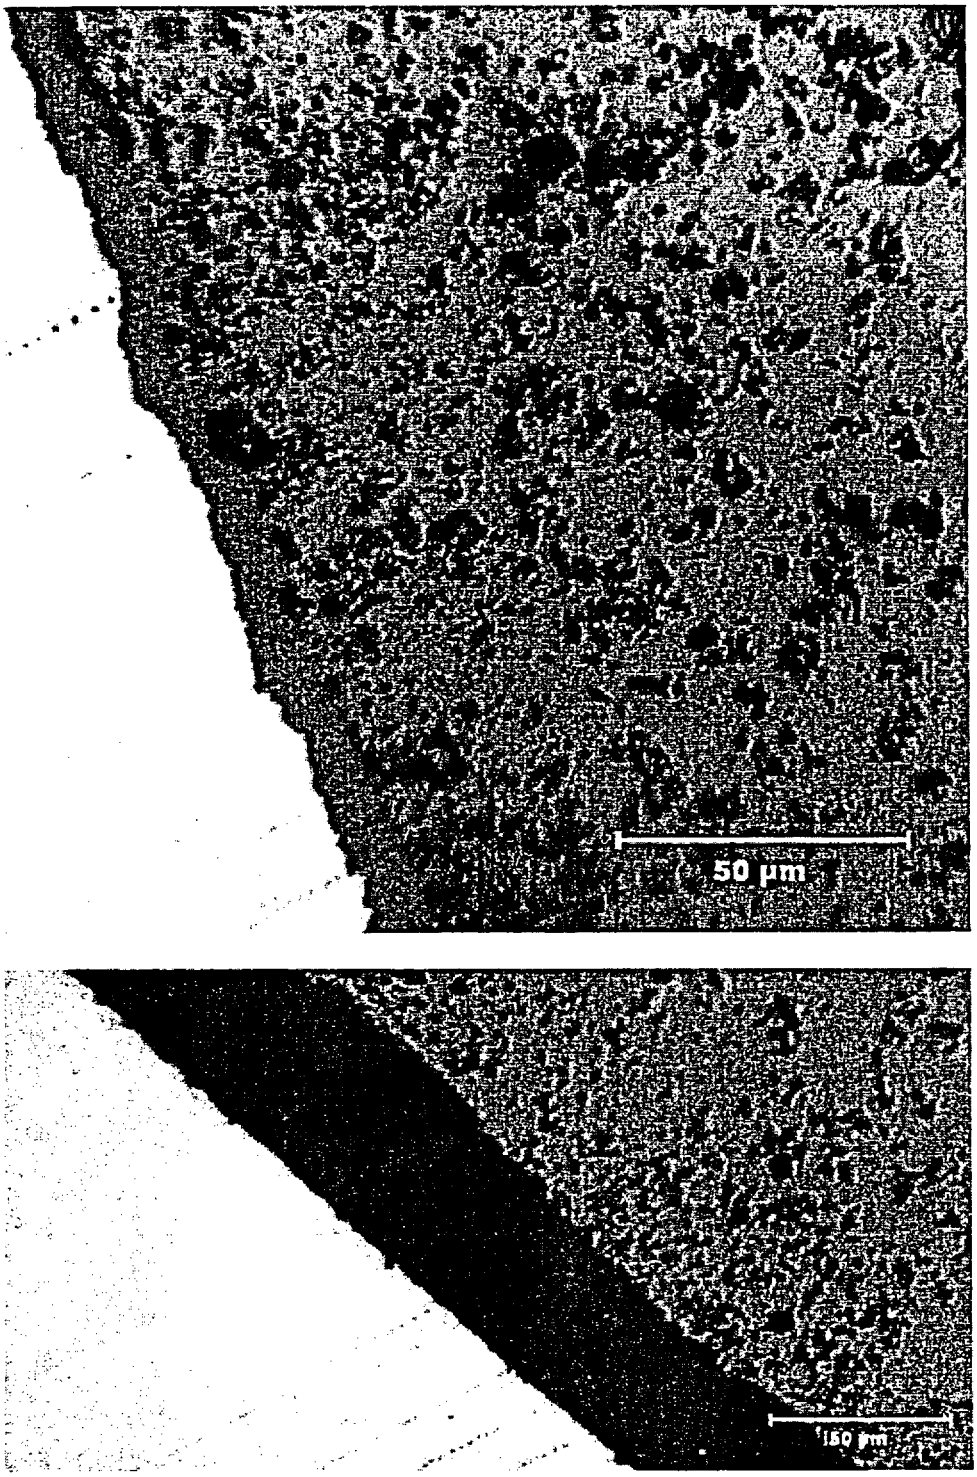
Fig. D.11 Cross-sectional view of Rod G6 fuel-cladding interface and cladding inner-surface oxide layer at two azimuthal positions at the approximate fuel midplane (areas 3-4). Scale marker = 50 µm.
JPG file = 592C4 ID Oxide Areas 3,4. ET703242, ET703243

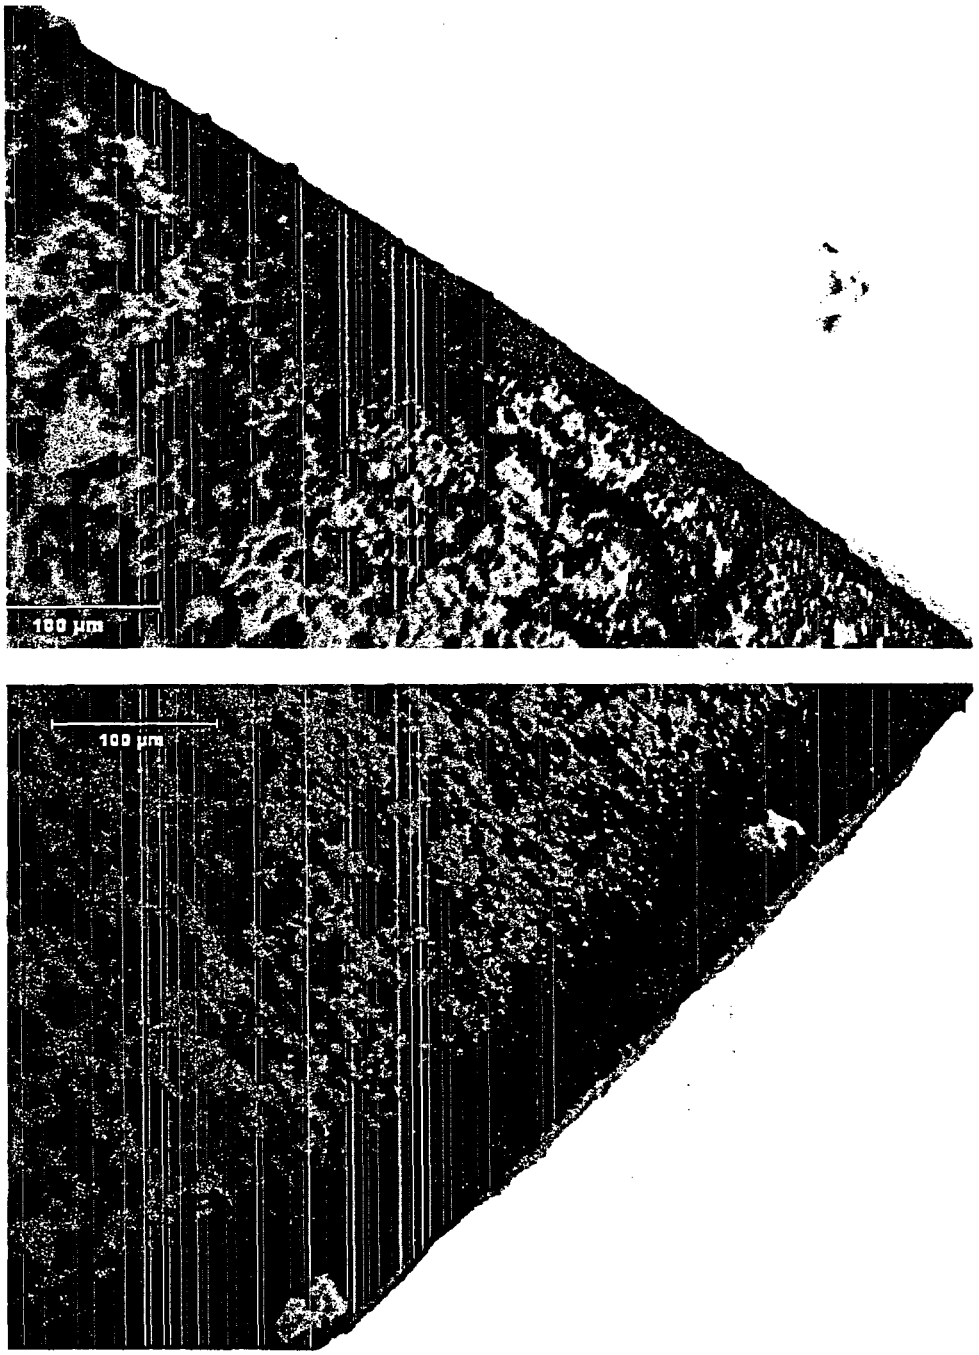
Fig. D.12 Cross-sectional view of Rod G6 fuel-cladding interface and/or cladding inner surface oxide layer at two azimuthal positions located at ≈500 mm above the fuel midplane (areas 2-4). Scale marker = 100 µm.
JPG file = 592C12 ID Oxide Areas 2,4. ET703111, ET703117

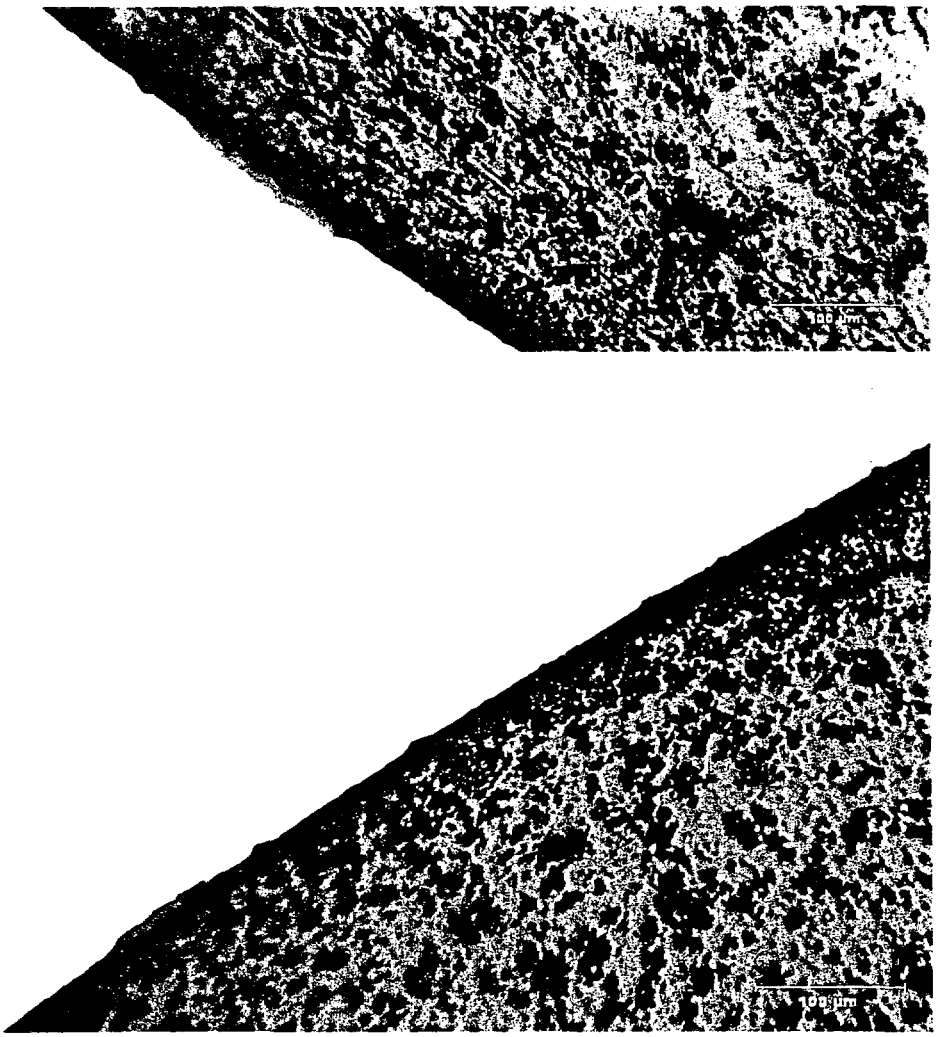
Fig. D.13 Cross-sectional view of Rod G6 fuel-cladding interface and cladding inner-surface oxide layer at two azimuthal positions located at ≈500 mm above the fuel midplane (areas 6-8). Scale marker = 100 μm.
JPG file = 592C12 ID Oxide Areas 6,8. ET703123, ET703129

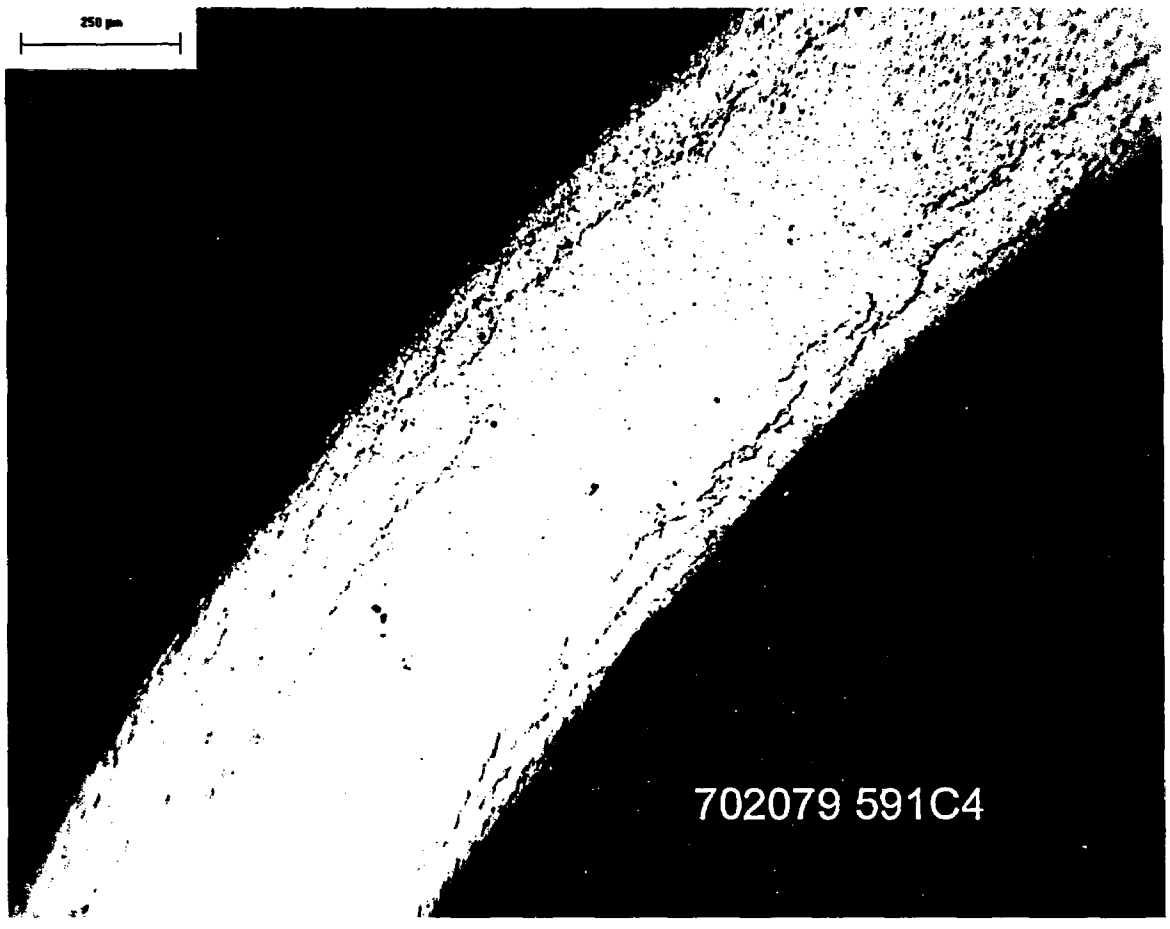
Fig. D.53 Cross-sectional view of Rod H9 cladding hydride morphology at approximate fuel midplane (area 5). Scale marker = 250 μm.
JPG file = 591C4 Hydrides Area 5.

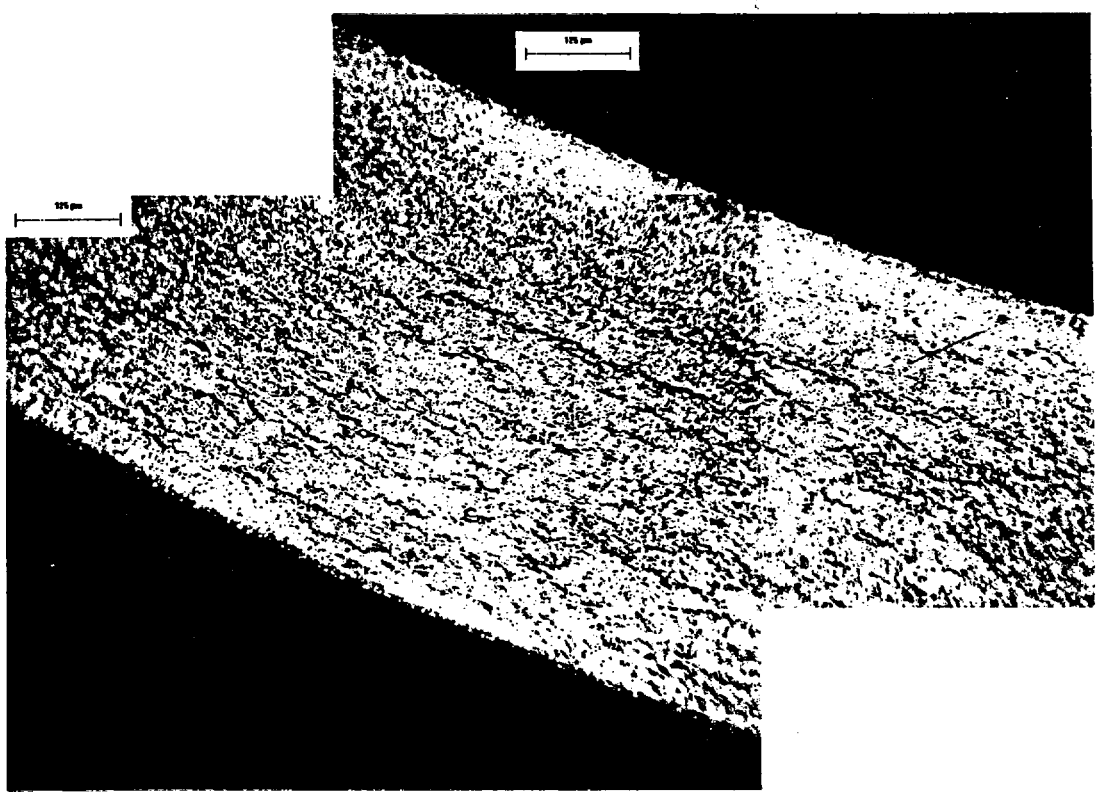
Fig. D.57 Cross-sectional view of Rod H9 cladding hydride morphology at ≈500 mm above fuel midplane (area 1). Scale marker = 250 μm.
JPG file = 591C12 Hydrides Area 1.

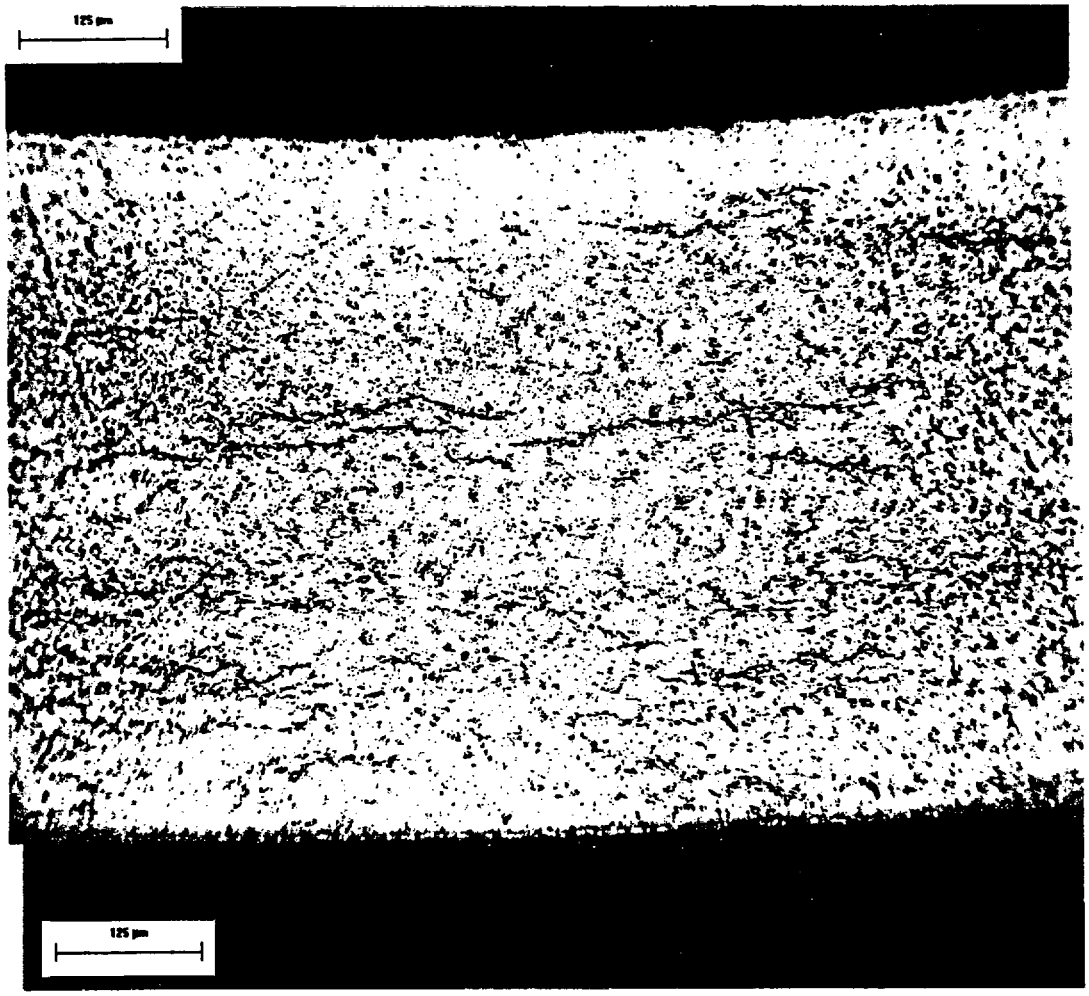
Fig. D.59 Cross-sectional view of Rod H9 cladding hydride morphology at ≈500 mm above fuel midplane (area 3). Scale marker = 250 μm.
JPG file = 591C12 Hydrides Area 3.

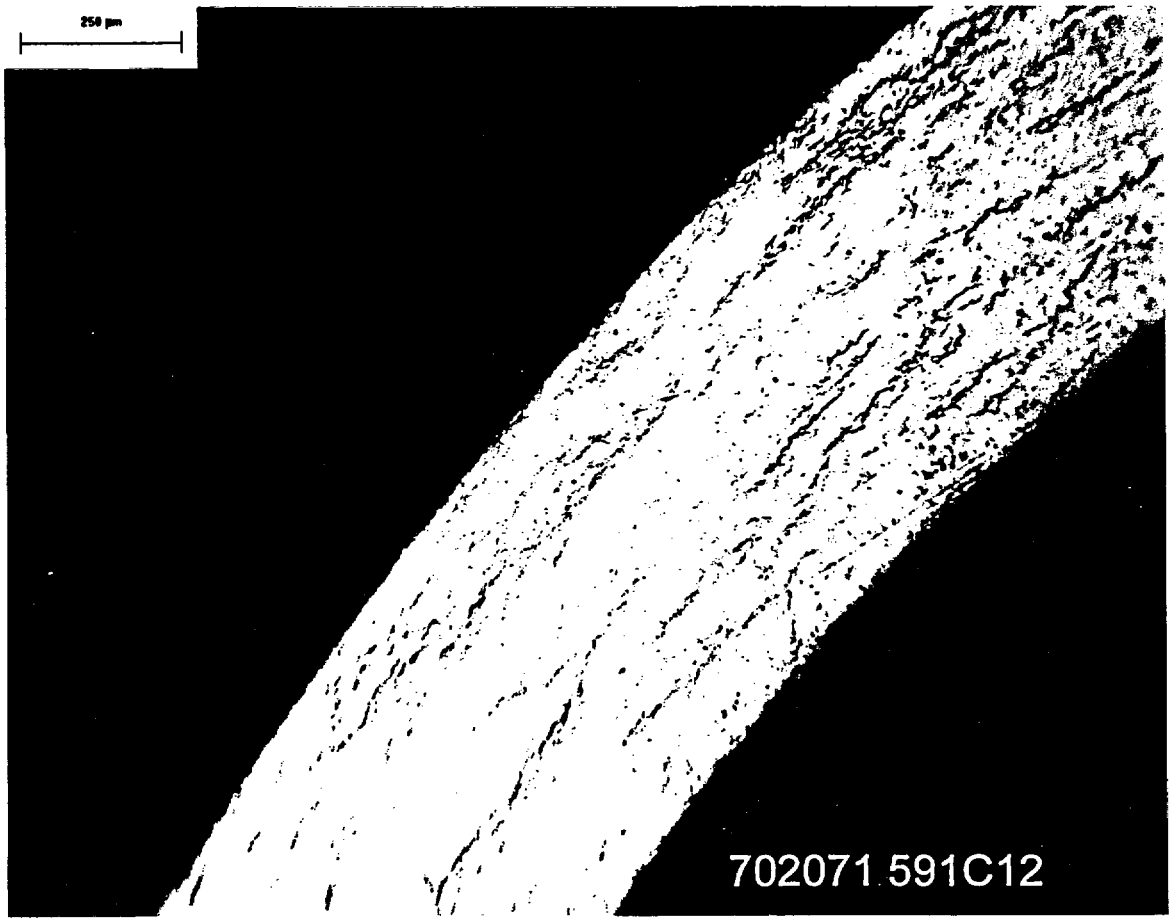
Fig. D.62 Cross-sectional view of Rod H9 cladding hydride morphology at ≈500 mm above fuel midplane (area 6). Scale marker = 250 µm.
JPG file = 591C12 Hydrides Area 6.
