NUREG/CR-6831
ANL-03/17

Examination of Spent PWR Fuel Rods after 15 Years in Dry Storage

Argonne National Laboratory

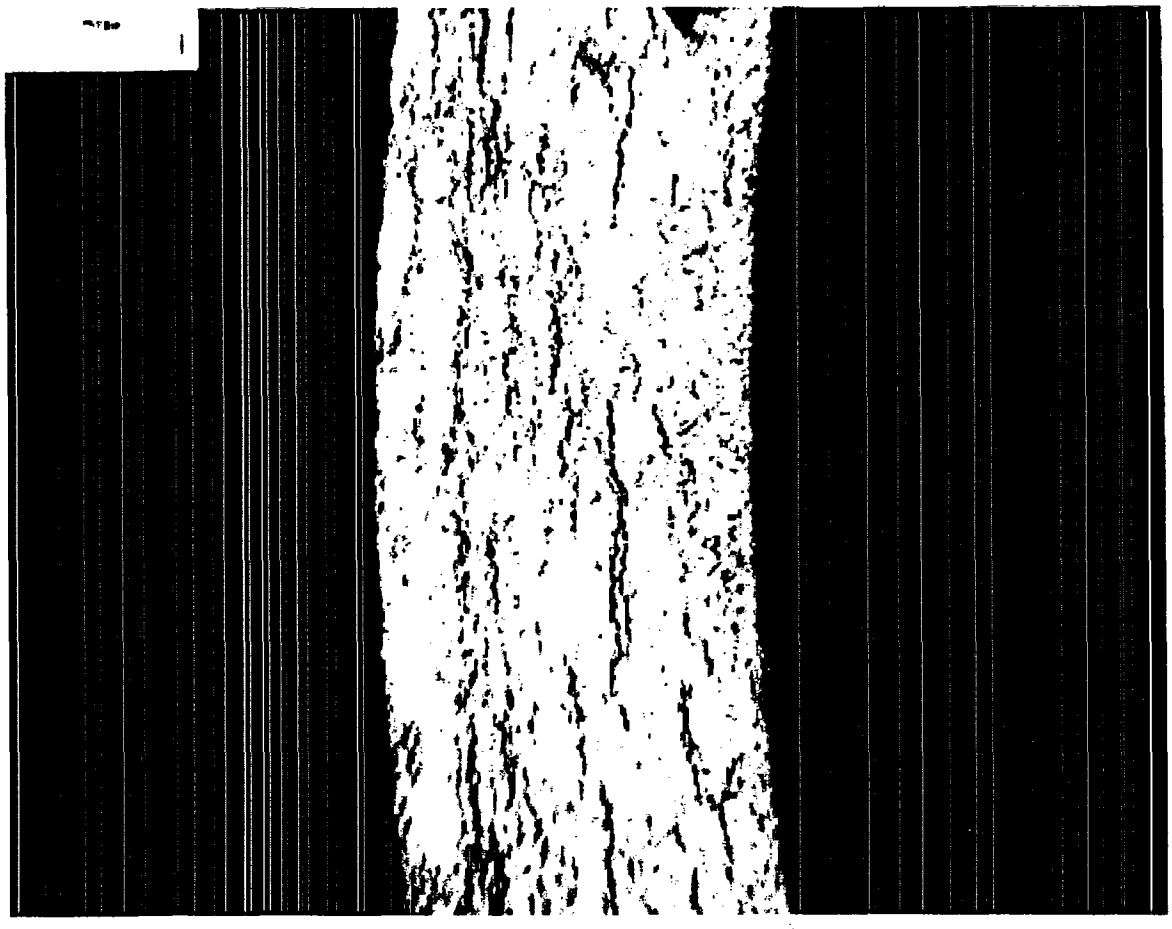
Fig. D.63 Cross-sectional view of Rod H9 cladding hydride morphology at ≈500 mm above fuel midplane (area 7). Scale marker = 250 μm.
JPG file = 591C12 Hydrides Area 7.

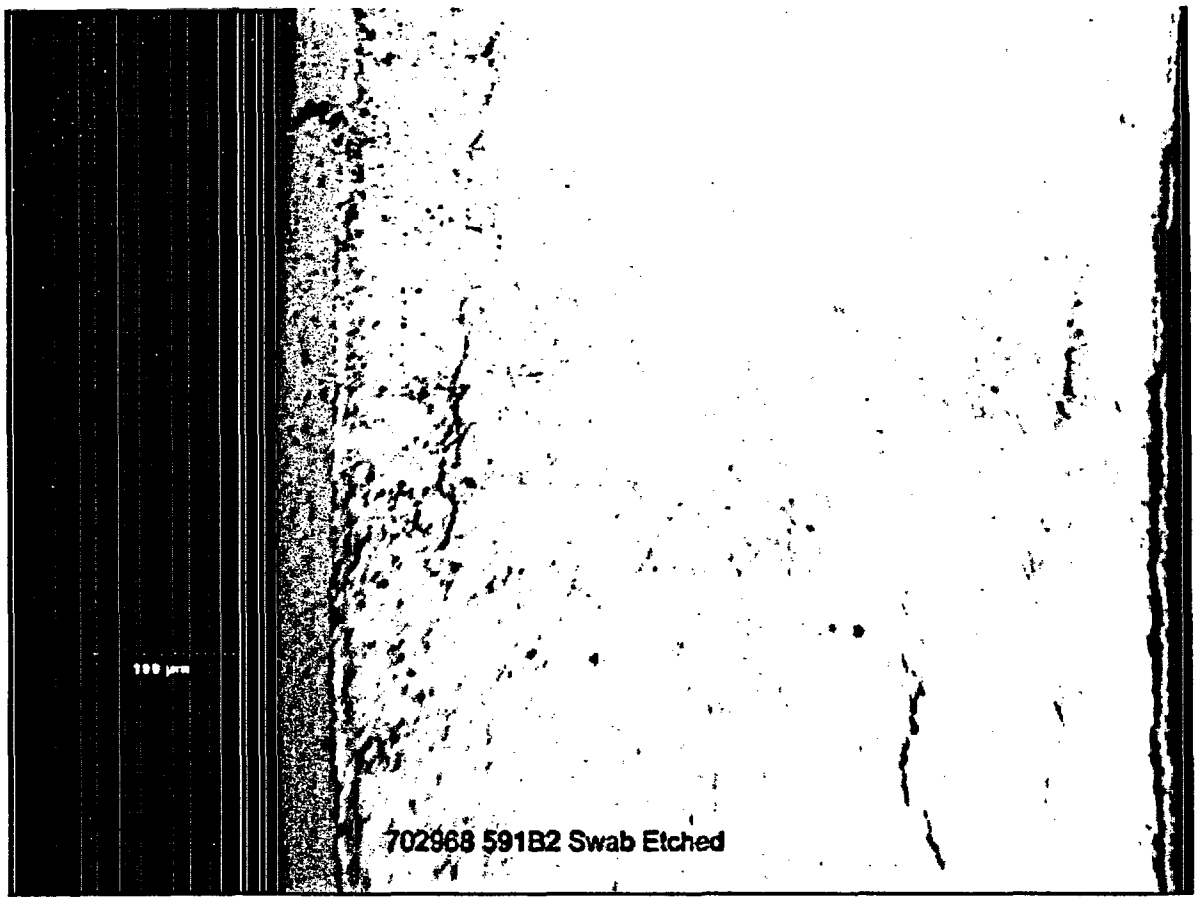
Fig. D.65 Cross-sectional view of Rod H9 cladding hydride morphology at ≈1000 mm above fuel midplane (area 1). Scale marker = 100 μm.
JPG file = 591B2 Hydrides Area 1.

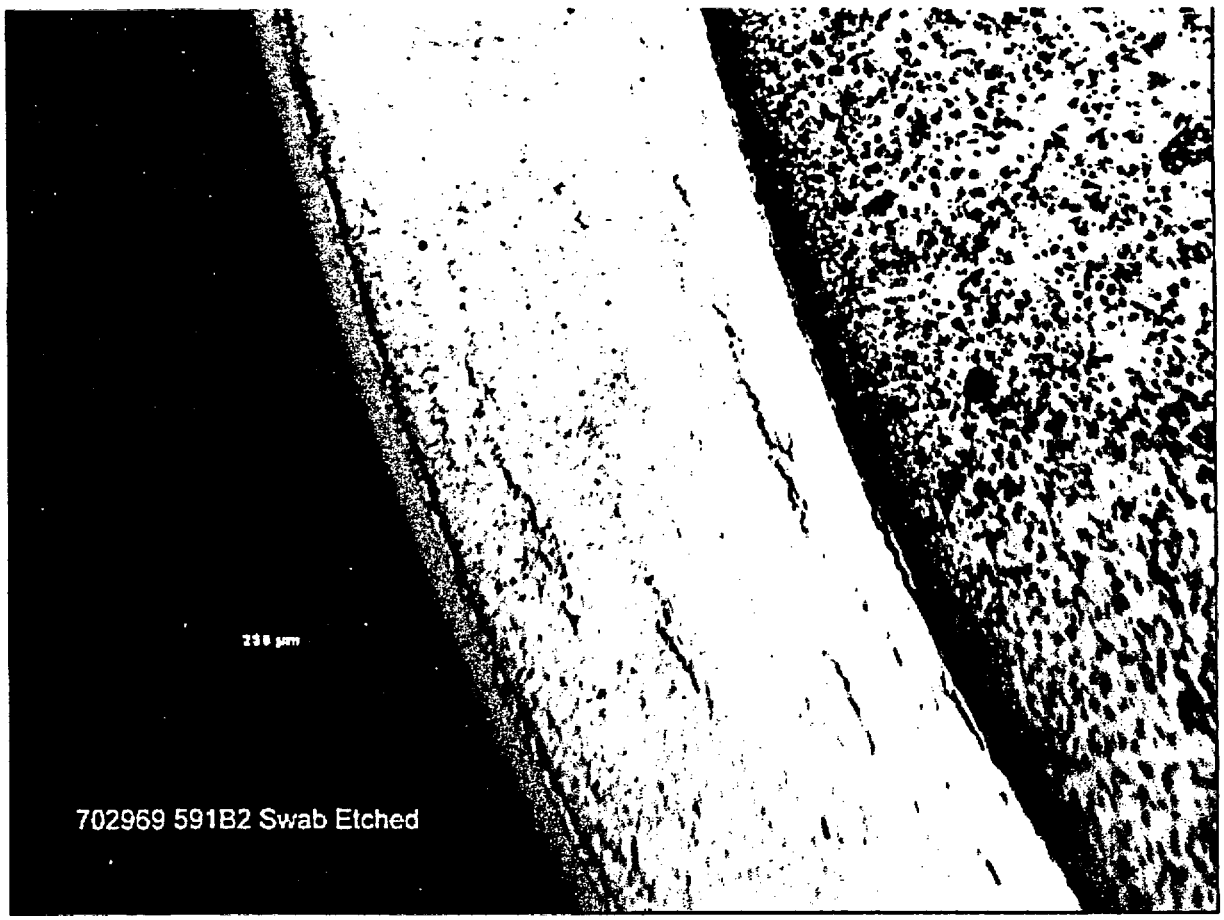
Fig. D.66 Cross-sectional view of Rod H9 cladding hydride morphology at ≈1000 mm above fuel midplane (area 2). Scale marker = 250 μm.
JPG file = 591B2 Hydrides Area 2.

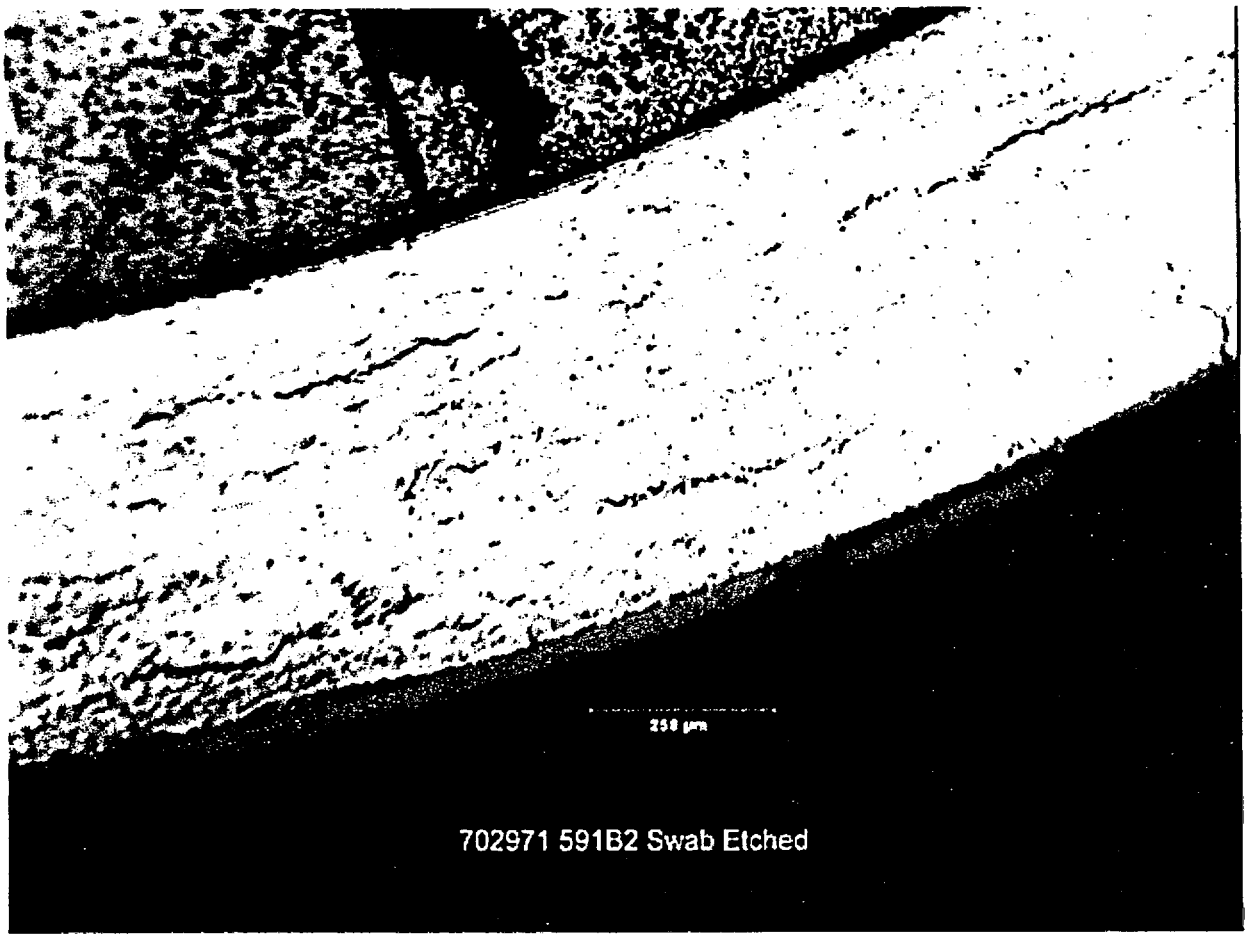
Fig. D.68 Cross-sectional view of Rod H9 cladding hydride morphology at ≈1000 mm above fuel midplane (area 4). Scale marker = 250 μm.
JPG file = 591B2 Hydrides Area 4.

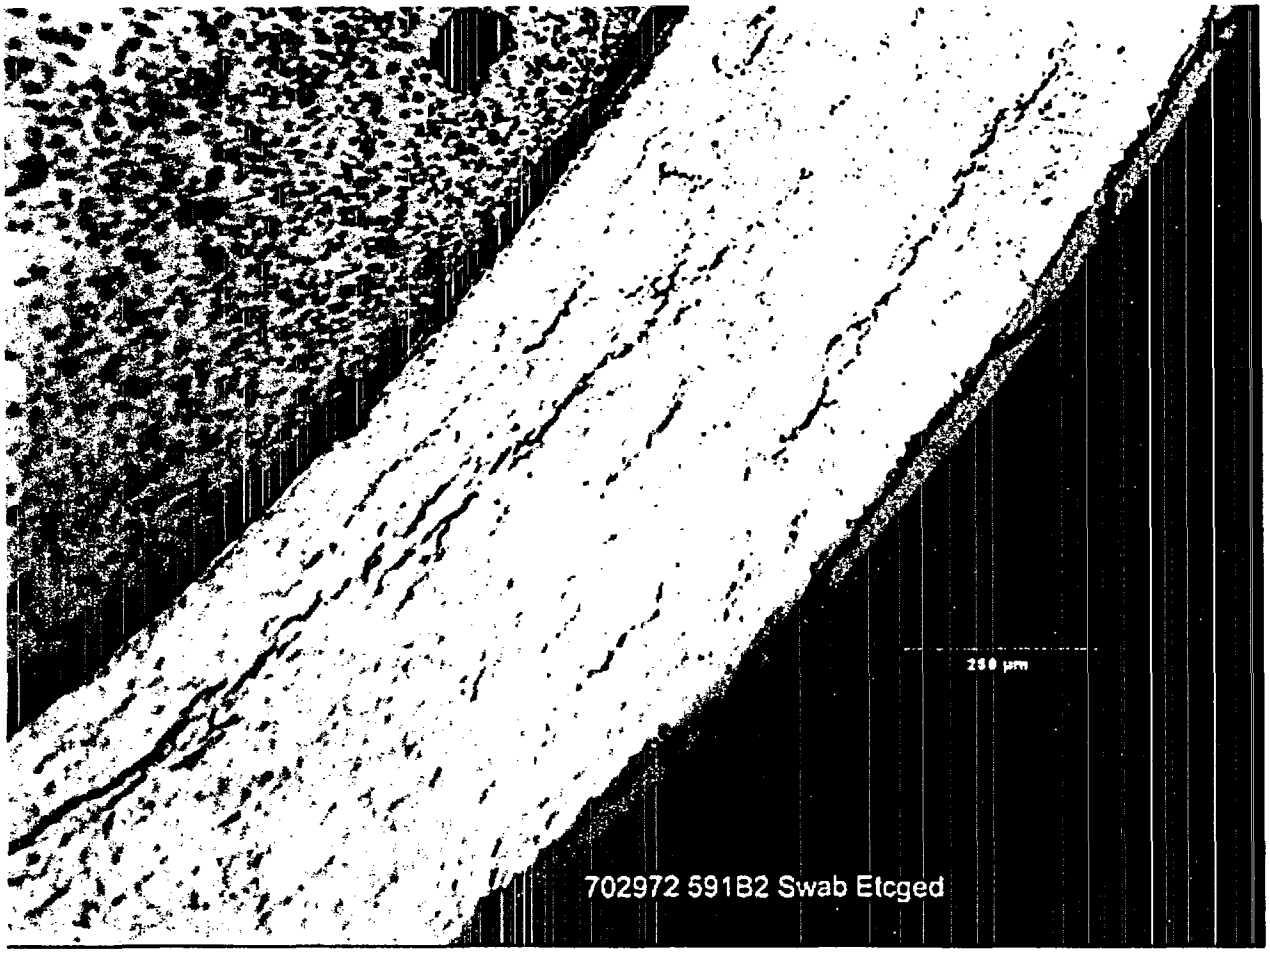
Fig. D.69 Cross-sectional view of Rod H9 cladding hydride morphology at ≈1000 mm above fuel midplane (area 5). Scale marker = 250 µm.
JPG file = 591B2 Hydrides Area 5.

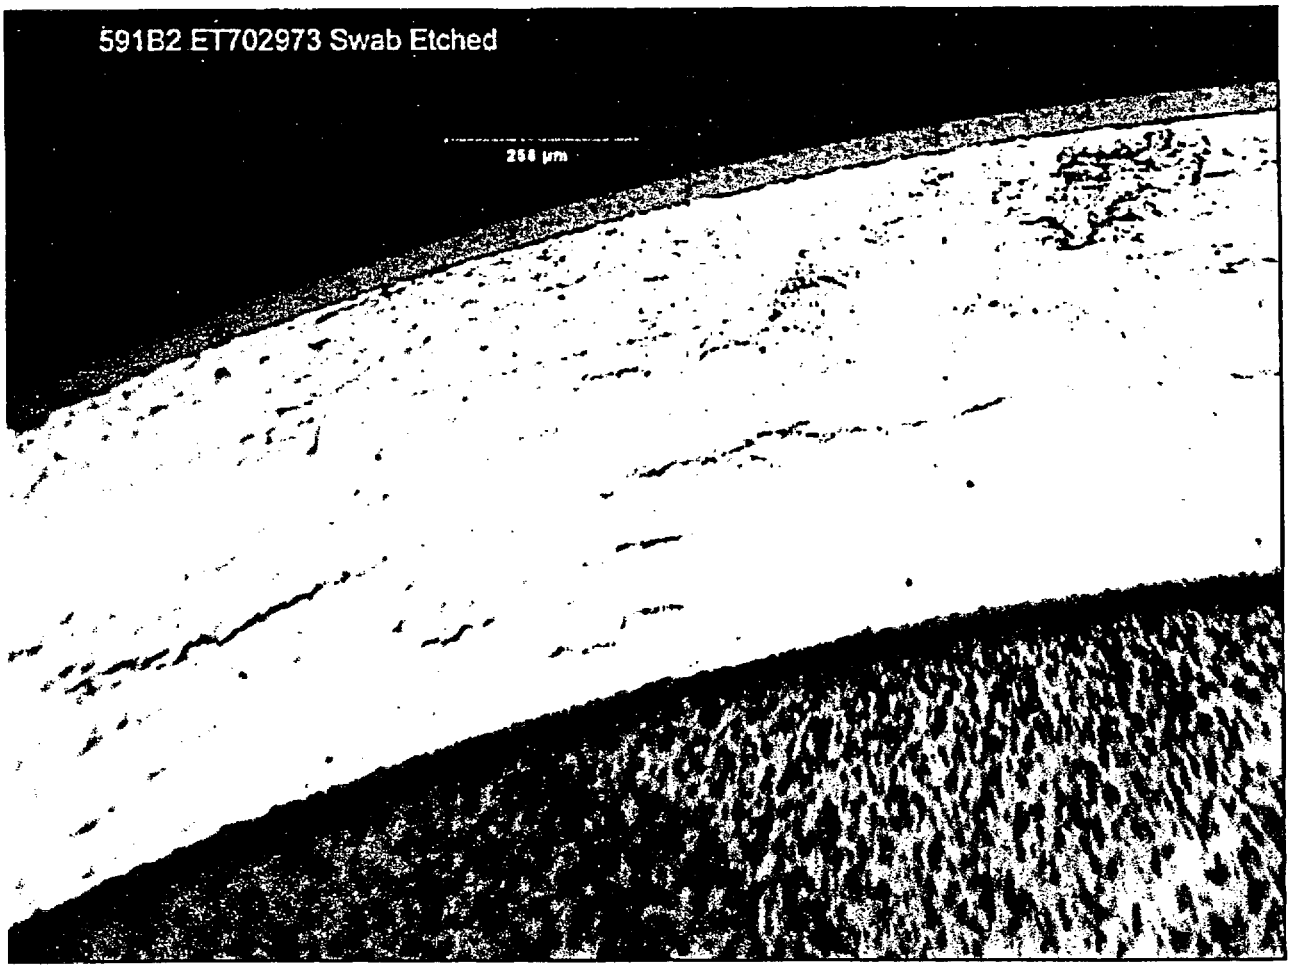
Fig. D.70 Cross-sectional view of Rod H9 cladding hydride morphology at ≈1000 mm above fuel midplane (area 6). Scale marker = 250 µm.
JPG file = 591B2 Hydrides Area 6.

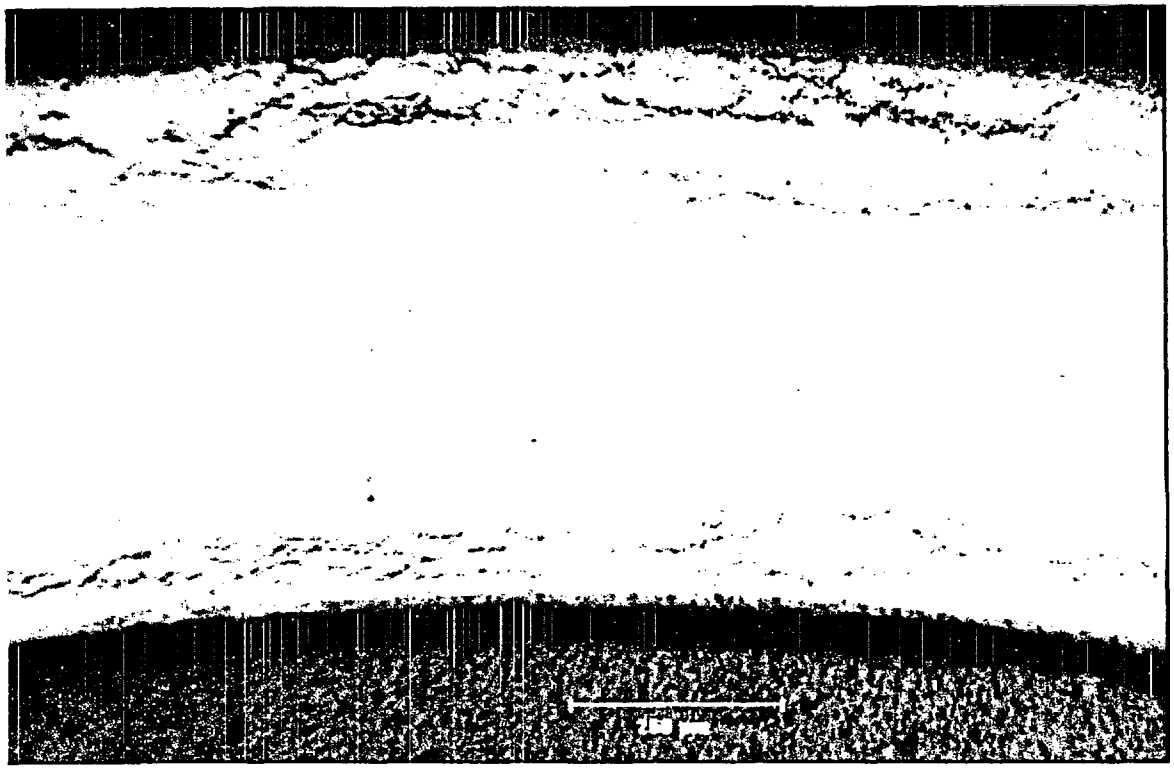
Fig. D.71 Cross-sectional view of Rod G6 cladding hydride morphology at the approximate fuel midplane (area 1). Scale marker = 250 μm. JPG file = 592C4 Hydrides Area 1. ET703343.

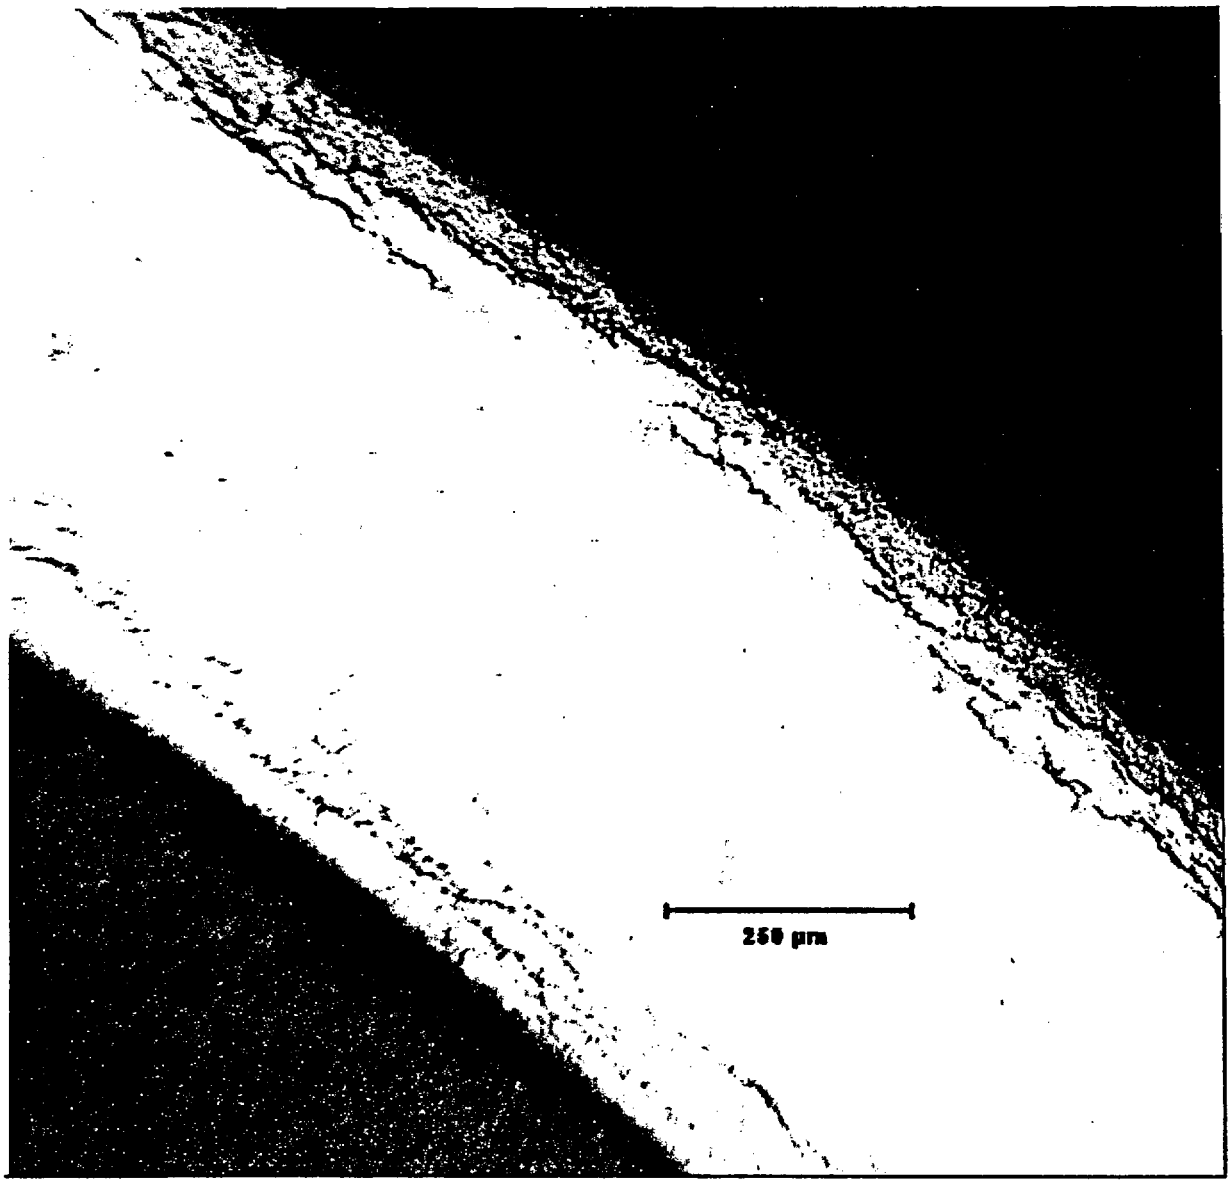
Fig. D.72 Cross-sectional view of Rod G6 cladding hydride morphology at the approximate fuel midplane (area 2). Scale marker = 250 µm. JPG file = 592C4 Hydrides Area 2. ET703344.

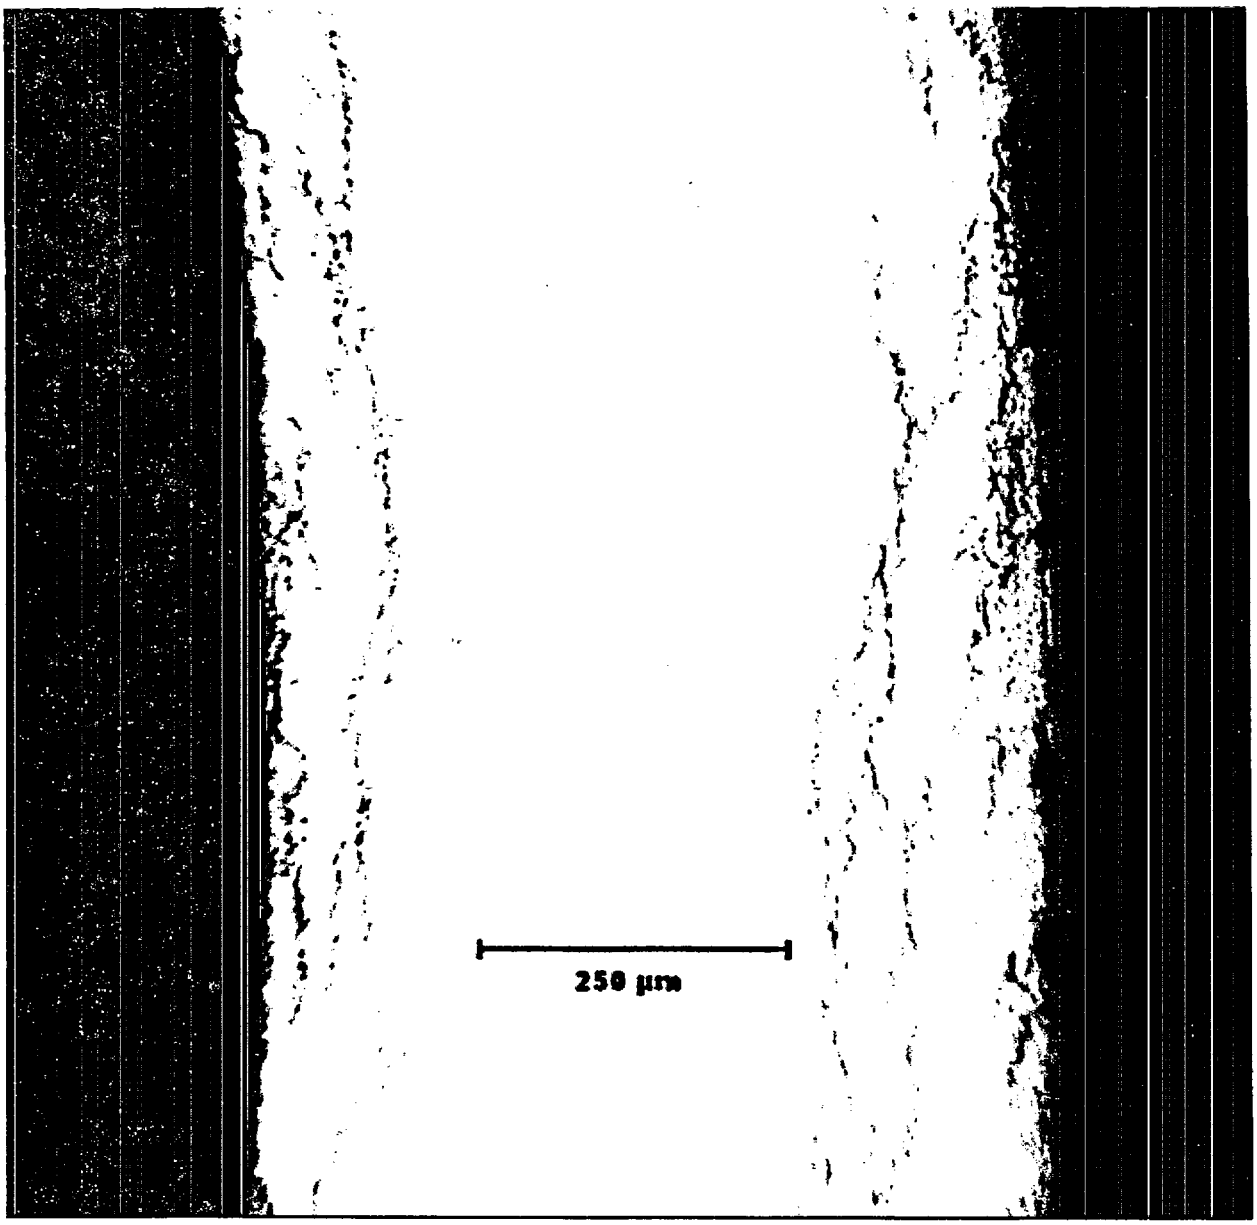
Fig. D.73 Cross-sectional view of Rod G6 cladding hydride morphology at approximate fuel midplane (area 3). Scale marker = 250 µm.
JPG file = 592C4 Hydrides Area 3. ET703345.

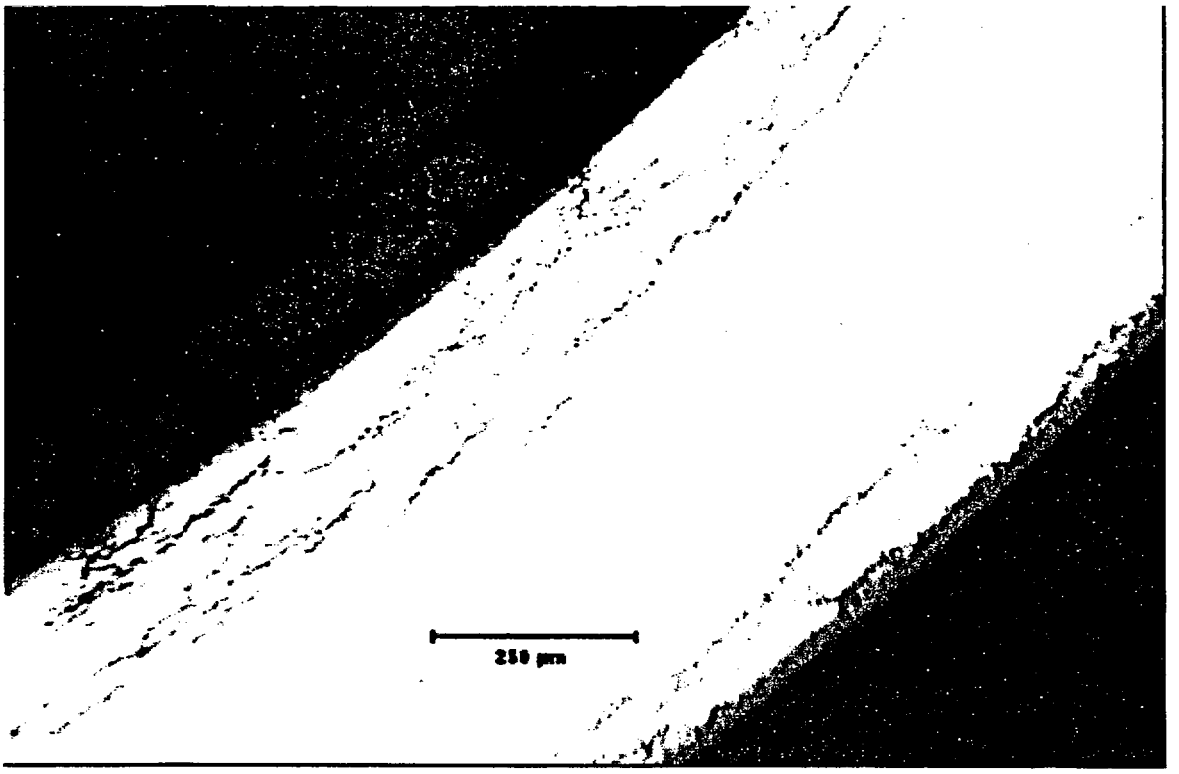
Fig. D.74 Cross-sectional view of Rod G6 cladding hydride morphology at approximate fuel midplane (area 4). Scale marker = 250 µm.
JPG file = 592C4 Hydrides Area 4. ET703346.

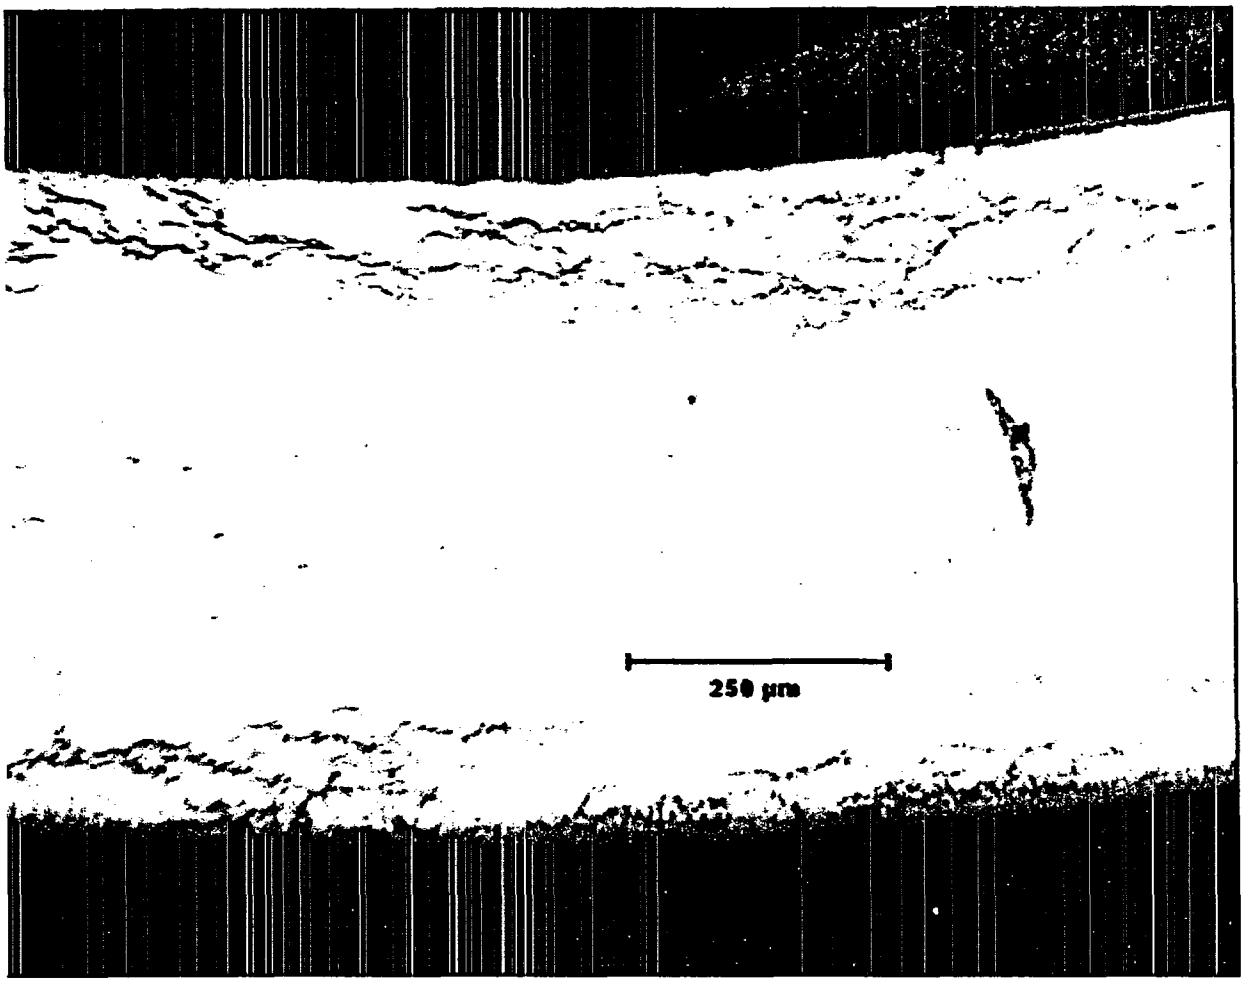
Fig. D.75 Cross-sectional view of Rod G6 cladding hydride morphology at approximate fuel midplane (area 5). Scale marker = 250 µm. JPG file = 592C4 Hydrides Area 5. ET703347.

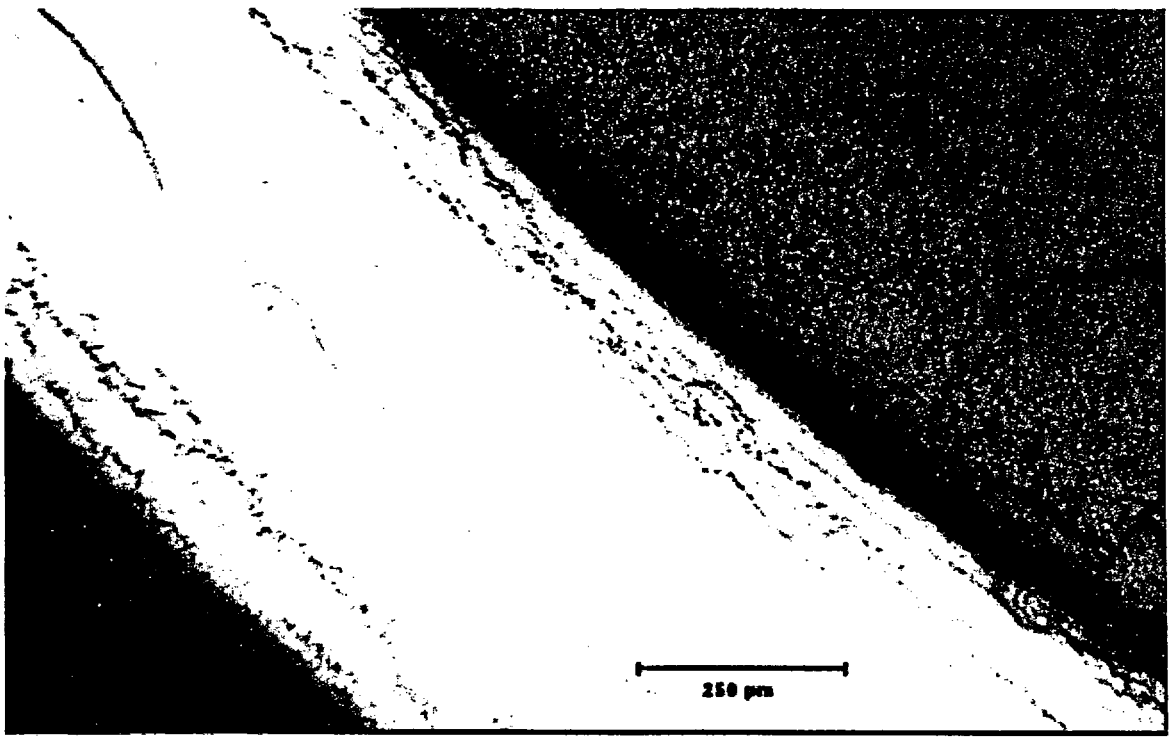
Fig. D.76 Cross-sectional view of Rod G6 cladding hydride morphology at approximate fuel midplane (area 6). Scale marker = 250 µm. JPG file = 592C4 Hydrides Area 6. ET703348.

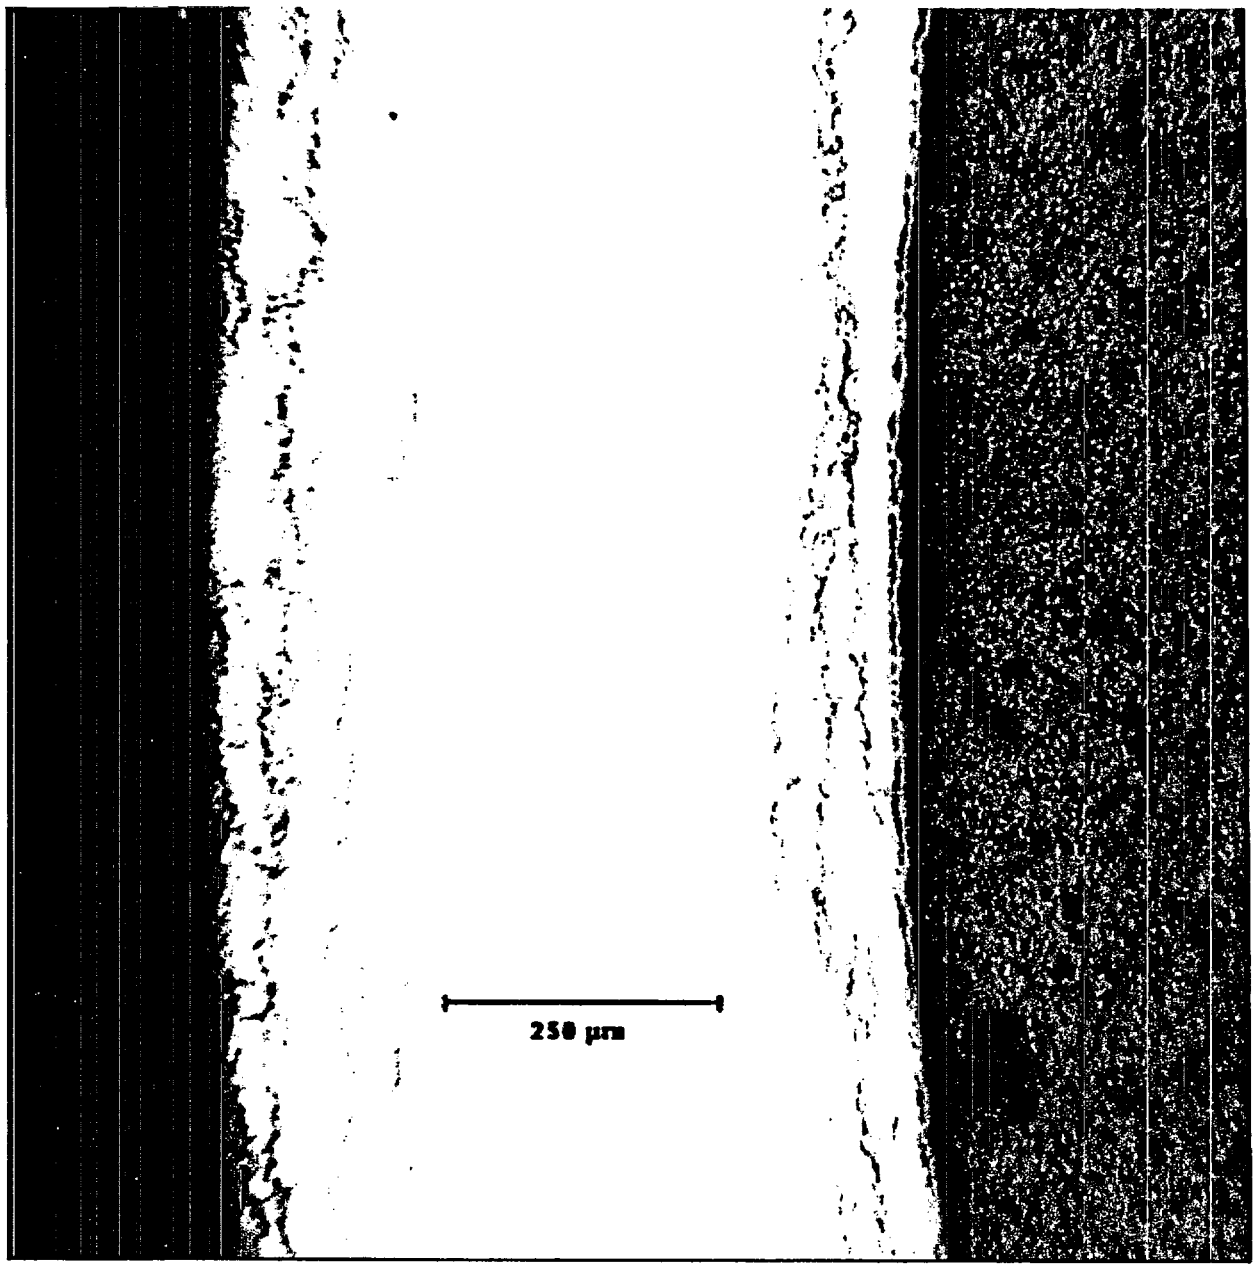
Fig. D.77 Cross-sectional view of Rod G6 cladding hydride morphology at approximate fuel midplane (area 7). Scale marker = 250 µm. JPG file = 592C4 Hydrides Area 7. ET703349.

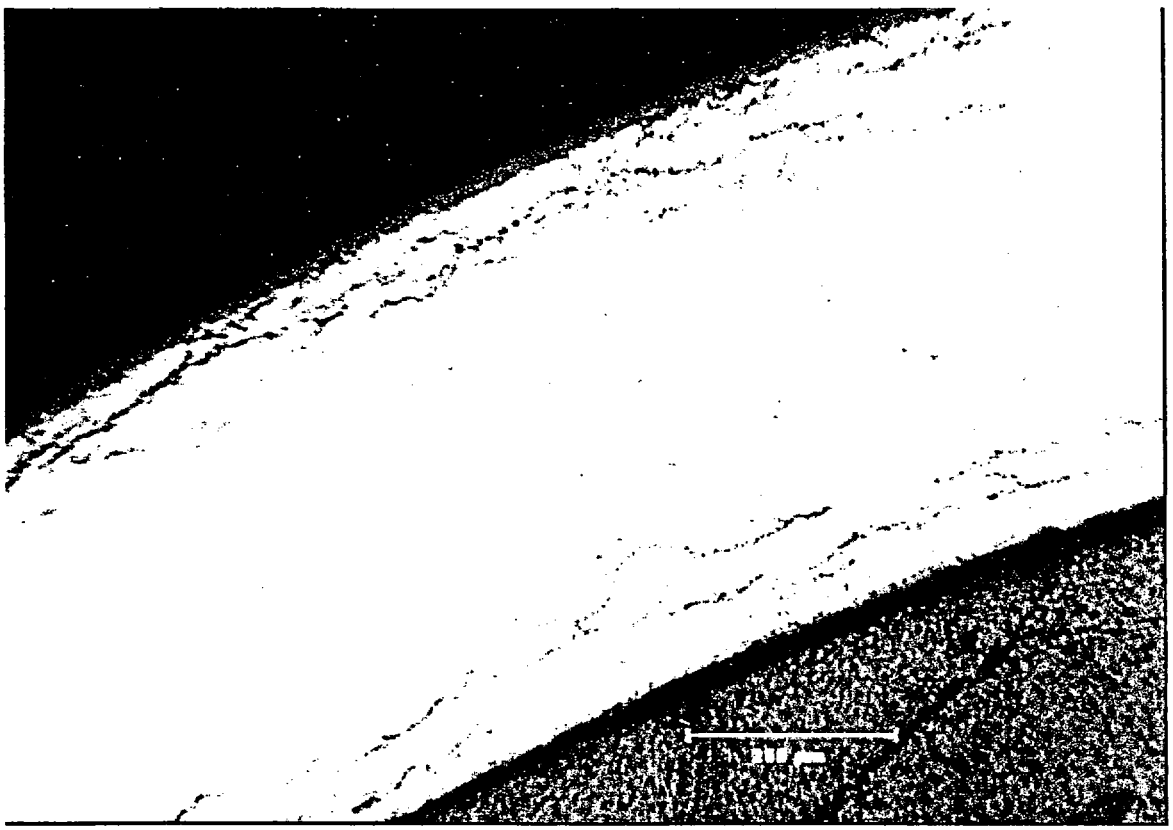
Fig. D.78 Cross-sectional view of Rod G6 cladding hydride morphology at approximate fuel midplane (area 8). Scale marker = 250 μm. JPG file = 592C4 Hydrides Area 8. ET703350.

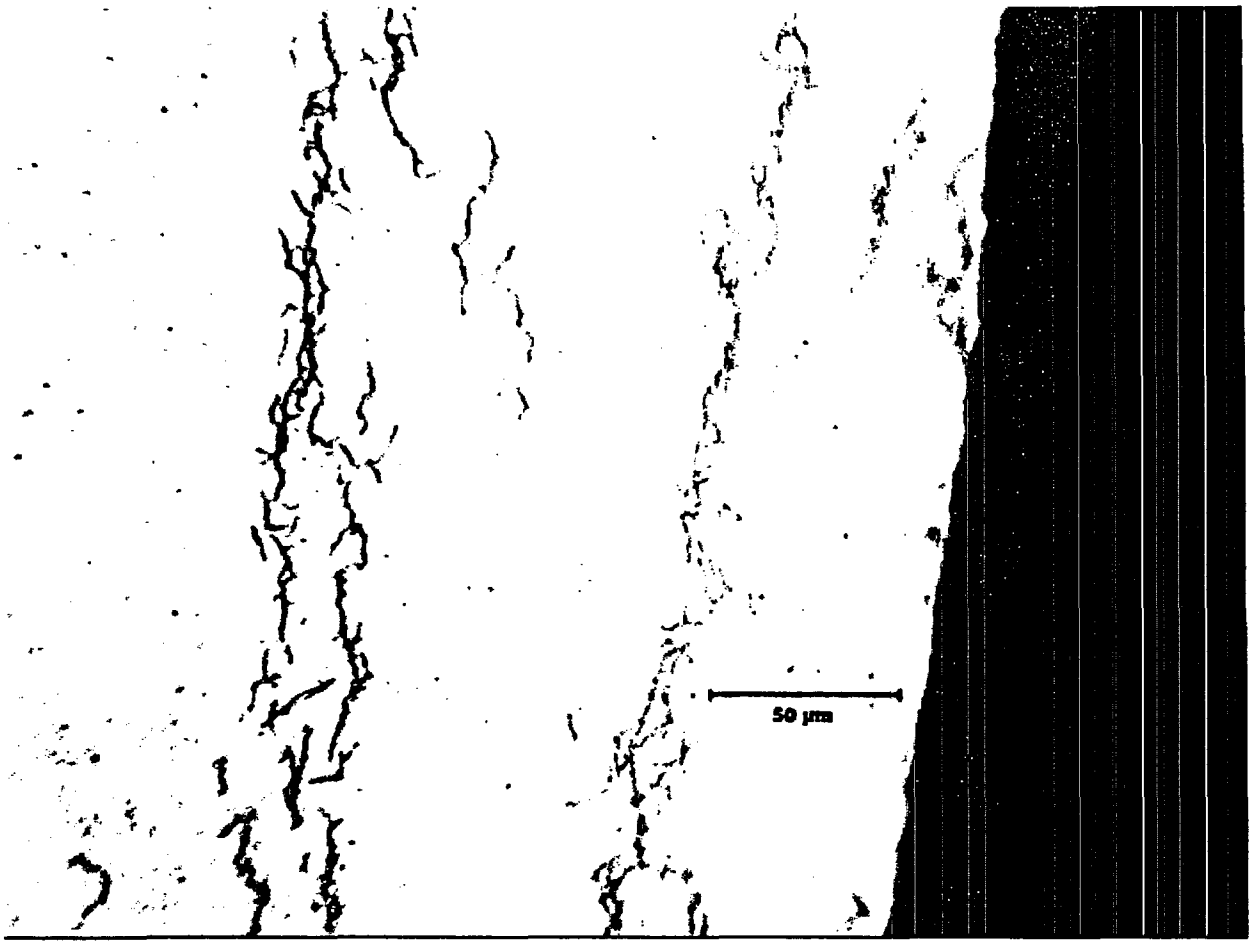
Fig. D.79a Hydride orientation/distribution at area 5 within Rod G6 cladding at the approximate fuel midplane position. High magnification photomicrograph near the cladding outer surface.
JPG file = 592C4 etched OD hydrides. ET703374.

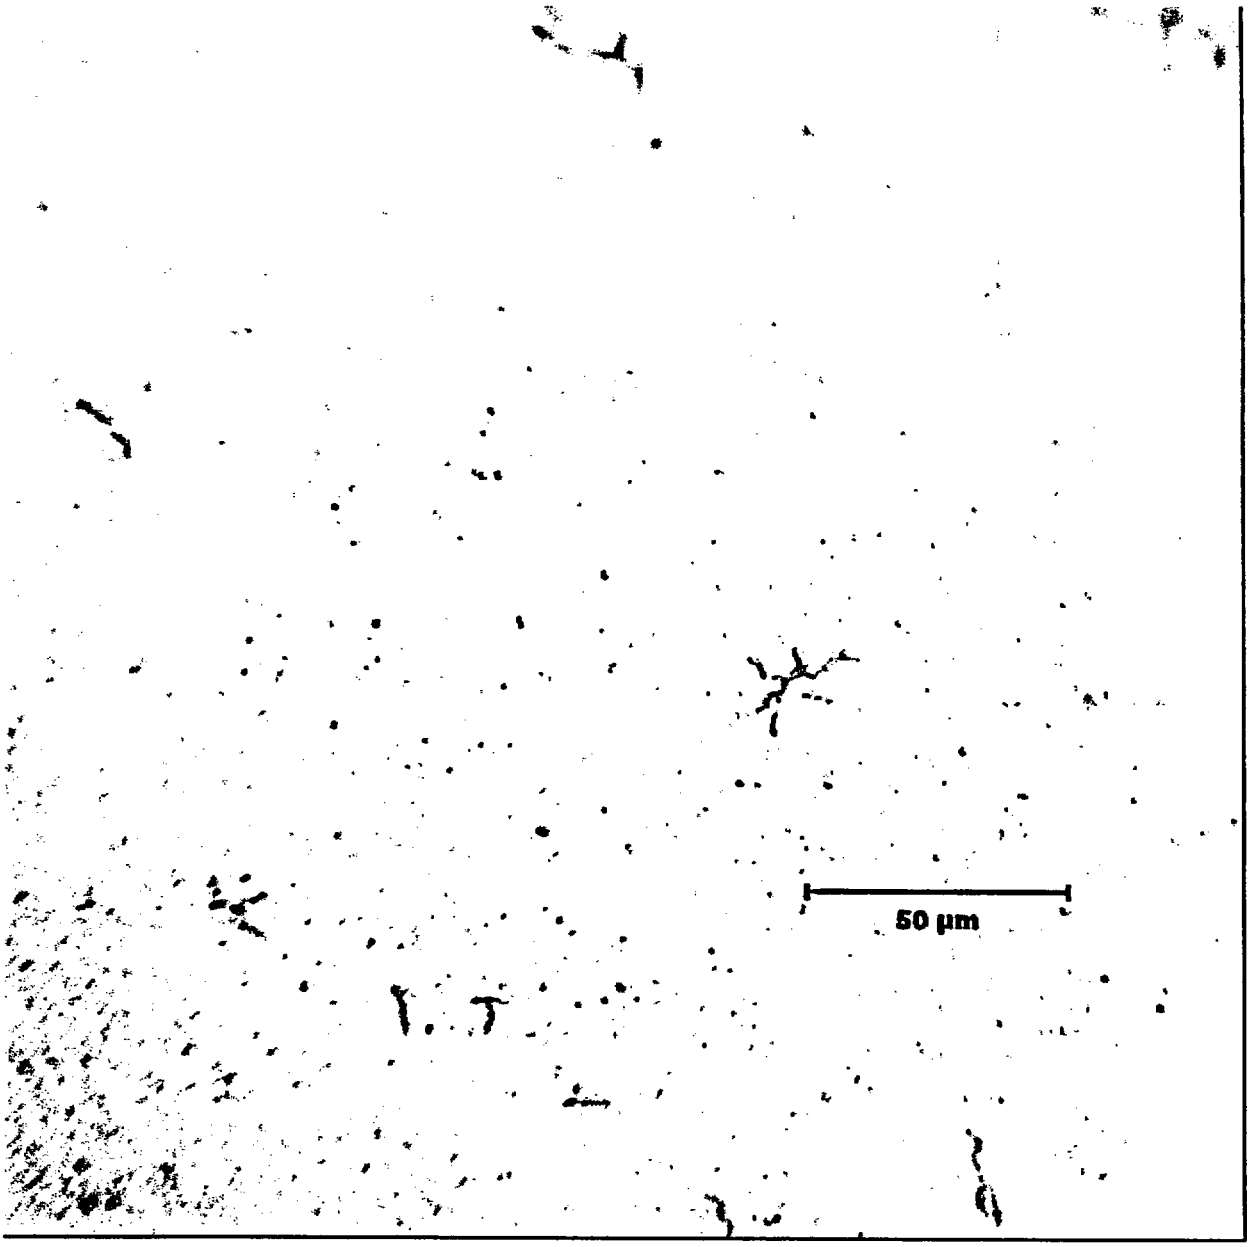
Fig. D.79b. Hydride orientation/distribution within Rod G6 cladding at the approximate fuel midplane position. High magnification photomicrograph near the cladding middle surface.
JPG file = 592C4 etched crowfeet1. ET703367.

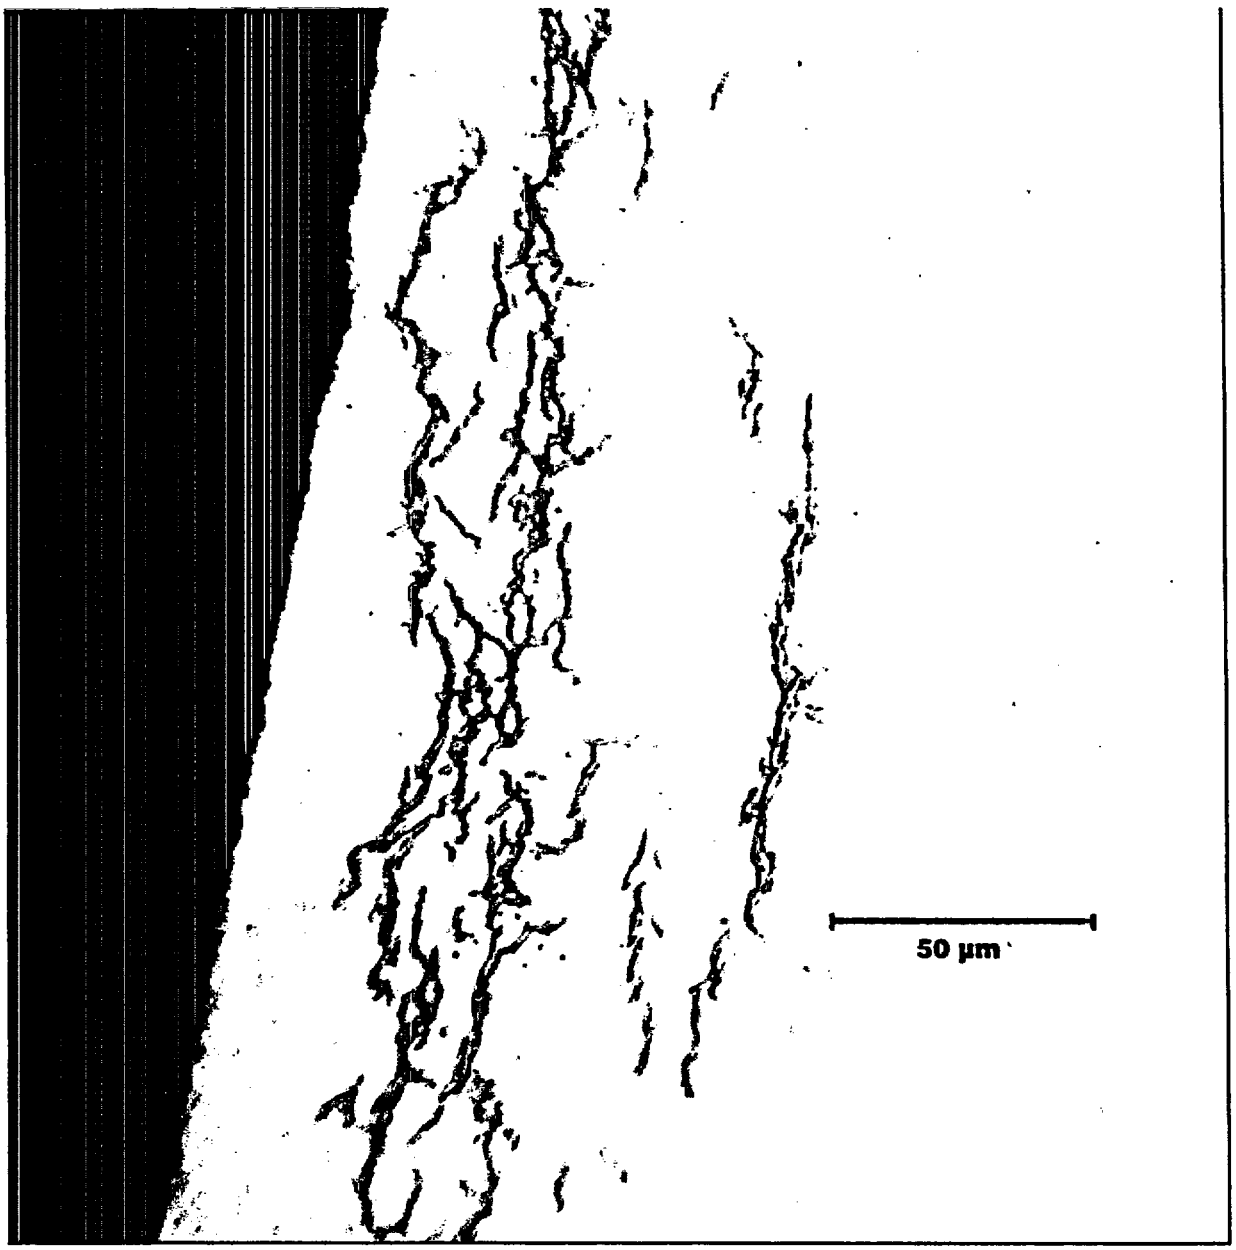
Fig. D.79c. Hydride orientation/distribution within Rod G6 cladding at the approximate fuel midplane (area 5). High magnification photomicrograph near the cladding inner surface.
JPG file = 592C4 etched ID hydrides. ET703373.

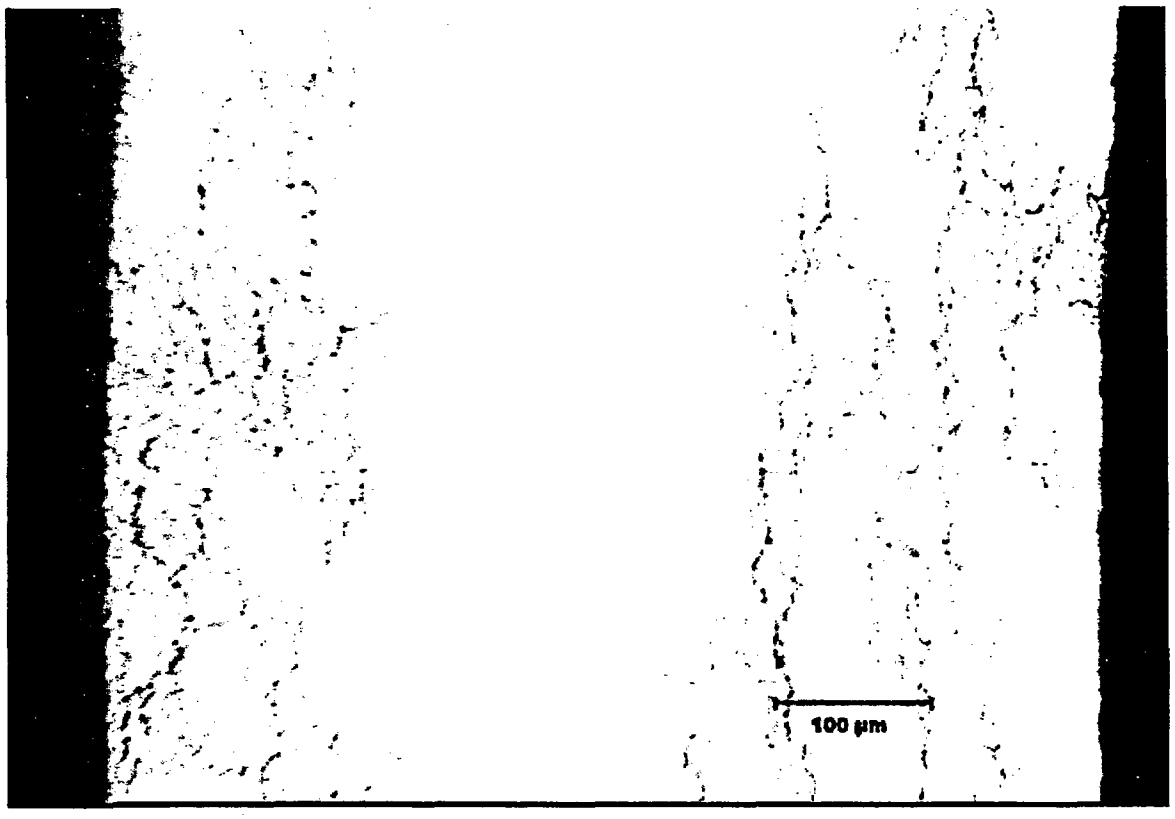
Fig. D.80 Cross-sectional view of Rod G6 cladding hydride morphology at ≈ 500 mm above fuel midplane (area 1). Scale marker = 100 µm.
JPG file = 592C12 Hydrides Area 1. ET703257.
