NUREG/CR-6831
ANL-03/17

Examination of Spent PWR Fuel Rods after 15 Years in Dry Storage

Argonne National Laboratory

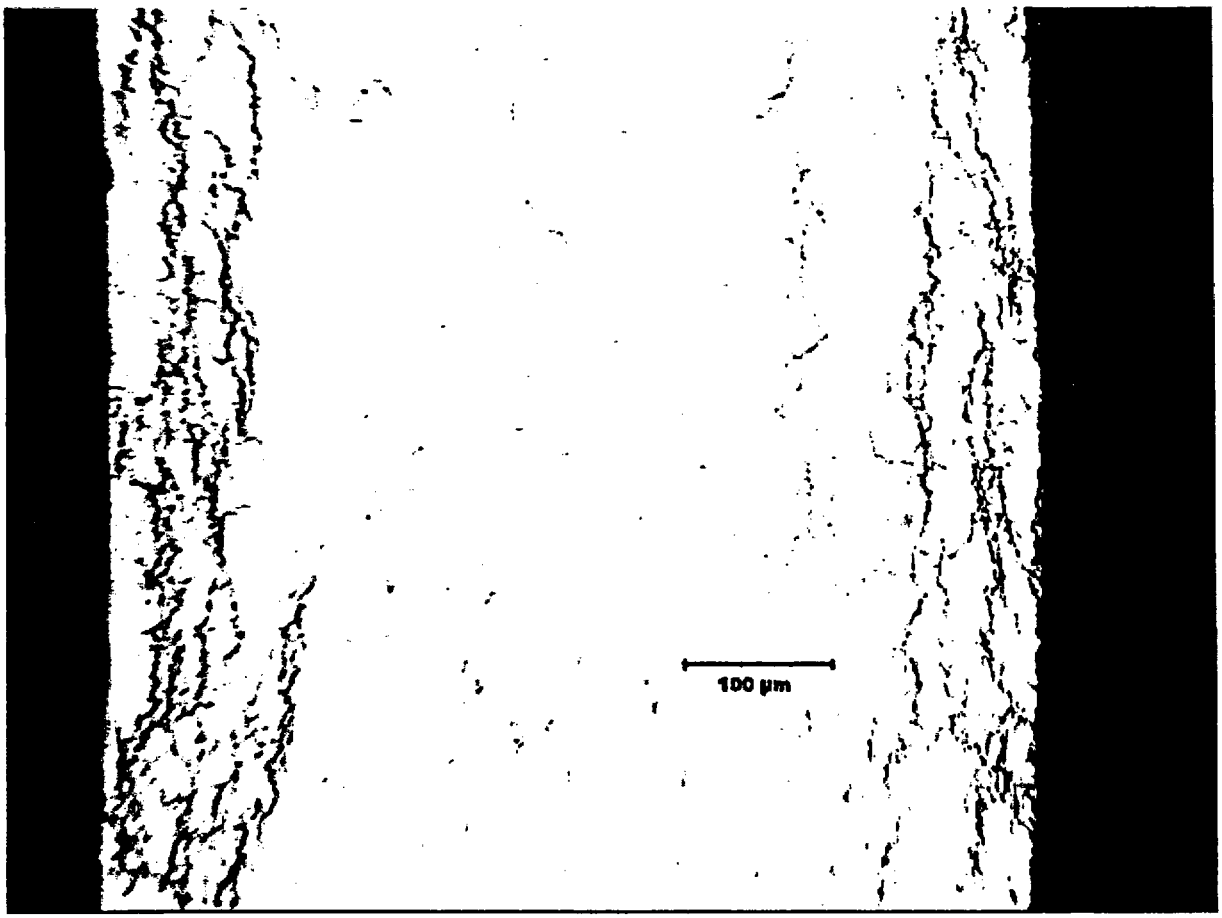
Fig. D.82 Cross-sectional view of Rod G6 cladding hydride morphology at ≈500 mm above fuel midplane (area 3). Scale marker = 100 µm.
JPG file = 592C12 Hydrides Area 3. ET703263.

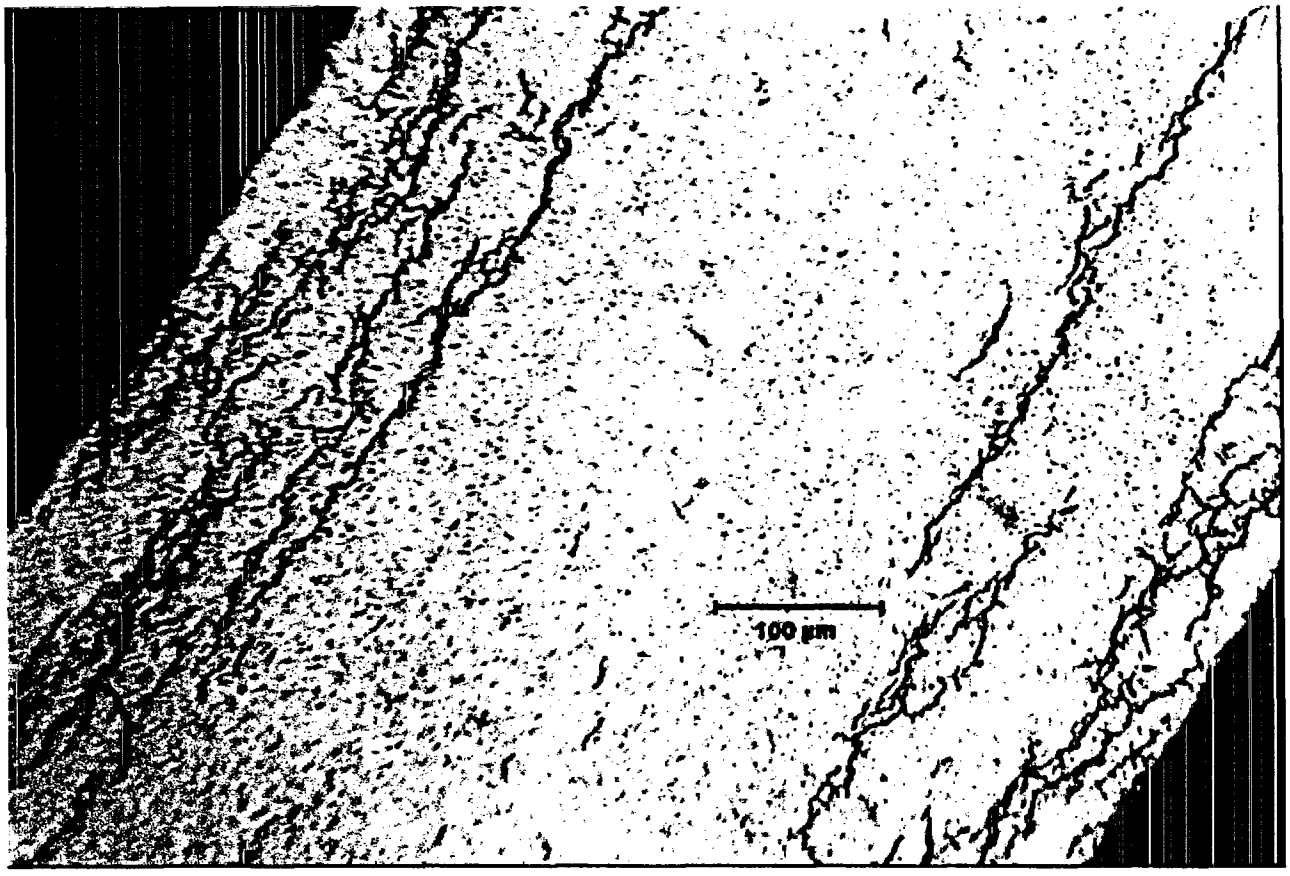
Fig. D.83 Cross-sectional view of Rod G6 cladding hydride morphology at ≈500 mm above fuel midplane (area 4). Scale marker = 100 µm.
JPG file = 592C12 Hydrides Area 4. ET703266.

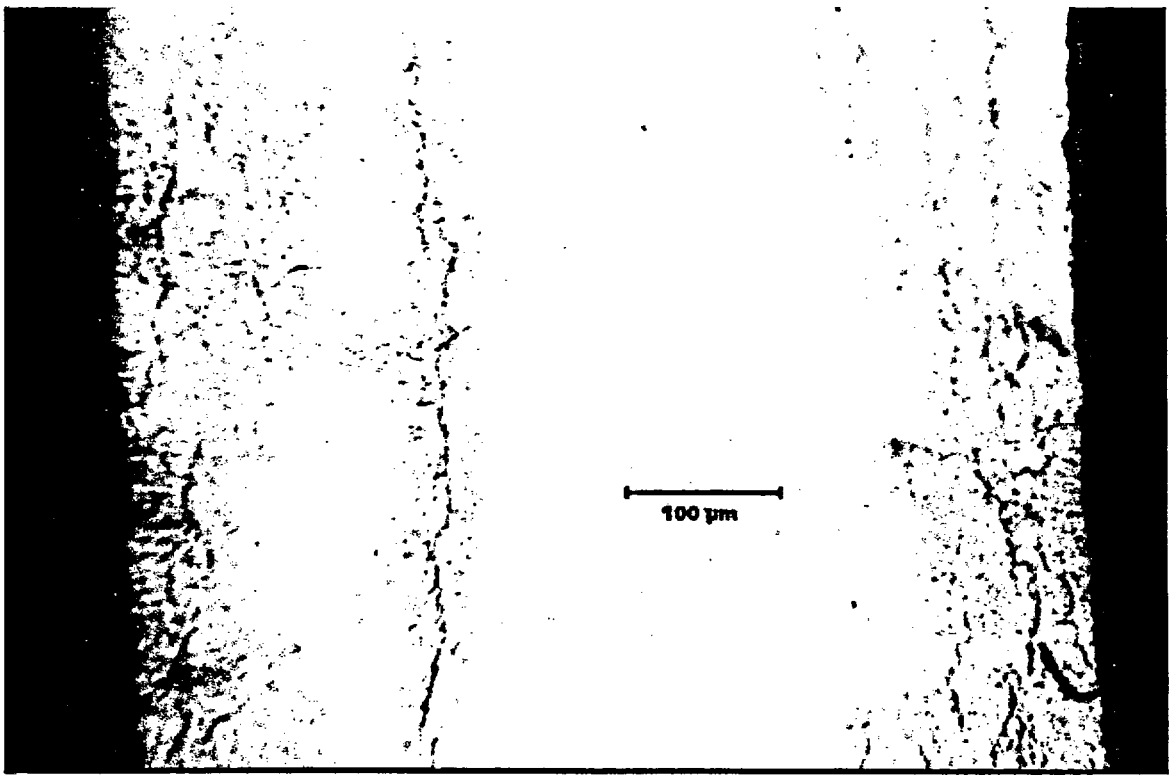
Fig. D.84 Cross-sectional view of Rod G6 cladding hydride morphology at ≈500 mm above fuel midplane (area 5). Scale marker = 100 µm.
JPG file = 592C12 Hydrides Area 5. ET703269.

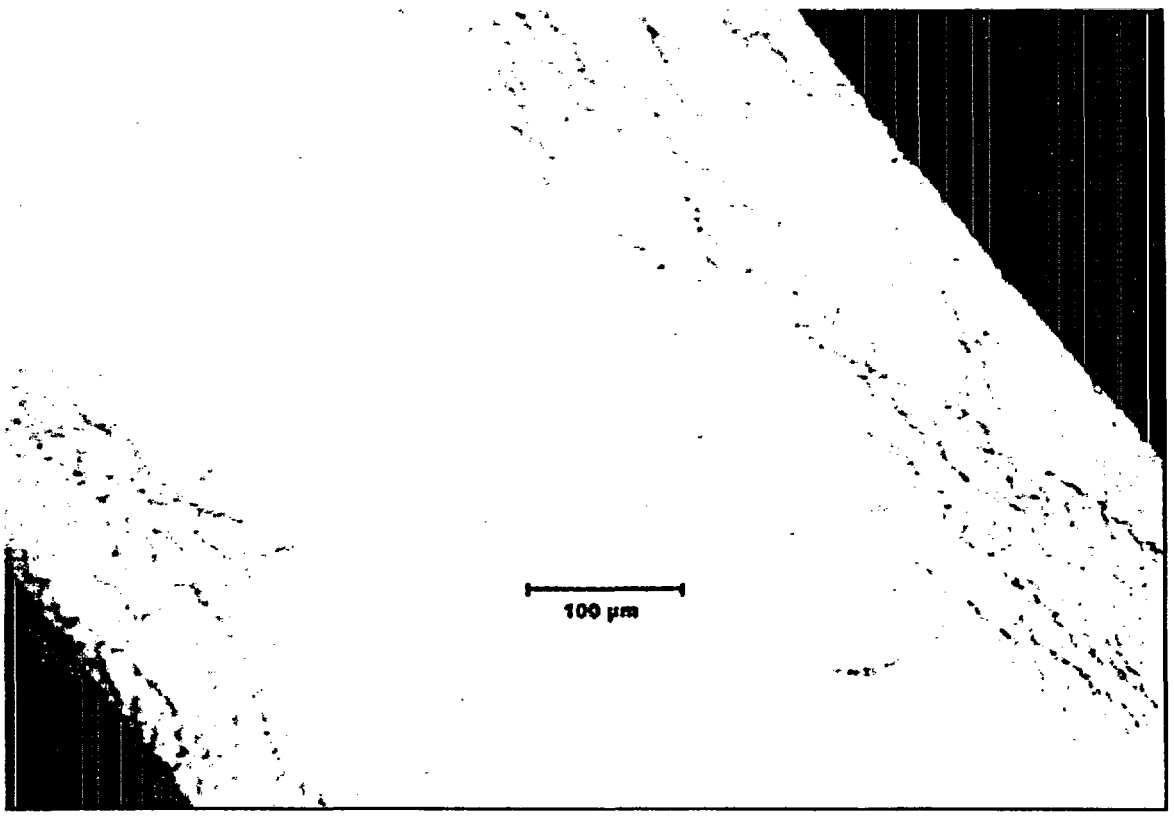
Fig. D.85 Cross-sectional view of Rod G6 cladding hydride morphology at ≈500 mm above fuel midplane (area 6). Scale marker = 100 µm.
JPG file = 592C12 Hydrides Area 6. ET703272.

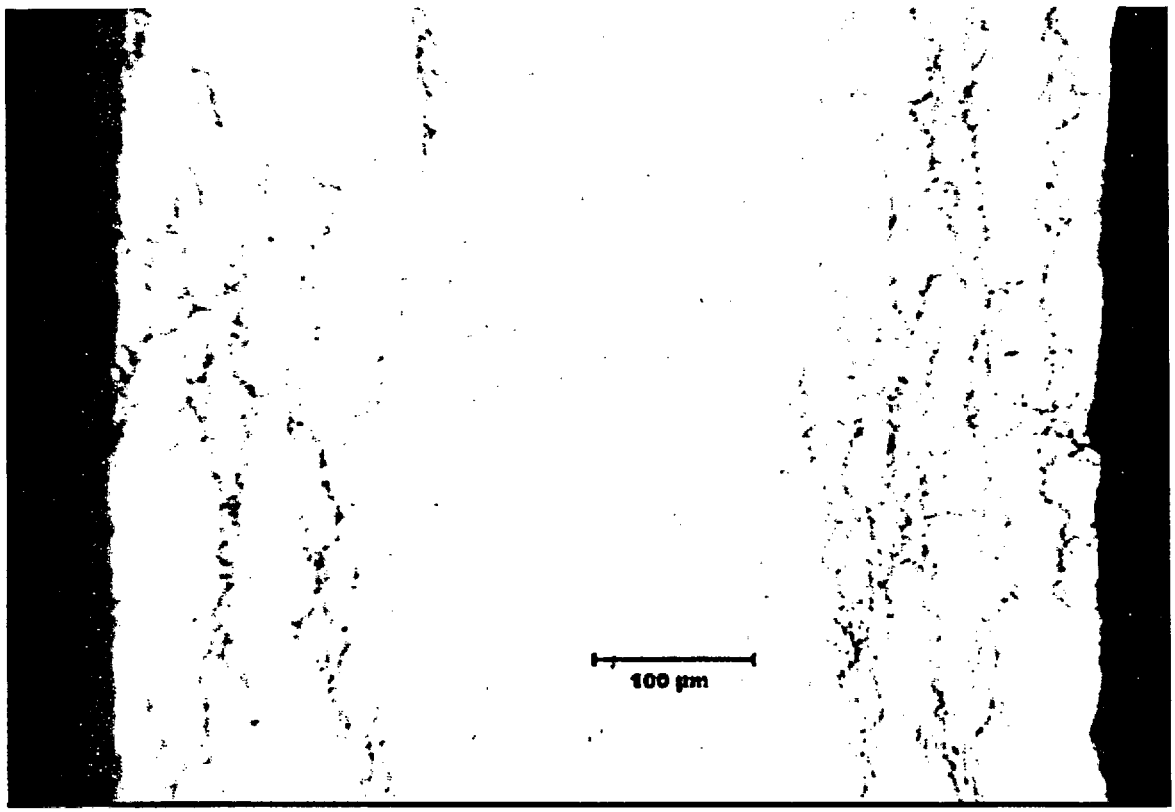
Fig. D.86 Cross-sectional view of Rod G6 cladding hydride morphology at ≈500 mm above fuel midplane (area 7). Scale marker = 100 µm.
JPG file = 592C12 Hydrides Area 7. ET703275.

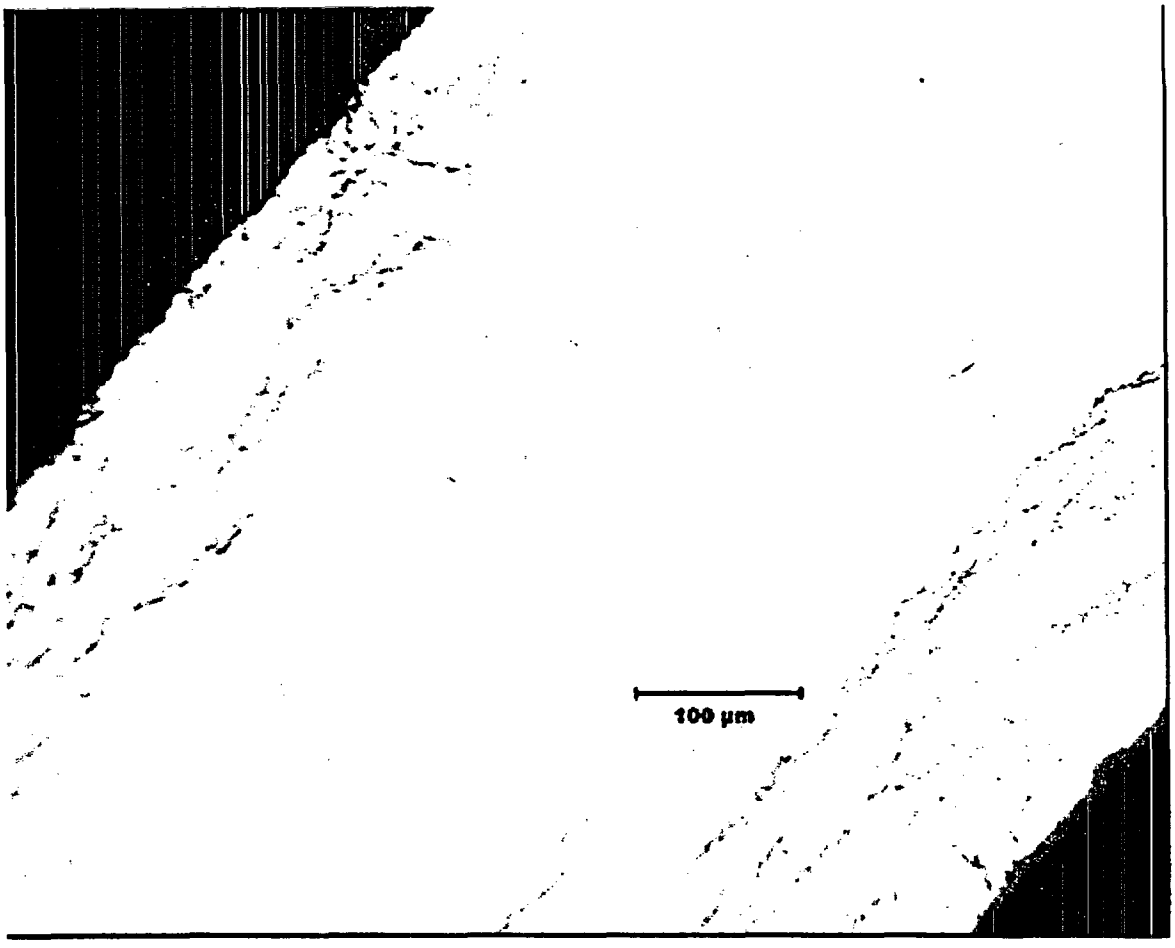
Fig. D.87 Cross-sectional view of Rod G6 cladding hydride morphology at ≈500 mm above fuel midplane (area 8). Scale marker = 100 µm.
JPG file = 592C12 Hydrides Area 8. ET703278.

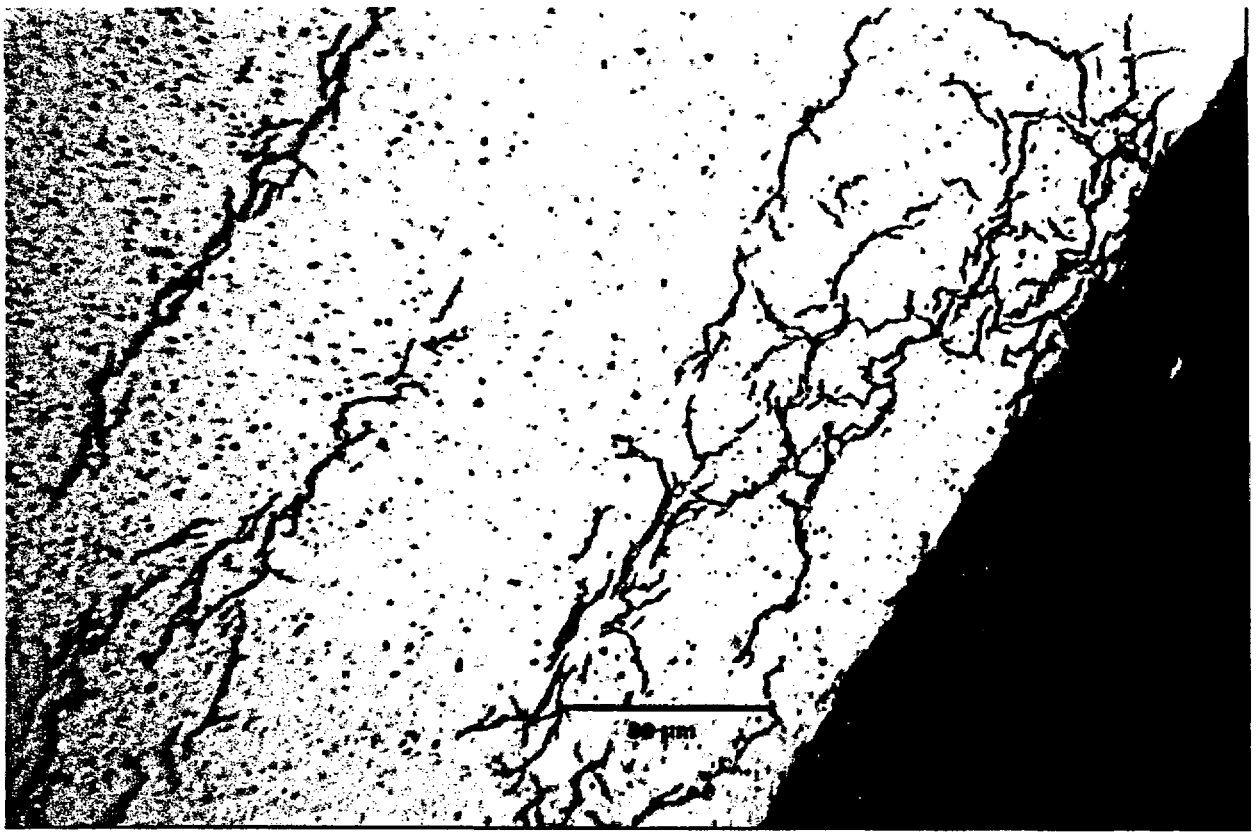
Fig. D.88a. High magnification of hydride orientation/distribution near the outer surface ≈500 mm above the fuel midplane (area 4) within Rod G6 cladding. JPG file = 592C12 etched area 4 outer. ET703267.

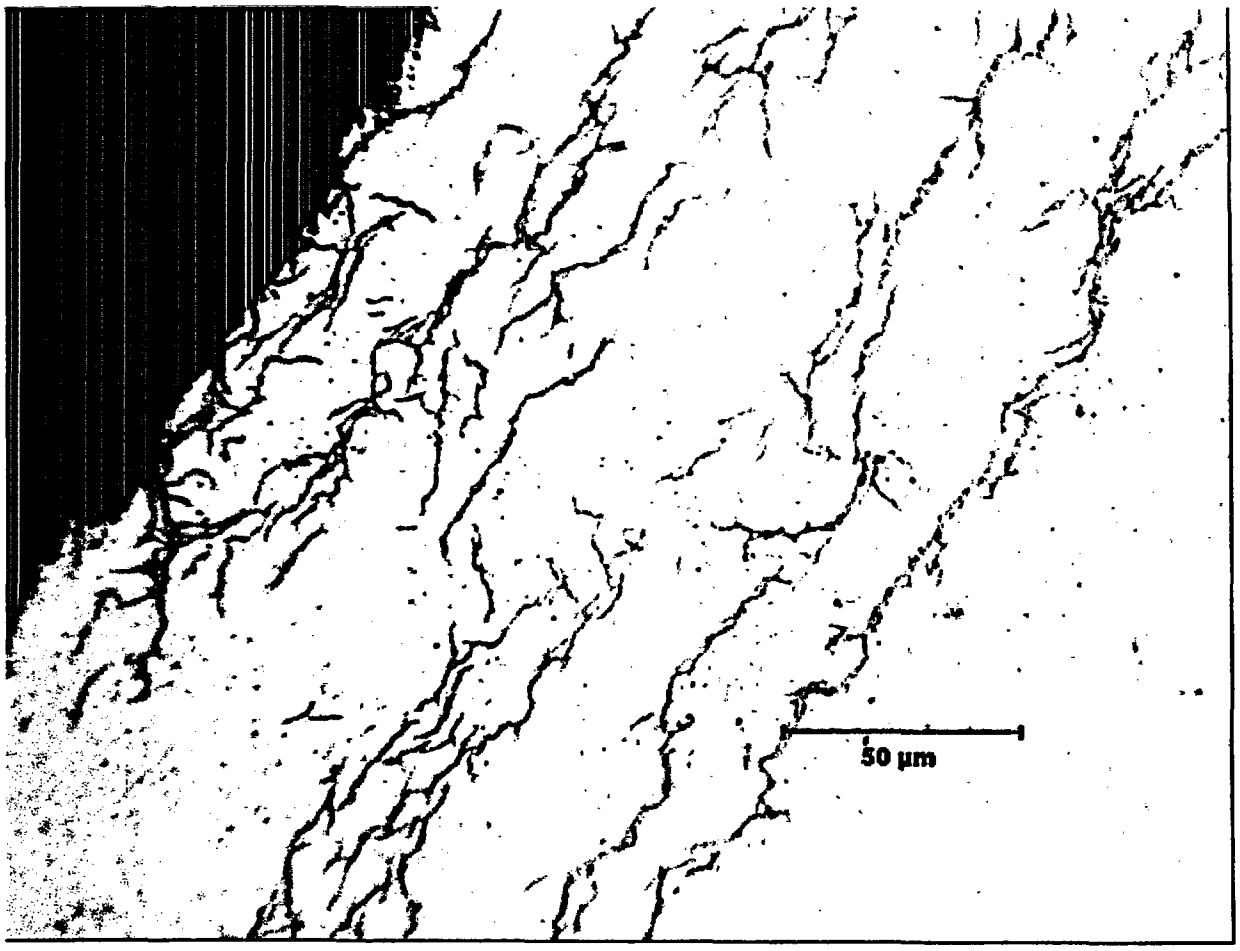
Fig. D.88b. High magnification of hydride orientation/distribution near the inner surface ≈500 mm above the fuel midplane (area 4) within Rod G6 cladding. JPG file = 592C12 etched area 4 inner. ET703268.

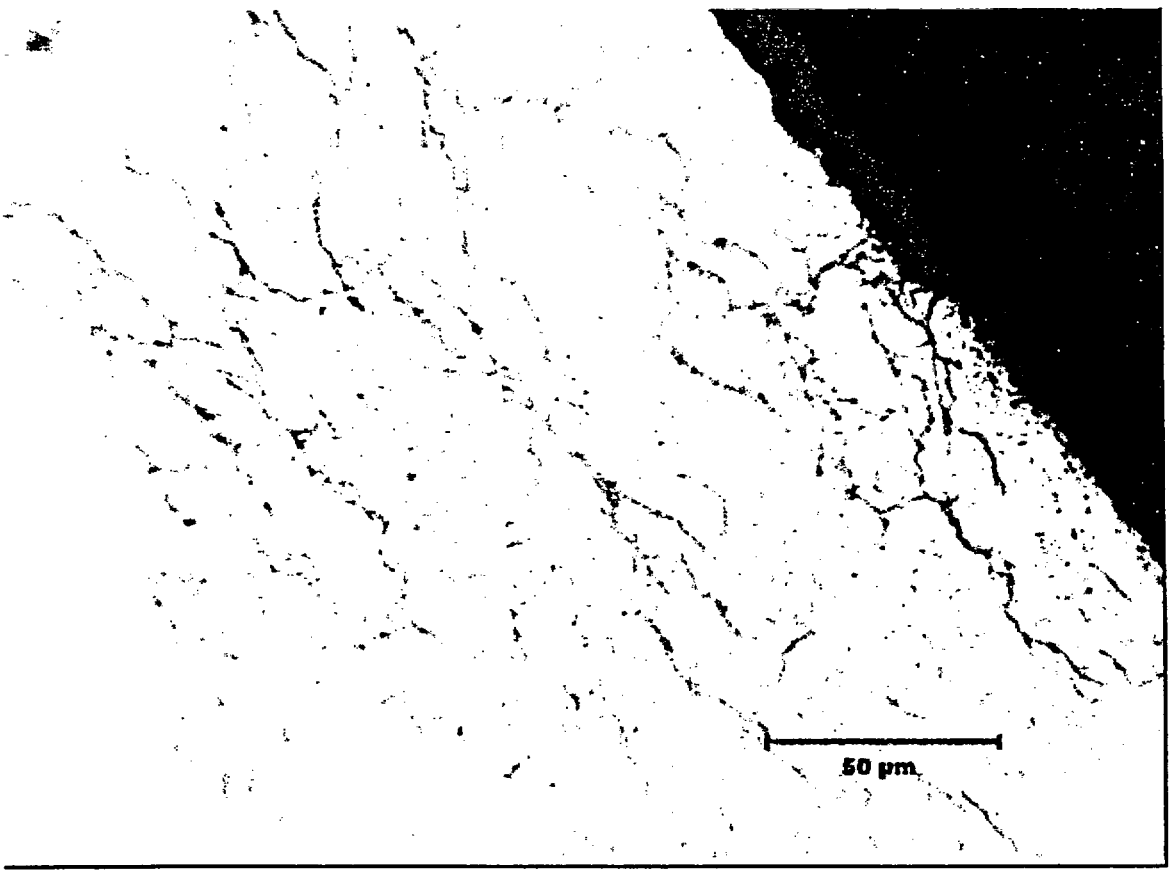
Fig. D.89a. High magnification of hydride orientation/distribution near the inner surface ≈500 mm above the fuel midplane (area 6) within Rod G6 cladding. Note the fine precipitates around the hydrides.
JPG file = 592C12 etched area 6 inner. ET 703274.

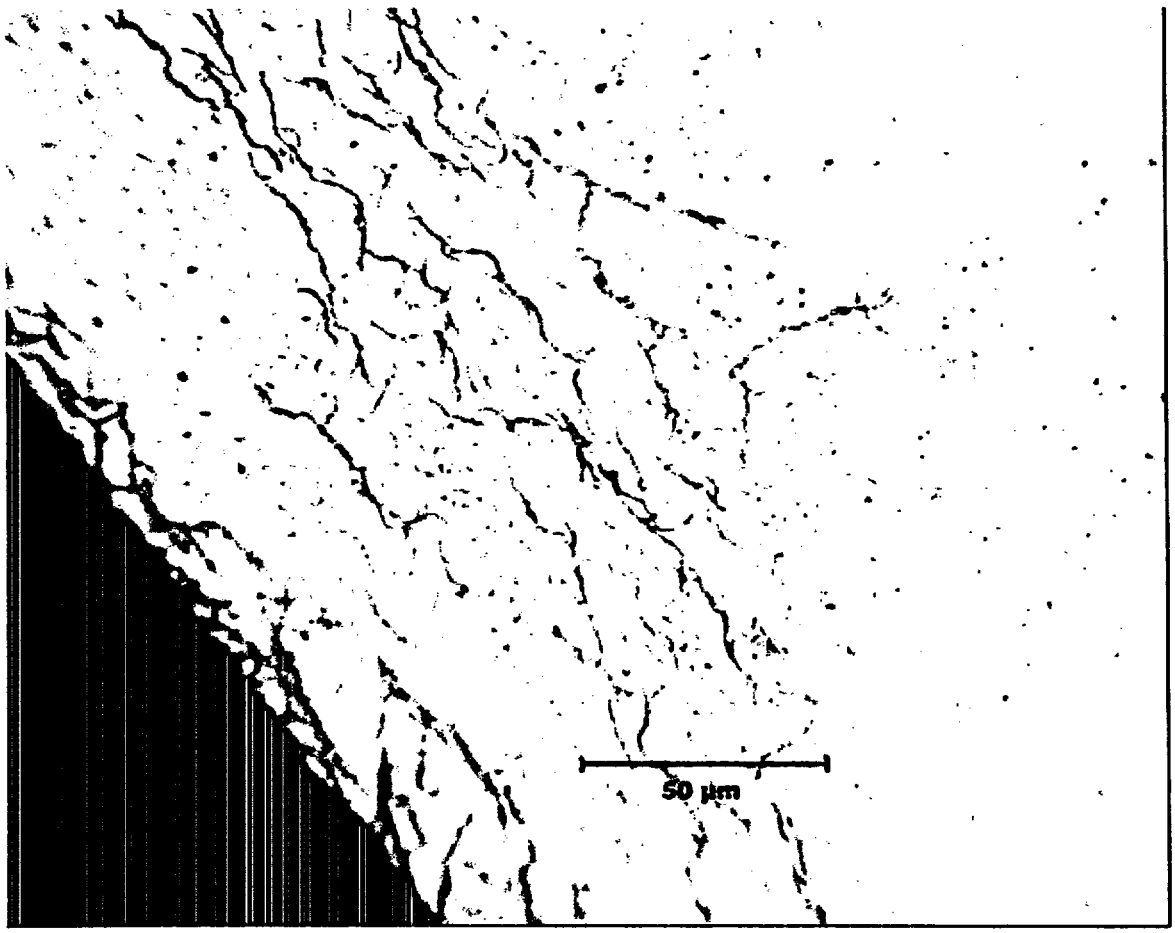
Fig. D.89b. High magnification of hydride orientation/distribution near the outer surface ≈500 mm above the fuel midplane (area 6) within Rod G6 cladding. Note the fine precipitates around the hydrides.
JPG file = 592C12 etched area 6 outer. ET 703273.

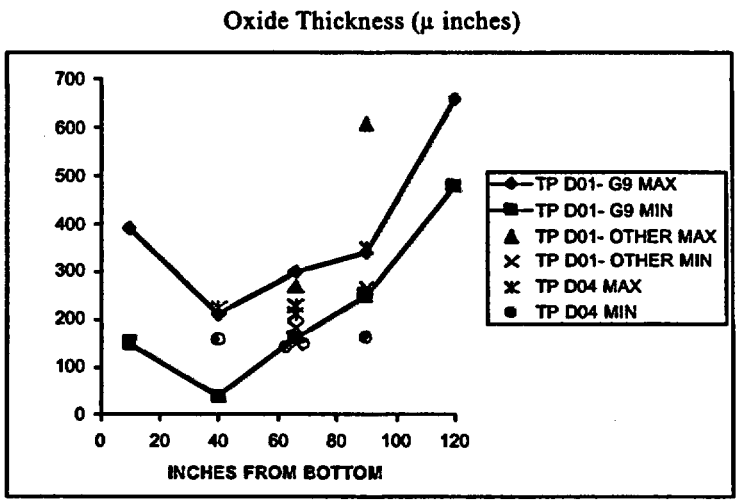
Fig. E.1 Cladding OD Oxide Layers for Three-Cycle Turkey Point PWR Rods. (Refs. E.1 and E.2).

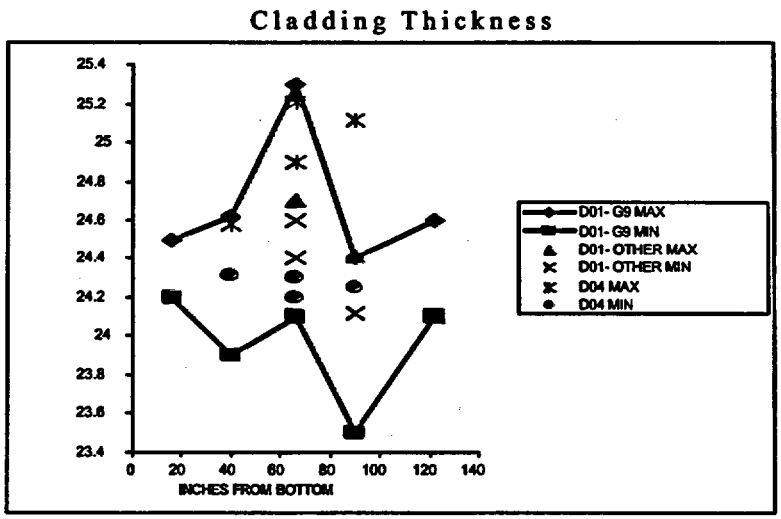
Fig. E.2 Cladding Thicknesses (μ-inch) for Three-Cycle Turkey Point PWR Rods. (Refs. E.1 and E.2).

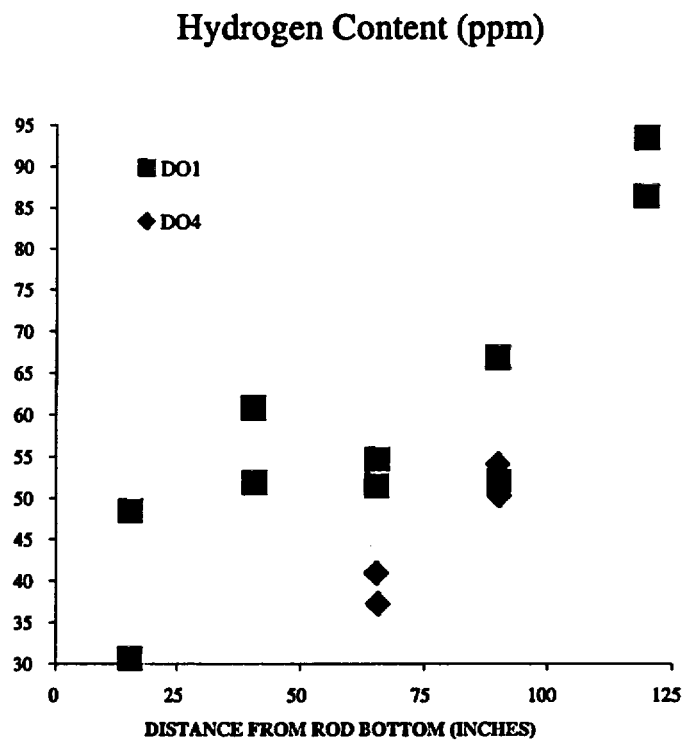
Fig. E.3. Hydrogen Contents for Three-Cycle Turkey Point (D01 and D04) Fuel Rods (Refs. E.1 and E.2)

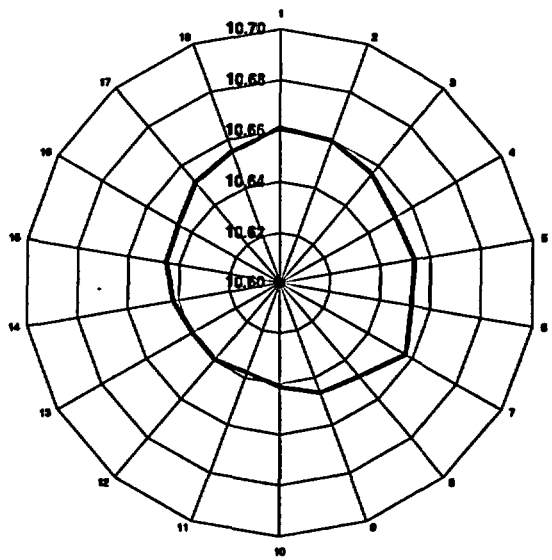
Fig. F.8 Cross-Sectional Profile of the C8 Sample at the Axial Midplane prior to the Thermal Creep Test. The reference diameter for creep measurements is 10.6492 mm

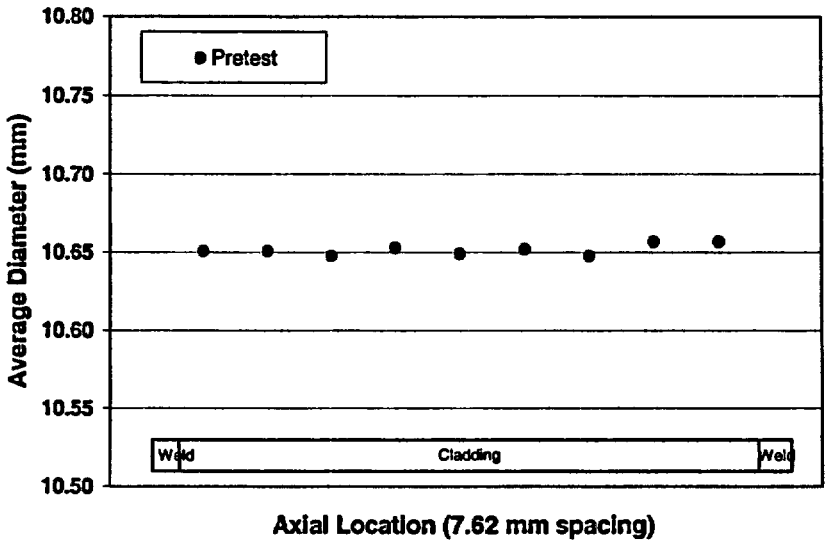
Fig. F.9 Outer Diameter of the C8 Sample as a Function of Axial Location. The middle five readings were averaged to yield the average OD (10.6497 mm =0.41928 in.) of the sample.

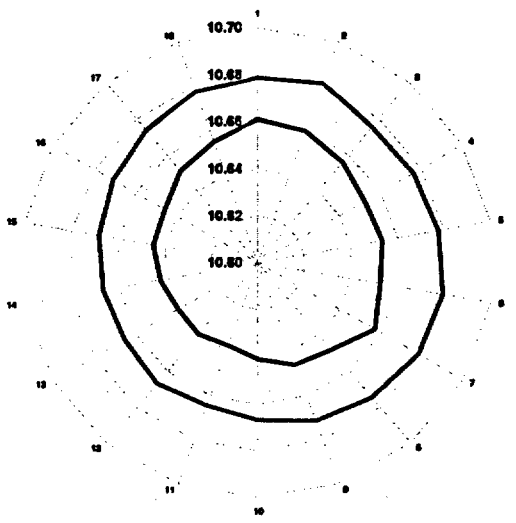
Fig. F.12 Diameter Profile of the C8 Sample at the Axial Midplane before and after the First Run Segment.

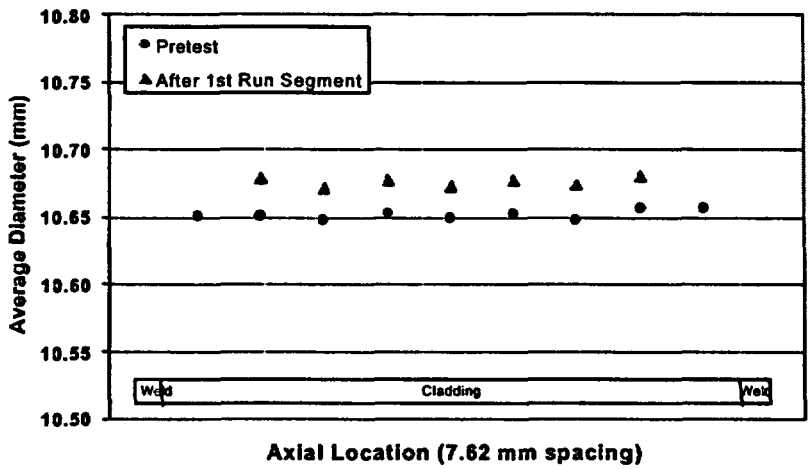
Fig. F.13 Outer Diameter of the C8 Sample before and after the First Run Segment. The two readings near the ends became unavailable due to the hose clamping of the cladding near the welds.

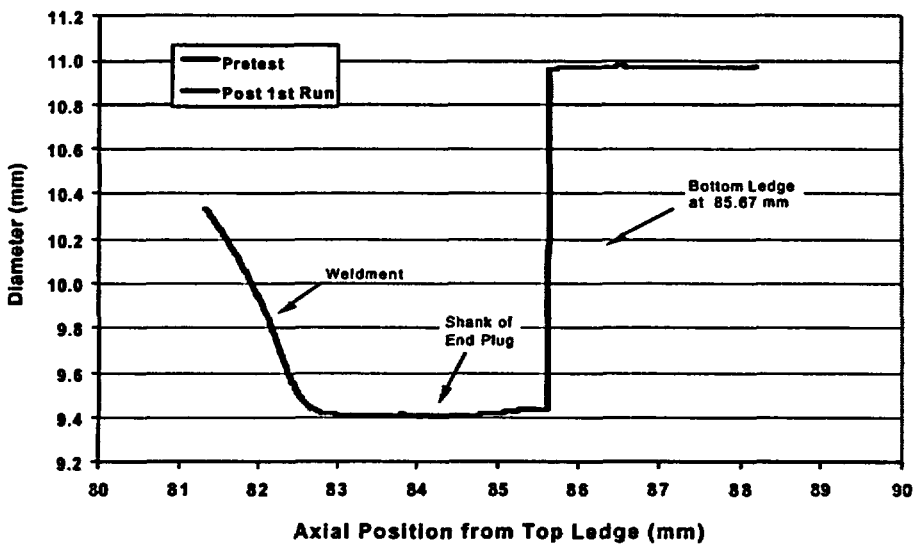
In Figure F.14, the diameter of the lower end plug (Zr-702) was found to be the same before and after the run. Since the end plug was stress-free and not deforming, this result indicated that the purge chamber was effective, and that there was no discernible oxidation of the C8 cladding.

Fig. F.14 Pre- and Post-Run Profiles of the C8 Bottom End Fitting. Overlapping suggests no sample length change.

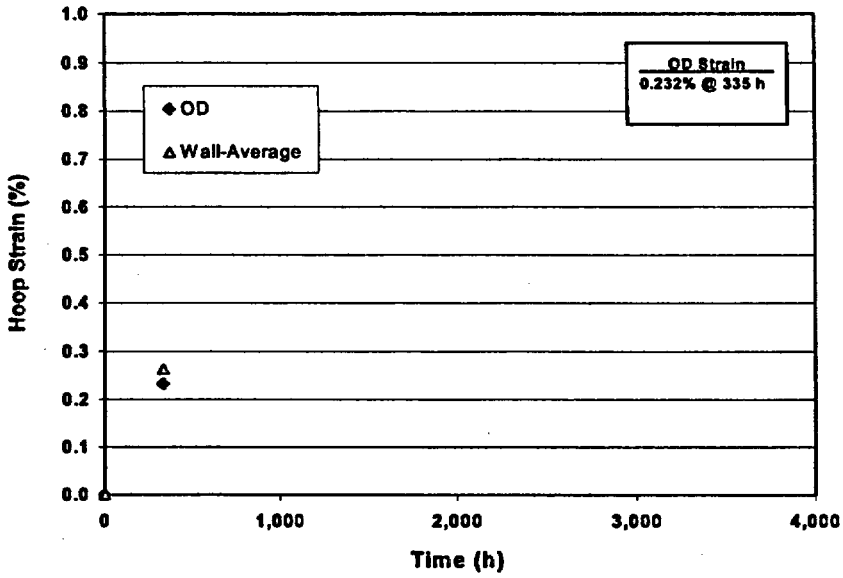
Fig. F.15 Strain vs. Time Plot for the C8 Sample after the First Run Segment. The calculated wall-average hoop strain is 1.13 times that of the OD hoop strain.

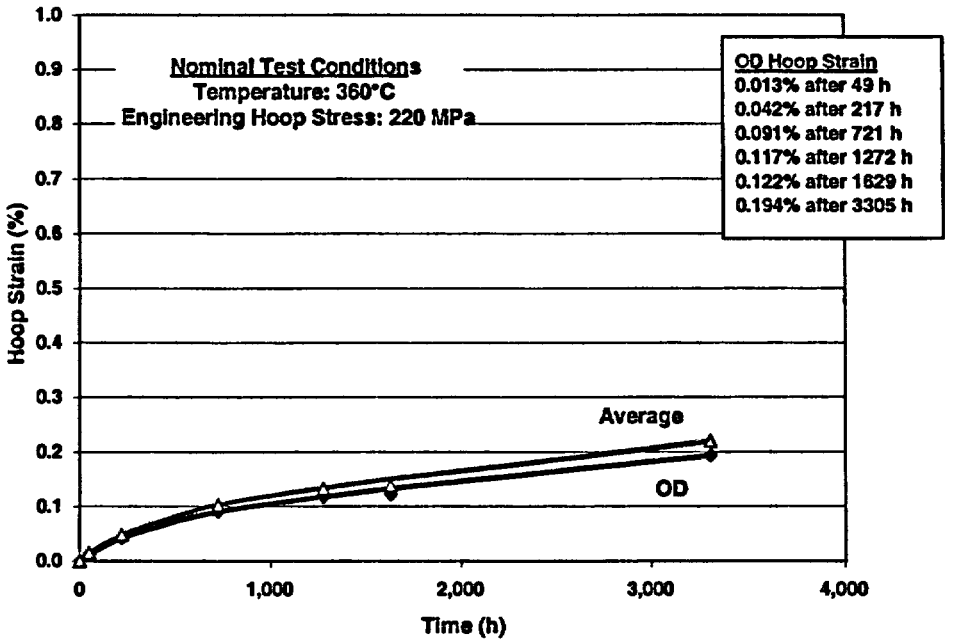
Fig. F.18 Deformation History of Sample C3 Operated Nominally at 220 MPa and 360°C for 3305 h.

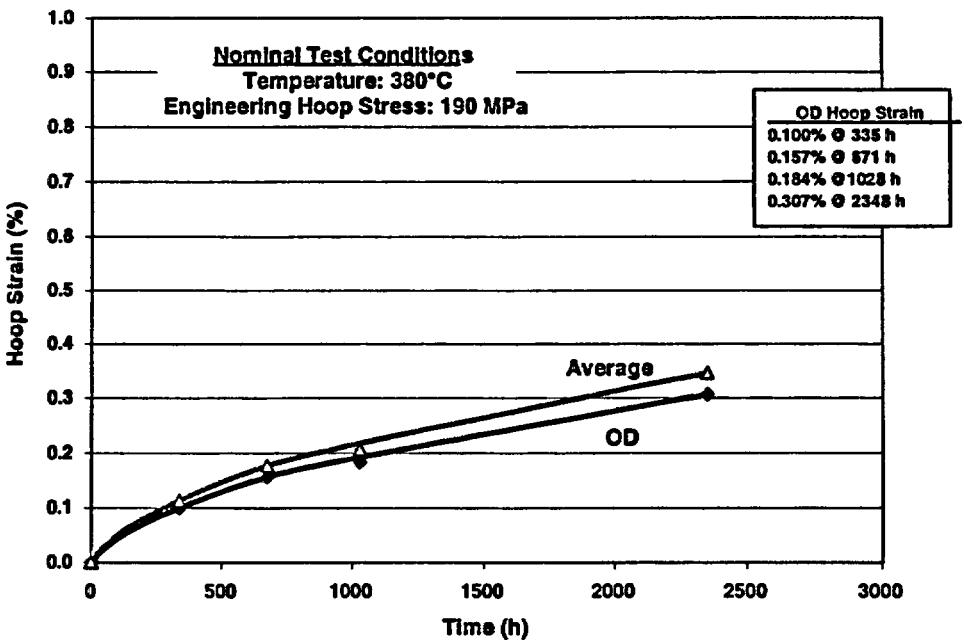
Fig. F.19 Deformation History of Sample C6 Operated Nominally at 190 MPa and 380°C for 2348 h.

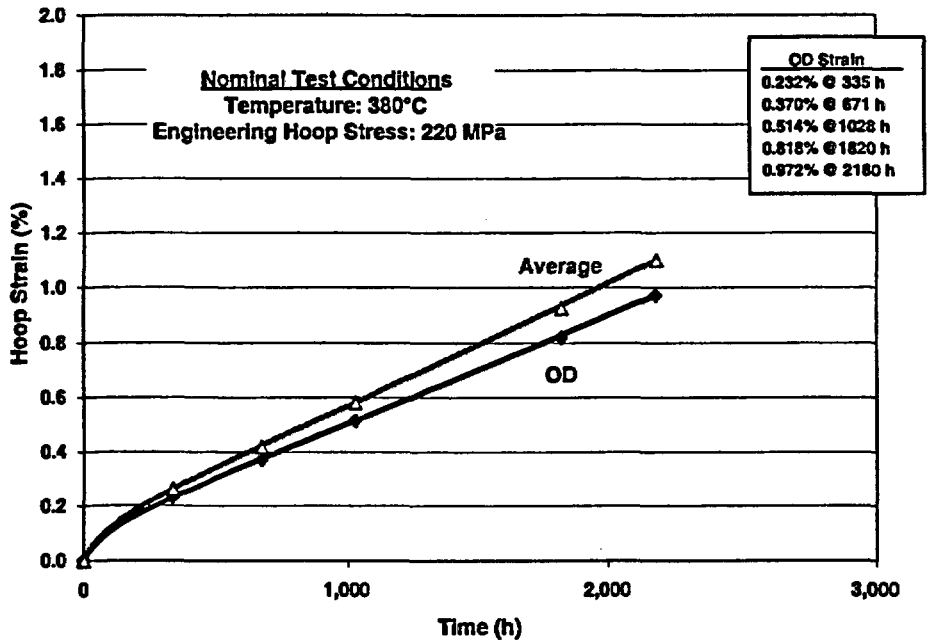
Fig. F.20 Deformation History of Sample C8 Operated Nominally at 220 MPa and 380°C for 2182 h.

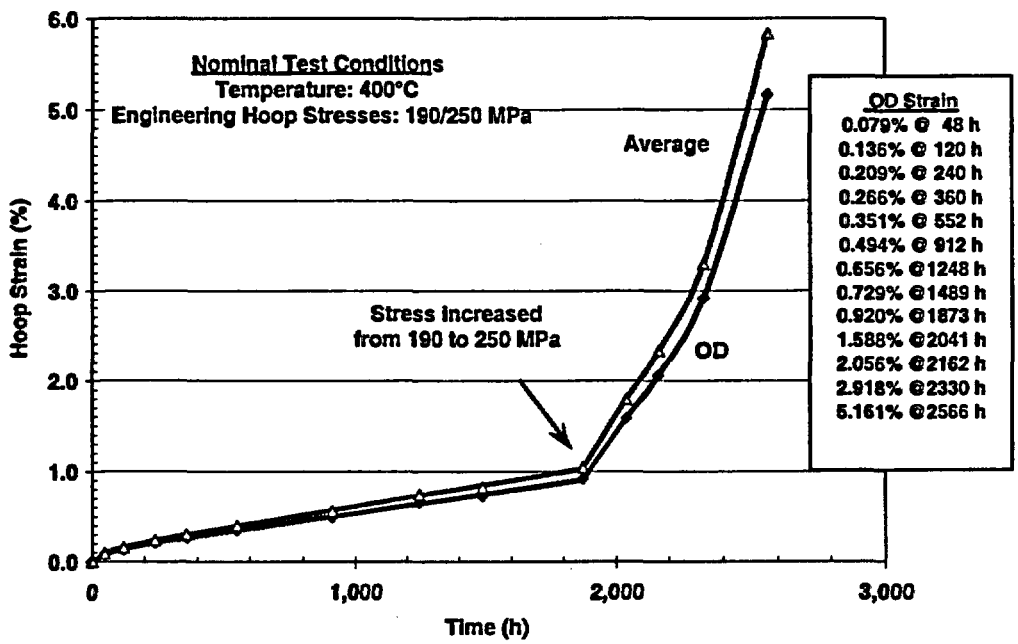
Fig. F.21 Deformation History of Sample C9 Operated Nominally at 190 MPa and 400°C for 1873 h and Subsequently at 250 MPa and 400°C for 693 h.

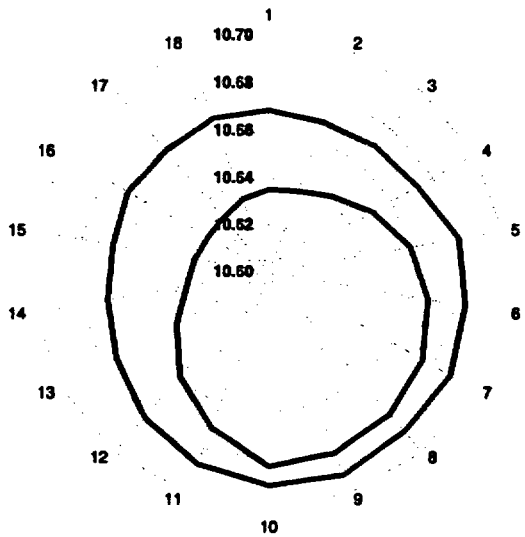
The radial plots of the sample cross section may be useful to detect localized bulging which may indicate non-uniform wall thinning or impending burst rupture. These data were evaluated after every run. All results indicate the deformation to be azimuthally uniform, even for the C9 sample with a wall-average hoop strain of 5.83% at the end of test. Figs. F.22, F.23, F.24, and F.25 show, respectively, the cladding cross-sectional profiles of the C3, C6, C8 and C9 samples (at the axial midplane) before and after the tests.

Fig. F.22 Cross-Section Profiles of the C3 Sample at the Axial Midplane before and after the Test.

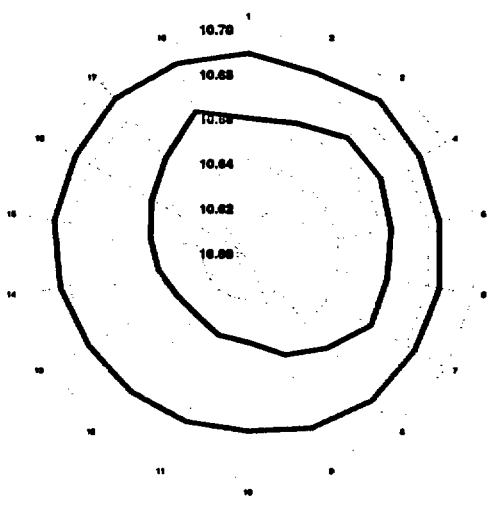
Fig. F.23 Cross-Section Profiles of the C6 Sample at the Axial Midplane before and after the Test.

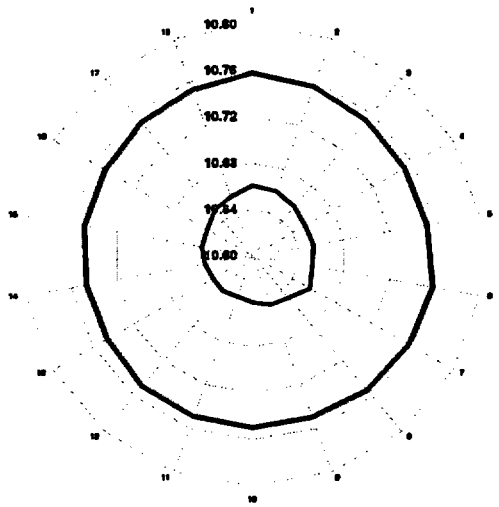
Fig. F.24 Cross-Section Profiles of the C8 Sample at the Axial Midplane before and after the Test.

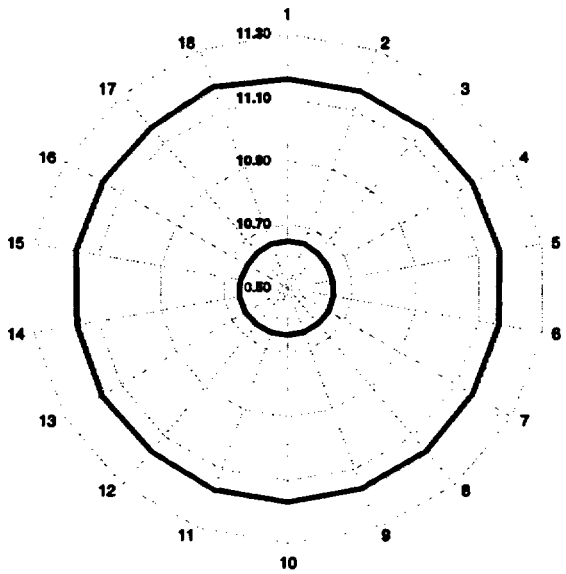
Fig. F.25 Cross-Section Profiles of the C9 Sample at the Axial Midplane before and after the Test.

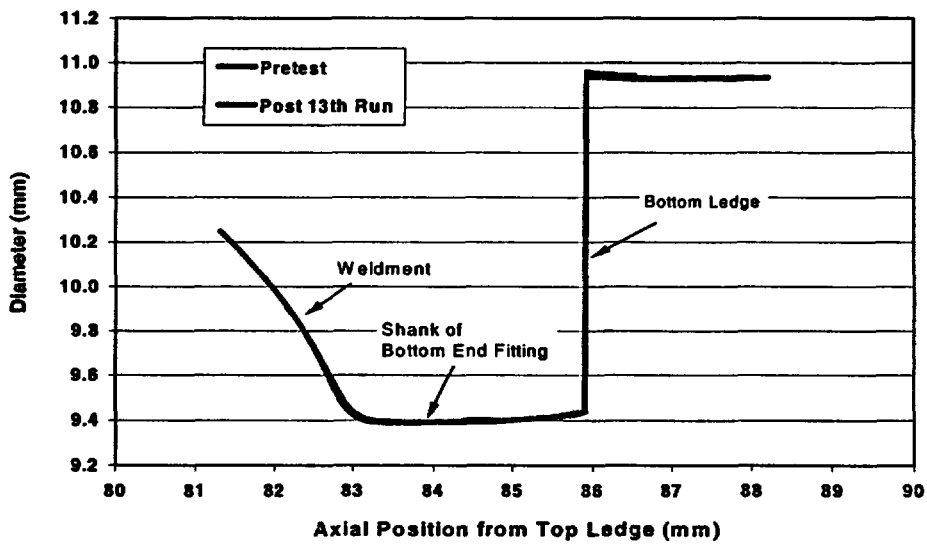
Fig. F.26 Pre- and Post-run Profiles of the Lower End Fitting of the C9 sample (as measured from the top of the sample). Near identical position of curves indicates no change in the sample length.
