TRANSMITTAL OF MEETING HANDOUT MATERIALS FOR IMMEDIATE PLACEMENT IN THE PUBLIC DOMAIN

DATE OF MEETING
10/21/2003

Davis-Besse Nuclear Power Station

Modification of High Pressure Injection Pumps

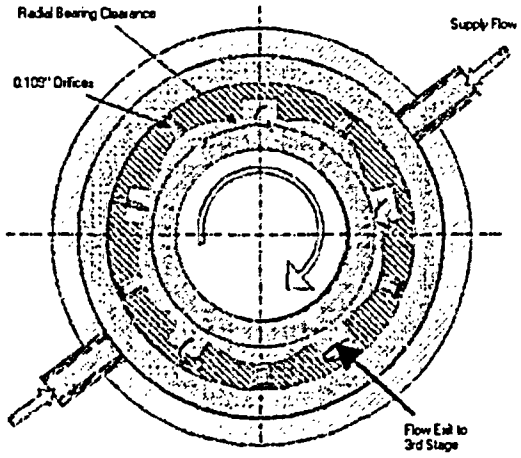
Original Hydrostatic Bearing

- Orifices in supply to hydrostatic bearing pockets are 0.109 inch diameter
- New containment emergency sump strainer has 0.188 inch diameter openings
- Orifices may plug with debris that passed through sump strainer, degrading bearing performance

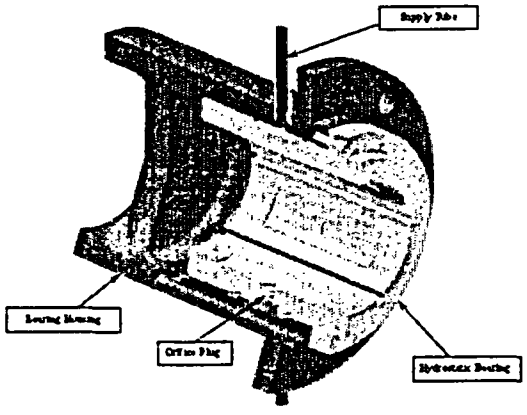
Original Hydrostatic Bearing

- Bearing includes tight clearances (0.006 inch to 0.007 inch) at edges of pockets
- Debris in supply water may be larger than clearance and accumulate in the bearing pocket
- Degradation of bearing performance may impact pump operation

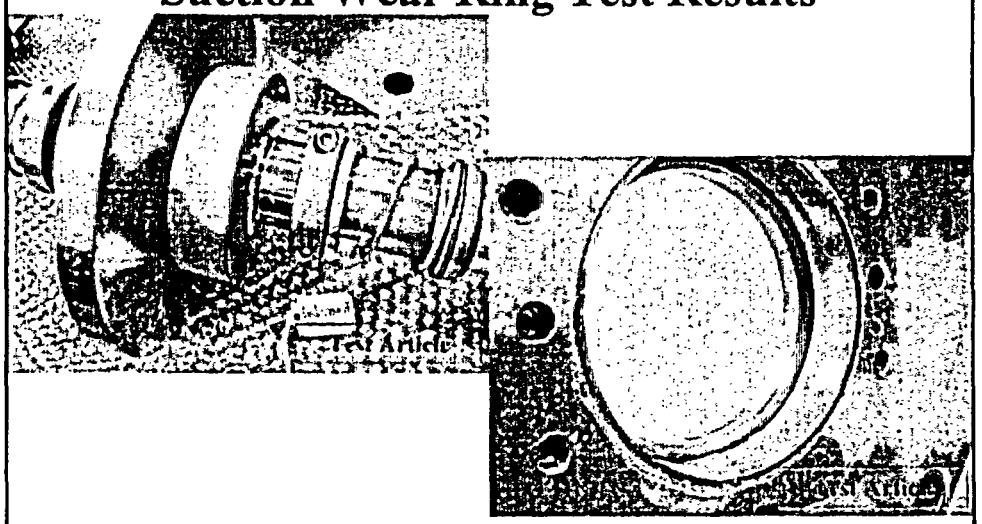
Suction Wear Ring Test Results

- Suction Wear Ring
  - Minimal wear on wear ring and impeller hub
  - Little impact on leakage flow
- Discharge Wear Ring
  - Minimal wear on wear ring
  - Abrasive "grooving" on impeller hub from plugging, small wear elsewhere on hub
  - Essentially no impact on pump performance

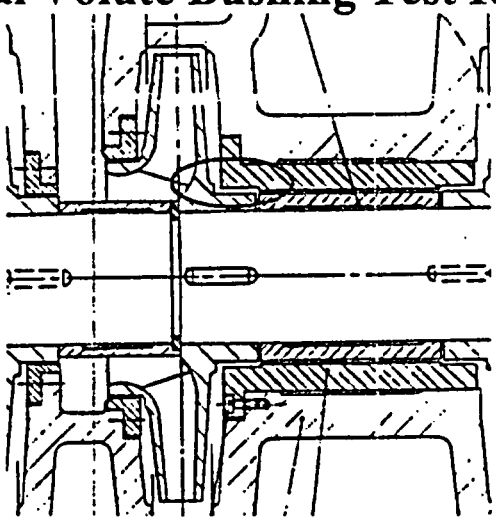
Central Volute Bushing Test Results

- Central Volute Bushing
  - Minimal wear on bushing
  - Abrasive wear on shaft sleeve from plugging
  - Leakage flow depends on plugging and axial extent of abrasive wear
- Hydrostatic Bearing
  - Minimal wear on bearing
  - Abrasive wear on shaft sleeve
  - Bearing flow remained adequate (~ 5% decrease)
- Strainers
  - Essentially constant flow throughout test
