IGSCC of 316NG Stainless Steel Piping in Japan

George Inch

Constellation Generation

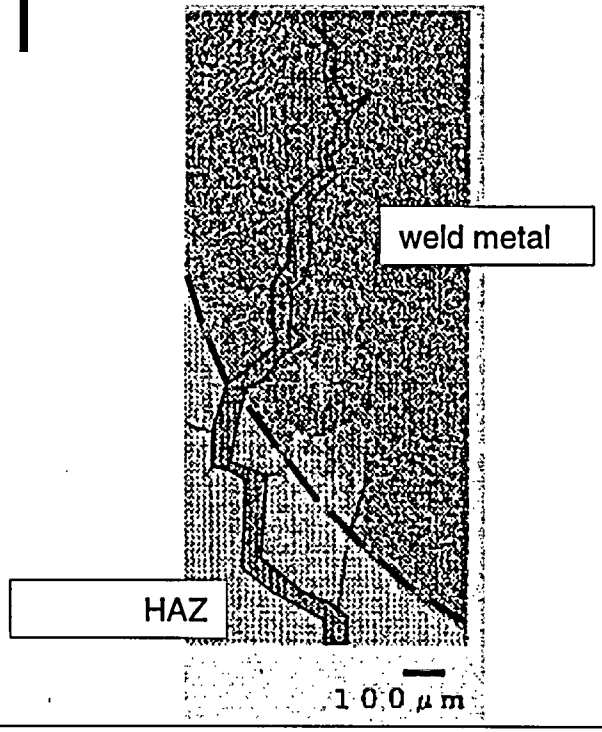
- Transgranular cracking initiated at surface hardening layer and propagated intergranularly
- Circumferential cracks close to the fusion line
- Some cracks propagated into the 316L weld metal

cracking into weld metal

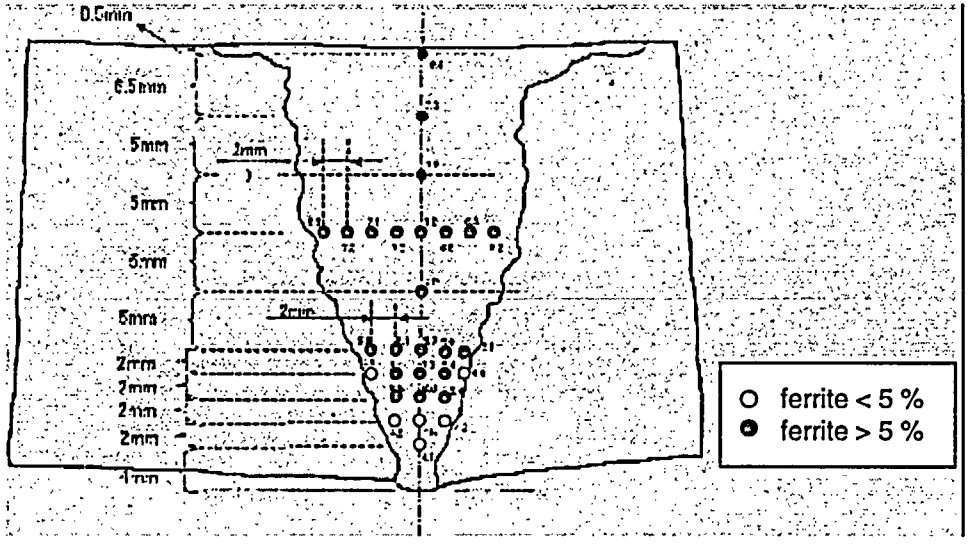
ferrite distribution

- Cracking propagated into weld metal containing ferrite less than 5%
