NUREG/CR-6048
ORNL-TM-12371

Pressurized-Water Reactor Internals Aging Degradation Study

Phase I

Oak Ridge National Laboratory

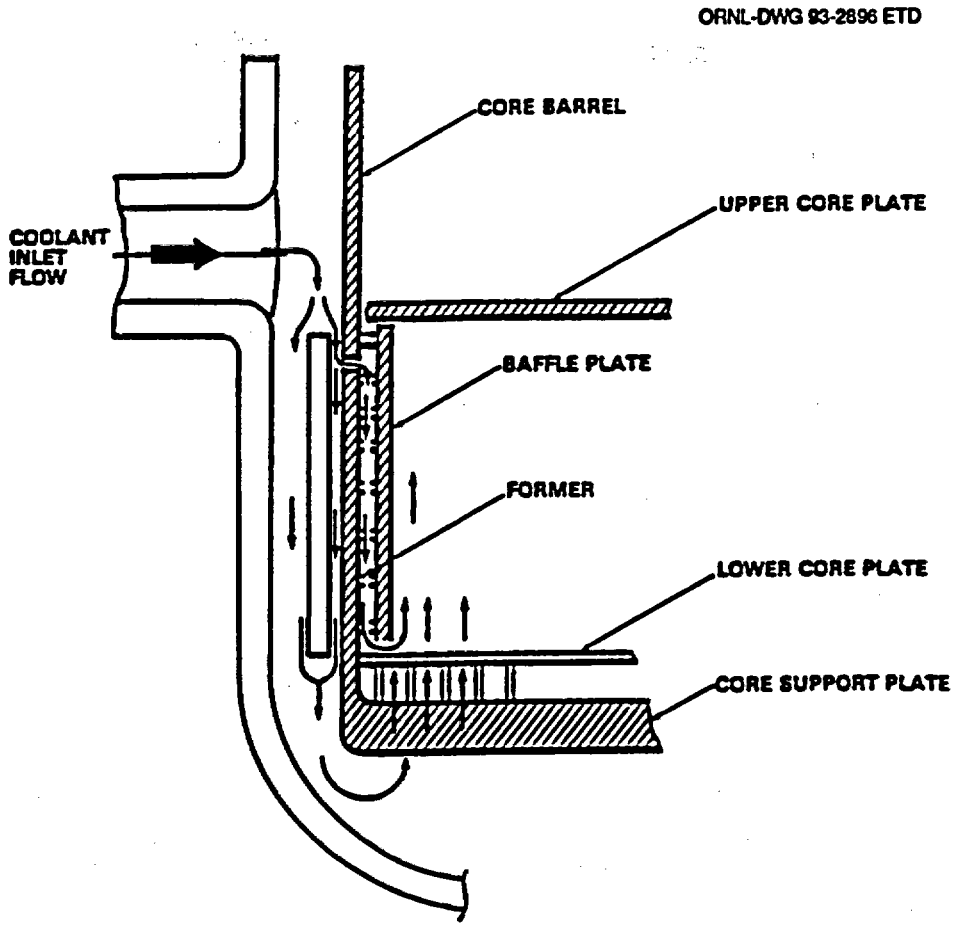
Figure 5.1 Westinghouse PWR downward bypass flow scheme

Fuel rod damage caused by baffle plate water-jetting has been reported in a number of WE reactors.[2,3] The core baffle outlines the boundary of the core. A bypass flow is established in the region between the core baffle and the core barrel, and it is used to provide more effective cooling to the core barrel. In some of the older WE reactors, the bypass flow is introduced into the region between the core baffle and the core barrel by holes located in the upper core barrel. The bypass flow moves in a downward direction through holes in the horizontal former plates, and it is turned around at the bottom of the core barrel and then merged with the main flow going through the core. When the bypass flow is in a downward direction, as illustrated in Fig. 5.1, the bypass flow pressure is higher than that of the main coolant flow in the core. A pressure differential is established between the bypass flow and the core, and it will push the coolant into the core if gaps exist between the vertical baffle plates. The jetlike leakage flow will impinge on fuel rods in the vicinity of the gaps and set the rods into whirling motions and vibrations. Excessive fuel rod motions will eventually lead to cladding degradations and failures.

Several remedies have been tried to reduce the severity of the baffle plate water-jetting impingement problem. One remedy that has been tried is the peening of an entire joint to reduce the gap width between the vertical plates. Subsequent inspections revealed that peening the joints was not effective because damaged fuel rods were found around the peened joint. There was also evidence to suggest that peening a center-injection joint will have the effect of enlarging the gap width in nearby corner-injection joints. A more effective remedy is to replace the fuel rods in the water-jet impingement region with solid stainless steel rods of the same diameter. The insertion of partial grids, which will serve as midspan supports for fuel rods in the impingement region, has also been effective in reducing fuel rod damage. However, uses of solid stainless steel rods and partial grids are not considered as the permanent solution to the baffle plate water-jetting problems. A more effective solution is to reduce or eliminate the driving force behind the water-jetting flow.

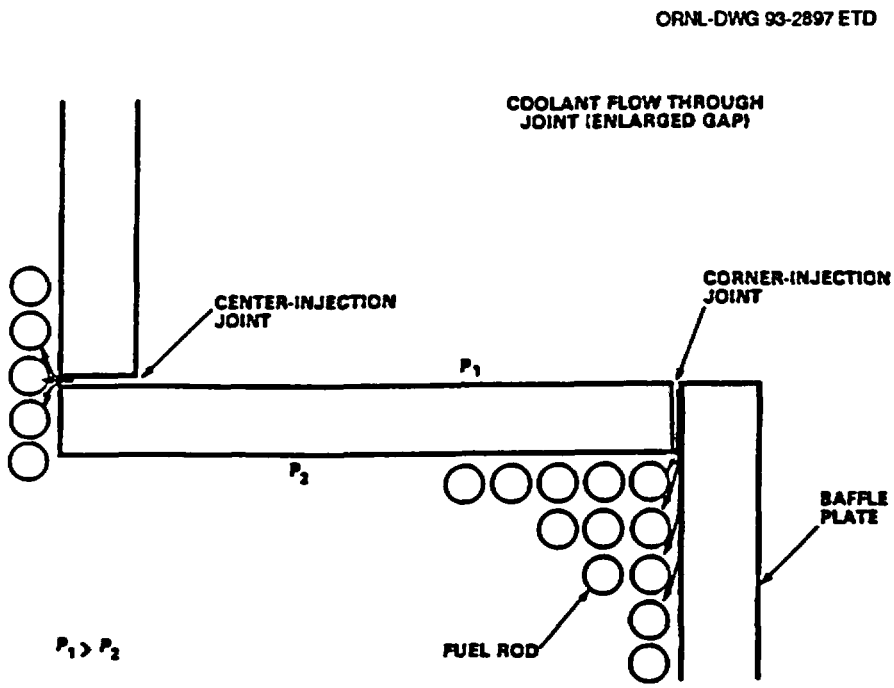
Figure 5.2 Westinghouse PWR baffle water-jet impingement patterns

Two types of baffle plate water-jet impingement patterns have been observed and are illustrated in Fig. 5.2. The jet from a center-injection joint impinges directly on a fuel rod, while that from a corner-injection joint will have a more sideways, impact. They can both set the affected fuel rods into vibrations and whirling motions.

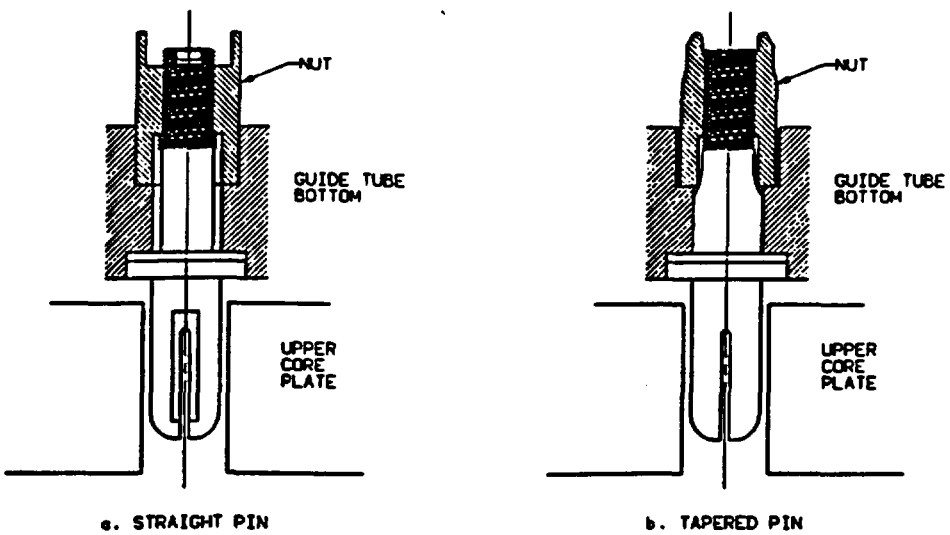
Figure 5.3 Westinghouse PWR guide tube support pins

Crevice conditions are created when the pins are inserted into the upper core plate and the pins are exposed to a locally corrosive fluid medium. Improper heat treatment and overtorquing of the nuts during installation of the pins may have contributed to the development of IGSCC in the bottom region of the shank. As a remedy to the IGSCC problems, WE now recommends a solution heat treatment at a higher temperature, increasing the size of the pins, peening the nuts, and reducing the preloads during installation. The objective is to reduce the susceptibility of the material to the corrosive environment and to reduce tensile stresses that are necessary to the development of IGSCC.

The guide tube split pin IGSCC problems at PWR plants were addressed in a NRC IE Information Notice No. 82-29.[4] Many plants have initiated programs to replace the existing guide tube split pins with pins of the new design.

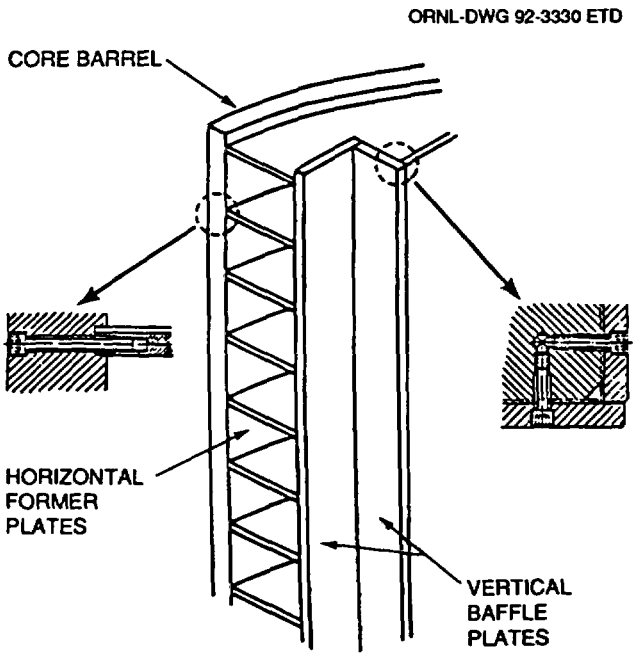
Figure 5.4 KWU-built PWR core baffle and bolting scheme

The core baffle maintains the geometry of the fuel assemblies and controls the coolant flow through the core. It is a bolted structure composed of horizontal former plates and vertical baffle plates. The outer edges of the former plates are bolted to the inside of the core barrel, and vertical baffle plates are bolted to inner edges of the former plates. In reactors built by KWU before 1979, the core baffle bolts were made of a nickel-alloy (Inconel X750). After they were installed, the bolts were secured by tack welds. After 1979, the core baffle is a welded structure in KWU-built units. A simplified view of the core baffle and its bolting scheme are shown in Fig. 5.4.

Routine UT inspections detected signs of cracks in core baffle bolts in five KWU-built PWRs. A typical bolt failure pattern is shown in Fig. 5.5. The problem was first reported in 1987.[5] Failures were attributed to IGSCC. The suspected cause was the sensitization of the nickel-alloy bolts by the welding process, coupled with crevice conditions and high tensile stresses in the bolts.
