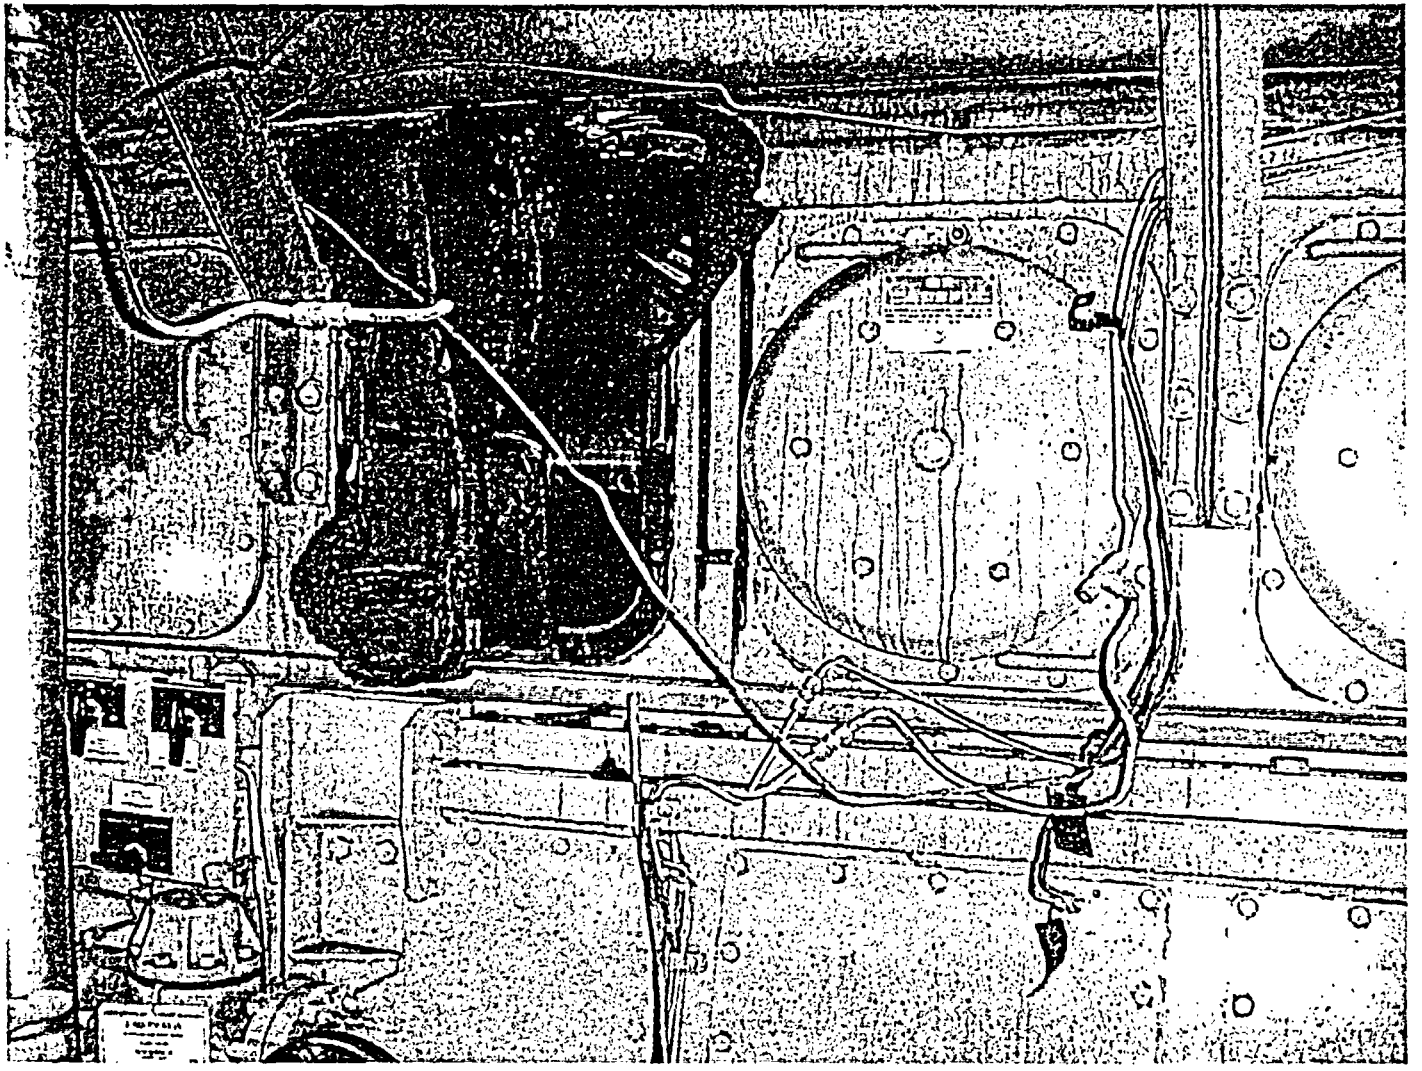
Hole at position 9-Right

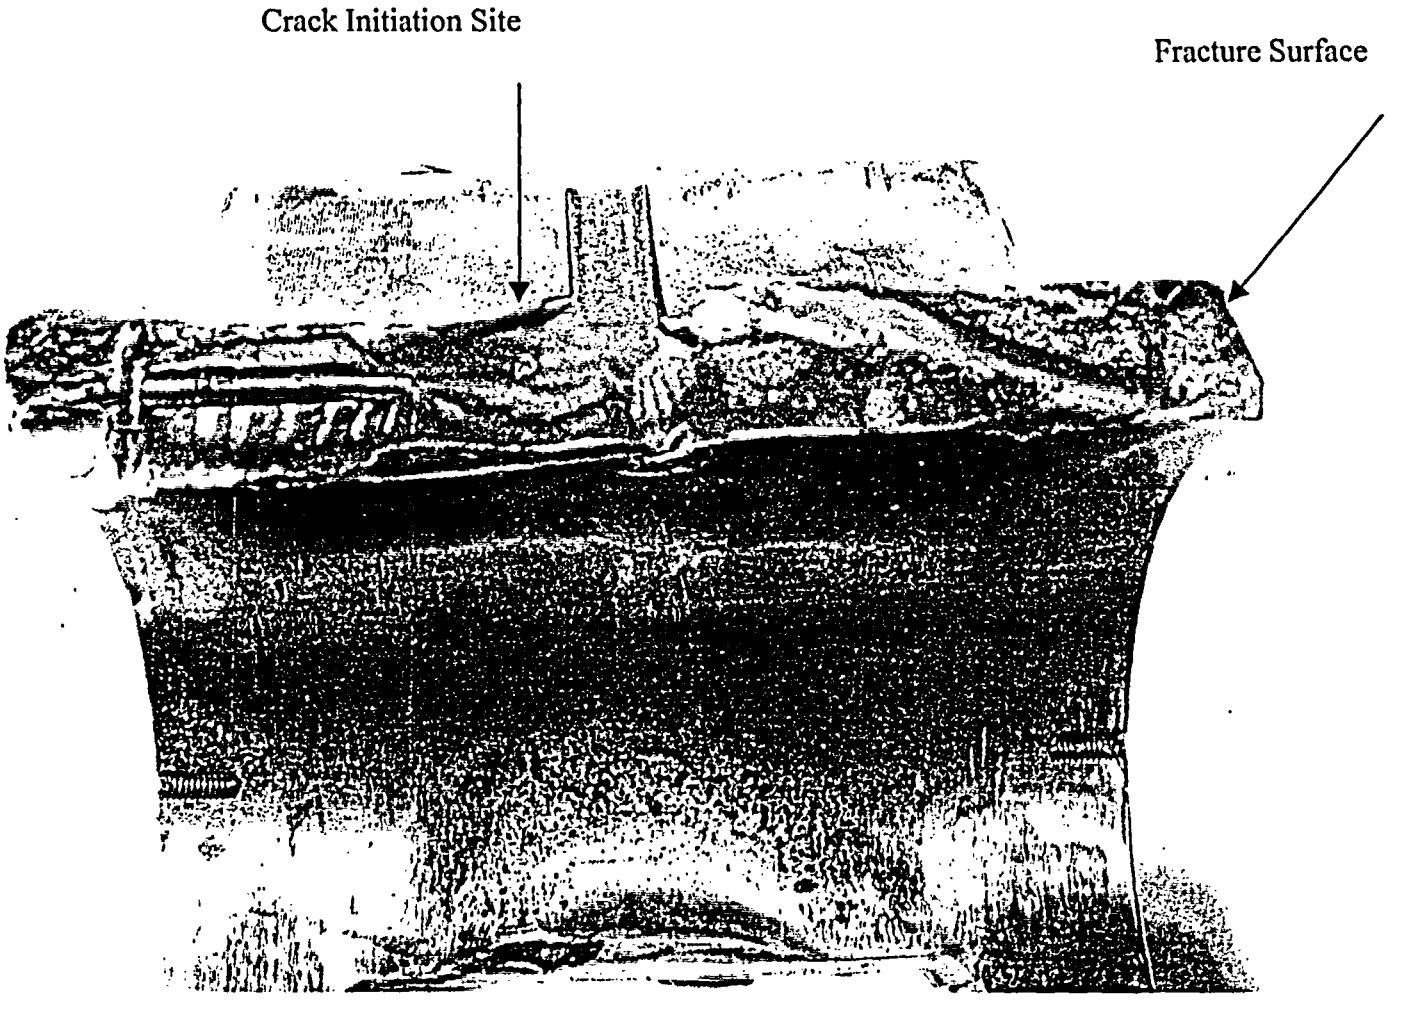
Piece of master rod showing fracture surface

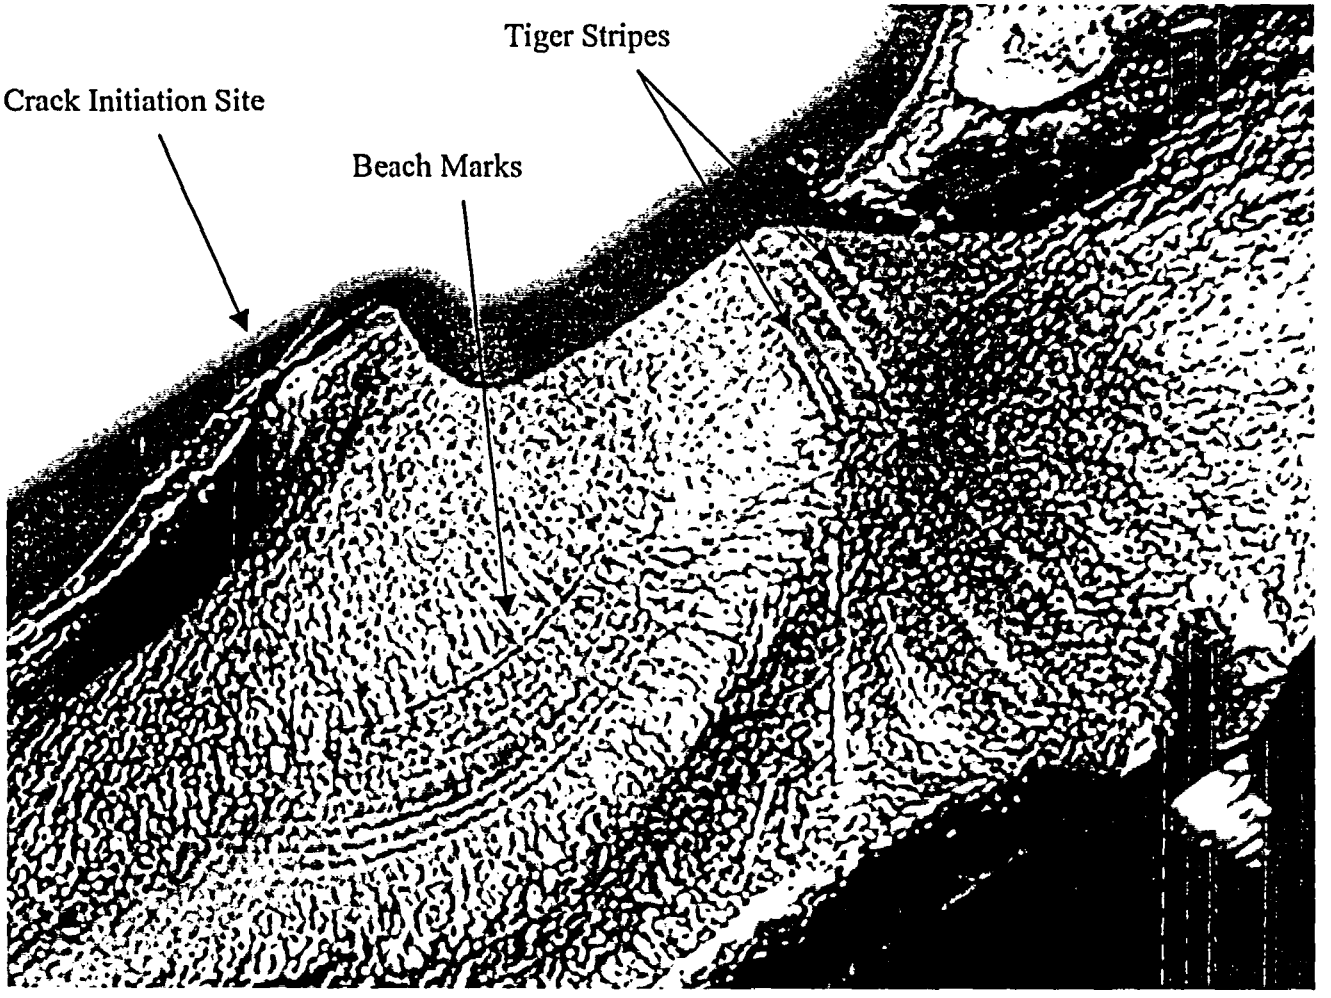
Fracture surface
Showing beach marks and "tiger stripes"

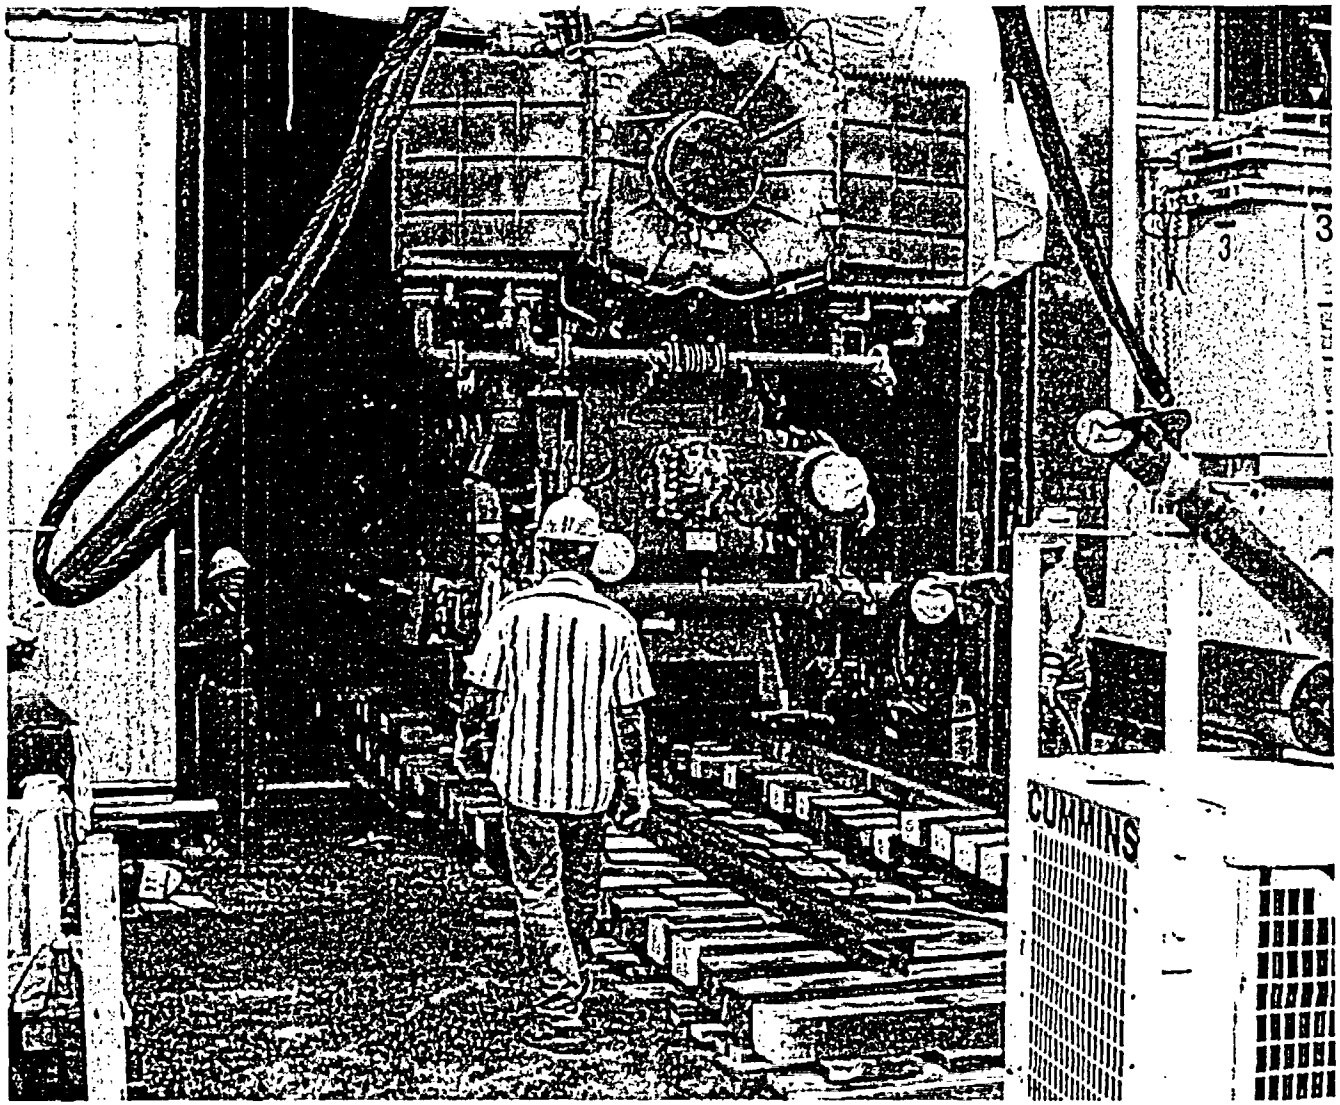
DG 22 Being Removed from its Bay at STP

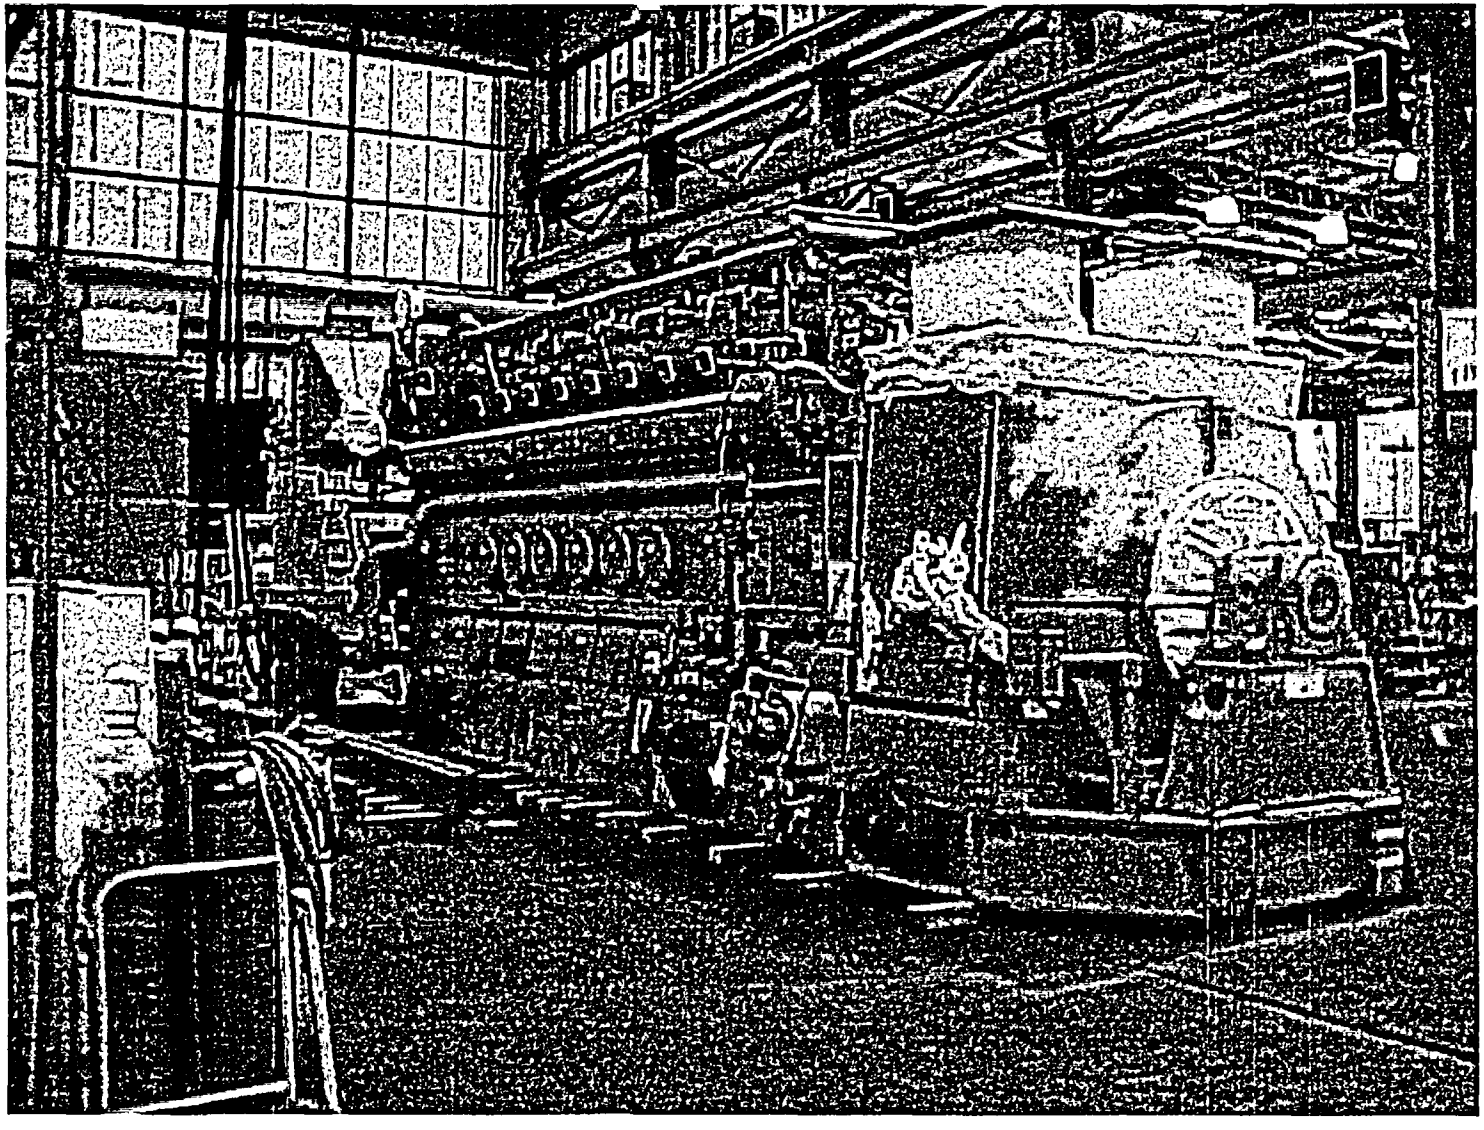
DG22 arrives at EDC and is offloaded to repair shop floor.

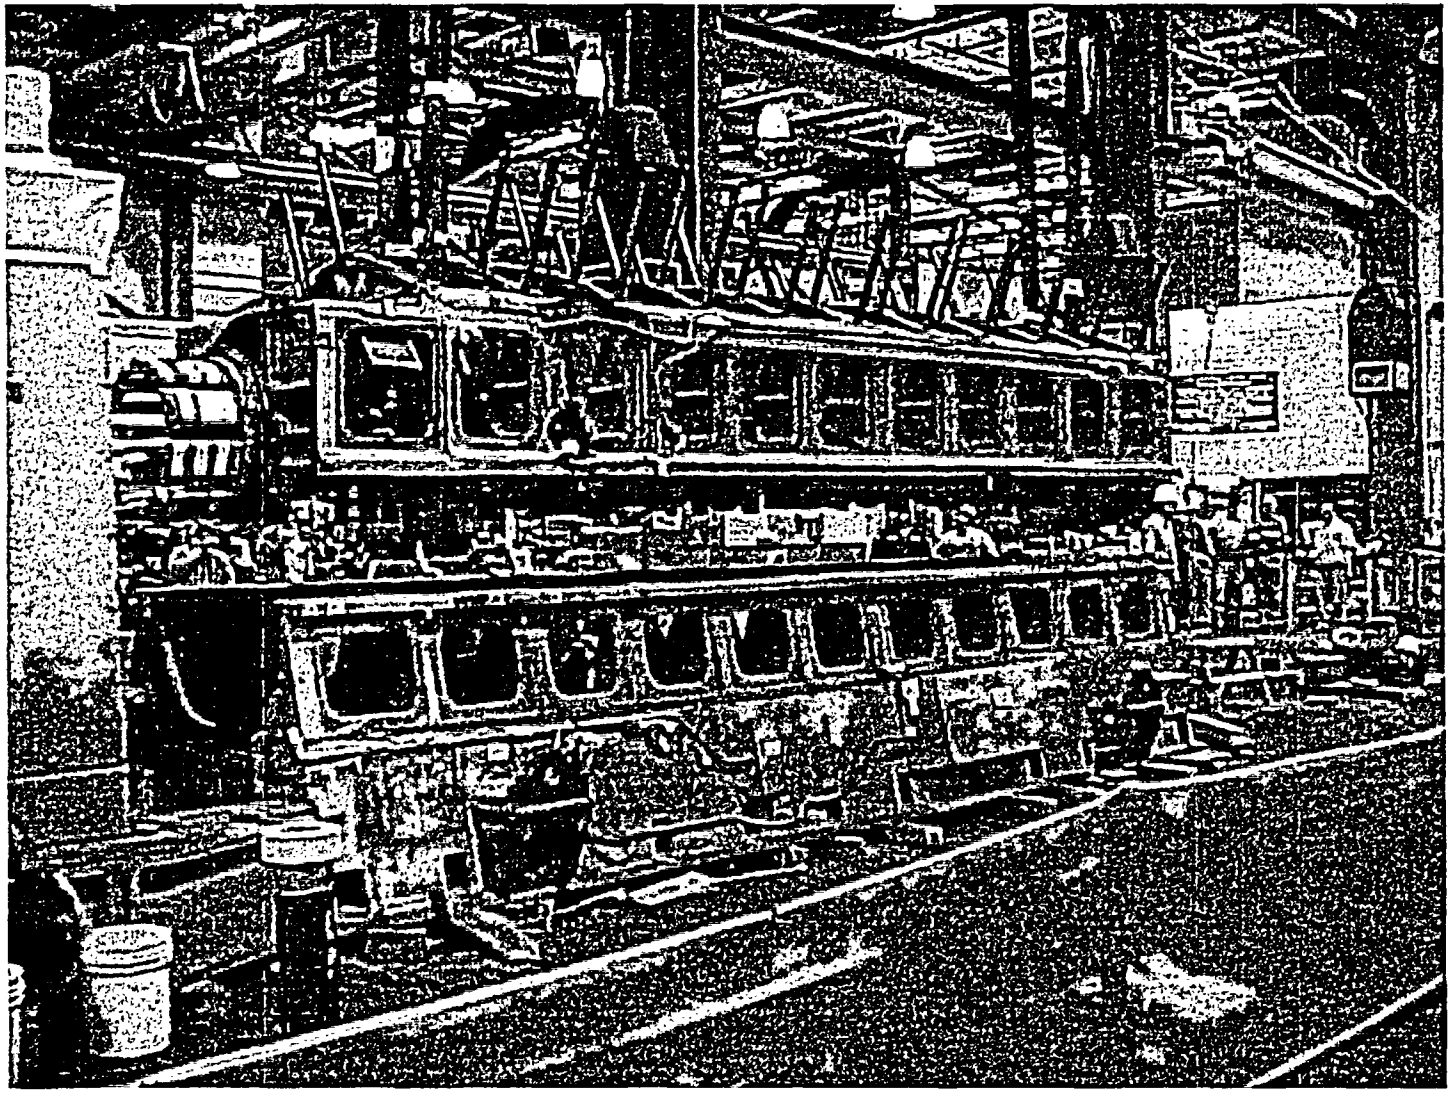
DG22 Disassembly

Centerframe removal from base.
