Re: St. Lucie Unit 1
Docket No. 50-335
Order (EA-03-009) Relaxation Requests 1 and 2
Examination Coverage of Reactor Pressure
Vessel Head Penetration Nozzles – Supplement 2

St. Lucie Unit 1 Relaxation Request No. 2 Revision 1
From NRC First Revised Order EA-03-009

St. Lucie Unit 1

Ultrasonic Test Inspection Data

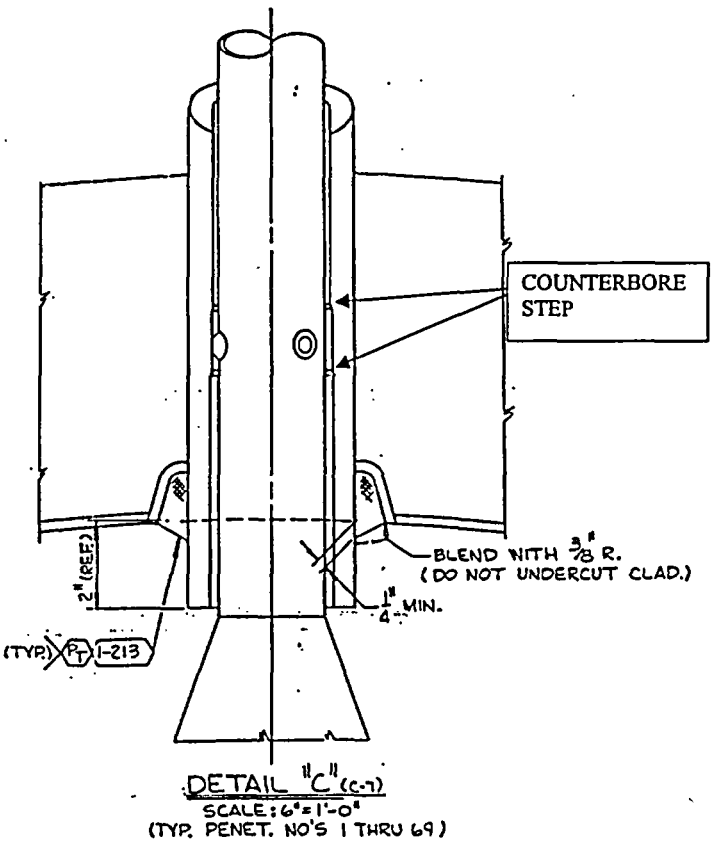
A typical example of the St. Lucie Unit 1 CEDM nozzle, guide sleeve and funnel configuration is shown in Figure 1 for the center nozzle. Figure 1 also shows the counterbore that is limiting UT examination up to 2 inches above the weld root for 17 CEDMs.

Figure 1: St. Lucie Unit 1 CEDM Nozzle Configuration showing the Guide Sleeve and Counterbore.

- The UT blade probe design was used based on its ability to interrogate the nozzle penetration material with the permanently installed guide sleeve and funnel in place. However, as shown in Figure 1, a counterbore reduces the clearance for the blade probe to travel at a distance above the weld. For 17 CEDM nozzles this distance was 1.65 inches to 1.95 inches above the weld root. New probe designs and the ability of the delivery equipment to push the guide sleeve (industry lessons learned) provided significant improvement in data collection over the examination of the RPV nozzle penetrations performed in 2002.[2] These improvements did not allow inspection above the counterbore region.

The proposed alternative is to perform the UT examination to the maximum extent practical, but not less than 1.11 inches above the weld root (on a horizontal plane perpendicular to the nozzle axis) on the uphill side for the 17 CEDMs (nos. 35, 24, 62, 6, 12, 26, 38, 60, 34, 63, 14, 19, 25, 32, 33, 23, and 28) identified in Attachment 2. In all cases, the examination area will include all nozzle material with operating stress levels of 20 ksi or greater.

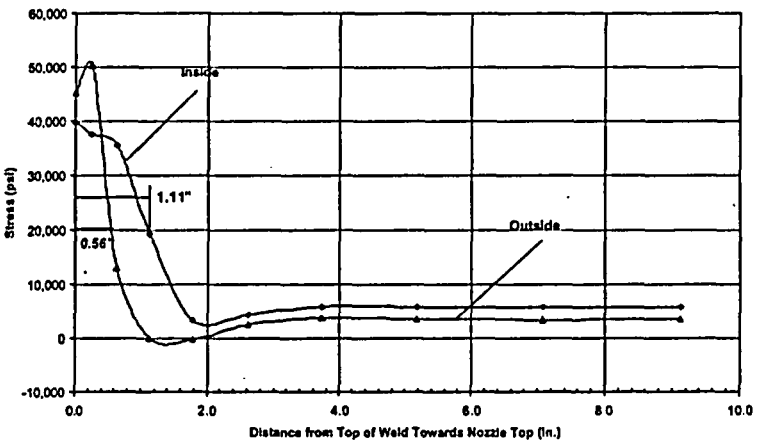
The plots of stress versus distance above the weld root are provided in Attachment 3. The uphill plots of stress levels versus distance are limiting for all locations, except the zero degree nozzle. For the zero degree nozzle, the uphill and downhill stress levels are identical. These plots show that the stress levels in the actual area of missing UT coverage (≥ 1.65 inches above the weld) on the uphill side are well below 20 ksi. Therefore, it is unlikely that a flaw would initiate in this low stress area. Any flaw in this area would have propagated from the higher stressed area below, which is within the examination boundary. Finally, a review of prior plant inspection data from a large cross-section of US pressurized water reactors, documented in MRP-95[4] (Figure 5-1 of MRP-95), revealed that of the 237 flaw indications reported, all flaws would have been detected had the inspections been limited to the 1.11 inches proposed examination zones.

Hoop Stress in 0° CEDM Nozzle vs. Distance from Top of Weld, Uphill and Downhill

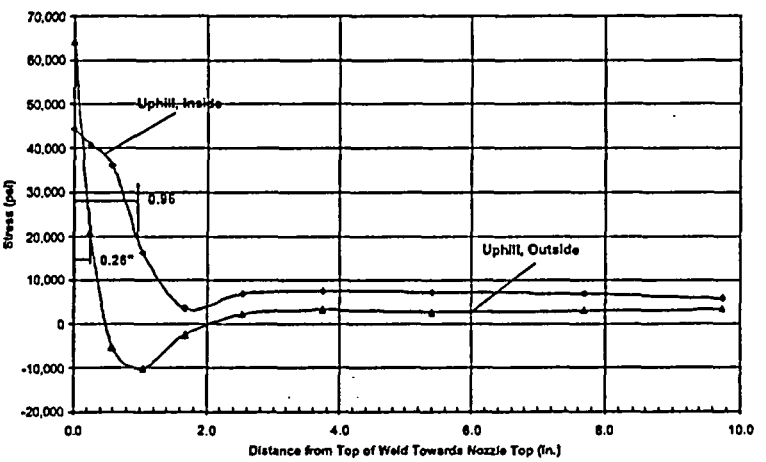
1. The operational stress levels on the inside diameter of the penetration drop below 20 ksi at approximately 1.11 inches above the weld root on the uphill side for all penetrations modeled (0° through 42.5°).

Hoop Stress in 29.1° CEDM Nozzle vs. Distance from Top of Weld, Uphill

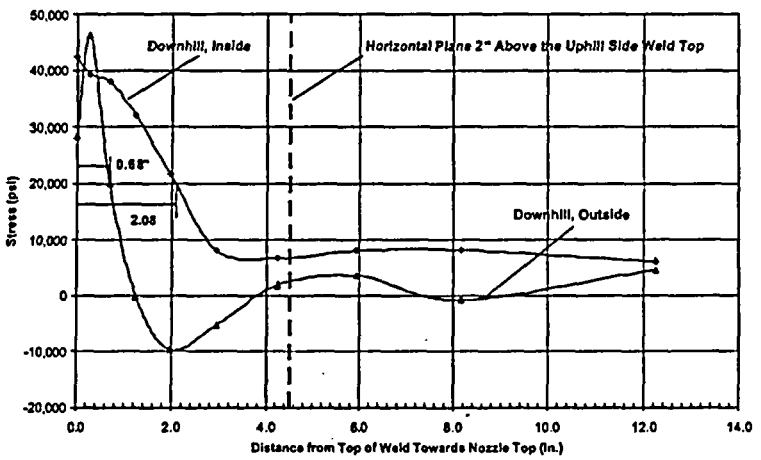
Hoop Stress in 29.1° CEDM Nozzle vs. Distance from Top of Weld, Downhill

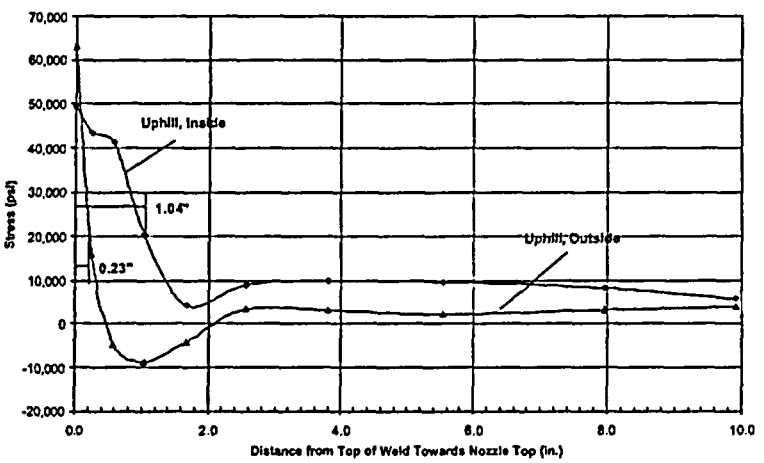
Hoop Stress in 37.1° CEDM Nozzle vs. Distance from Top of Weld, Uphill

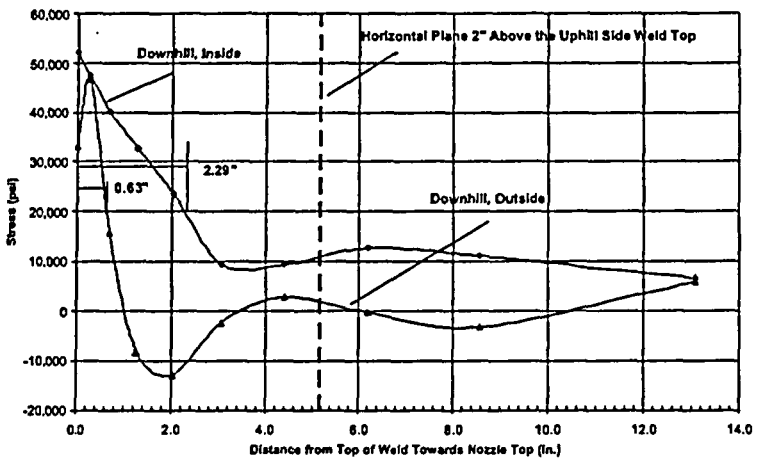
Hoop Stress in 37.1° CEDM Nozzle vs. Distance from Top of Weld, Downhill

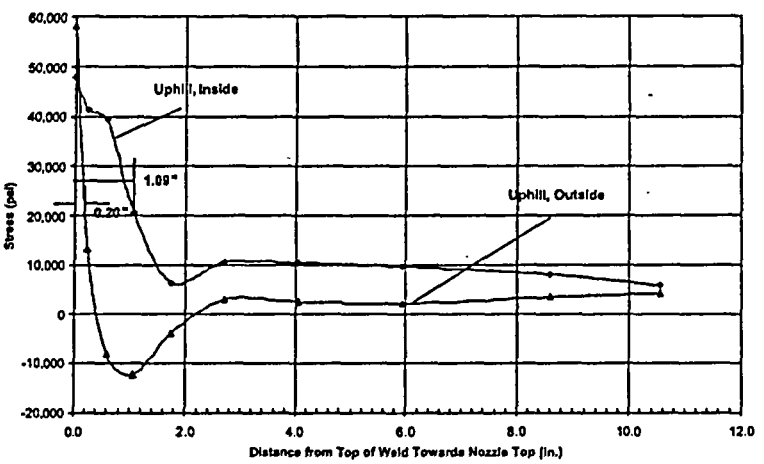
Hoop Stress in 42.5° CEDM Nozzle vs. Distance from Top of Weld, Uphill

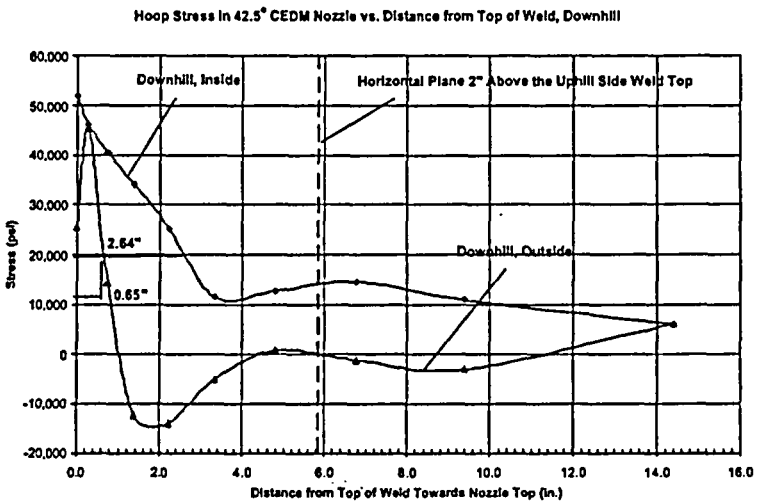
Hoop Stress in 42.5° CEDM Nozzle vs. Distance from Top of Weld, Downhill
Downhill, Inside
Horizontal Plane 2" Above the Uphill Side Weld Top
Downhill, Outside
2.64"
0.65"
Stress (psi)
60,000
50,000
40,000
30,000
20,000
10,000
0
-10,000
-20,000
0.0
2.0
4.0
6.0
8.0
10.0
12.0
14.0
16.0
Distance from Top of Weld Towards Nozzle Top (in.)
