SUBJECT: Calvert Cliffs Nuclear Power Plant
Unit No. 1; Docket No. 50-317
Supplemental Data for Request for Relaxation from Interim Inspection Requirements for Reactor Pressure Vessel Head (TAC No. MC1921)

RESPONSE TO REQUESTS FOR ADDITIONAL INFORMATION

REACTOR PRESSURE VESSEL HEAD UT EXAMINATION RESULTS

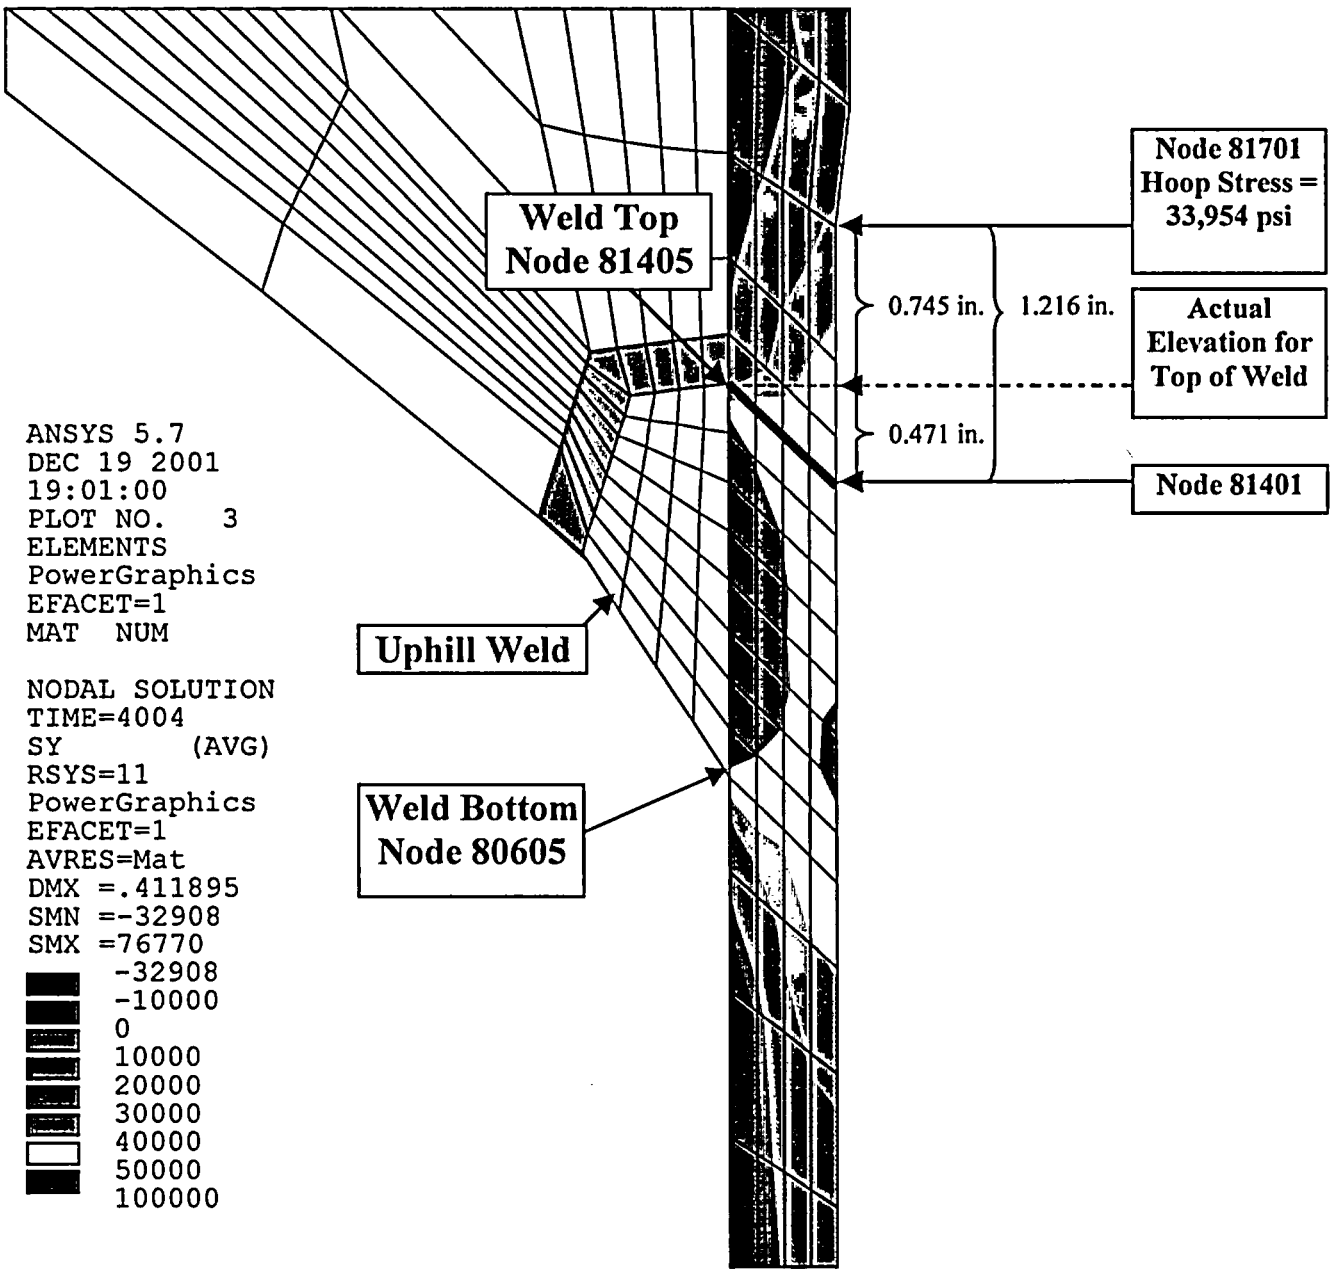
Figure 1: Illustration of Stress Analysis Mesh Indexed to Node 81401

nodes at the nozzle outside diameter (OD)/weld interface. The bottom of the weld is the lowest node along this interface and the top of the weld is the highest node along this interface. Please refer to Figure 1 where the top and the bottom of the weld for the uphill weld are identified for the 43degree angle model.

The discrepancy in stress values between the 2003 relaxation request and the 2004 relaxation request is due to a conservative simplification of the model geometry used in 2003 to calculate stresses above the top of the weld at the uphill side. Figure 1 is a plot of the operating hoop stresses at the uphill side of the 43 degree nozzle. The nodes at the top and bottom of the weld are identified, as are nodes of interest on the inside diameter (ID) side of the nozzle.

As shown in the table, nodes 81405 (on the OD) and 81401 (on the ID) were both assumed to be at the same absolute elevation (shown in bold). In fact, node 81405 is at the elevation of the weld root, but node 81401 is below the elevation of the weld root as shown in Figure 1 (by the bold line). In 2003 we reported the stresses on the nozzle ID surface at various distances with respect to 81401 instead of with respect to 81405. The assumption that 81401 and 81405 were at the same elevation simplified the determination of stresses, but provided values that were conservatively high.

The stress at node 81701, which is 1.216 inches above node 81401, is 33,954 psi. The stress at this node in 2004 is that same as it was in 2003. As shown in Figure 1, this stress value agrees with the stress contours of the hoop stress plot.

In 2004, it was decided to report ID stresses in reference to the location of the top of the weld. As shown in Figure 1, node 81701 is actually only 0.745 inches above the top of the J-groove weld.

2003 Determination that Stress equals 33,954 psi 1.216 inches above the J-groove Weld Root (at Node 81701) is Referenced to Node 81401 Elevation

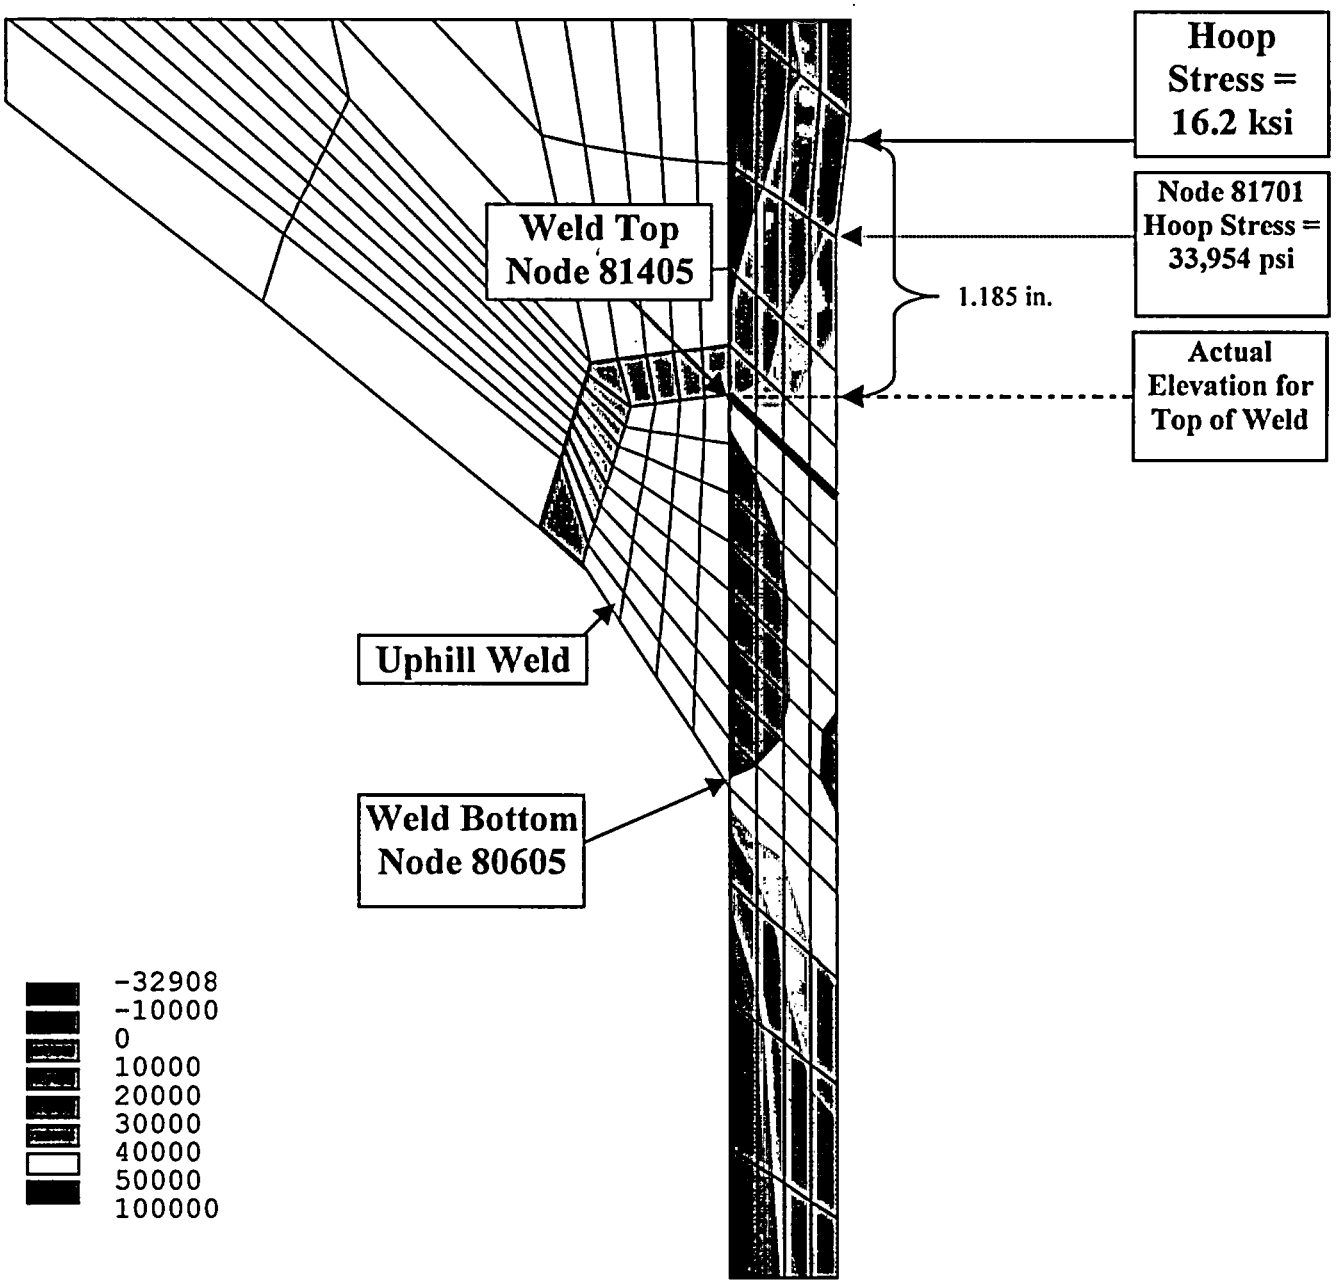
Figure 2: Illustration of Stress Analysis Mesh Indexed to the Root of the J-groove Weld

The actual nozzle ID stress at an elevation of 1.185 inches above the top of the weld for the 43 degree nozzle is 16.2 ksi. As shown in Figure 2, this stress value agrees with the stress contours of the hoop stress plot.

In conclusion, the differences between the stress values reported in the 2003 and 2004 relaxation requests was due to the different ways the ID nodes were indexed to the J-groove weld root elevation. In 2003 the stresses were conservatively indexed to the ID node along the same mesh line that intersected the weld root. In 2004 the stresses were indexed to the actual weld root elevation.

2004 Determination that Stress equals 16.2 ksi 1.185 Inches above the J-groove Weld Root is Referenced to Node 81405 Elevation (Actual Weld Root)
