Molycorp

Supplemental Site Characterization Report for the Washington, Pennsylvania Site

April 2004
4812001

Supplemental Site Characterization Report

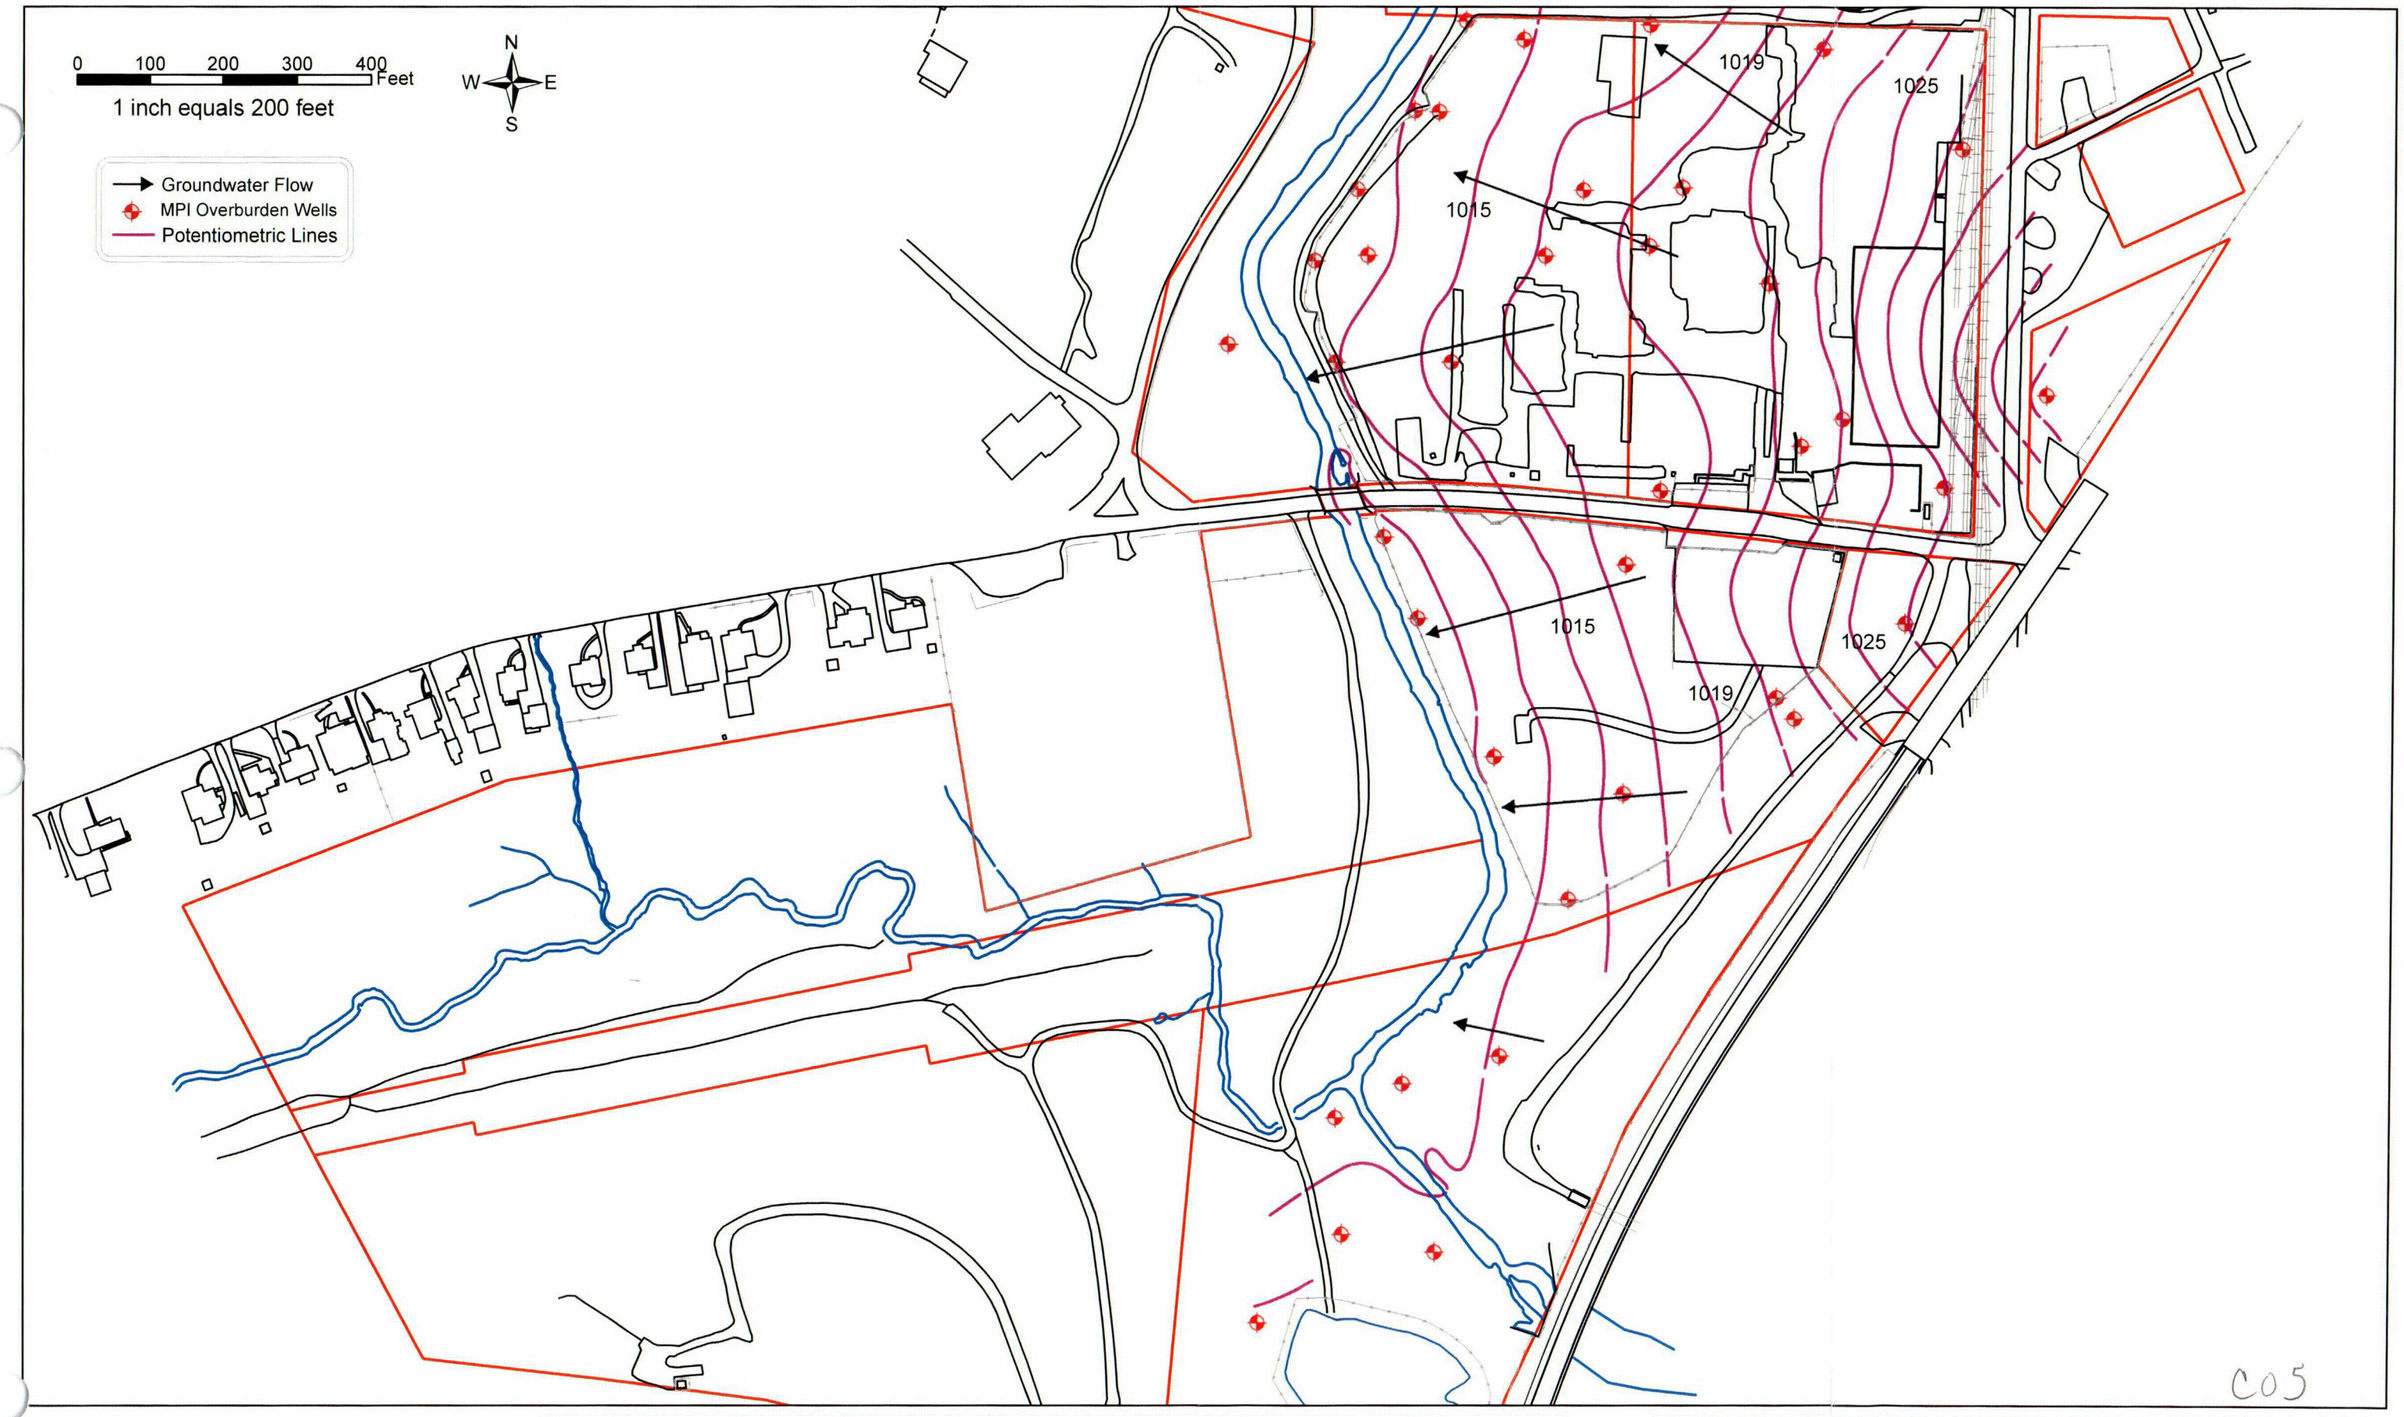
Figure 6
Site Potentiometric Map
Overburden Wells, December 2003

Groundwater in the overburden wells was observed to occur at an elevation ranging from 1038.03 to 1012.16 feet AMSL on December 3, 2003, immediately prior to beginning groundwater sampling activities (Figure 6). Groundwater in the Bedrock Wells BR-1 through BR-8 was observed to range from 1037.81 to 1010.77 feet AMSL. In both cases the horizontal groundwater flow direction primarily is toward Chartiers Creek with an approximate hydraulic gradient ranging from 0.022 to 0.048 in the overburden wells. In addition, based on the groundwater elevation data, it appears that there is an upward vertical gradient in the bedrock monitoring wells located adjacent to Chartiers Creek, indicating that Chartiers Creek acts as a hydrological divide of the overburden and uppermost bedrock aquifers. As a result, groundwater in the vicinity of the site will discharge to Chartiers Creek.
