H. B. ROBINSON STEAM ELECTRIC PLANT, UNIT NO. 2
DOCKET NO. 50-261/LICENSE NO. DPR-23

RESULTS OF INSPECTIONS CONDUCTED IN ACCORDANCE WITH THE FIRST REVISED ORDER ESTABLISHING INTERIM INSPECTION REQUIREMENTS FOR REACTOR PRESSURE VESSEL HEADS AT PRESSURIZED WATER REACTORS

WESTINGHOUSE REACTOR VESSEL HEAD PENETRATION EXAMINATION FINAL REPORT

H.B. Robinson Unit 2–RO22 Reactor Vessel Head Penetration Examination

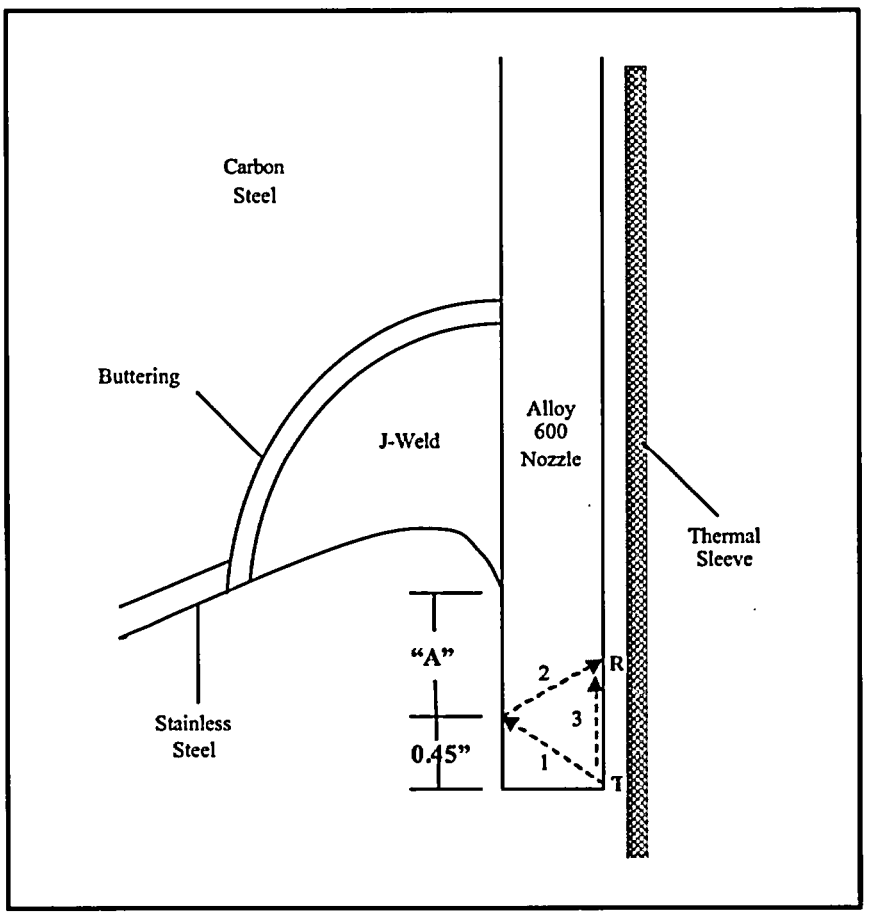
Figure 4-1: Illustration of Axially Oriented TOFD Examination Coverage on H.B. Robinson Penetration Geometry at 0° (Downhill Side)

The typical configuration of a sleeved H.B. Robinson Unit 2 CRDM penetration tube is illustrated in Figure 4-1. This figure represents the tube-to-head geometry at the penetration 0° azimuth, or "downhill" side of the tube. The tubes are 0.625" thick and have a 0.188" radius machined at the bottom. The distance from the bottom of the tube to the elevation where the fillet of the J-groove weld intersects the tube (identified as the sum of distances "A" and "0.45" in Figure 1) varies based on location of the penetration in the head. These distances are typically longer for penetrations at "inboard" locations and become progressively shorter for penetrations located further away from the center of the head. The examination methodology selected for each penetration in order to meet the revised NRC Order was dependent upon the penetration tube configuration and penetration-specific geometric conditions, as described in Sections 4.2, 4.3 and 4.4. A penetration-specific summary is provided in Appendix B.

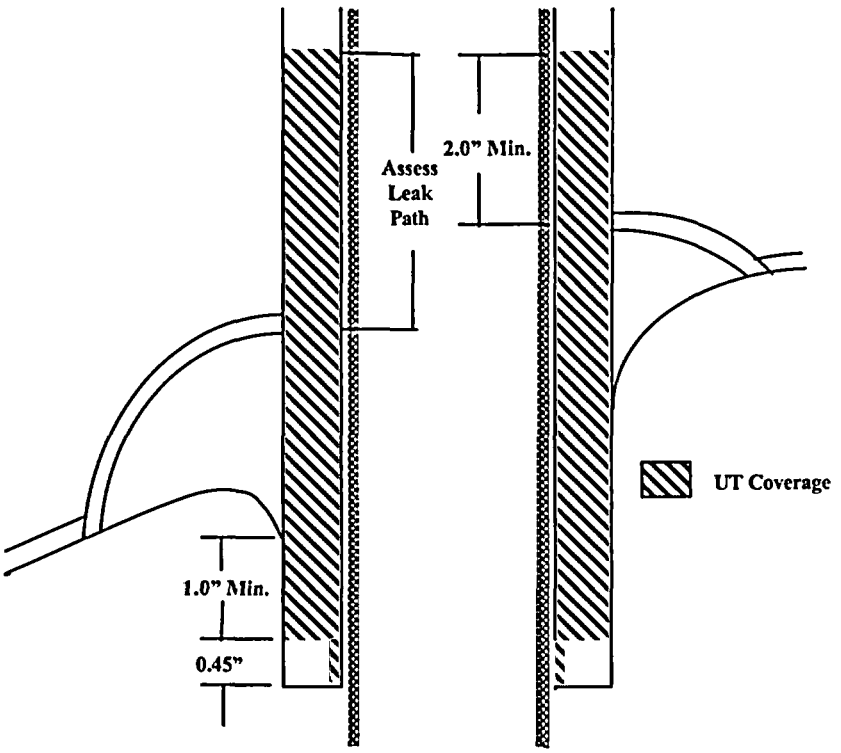
Figure 4-2: UT Coverage in Accordance With Section IV.C (5) (b) (i) of the Revised NRC Order

For OD examinations of fifty-two penetration tubes performed with the Open Housing Scanner and Trinity blade probes, the TOFD PCS24 transducer coverage extended from 0.45" above the bottom of each tube to elevations at least 2.0" above the welds. The extent of coverage was verified for each examination of each penetration by confirmation that 1) TOFD tube entry signals were evident ultrasonic data and 2) scan coverage elevations were in excess of 2.0" above the uppermost elevation of each weld. TOFD UT coverage obtained for forty-four of the fifty-two tubes included at least 2.0" above the uppermost elevation of the welds and 1.0" below the lowest elevation of the J-groove welds. This coverage is illustrated in Figure 4-2.

At eight penetration locations it was not possible to achieve 1.0" of TOFD coverage on the penetration tube OD surface below the lowest point of the weld. Supplementary eddy current examinations were performed on the tube OD surface at these eight locations to achieve the required 1.0" of coverage below the welds as described in Section 4.4.

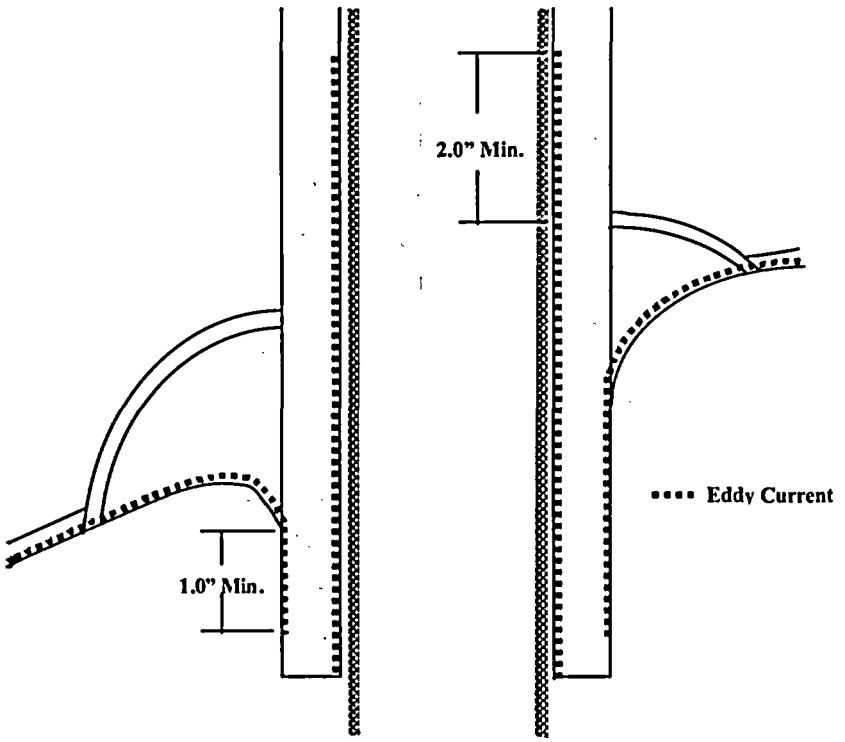
Figure 4-3: Wetted Surface Examination Coverage in Accordance With Section IV.C (5) (b) (ii) of the Revised NRC Order

Eddy current examinations were also conducted on the J-groove weld surfaces to a distance of 0.25" past the welds and on the OD surfaces of the penetration tubes using the Grooveman end effector.

Coverage provided by the eddy current examination program is illustrated in Figure 4-3.

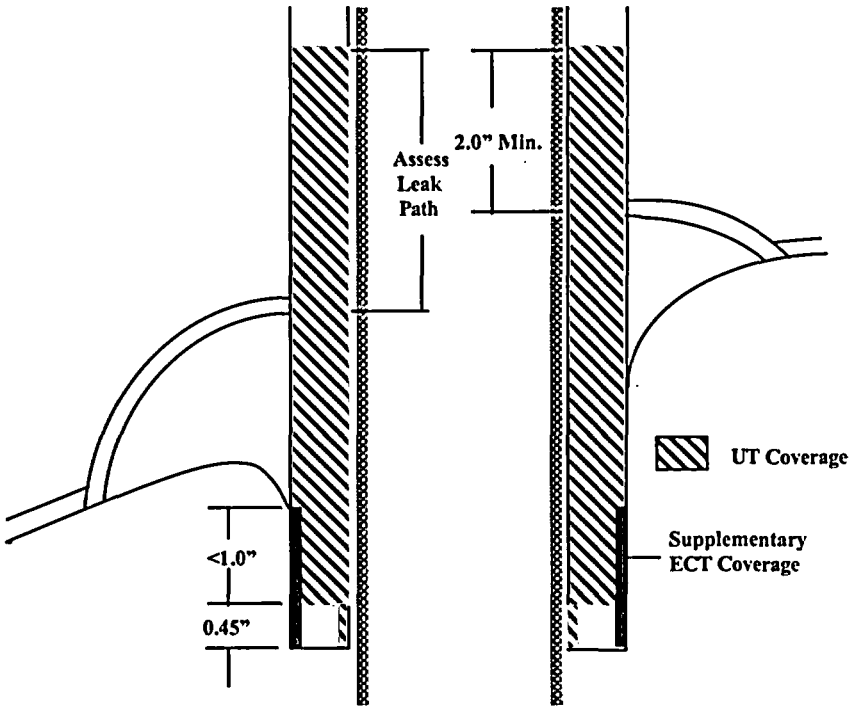
Figure 4-4: Combination UT and ECT Examination Coverage in Accordance With Section IV.C (5) (b) (iii) of the Revised NRC Order

For these locations, complementary eddy current examinations were performed on the OD penetration tube surfaces using the Grooveman end effector. These examinations were performed from the elevation where toe of the J-groove weld at its lowest elevation intersects the penetration tube to the bottom of the tube. Since the TOFD UT coverage below the weld at these eight locations varied from 0.6" to 0.96" below the weld, sufficient overlap was accomplished when the upper elevation of the scan was started at the point where weld intersects the tube.

Coverage provided by the combined ultrasonic and eddy current examination program is illustrated in Figure 4-4.

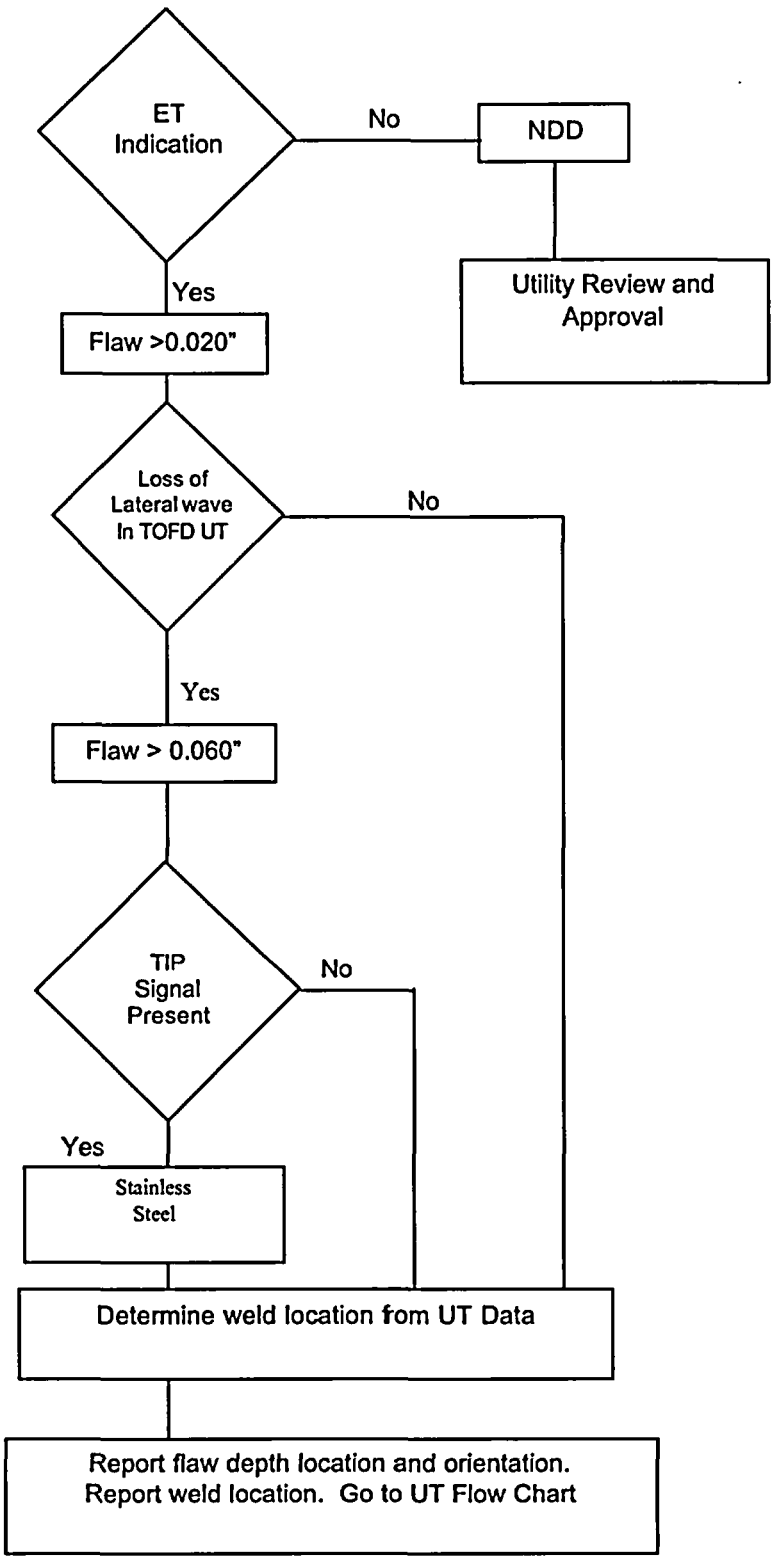
Figure 5-1 - Penetration Tube ID Flaw Evaluation

Eddy current results from tube inside diameter surface examinations identified twenty-four penetration tubes with indications characteristic of craze cracking. This phenomenon was found typically at the 180 degree location and below the weld. The craze cracking was not detectable with the TOFD ultrasonic probes, indicating the depths of this condition is significantly less than 0.040", the TOFD detection limit. As such, they are not considered to have any impact on the integrity of the reactor vessel head penetration tubes. All were confirmed by review of the historical data from the Fall 2002 reactor vessel head penetration examination and there was no increase in size.

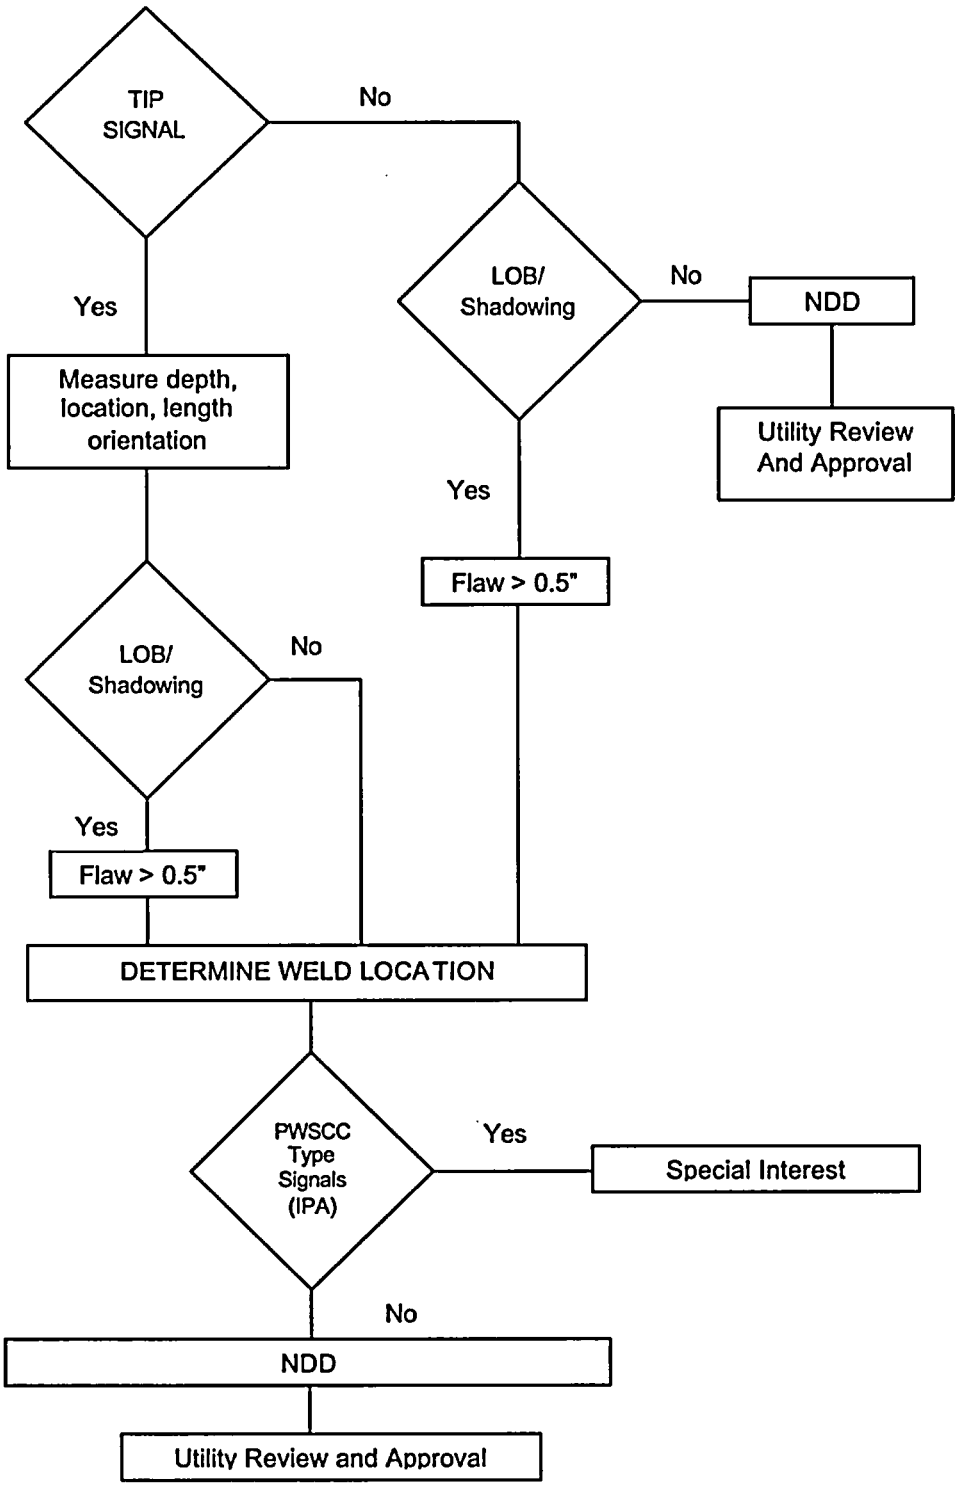
Figure 5-2 - Penetration Tube OD Flaw Evaluation

Results from the TOFD ultrasonic and eddy current examinations of the sixty-nine reactor vessel head penetrations identified no indications characteristic of PWSCC.
