FIRST REVISED NRC ORDER EA-03-009:
REACTOR PRESSURE VESSEL HEAD AND VESSEL HEAD PENETRATION NOZZLE POST OUTAGE INSPECTION RESULTS
SALEM GENERATING STATION UNIT 1
FACILITY OPERATING LICENSE NO. DPR-70
DOCKET NO. 50-272

Salem Unit 1-1R16 Reactor Vessel Head Penetration Examination

Final NDE Report

WDI-PJF-1302611-FSR-001

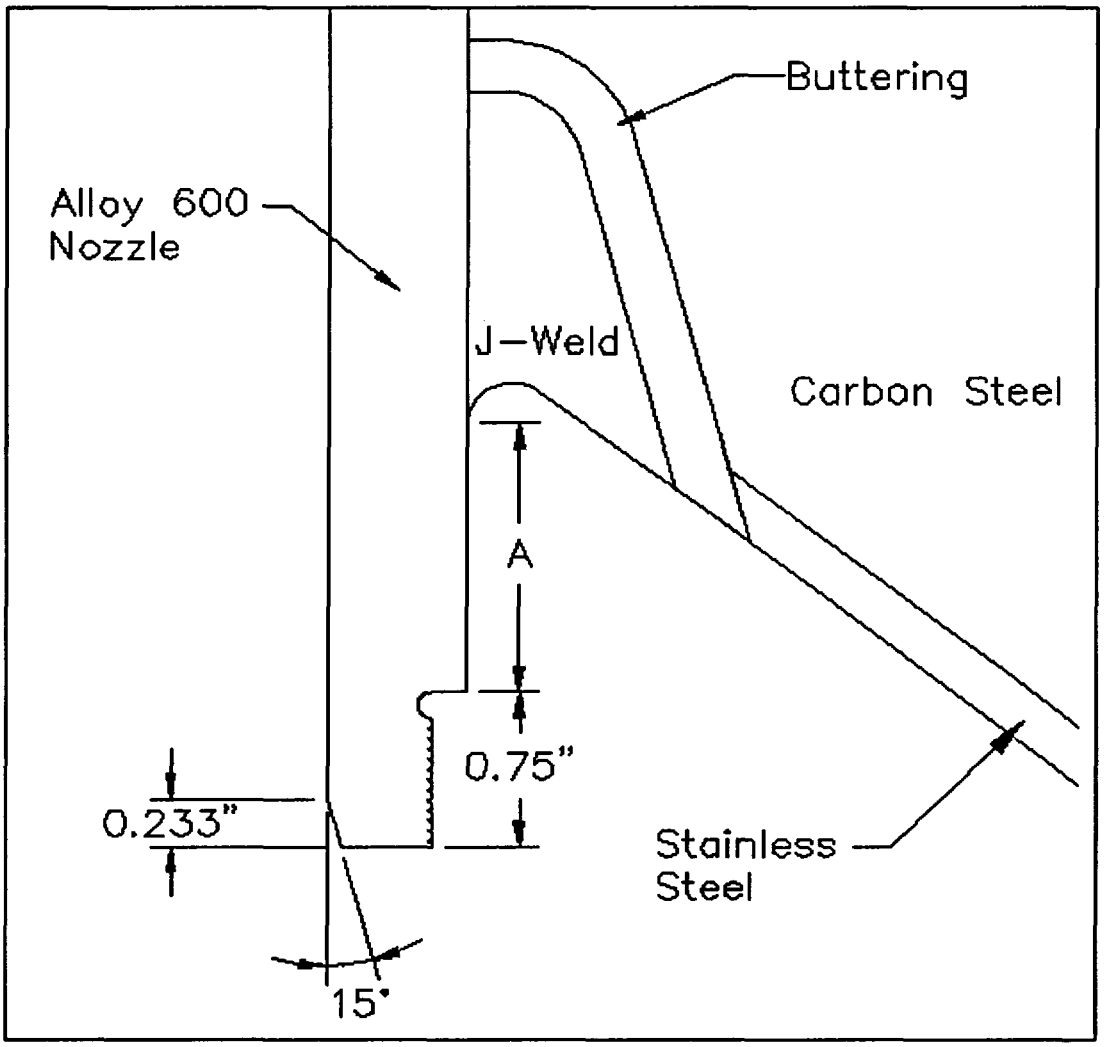
The configuration of the Salem Unit 1 CRDM penetration tubes is shown in the figure below. This figure represents the tube-to-head geometry on the "downhill" side of the tube (0° azimuth of the penetration). The bottom ends of all seventy-nine penetration tubes are threaded on the OD surface and have a 15° chamfer on the ID surface.

The threads on the OD surfaces extend from the bottom of the tube to an elevation of approximately 0.6875" where there a thread relief is machined. The top of the thread relief is 0.75" above the bottom of the tube. The distance from the top of the thread relief to the bottom of the fillet of the J-groove weld (identified as "A" in the figure) varies based on location of the penetration in the head. These distances are longer for penetrations at "inboard" locations and become progressively shorter for penetrations located further away from the center of the head.

The ID surfaces of the penetration tubes are chamfered at a 15° angle from the bottom of the tube to an elevation of 0.233".

The threads on the tube OD surfaces and chamfer on the ID surfaces represent geometric conditions which limit examination coverage near the bottoms of the tubes.

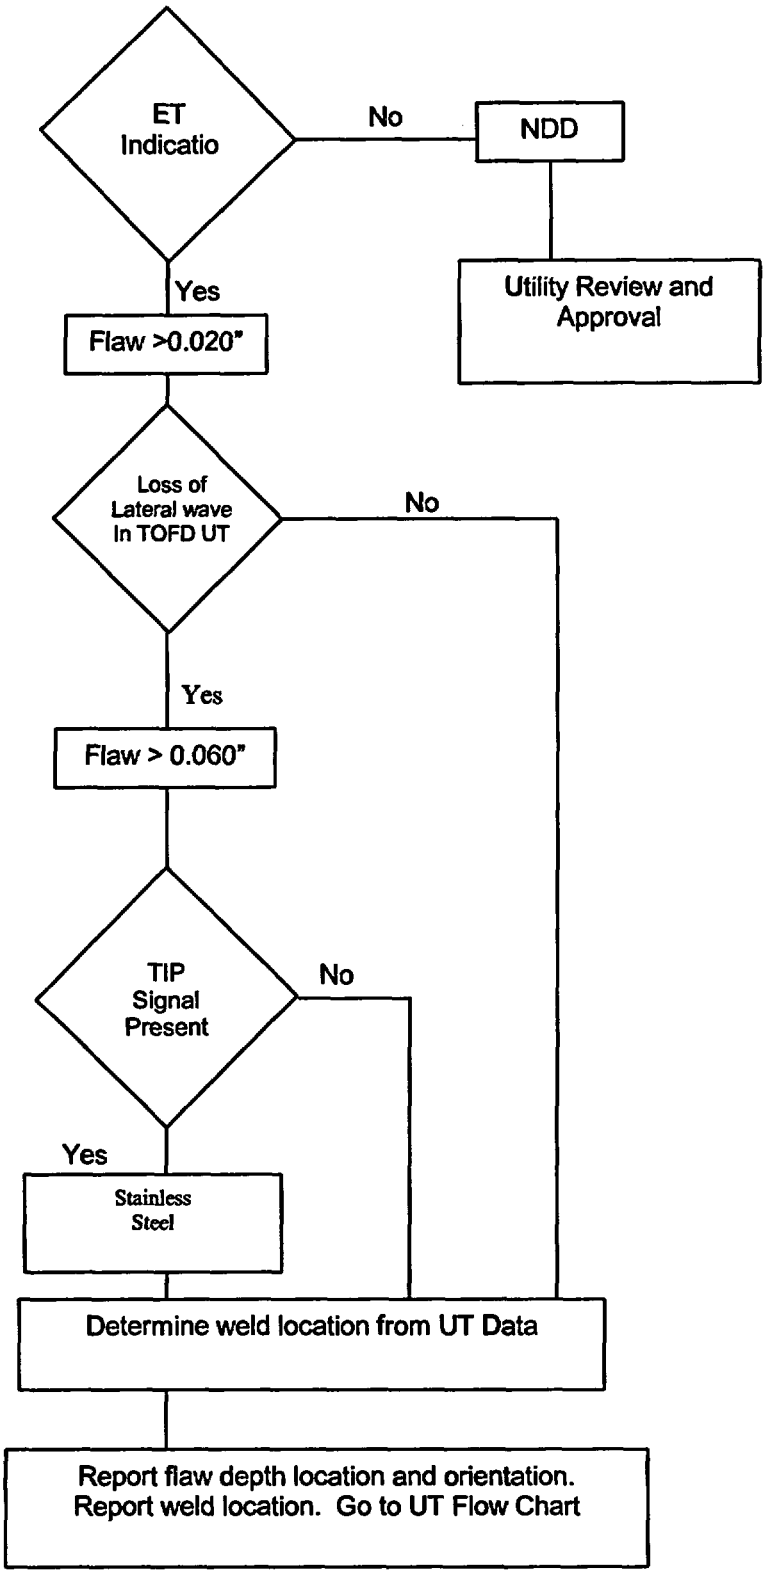
Figure 5-1 - Penetration Tube ID Flaw Evaluation

Eddy Current results from tube ID surface examinations showed 15 penetration tubes with indications characteristic of axial cluster cracking. With the exception of penetration #19 these indications were determined with the TOFD inspection to have a depth less than 0.040". Penetration #19 had indications characteristic of axial cluster cracking as described above. One indication in the cluster area had a reflector which produced a measurement of 0.047" with the TOFD inspection channel.

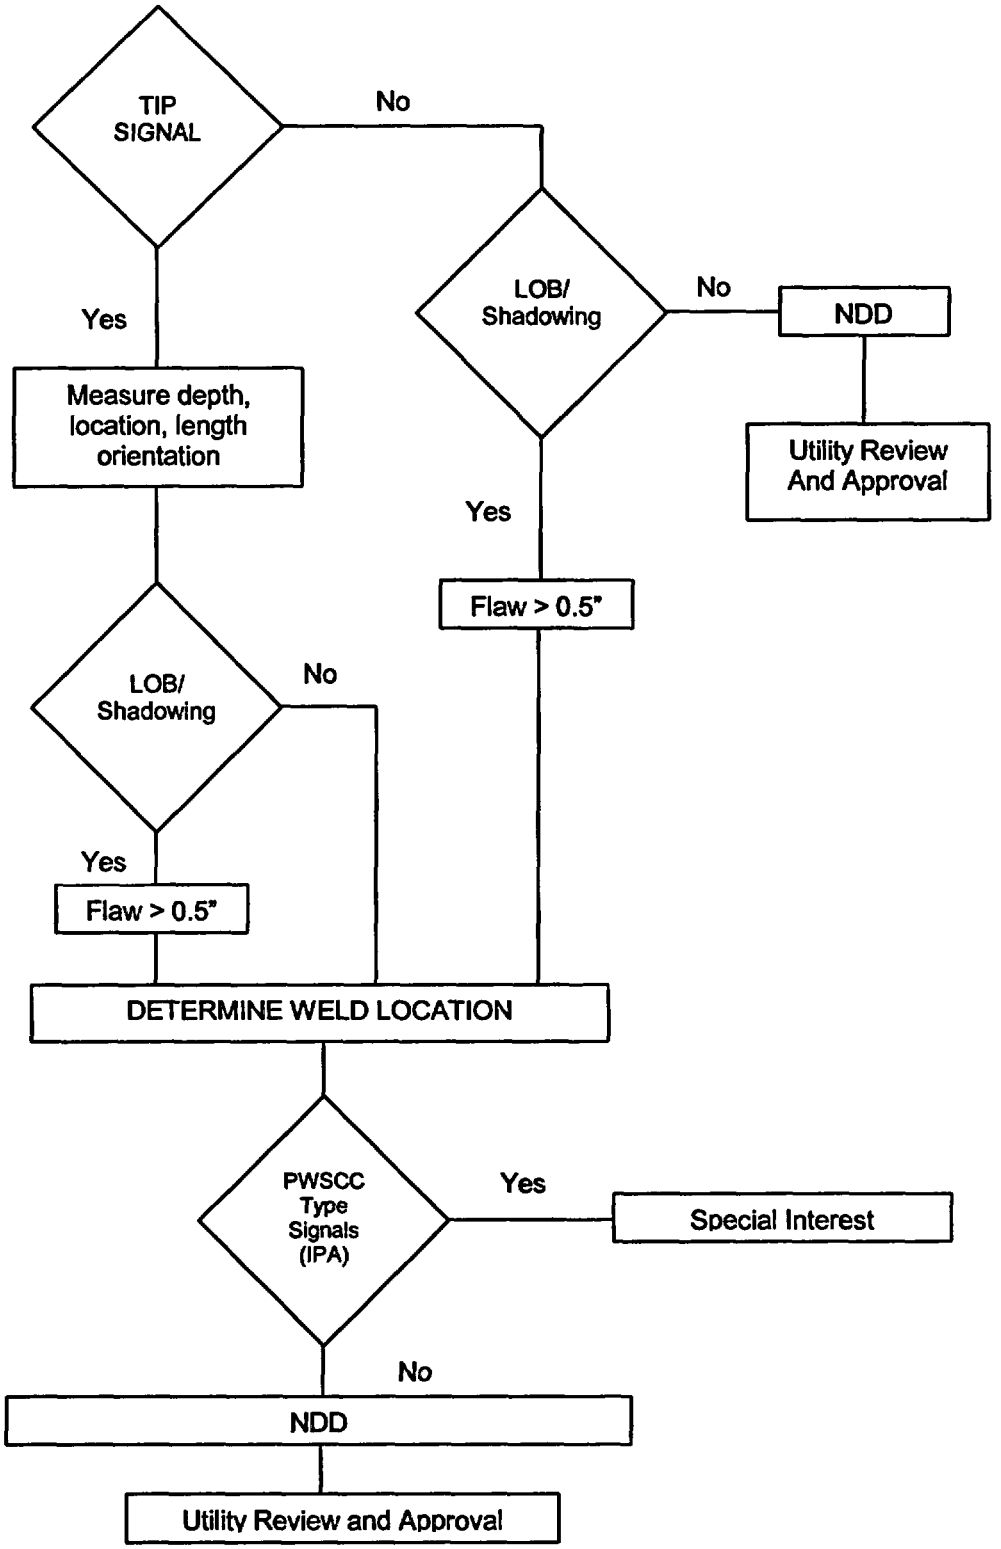
Figure 5-2 - Penetration Tube OD Flaw Evaluation

Results from the TOFD ultrasonic and eddy current examinations of the sixty-nine reactor vessel head penetrations identified no indications characteristic of PWSCC. The straight beam ultrasonic examinations of the shrink-fit regions of the seventy nine penetration tubes showed no evidence of leak paths.
