CONDITION REPORT NO. 1999-1300 Page 1 of 17

Problem Statement::

ANALYSIS OF FILTER DEPOSITS

Final Report
SwRI Project No. 18-2321-190

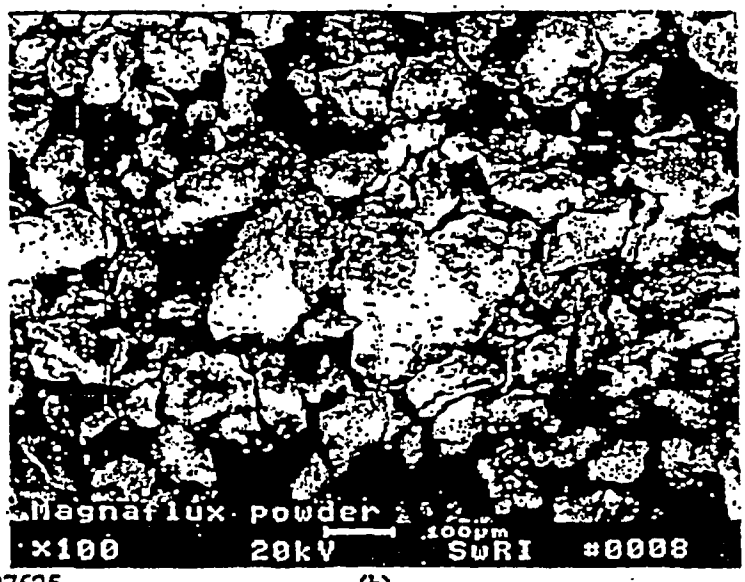
Figure 1. Scanning electron micrographs of the Magnaflux powder.

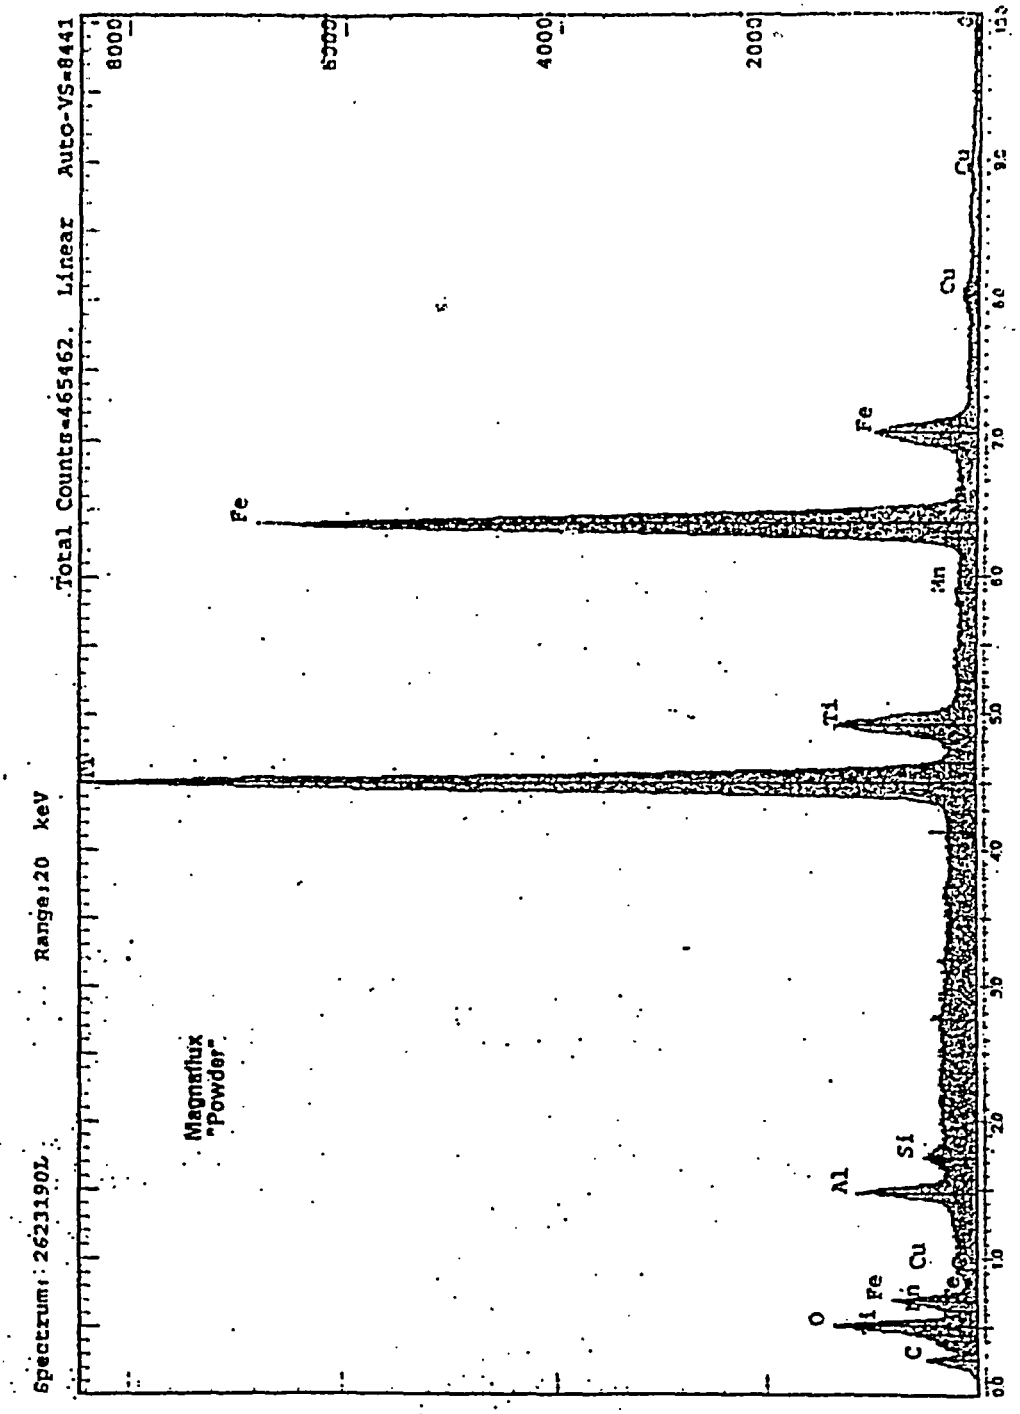
Figure 2. EDS spectrum obtained from the Magnaflux powder.

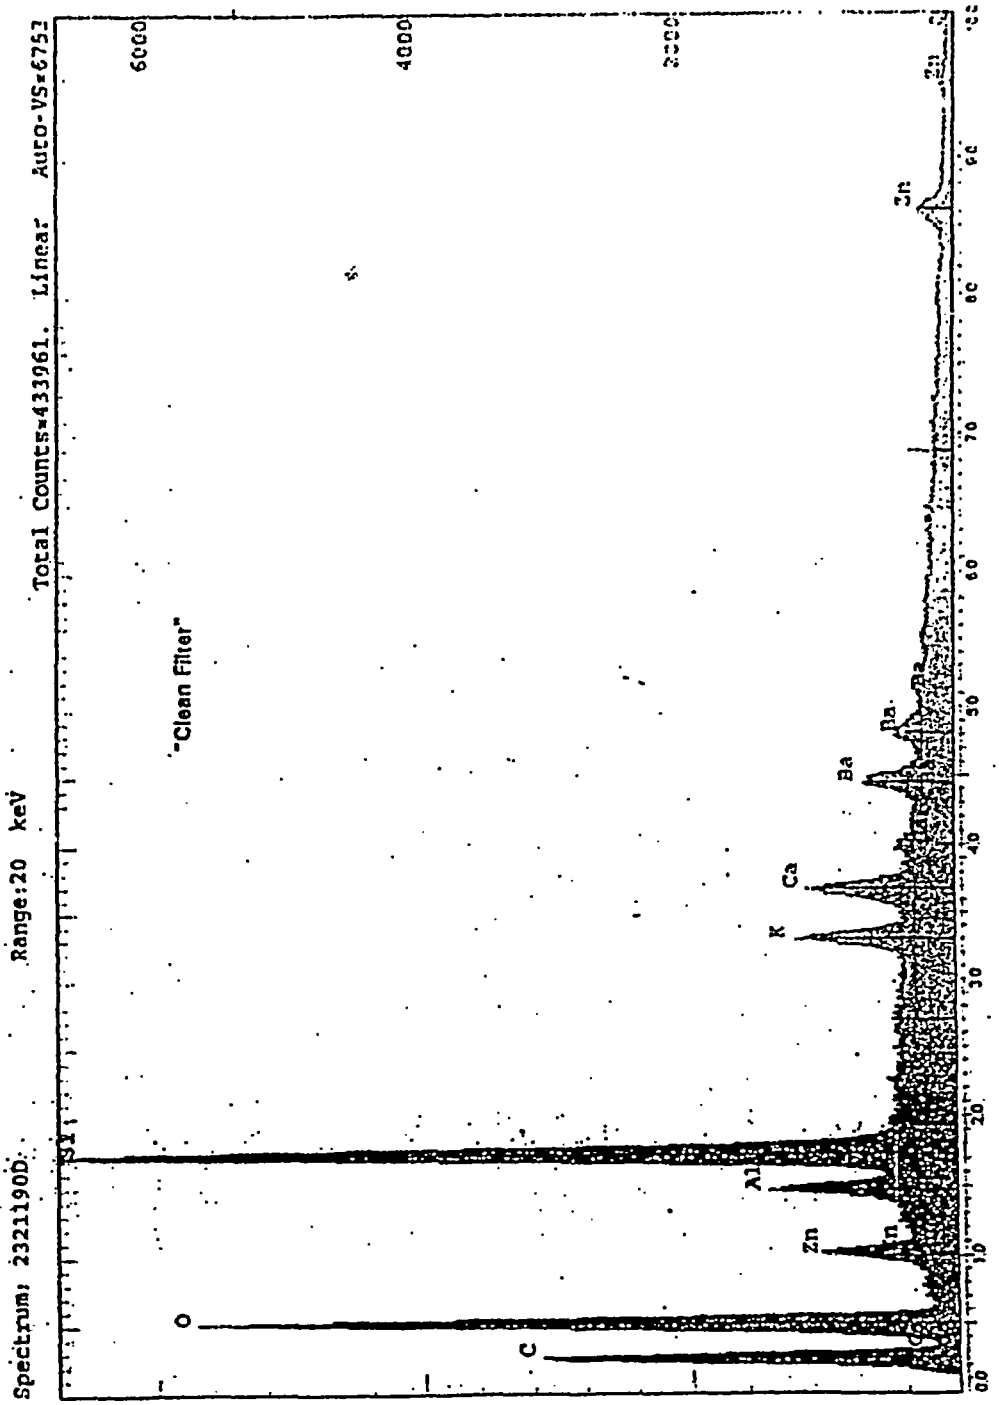
Figure 3. EDS spectrum obtained from a deposit free section of filter 4597BA 7/9/99@140(t).

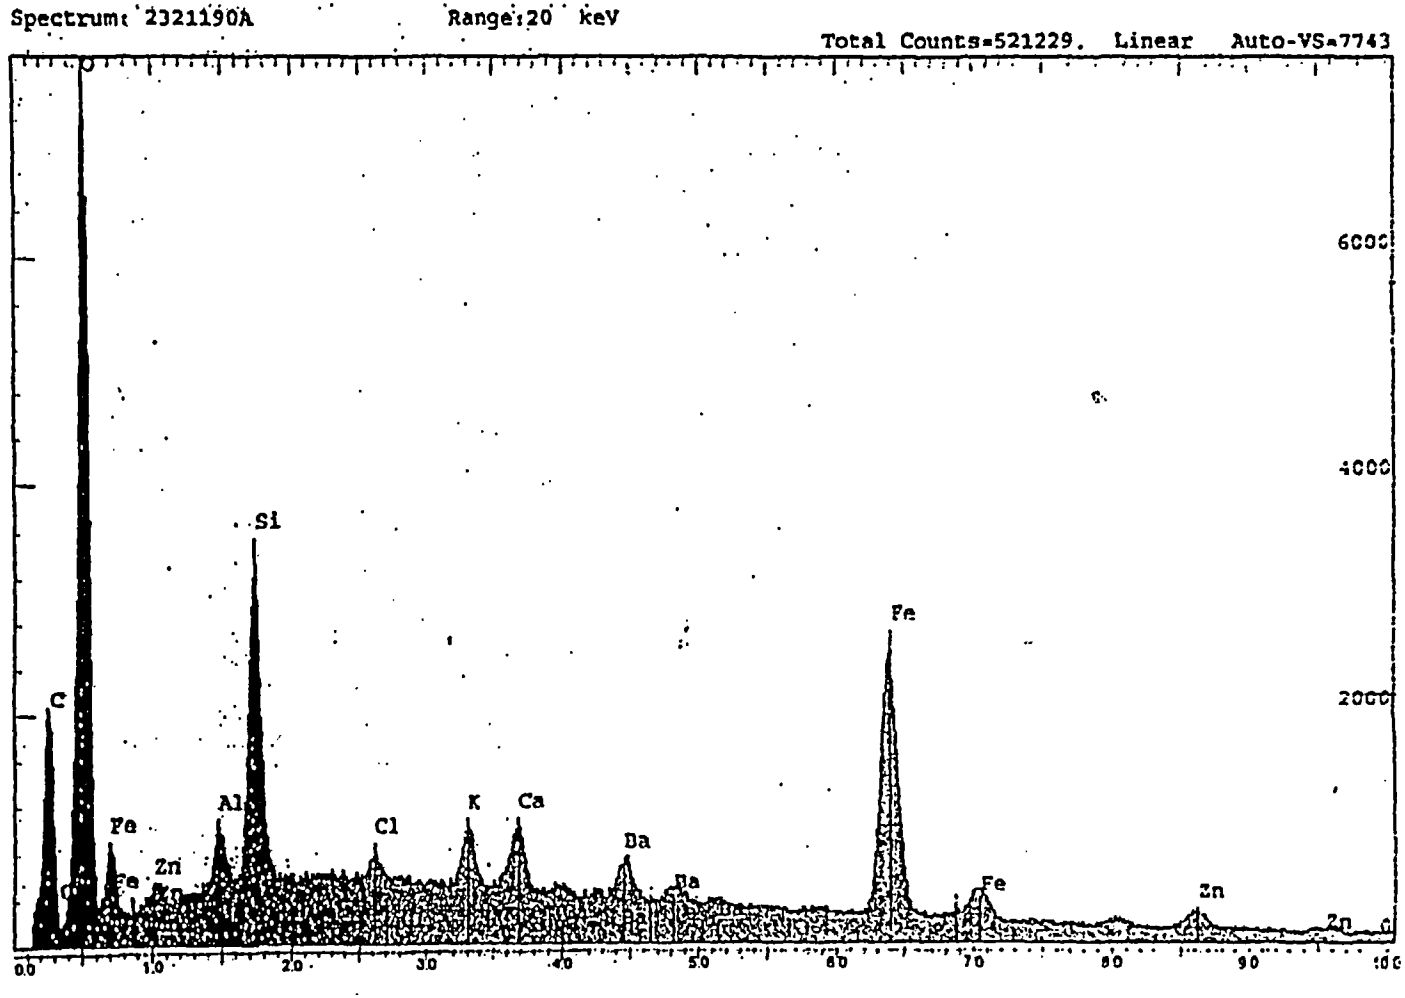
Figure 4. EDS spectrum from an overall area of deposits on filter 4597BA 7/3/99@1400.

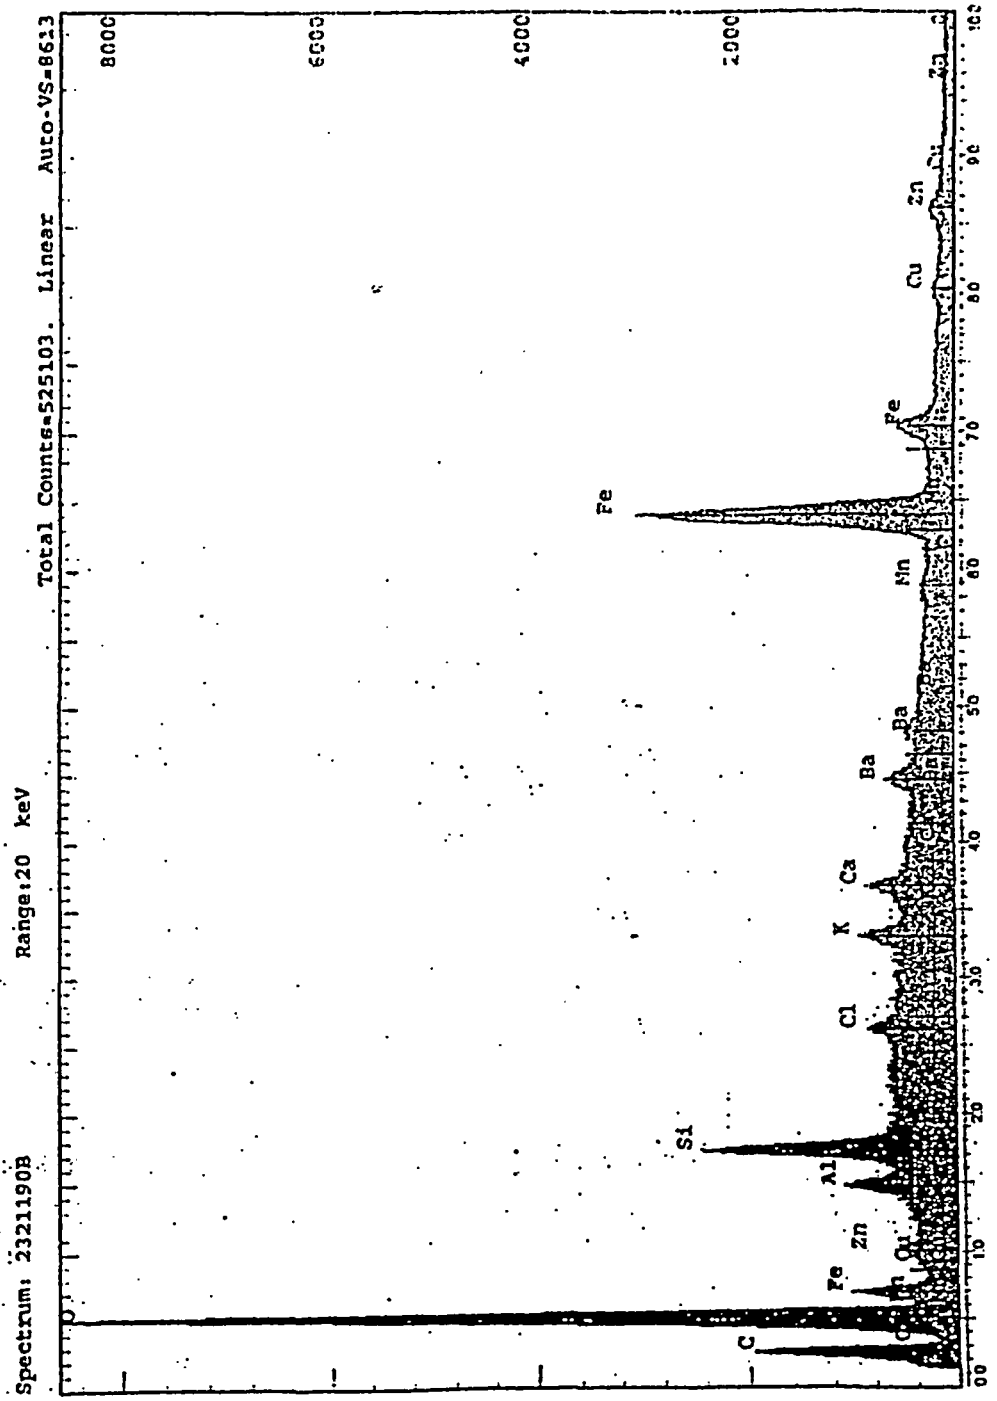
Figure 5. EDS spectrum from a second overall area of deposits on filter 4597BA 7/3/99@1400.

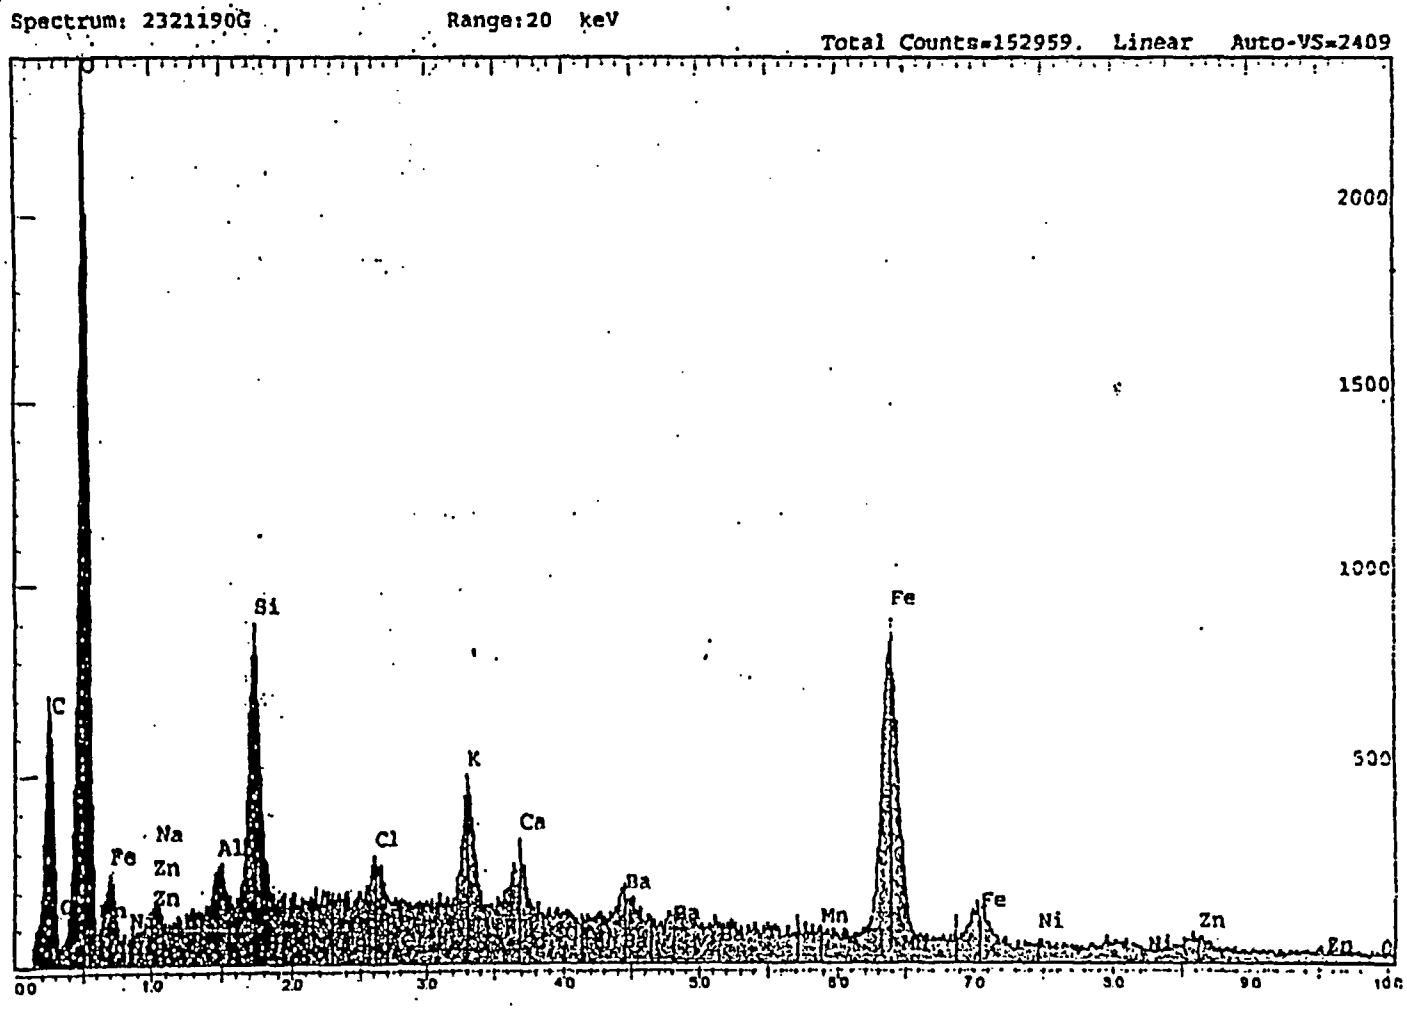
An EDS spectrum from an overall area of deposit on filter 4597BA 7/9/99@2014, Figure 6, was essentially identical to those obtained from filter 4597BA 7/3/99@1400. Spectra were also obtained from two of the dark particles on the filter, Figures 7 and 8. These particles were different from the overall deposit in that the iron peaks were reduced and high potassium and chlorine peaks were present.

Figure 6: EDS spectrum from an overall area of deposits on filter 4597BA 7/9/99@2016.

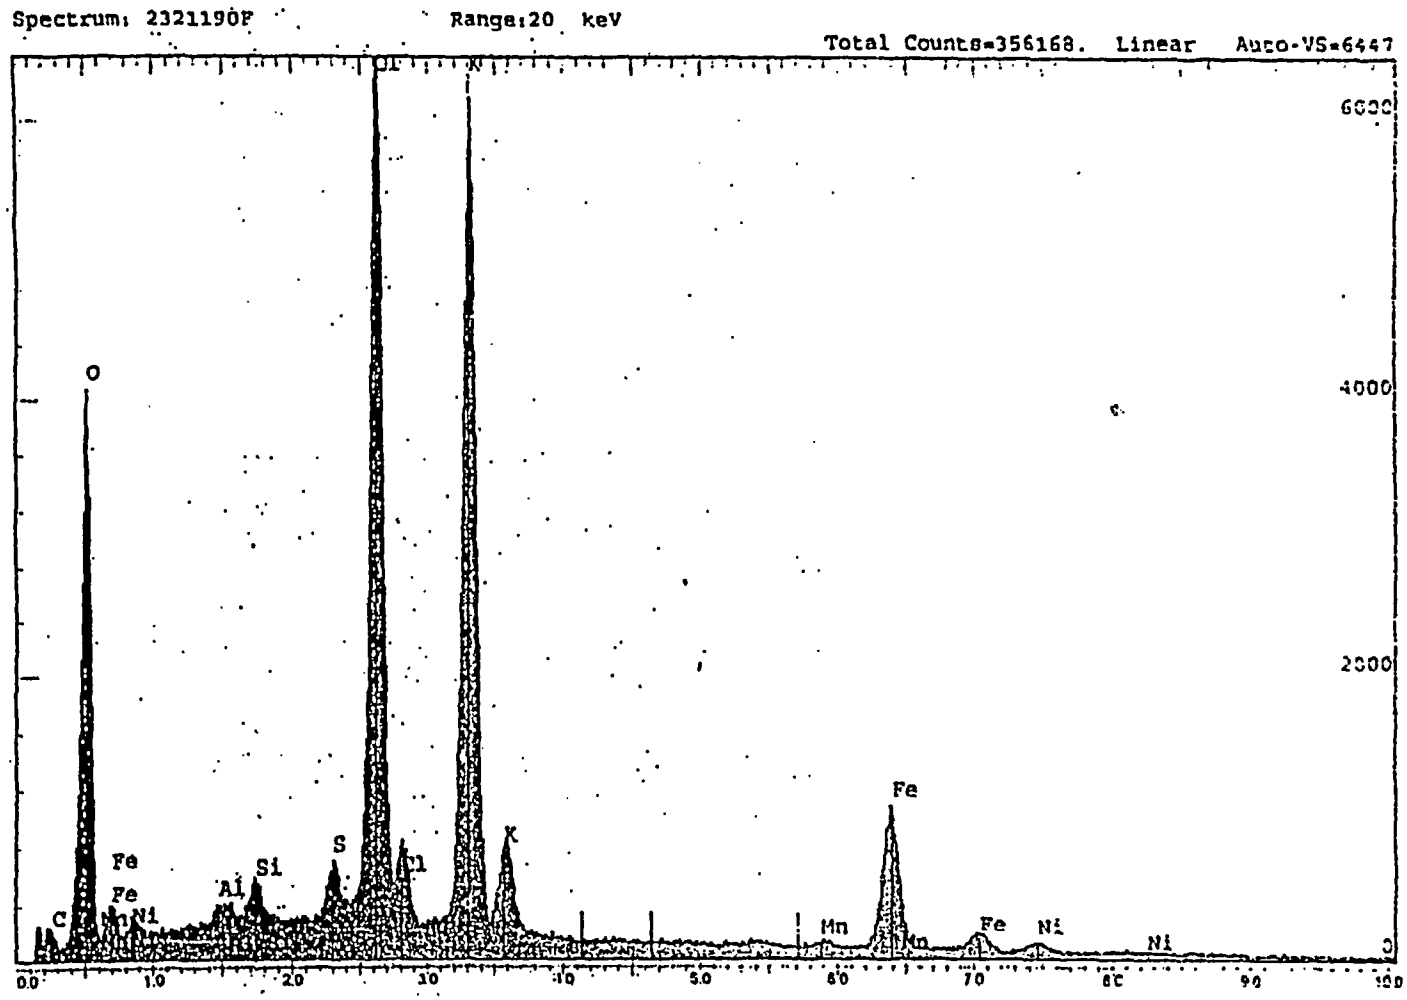
Figure 7. EDS spectrum from a single dark particle on filter 4597BA 7/9/99@2016.

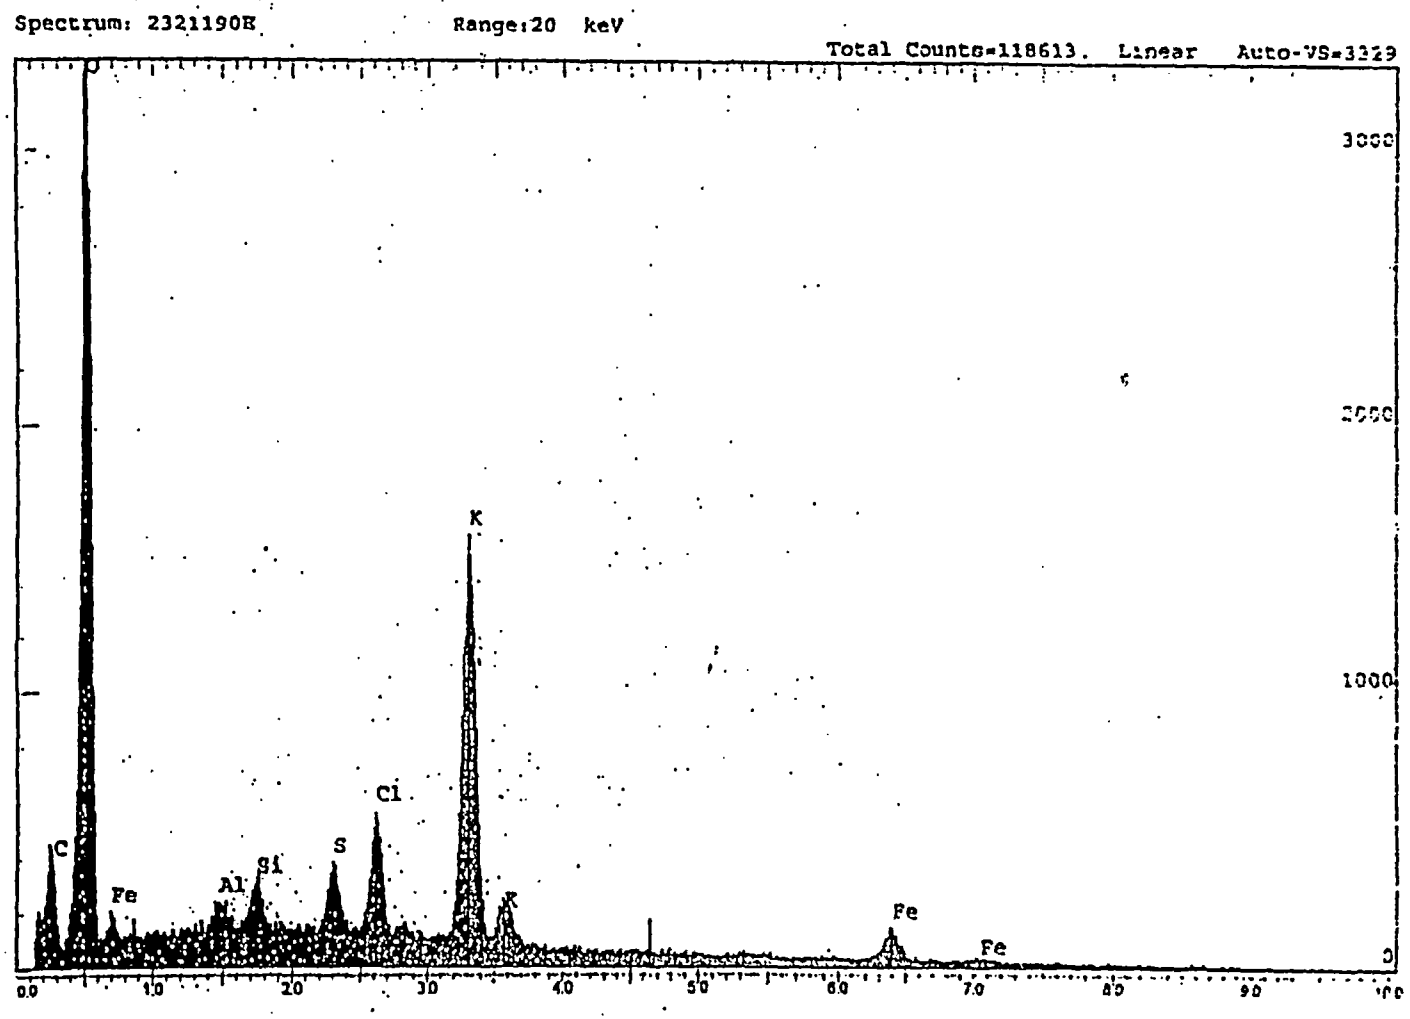
Figure 8. EDS spectrum from a second dark particle on filter 4597BA 7/9/99@2016.

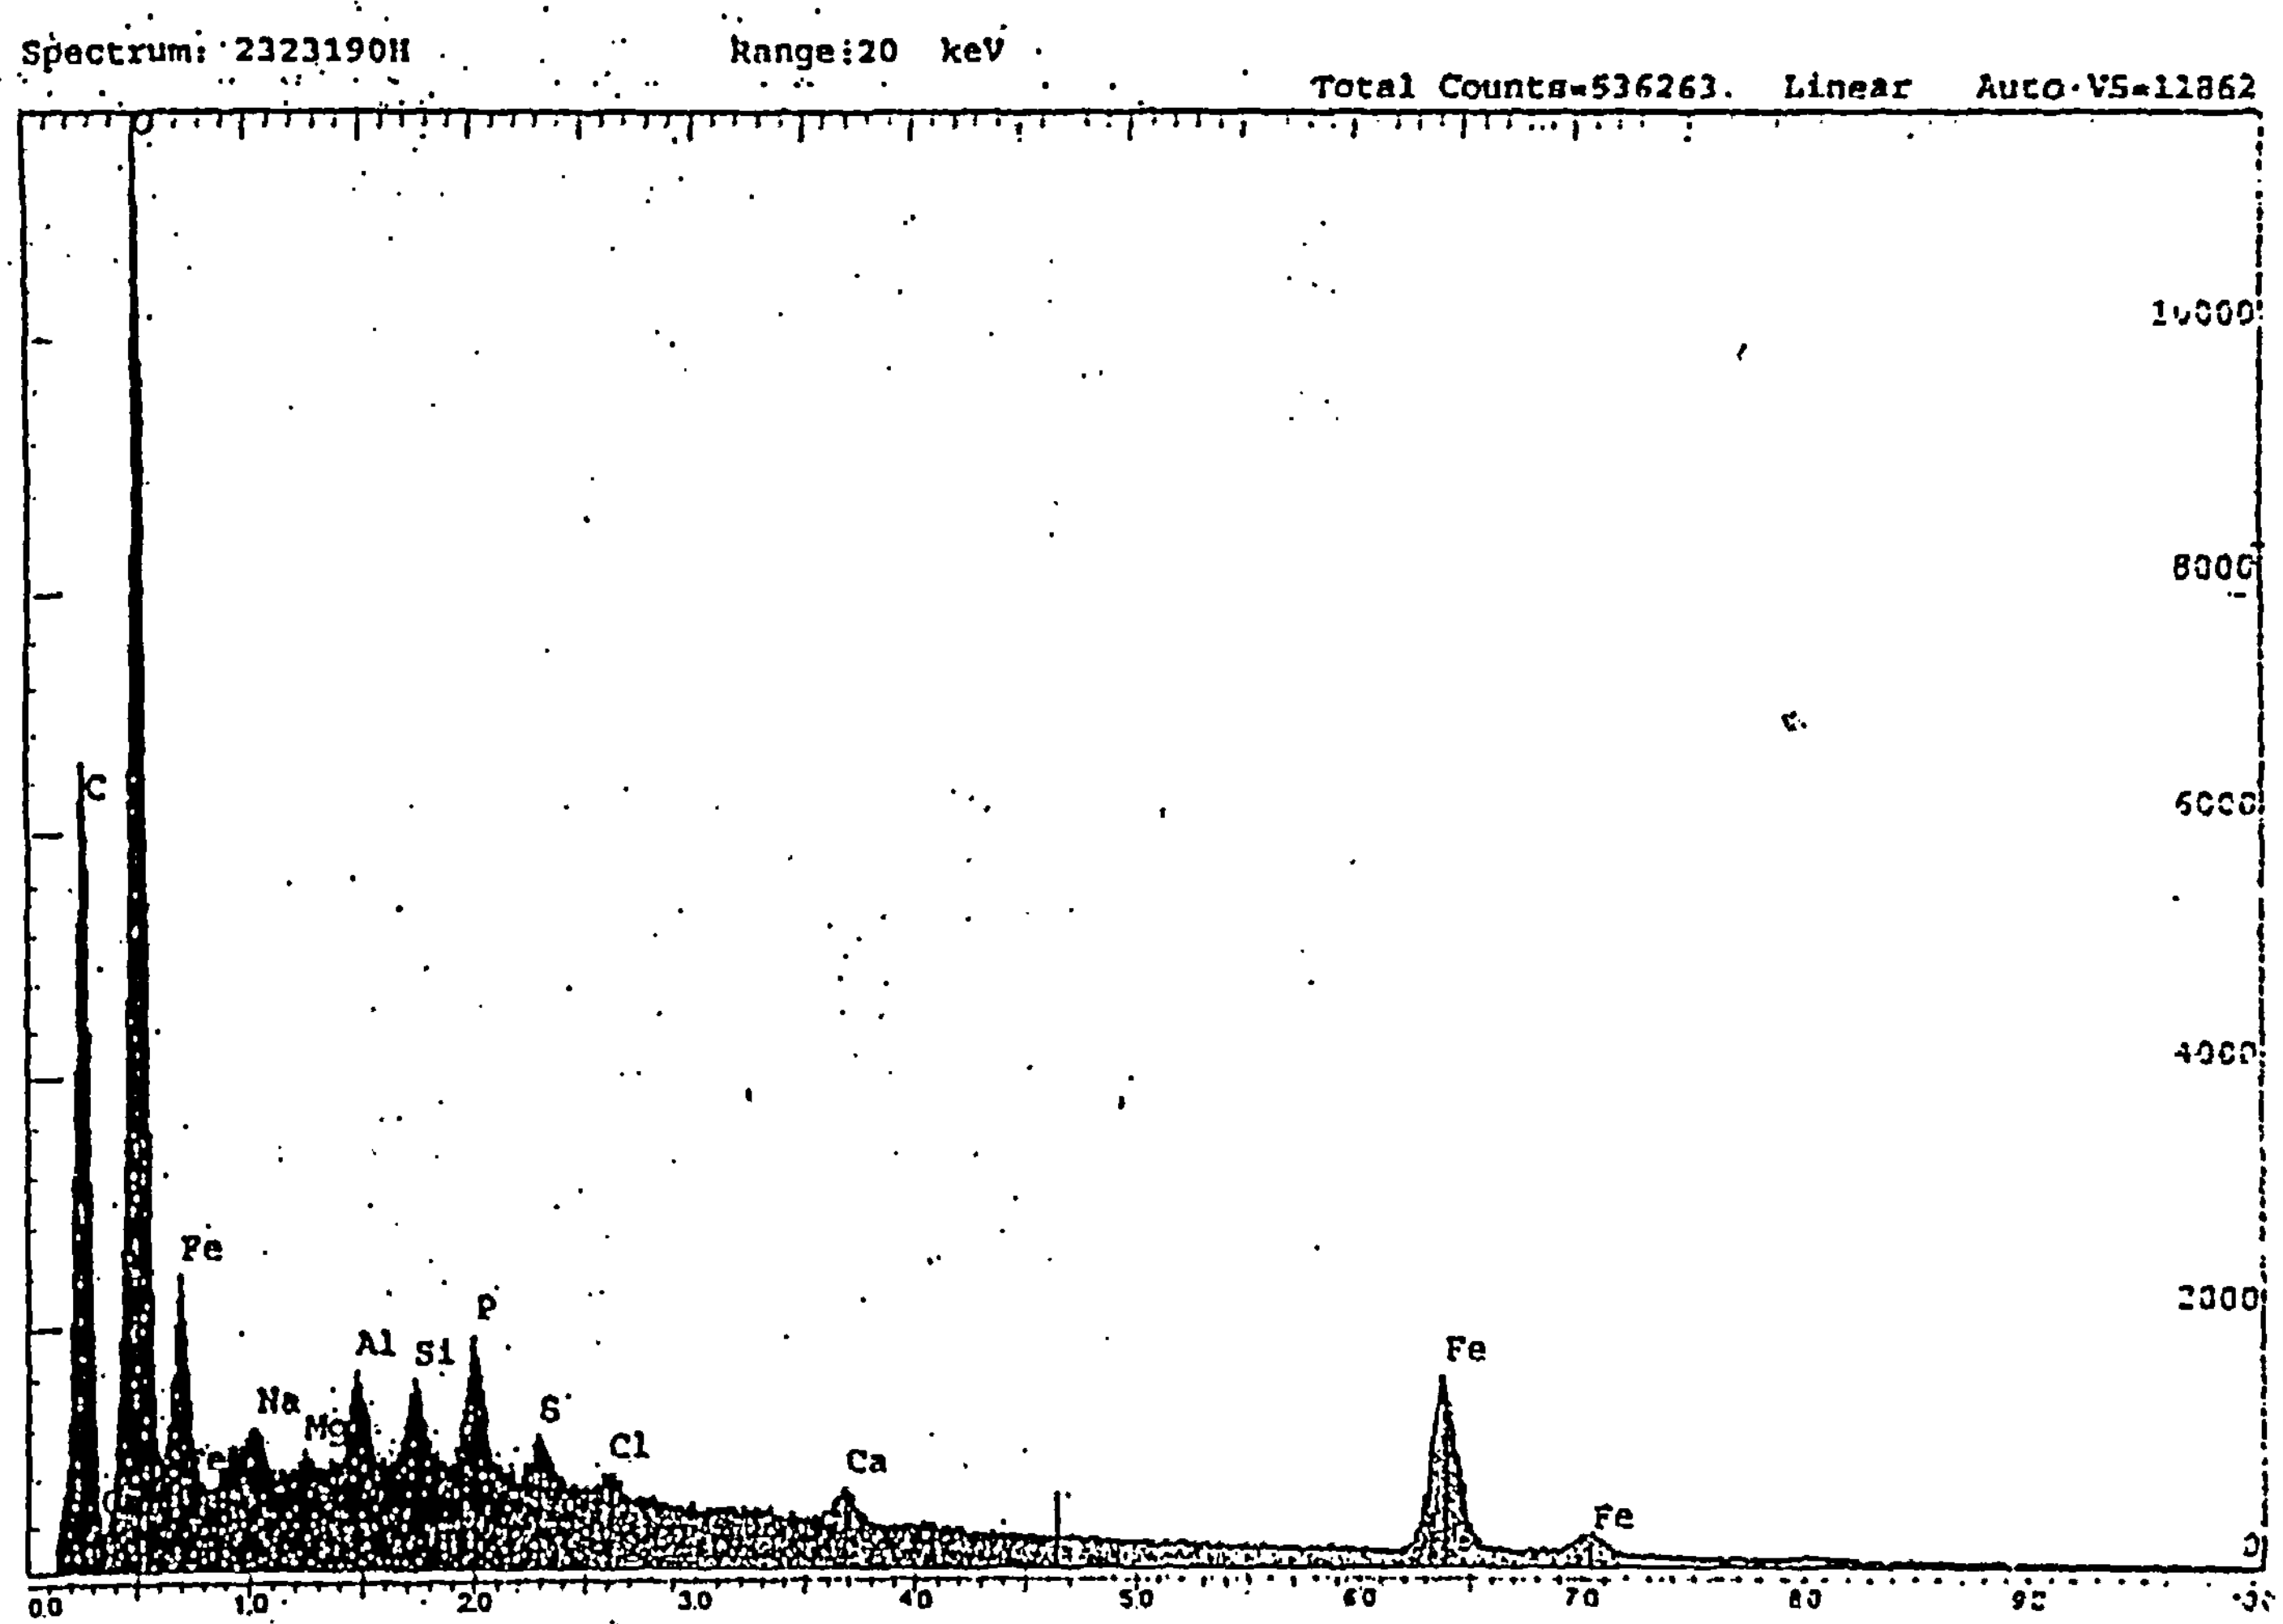
EDS spectra were also obtained from an overall area, Figure 9, and on an isolated particle Figure 10, on filter 7/16/99 White Bird. It is evident from these spectra that the deposits on the filter were also predominately iron oxide.

Figure 9. EDS spectrum from an overall area of deposits on filter 7/16/99 White Bird.

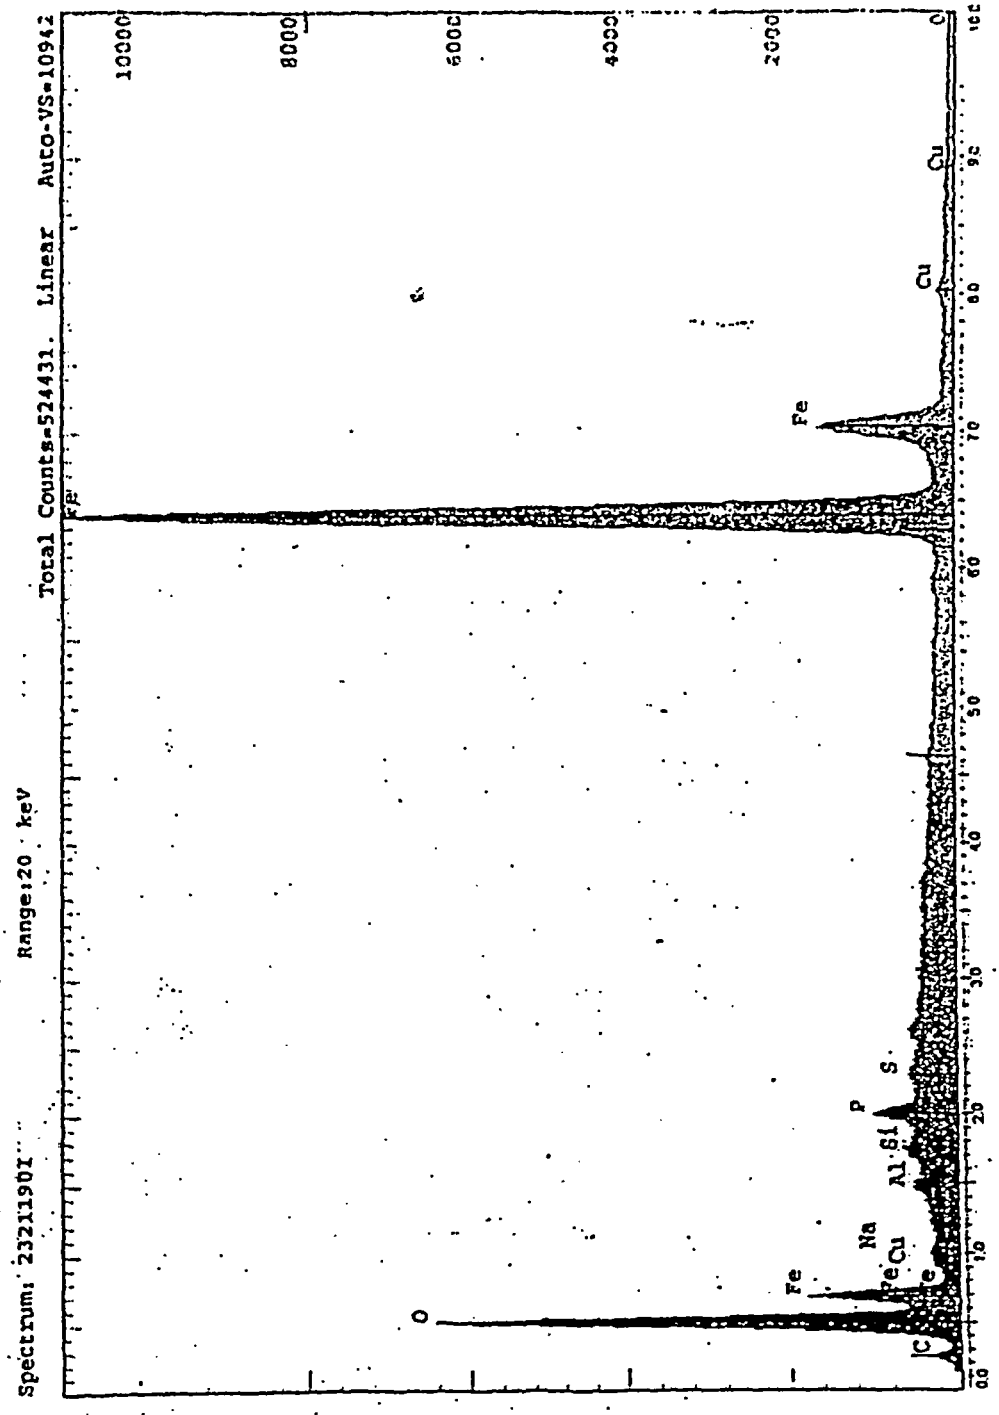
Figure 10. EDS spectrum from a single particle on filter 7/16/99 White Bird.

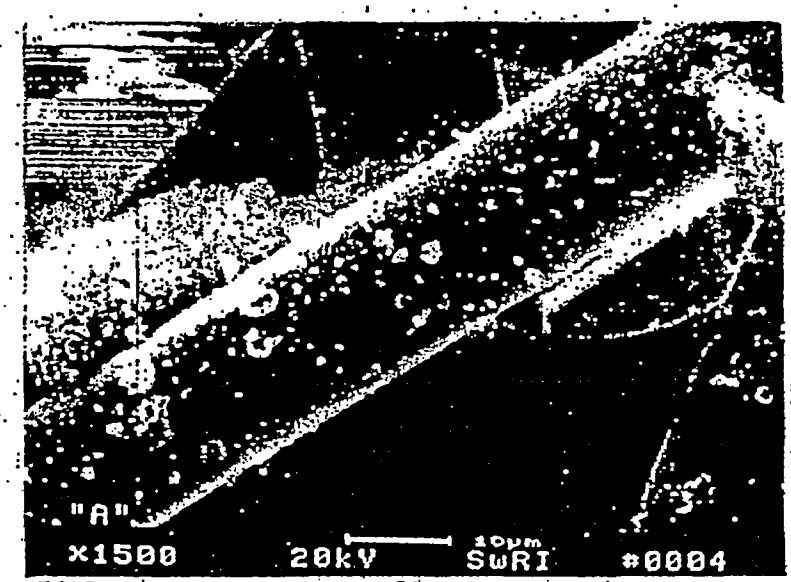
Imaging of the as-received filters in the SEM was limited by the low conductivity of the filter medium. To overcome this impediment, a gold palladium coating was applied to one of the filter samples, 4597BA 7/3/99@1400, following the EDS measurements. Electron micrographs obtained from the coated filter sample are shown in Figures 11 and 12. The deposits were generally less that 50μm in size and exhibited a very powdery appearance.

Figure 11. Scanning electron micrographs of an area of deposits on filter 4597BA 7/3/99@1400 following application of a gold/palladuim coating.

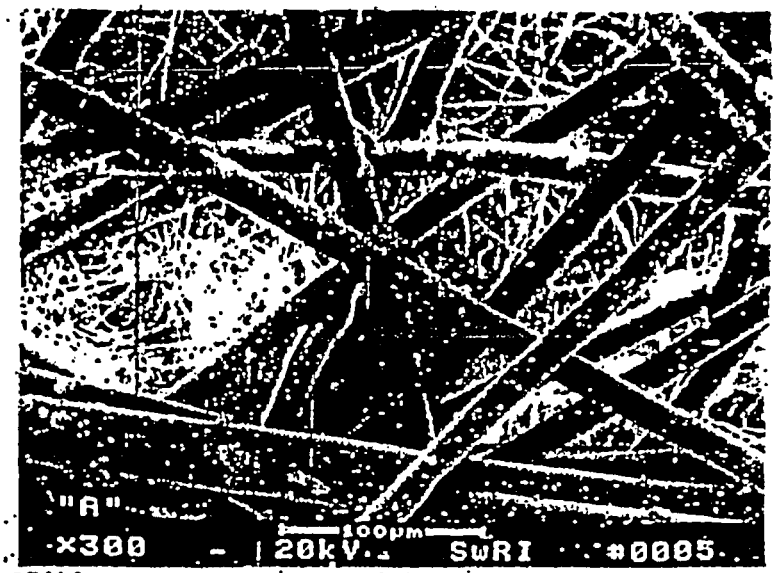
Figure 12. Scanning electron micrographs of a second area of deposits on filter 4597BA 7/3/99@1400 following application of a gold/palladium coating.
