Nuclear Operating Company
South Texas Project Electric Generating Station P.O. Box 289 Wadsworth, Texas 77483

South Texas Project
Unit 2
Docket No. STN 50-499
Response to Request for Additional Information Regarding
2RE10 Steam Generator Inspection

Response to Request for Additional Information

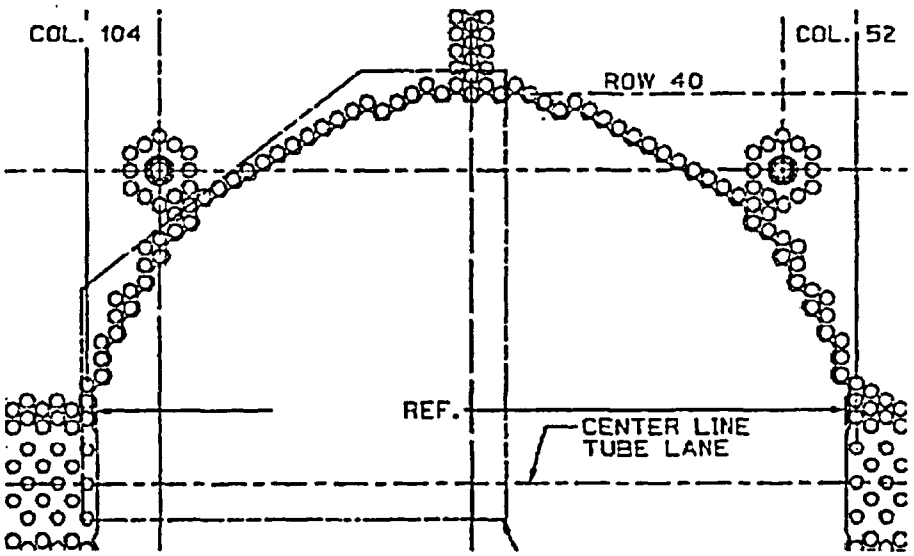
Figure 1

The central cut out area is a circular symmetric cutout of ~ 43" diameter on the hot and cold leg central bundle position. Refer to Figure 1. No specific inspection of these areas were required or performed during 2RE10. The PSI of the baffle cut out region was performed only to obtain baseline rotating coil data for these areas should STP bobbin coil examinations encounter possible loose parts later in service.

Cut Out Region
