AREVA DOCUMENT 32-5054699-00, "PALISADES CRDM NOZZLE IDTB J-GROOVE WELD FLAW EVALUATION," DATED NOVEMBER 2004 (NON PROPRIETARY)

Document Identifier 32 - 5054699 - 00

Title PALISADES CRDM NOZZLE IDTB J-GROOVE WELD FLAW EVALUATION - NP

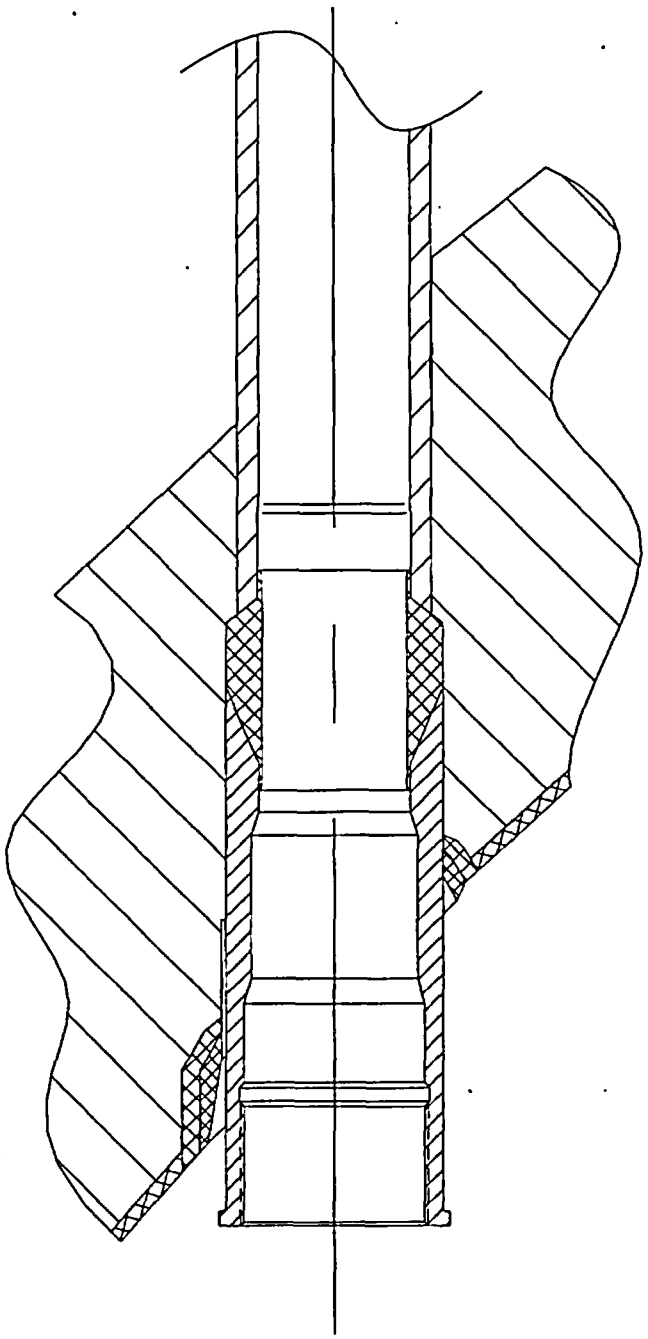
Figure 1. ID Temper Bead Weld Repair

Due to the susceptibility of Alloy 600 reactor vessel head partial penetration nozzles to primary water stress corrosion cracking (PWSCC), an ID temper bead weld repair procedure has been developed for Palisades CRDM nozzles wherein the lower portion of the nozzle is removed by a boring procedure and the remaining portion of the nozzle is welded to the low alloy steel reactor vessel head above the original [ ] J-groove attachment weld, as shown in Figure 1. A lower replacement nozzle is attached to the remaining original nozzle by this same weld. The repair is more fully described by the design drawing [1] and the technical requirements document [2]. Except for a chamfer at the corner, the original J-groove weld will not be removed, as shown in Figure 2. Since a potential flaw in the J-groove weld can not be sized by currently available non-destructive examination techniques, it is assumed that the "as-left" condition of the remaining J-groove weld includes degraded or cracked weld material extending through the entire J-groove weld and [ ] butter material.

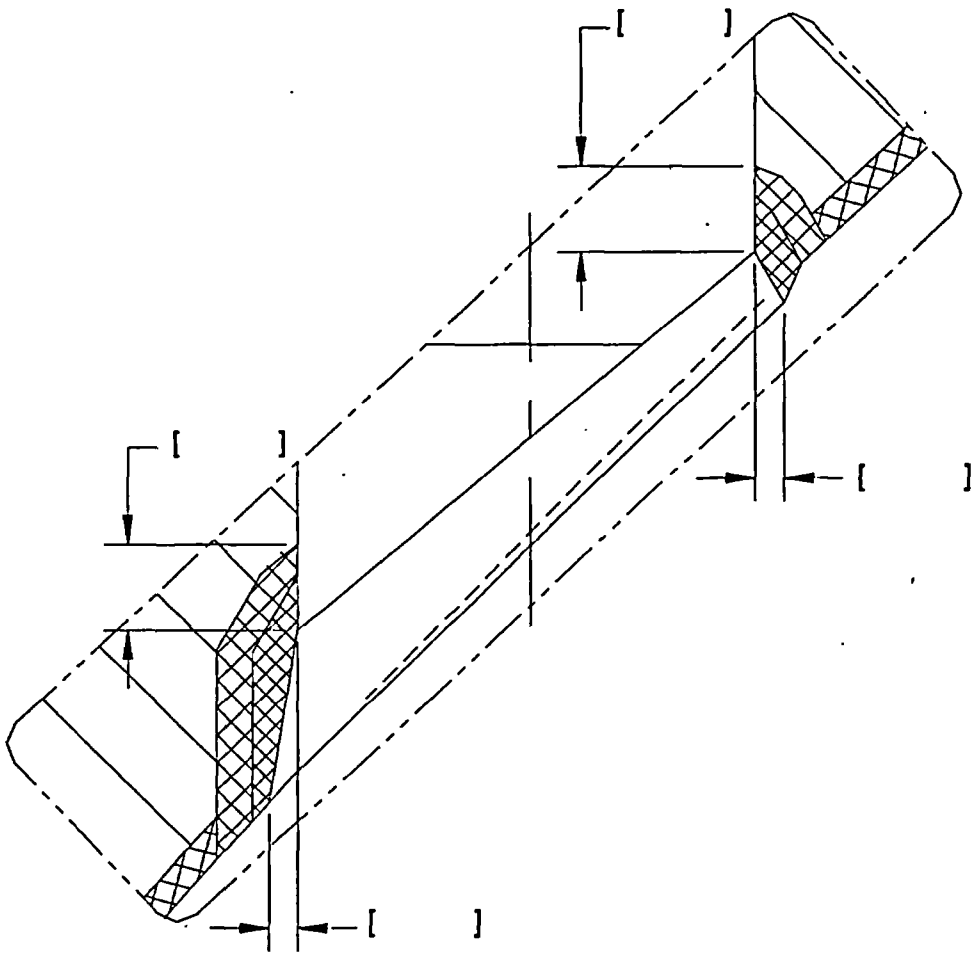
Figure 2. Remaining Portion of Original J-Groove Weld

Since it is known from analysis of the Palisades CRDM reactor vessel head nozzle penetrations [12] that the hoop stress in the J-groove weld is greater than the axial stress at the same location, the preferential direction for cracking would be axial, or radial relative to the nozzle. It is postulated that a radial crack in the [ ] weld metal would propagate by PWSCC, through the weld and butter, to the interface with the head material, where it is fully expected that such a crack would then blunt, or arrest, as discussed in Reference 4 for interfaces with low alloy steels. Since the height of the original weld along the bored surface is about [ ]", a radial crack depth extending from the corner of the weld to the low alloy steel head would be very deep. Although primary water stress corrosion cracking would not extend into the head, it is further postulated that a small fatigue initiated flaw forms in the low alloy steel head and combines with the stress corrosion crack in the weld to form a large radial corner flaw that would propagate into the head by fatigue crack growth under cyclic loading conditions. An ASME Section XI fracture mechanics analysis is performed to evaluate this worst case flaw in the original J-groove weld and butter.

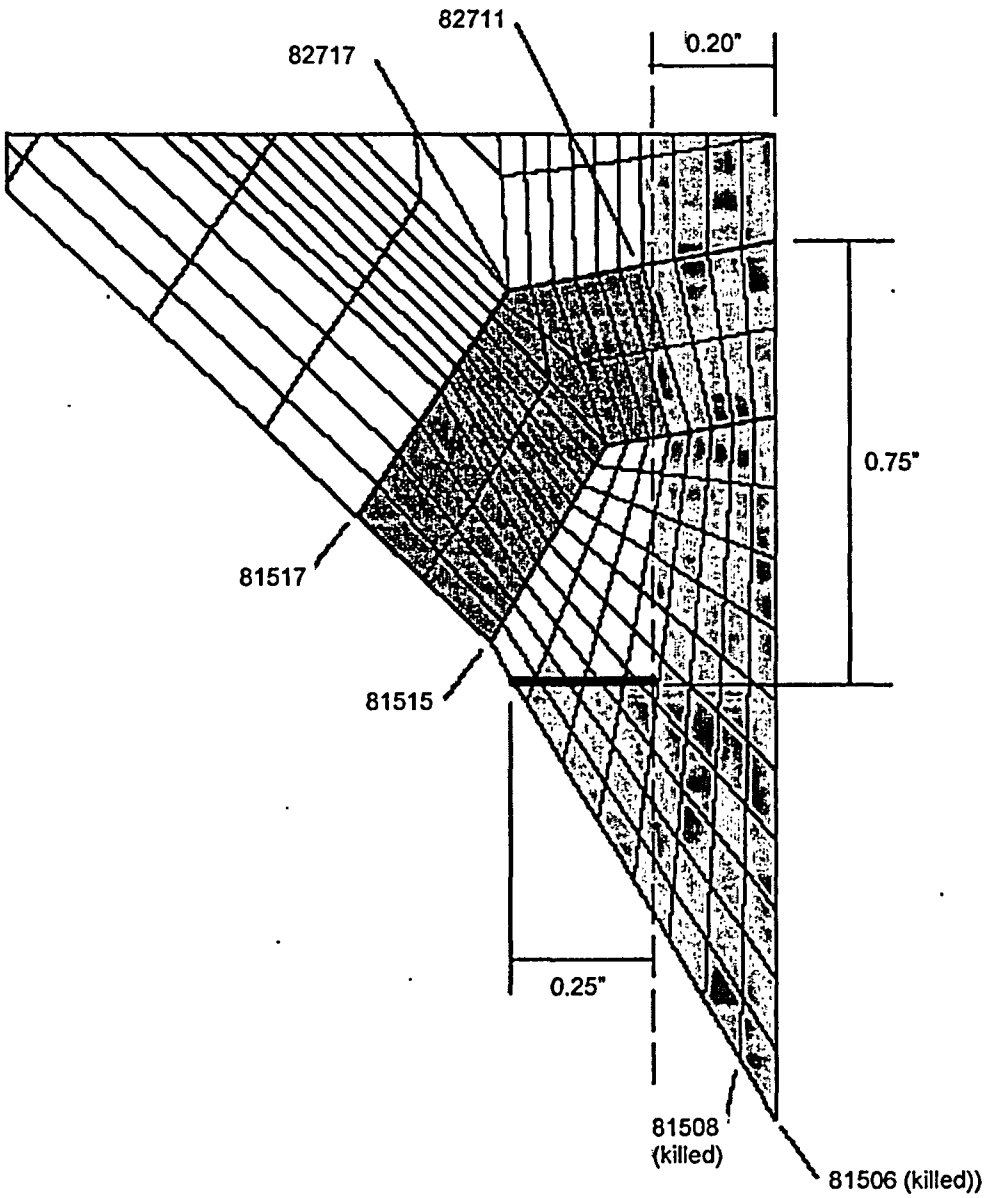
Figure 7. DEI Model of Uphill Weld Region for the Palisades Outermost CRDM Nozzle

The portion of the DEI finite element model shown in Figure 7 depicts the final simulated configuration of the repaired nozzle in the vicinity of the J-groove weld on the uphill side. Residual stresses are tabulated in Table 1 along the bored surface of the head, starting at the butter-to-head interface (node 82711). This location has been shown by finite element analysis to have the highest stress intensity factor along the postulated crack front (see Table A-1).

Although the residual hoop stress is still high at the butter/head interface (about [ ] psi), stresses decrease to zero at a distance of 0.640" into the head on the uphill side. As residual stresses would be relieved as a crack propagated through the weld and butter and past this distance into the head, the postulated flaw size will be increased by this amount so that it is not necessary to further consider residual stresses in the present flaw evaluations.

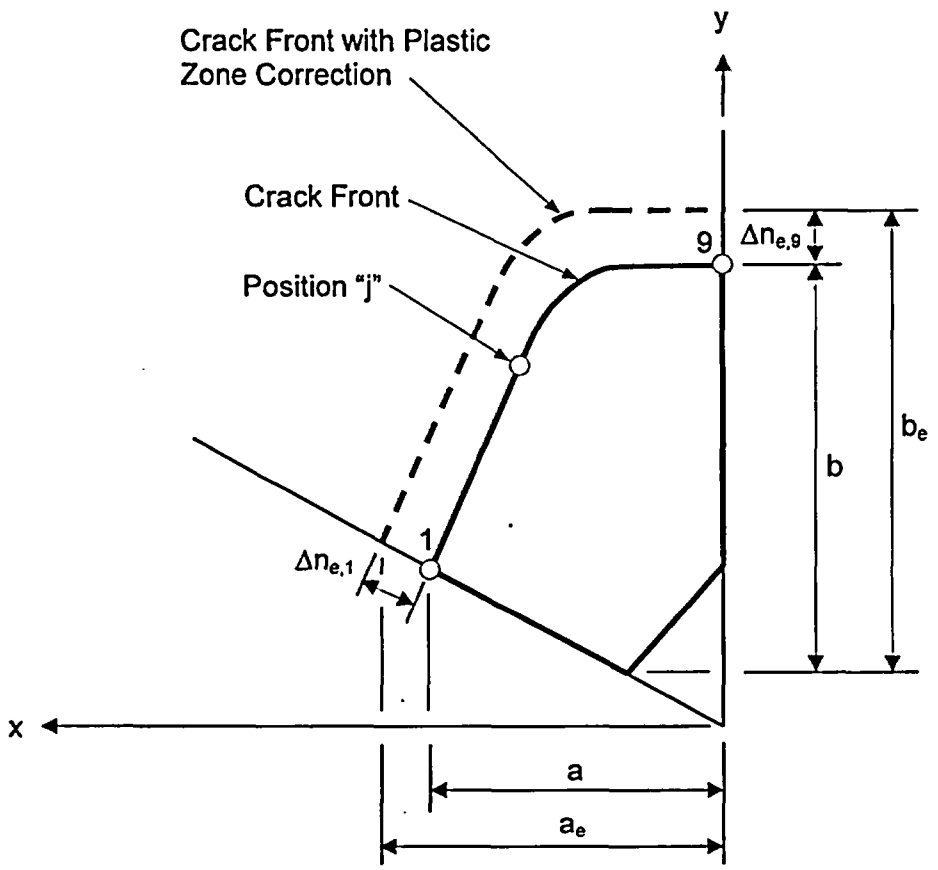
Figure 8. J-Groove Flaw Parameters (with Chamfer)

describing the bi-variant stress distribution over the crack face, and A_p is the pressure on the crack face. The x,y crack face coordinate axes are shown in Figure 8 for a typical J-groove flaw shape, along with the defining flaw size parameters, "a" (J-groove width), and "b" (J-groove height).
