April 12, 2000 SECY-00-0085

SUBJECT: REVIEW OF THE TOKAI-MURA CRITICALITY ACCIDENT AND LESSONS LEARNED

APRIL 2000

NRC REVIEW OF THE TOKAI-MURA CRITICALITY ACCIDENT

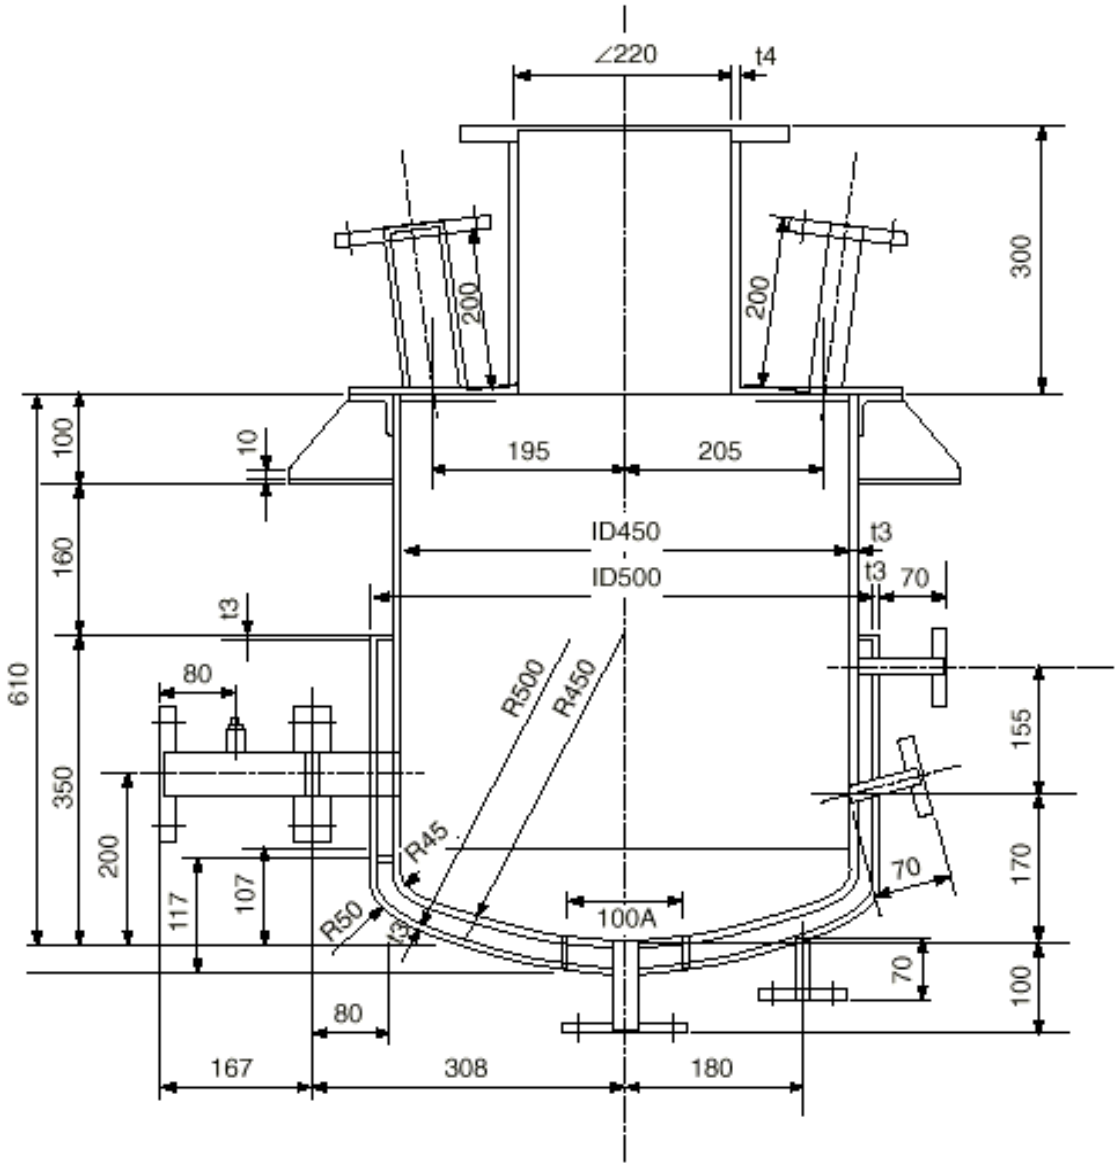
Fig. 6. Precipitation tank dimensions.

1&2. The workers exceeded the mass safety limit for the precipitation tank because the operational procedure used was not appropriate.

Both the mass and concentration limits were exceeded for the precipitation tank because of a number of human factors. The operation was conducted in violation of the approved safety procedures. The operational procedures actually used by the operators had not been reviewed by the safety division or the Japanese regulatory authorities to assure that it could be performed as written or that it would maintain the required criticality safety controls. Apparently, there was no review and approval process provisions for verification and validation of the procedure to assure that the procedure could be performed as written and that the operators interpreted the procedural steps in a manner consistent with the plant's safety function. There was no hardware failure that contributed to this event. Had the system been operated as designed, the criticality accident would not have happened. The Government of Japan initiated a criminal investigation for possible wrongdoing.
