Non-Proprietary Version
Materials Reliability Program: Evaluation of the Effect of Weld Repairs on Dissimilar Metal Butt Welds (MRP-114NP)

1009559

Final Report, July 2004

Structural Integrity Associates.

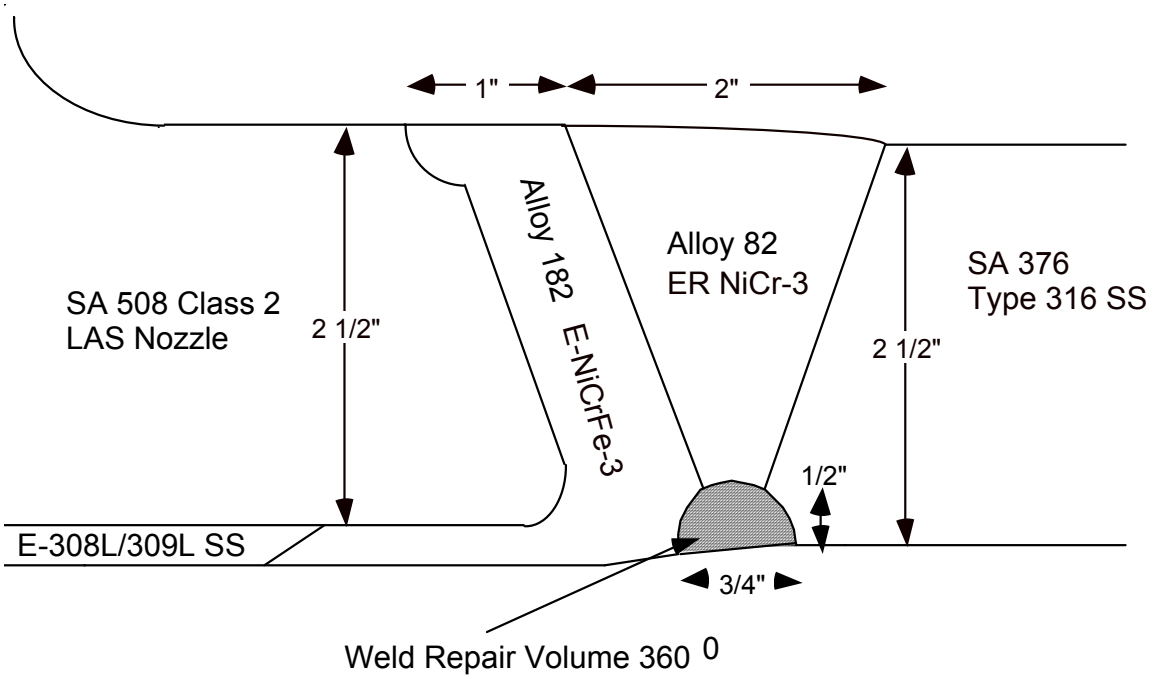
Figure 2-3
Schematic Cross-section of 360^0 ID Root Repair

This repair is particularly damaging because it enlarges the weld volume and finishes the weld on the surface exposed to the reactor coolant. In addition most of the deposited weld volume remains in-place to provide surfaces that are pulled in tension as the weld deposit solidifies and cools. Repair welding always alters the original residual stress distribution, but repairs applied directly to the ID are especially significant. This is because high residual tensile stresses are applied directly to the ID surface by contraction forces resulting from solidification and cooling on the ID surface. Thus, an ID root weld repair can be a particularly influential SCC damage mechanism. The completed weld repair will be ground to contour and smooth the weld root and newly welded interface. Figure 2-3 provides a schematic cross-section of the ID repair.

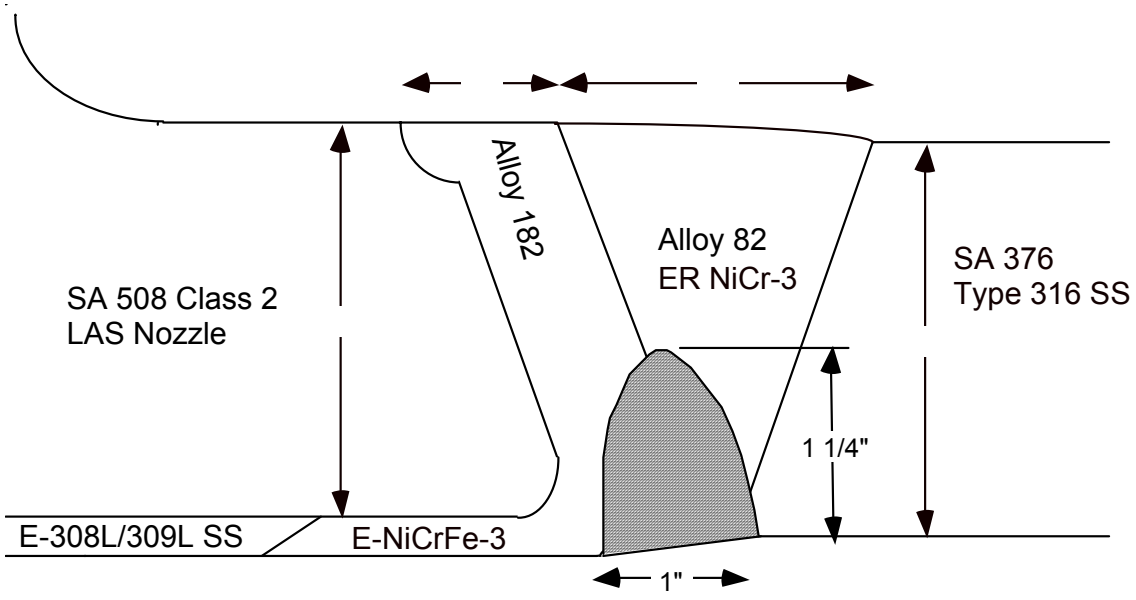
Repair length is 21.4 inches long, 1 1/4 inches deep and 1 inch across.

Figure 2-4
Schematic Cross-section of Limited Length Mid-wall Weld Repair from ID

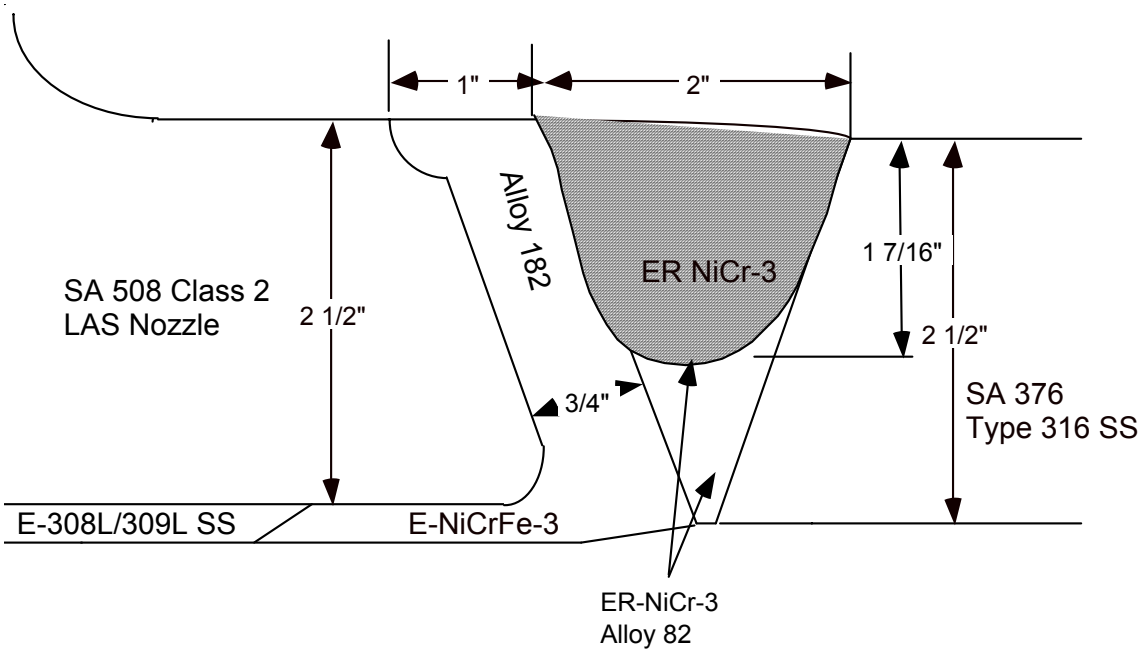
Figure 2-5
Schematic Cross-section of Deep 360^0 OD Repair

An OD repair to the entire circumference is often the best approach to repair extensive defects. This method normally would be performed using machine GTAW welding since the original weld made use of this process. The cavity would be excavated to a depth consistent with the deepest defect using a clamshell OD mounted portable lathe. See Figure 2-5. The advantage of this method over severing the weld and starting over is that no root purge is required for welding and the most likely source for weld defects is eliminated. The weld is contour ground flush after welding to facilitate ultrasonic inspection. Weld evaluations performed on stainless steel pipe welding for BWR applications suggested that excavating the weld below the centroid of the weld mass, then rewelding, produced weld residual stresses similar to an unrepaired weld. The centroid of the weld mass is about 2/3 of the wall thickness above the ID surface.

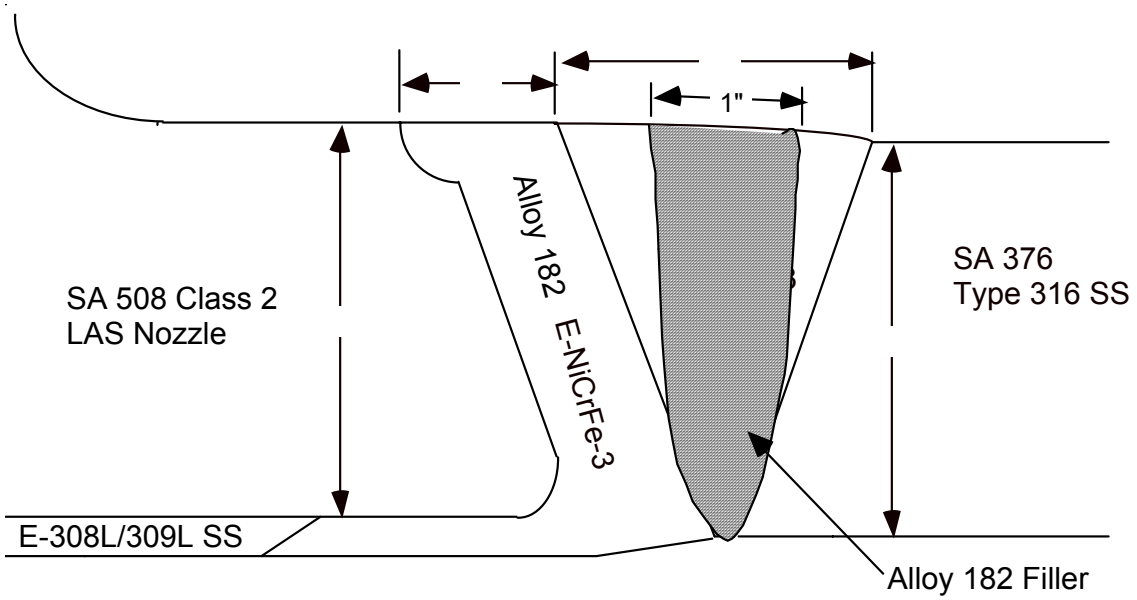
Repair Cavity is 7" long on ID and 27" long on OD
Ends are Tapered 4:1 Centered on ID Penetration
Root Opening is 1/8"

Figure 2-6
Schematic Cross-section for OD Repair of 7" Long Root Defect

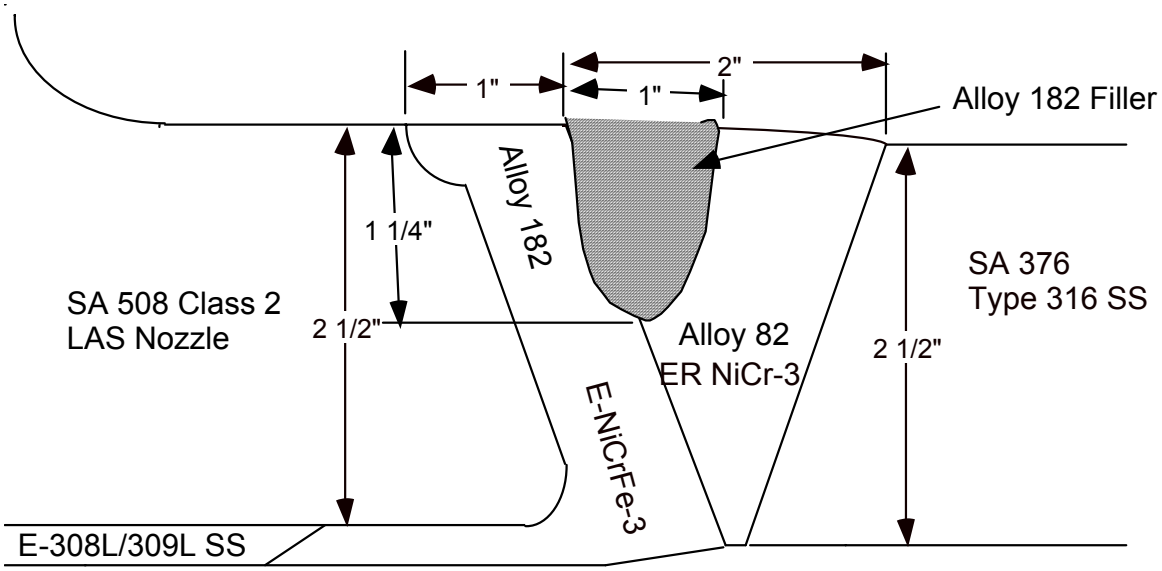
Repair Cavity is 7" long at Bottom and 17" long on OD
Ends are Tapered 4:1 Centered on 7" Excavation

Figure 2-7
Schematic of Cross-section of Limited Length Repair at Mid-wall

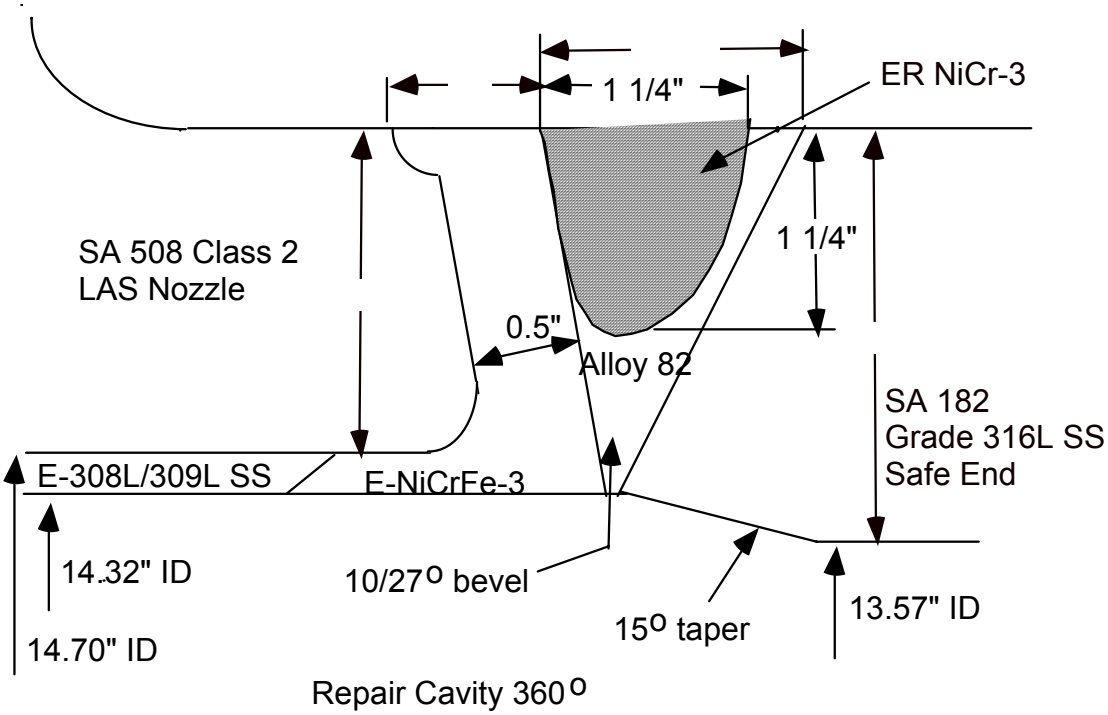
Figure 2-8
Schematic Cross-section of 360^0 Medal Repair to Surge Nozzle

This repair is conducted identically to that described in Scenario 3 above. The differences are in the dimensions of the repair. Figure 2-8 below provides the dimensions for the repair.

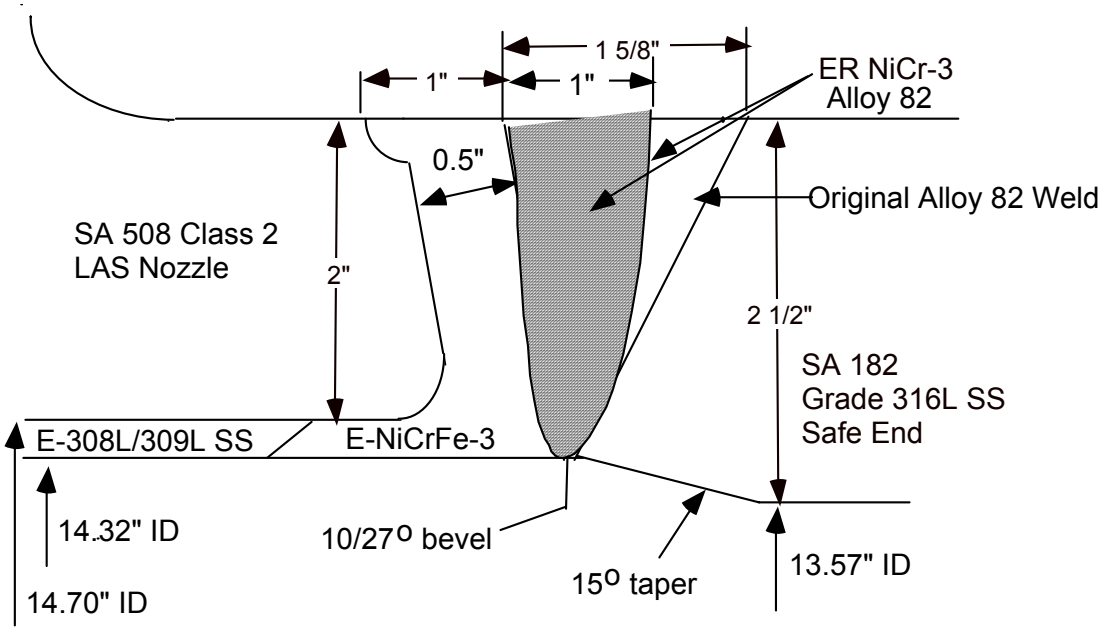
Repair Cavity is 7" Long at Bottom and 24.6" at Top and 1" Wide
Both Ends are Tapered over 8.8" (4:1 taper)
Root opening is 1/8"

Figure 2-9
Schematic Cross-section of 7" Through-wall OD Weld Repair to Surge Nozzle

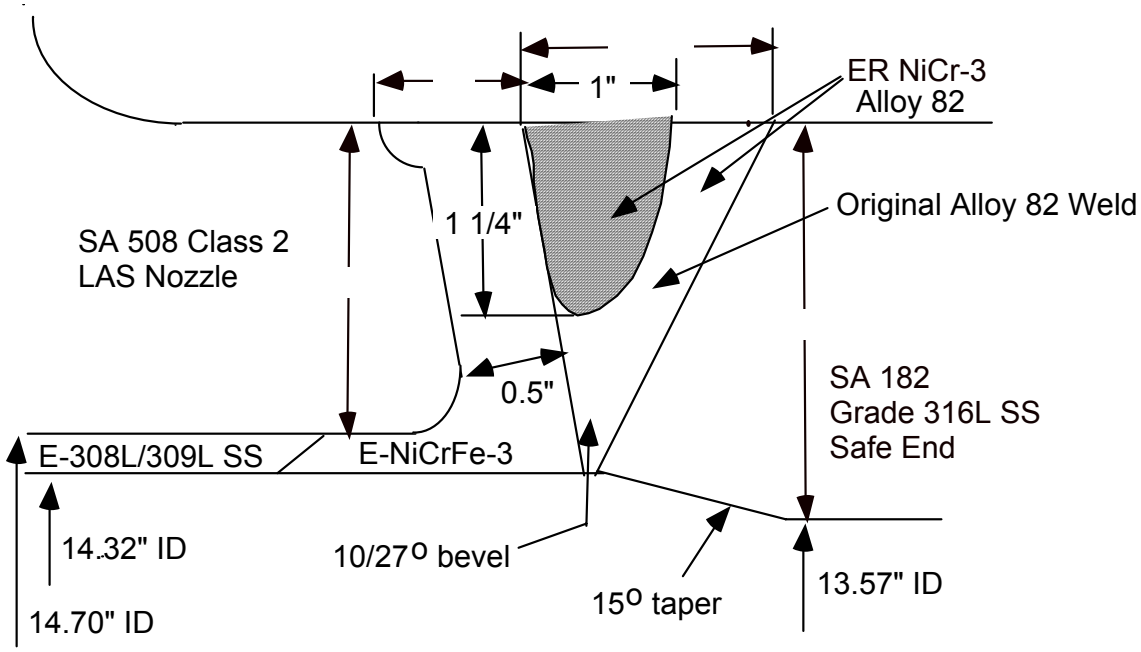
Repair Cavity is 7" Long at Bottom and 17" at Top and 1" Wide
Both Ends are Tapered over 5" (4:1 taper)

Figure 2-10
Schematic Cross-section of Limited Length Mid-wall Repair from OD of the Nozzle

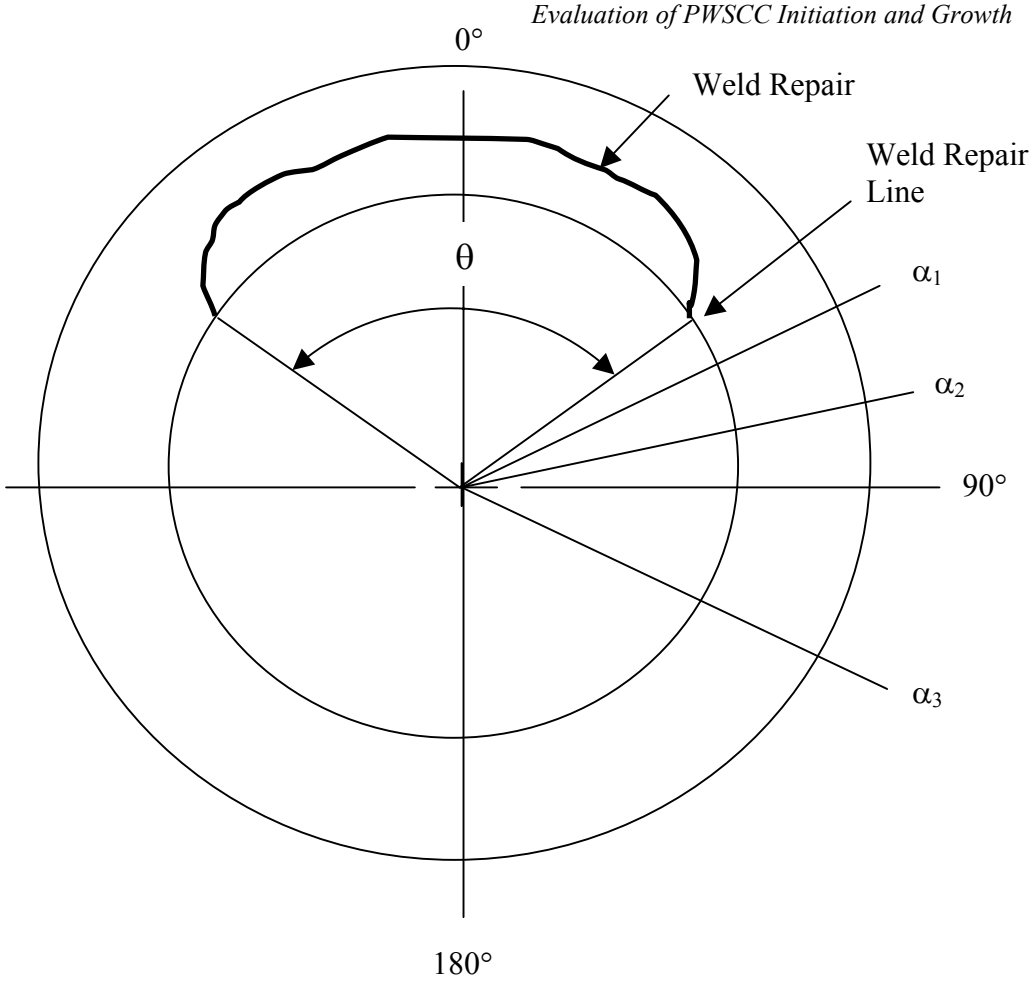
Figure 3-1
Circumferential Extent of Repair

It is well established that welding causes residual stress in the local vicinity to the weld. Also, the weld residual stress decreases rapidly with distance from the weld repair (both circumferentially and axially). In order to incorporate the effect of the rapid decrease in weld residual stress with distance from the weld repair, through-wall stress distributions at various angular locations with respect to the weld repair were used in the fracture mechanics analysis. Figure 3-1 shows these locations as α_1, α_2, and α_3.

Figure 3-1 is a schematic of a circumferentially oriented weld repair of angular length θ.

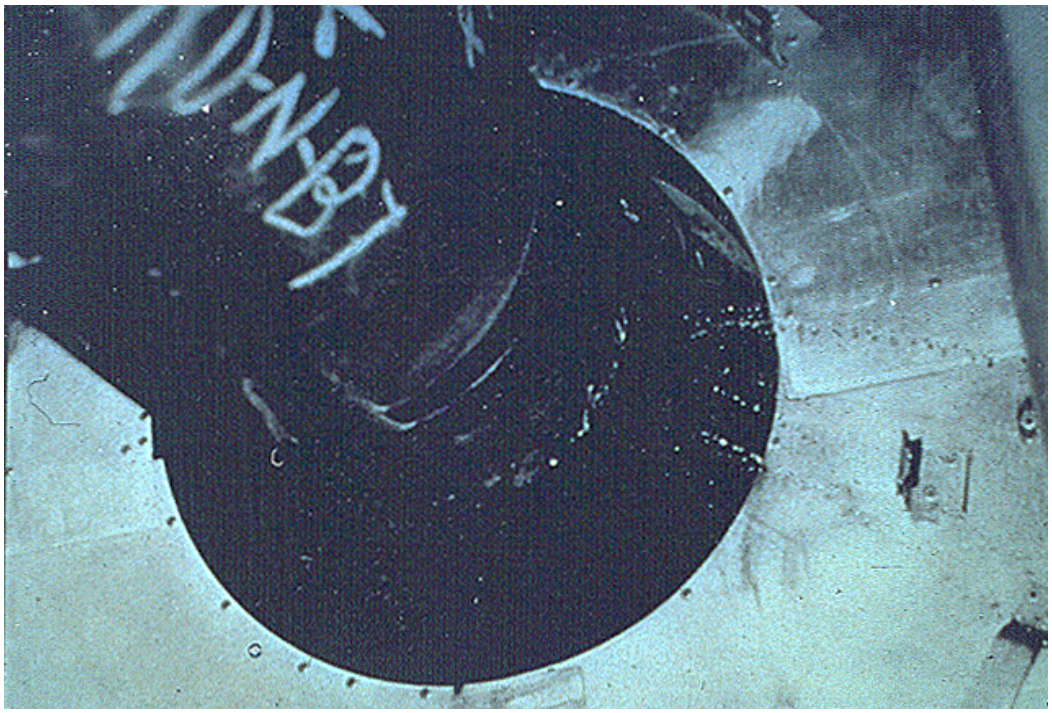
Figure 4-1
Leaking Alloy 600 Safe End at DAEC

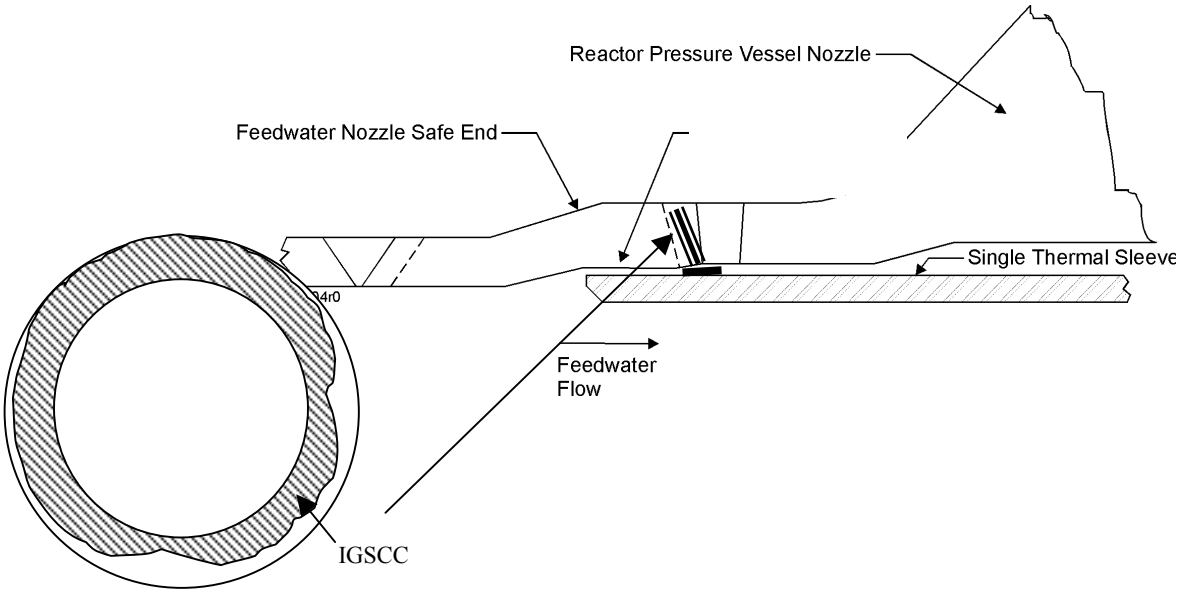
Figure 4-2
Schematic of the Circumferential IGSCC at Duane Arnold

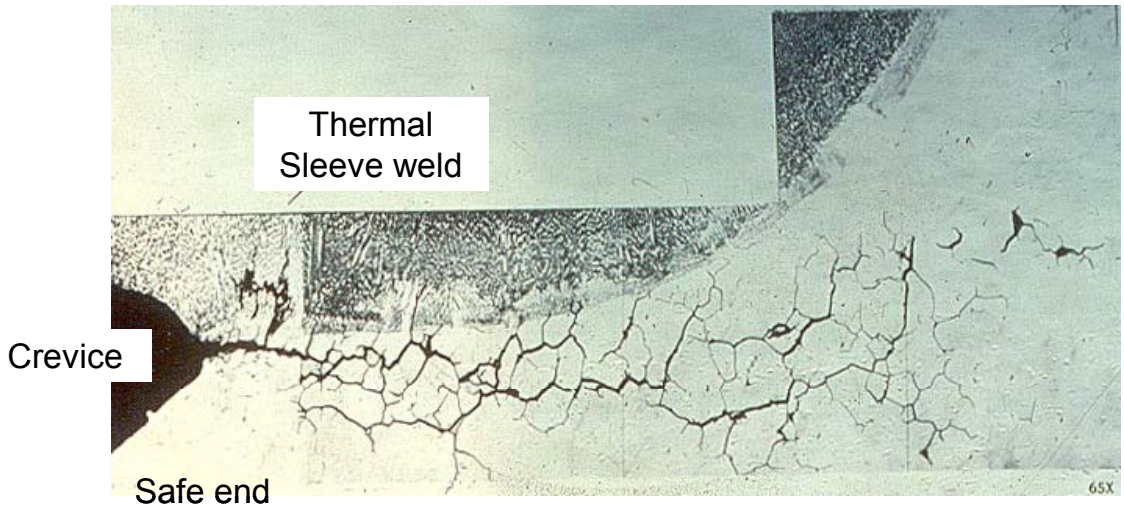
Figure 4-3
Duane Arnold Alloy 600 Recirculation Inlet Safe End Crevice with IGSCC

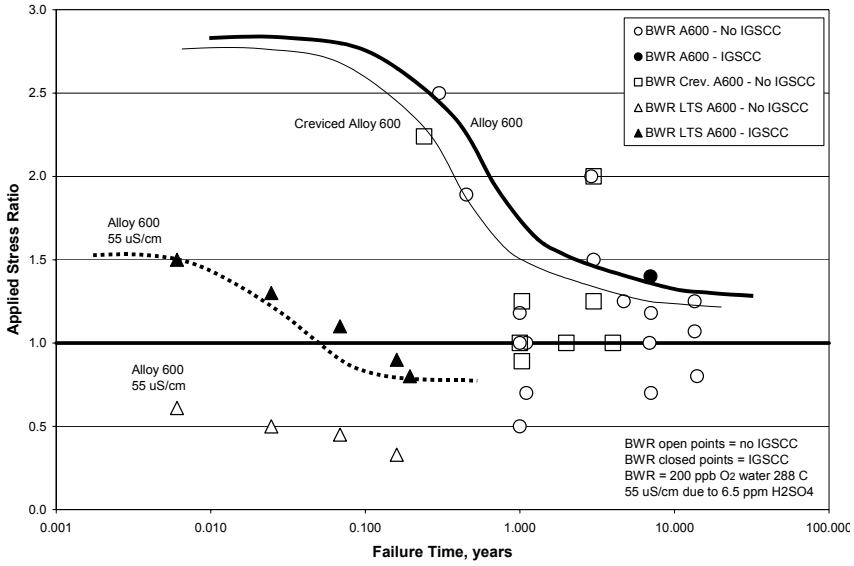
Figure 4-5
Effect of Crevices on IGSCC of Alloy 600 in BWR Environments [8][1]

90% through-wall crack after seven years of exposure at an applied stress ratio of 1.4. (See the solid point pinning the uncreviced Alloy 600 IGSCC curve in Figure 4-5.)

[1] The general shape of the Alloy 600 time-to-failure curves are based on sensitized stainless steel data where the uncreviced Alloy 600 curve is pinned by the single pressurized tube result. Since creviced Alloy 600 would be expected to crack after shorter exposures periods, the creviced curve is sketched to the left of the uncreviced curve.
