Dominion Nuclear Connecticut, Inc.
Millstone Power Station
Rope Ferry Road
Waterford, CT 06385

DOMINION NUCLEAR CONNECTICUT, INC.
MILLSTONE POWER STATION UNIT 2
THIRD 10 TEN YEAR INSERVICE INSPECTION (ISI) INTERVAL
RELIEF REQUEST RR-89-54, USE OF ALTERNATIVE ACCEPTANCE STANDARDS REQUIREMENTS WITHOUT FLAW REMOVAL IN ALLOY 600 SMALL BORE NOZZLES

RELIEF REQUEST RR-89-54, USE OF ALTERNATIVE ACCEPTANCE STANDARDS REQUIREMENTS WITHOUT FLAW REMOVAL IN ALLOY 600 SMALL BORE NOZZLES

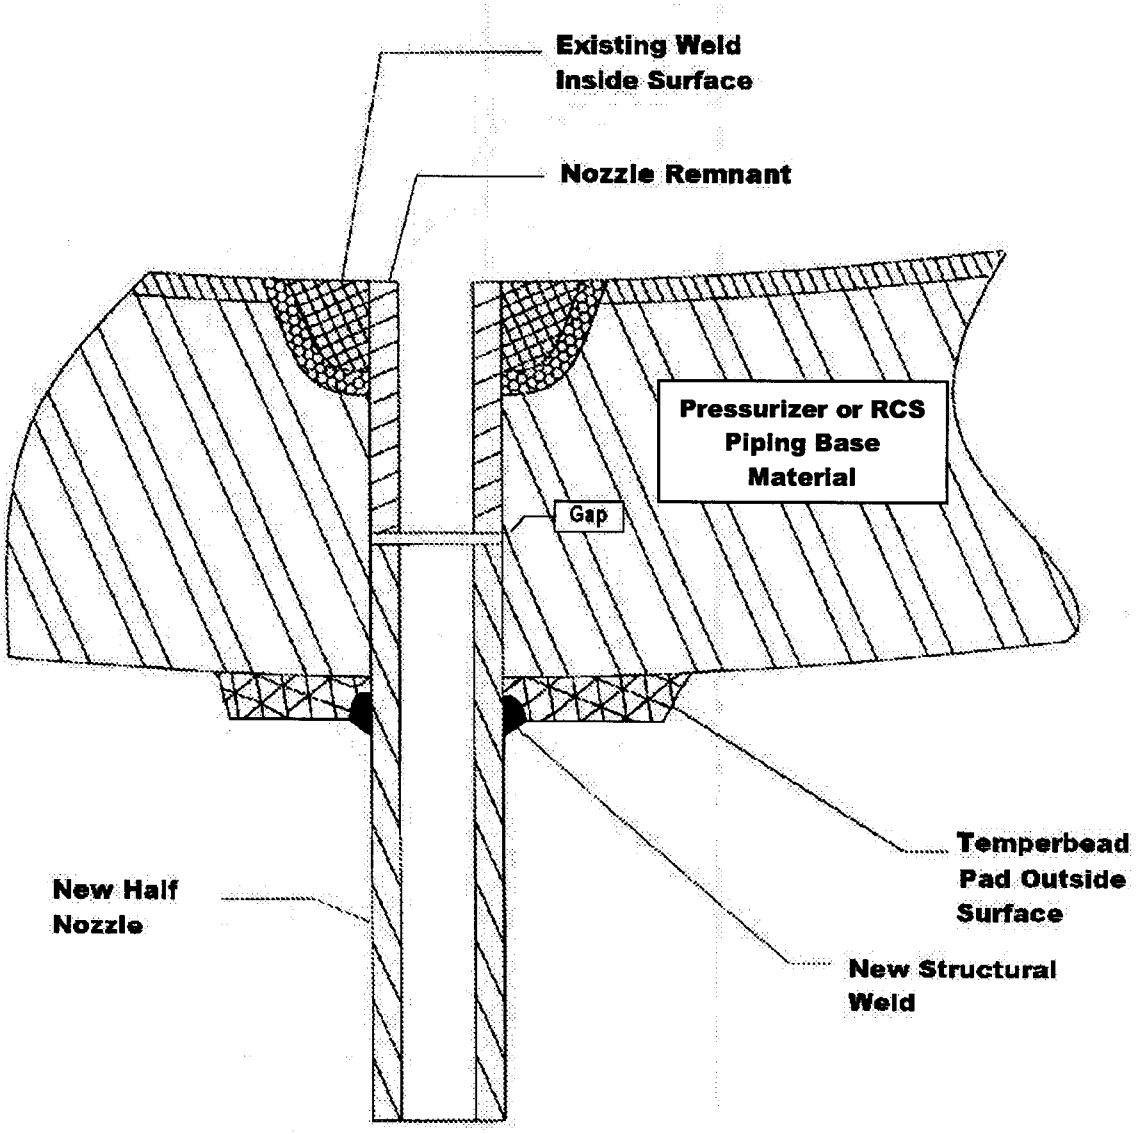
FIGURE 1:
TYPICAL HALF NOZZLE REPAIR/REPLACEMENT WITH
A WELD PAD DEPOSIT

If leakage is identified, MPS2 plans to perform a pressurizer and/or RCS hot leg piping half nozzle repair/replacement typically depicted in Figure 1 of this Attachment and installed as follows:

1. Mechanical removal of a portion of the existing nozzle.
2. Application of a weld pad or weld buildup (F-No. 43) to the pressurizer shell (P-No 1) base material, (not required for RCS hot leg piping)
2. Machining of the weld pad to accept the new replacement nozzle (P-No. 43) material, (not required for RCS hot leg piping)
3. Installing the new replacement nozzle by using conventional manual gas tungsten arc welding (GTAW) and a "J"-groove partial penetration weld on the outside of the pressurizer or RCS piping.
