Plum Brook Reactor Facility

SUPPLEMENTAL CHARACTERIZATION REPORT FOR THE PLUM BROOK REACTOR FACILITY

Revision 0
December 16, 2004

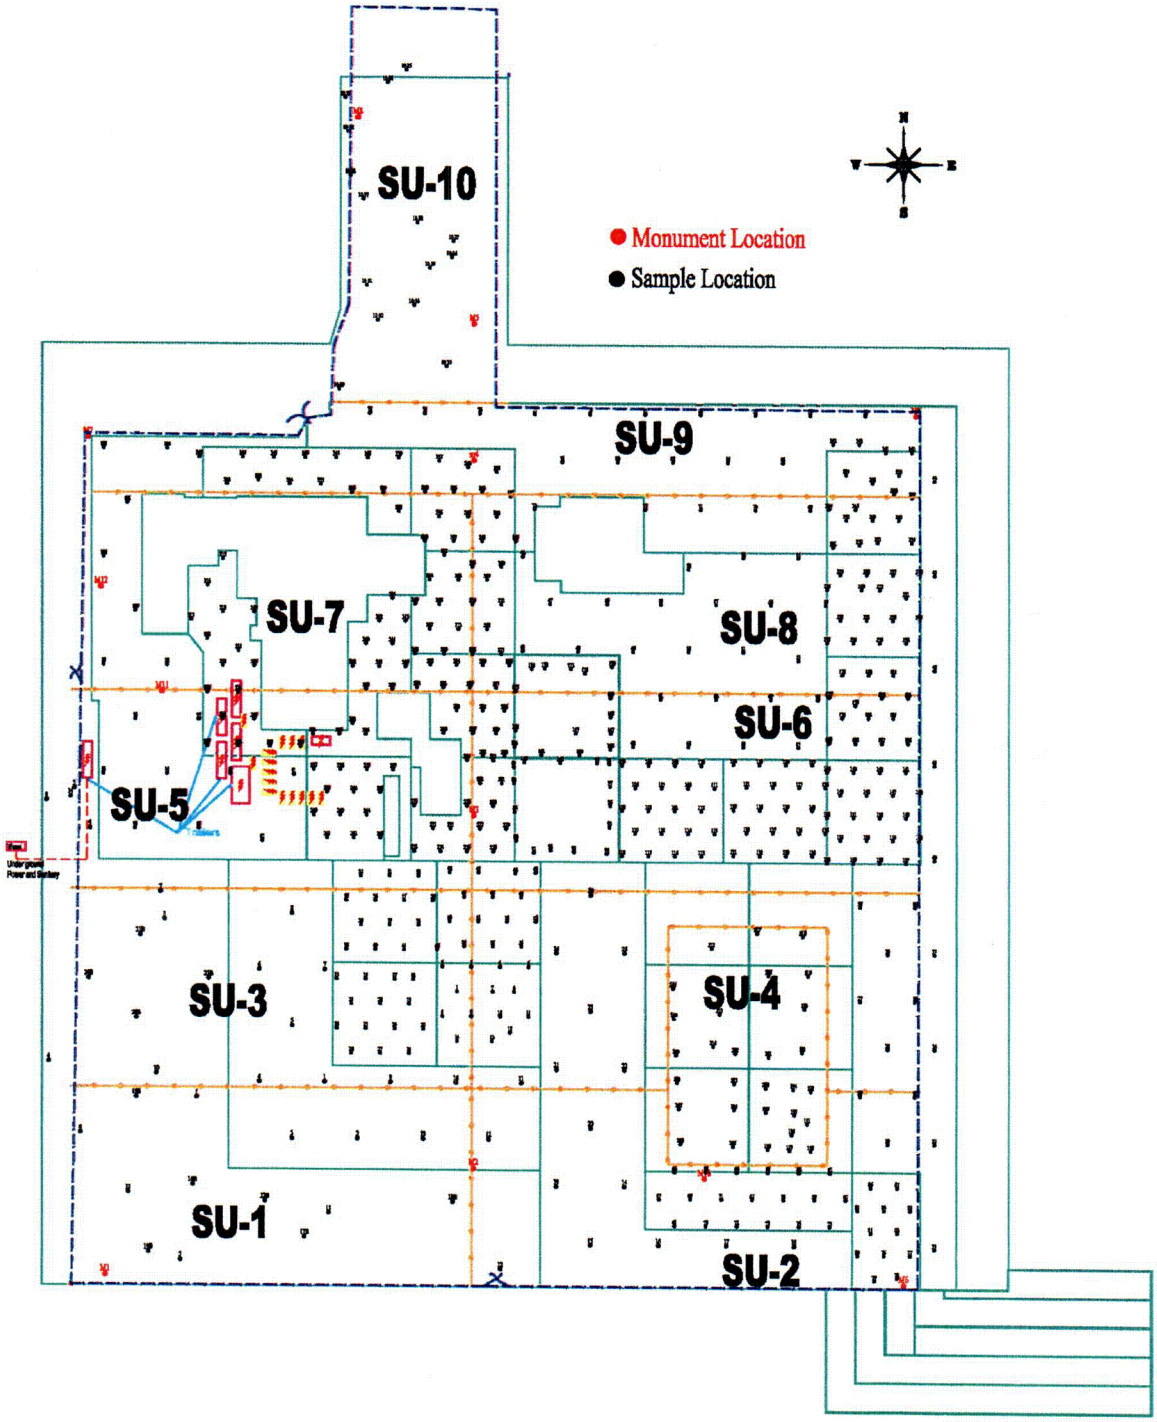
Figure 4-1, Site Environs Survey Units & Sample Locations

The specific survey unit characterization summary information is provided in the following sections.

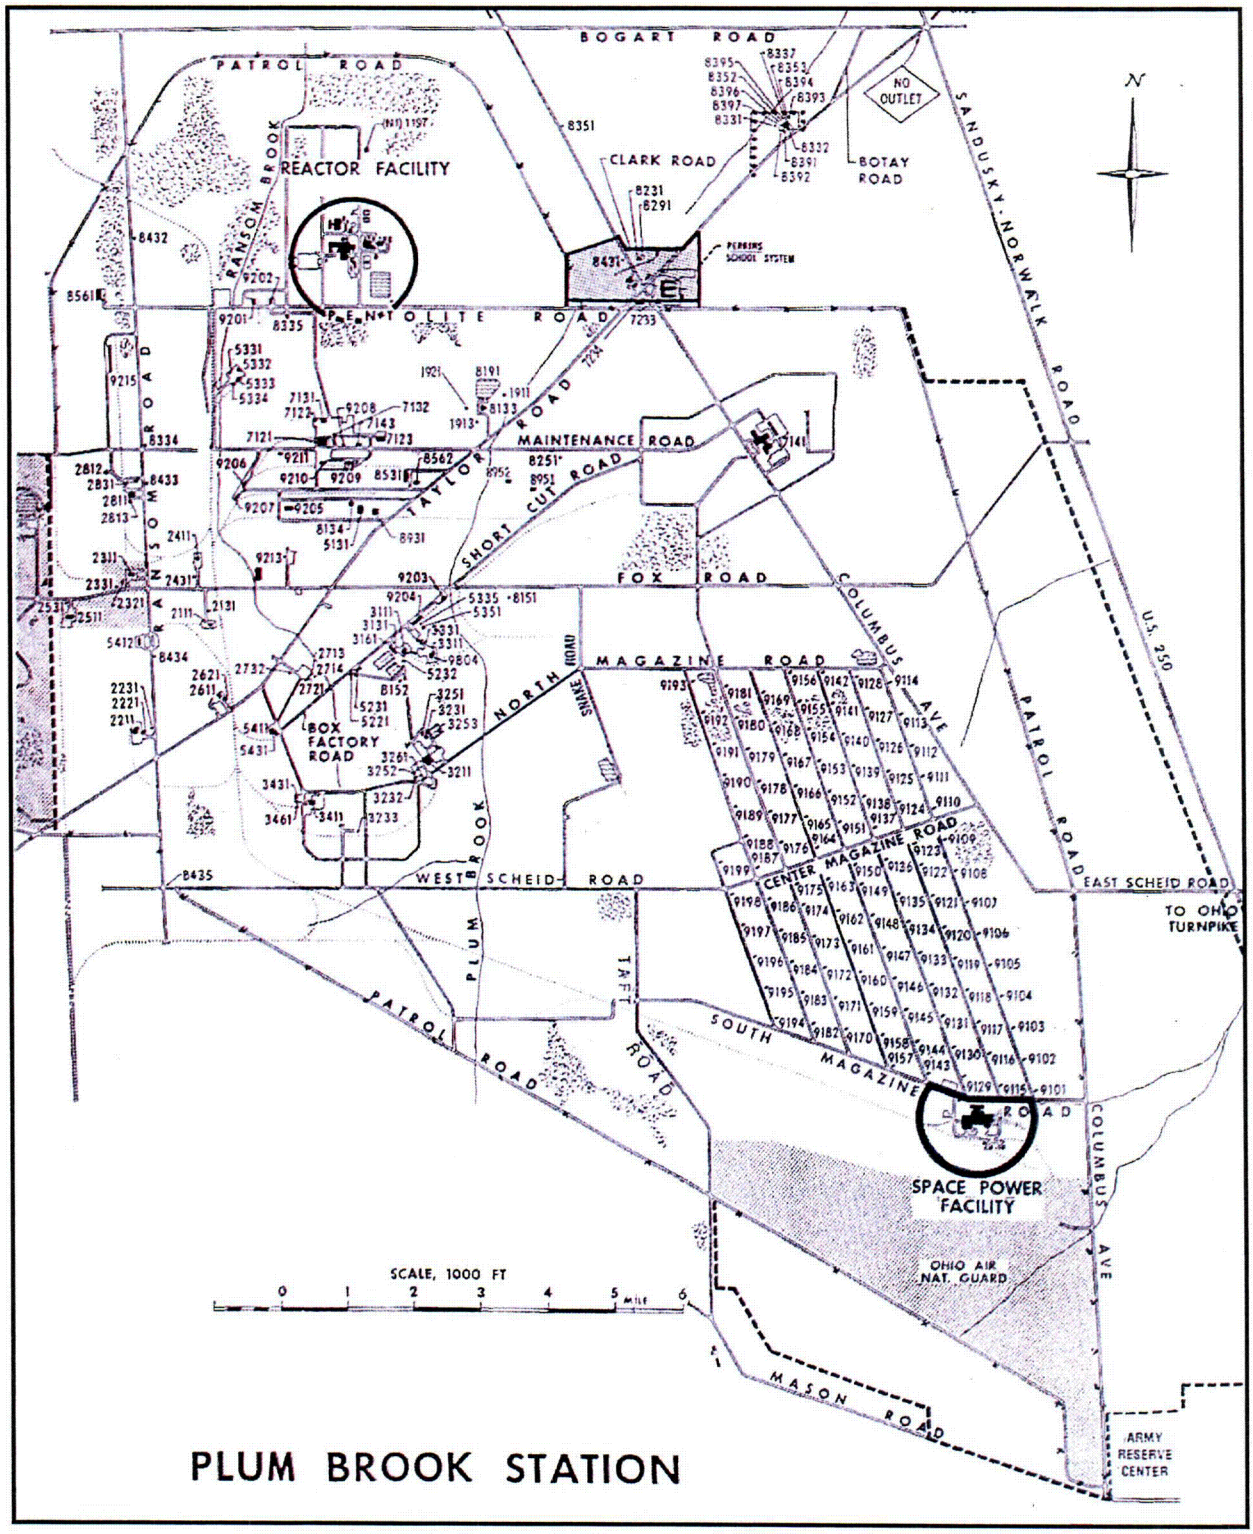
Figure 4-2, Plum Brook Station

Figure 4-2, below, illustrates the location of the PBRF in relation to the areas of the Plum Brook Station site where background studies were conducted.
