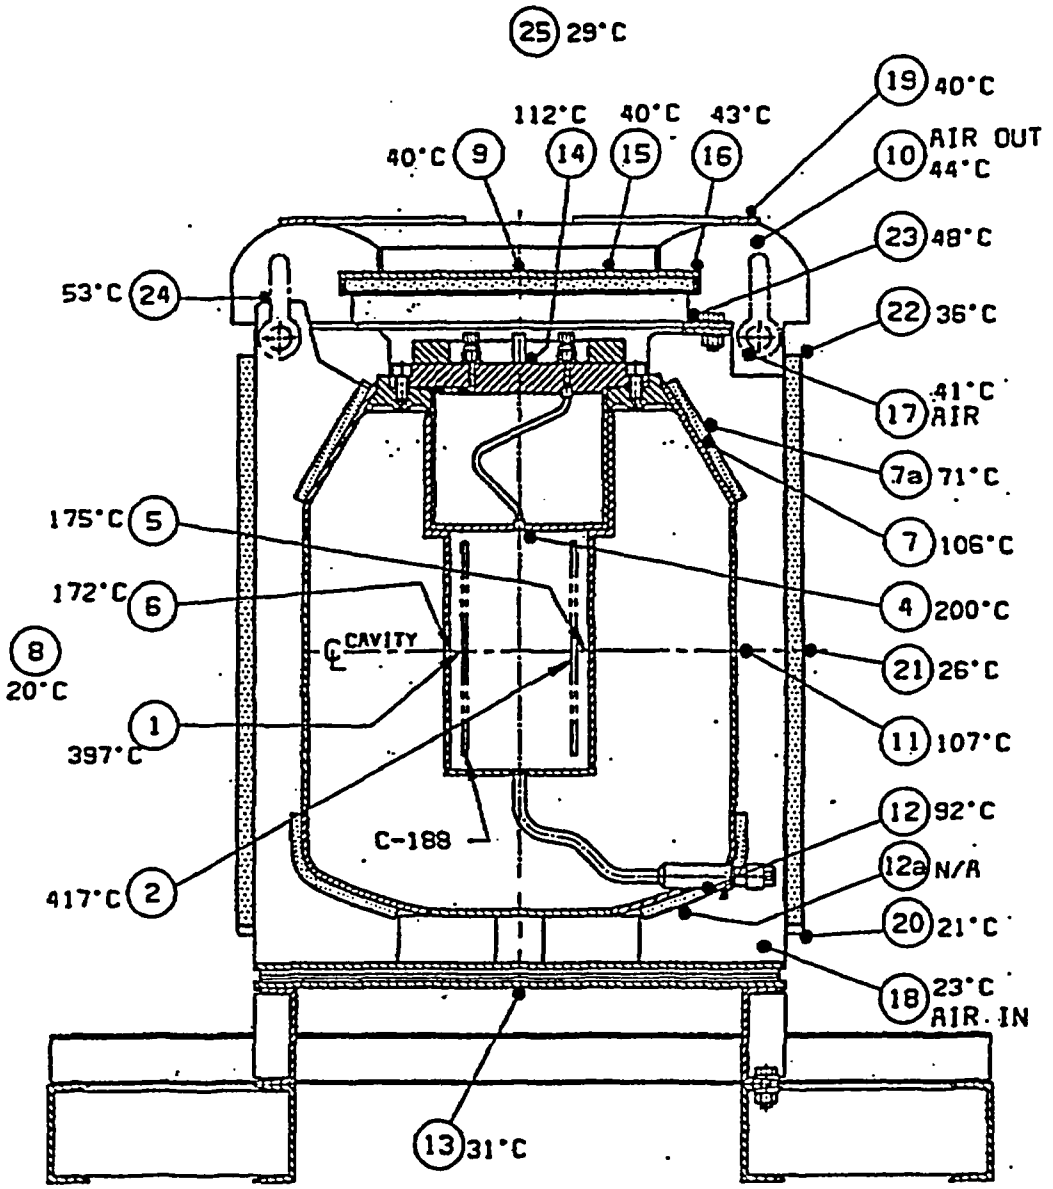
Figure 2.6-F1
Measured Steady State Temperature for F-294 Container (374,428 Ci load: 5.766 kW) Before the F-294 Drop Test (with F-313 Source Carrier)

T/C #3 - C-188 TEMPERATURE (415°C), NOT SHOWN IN THIS PLANE

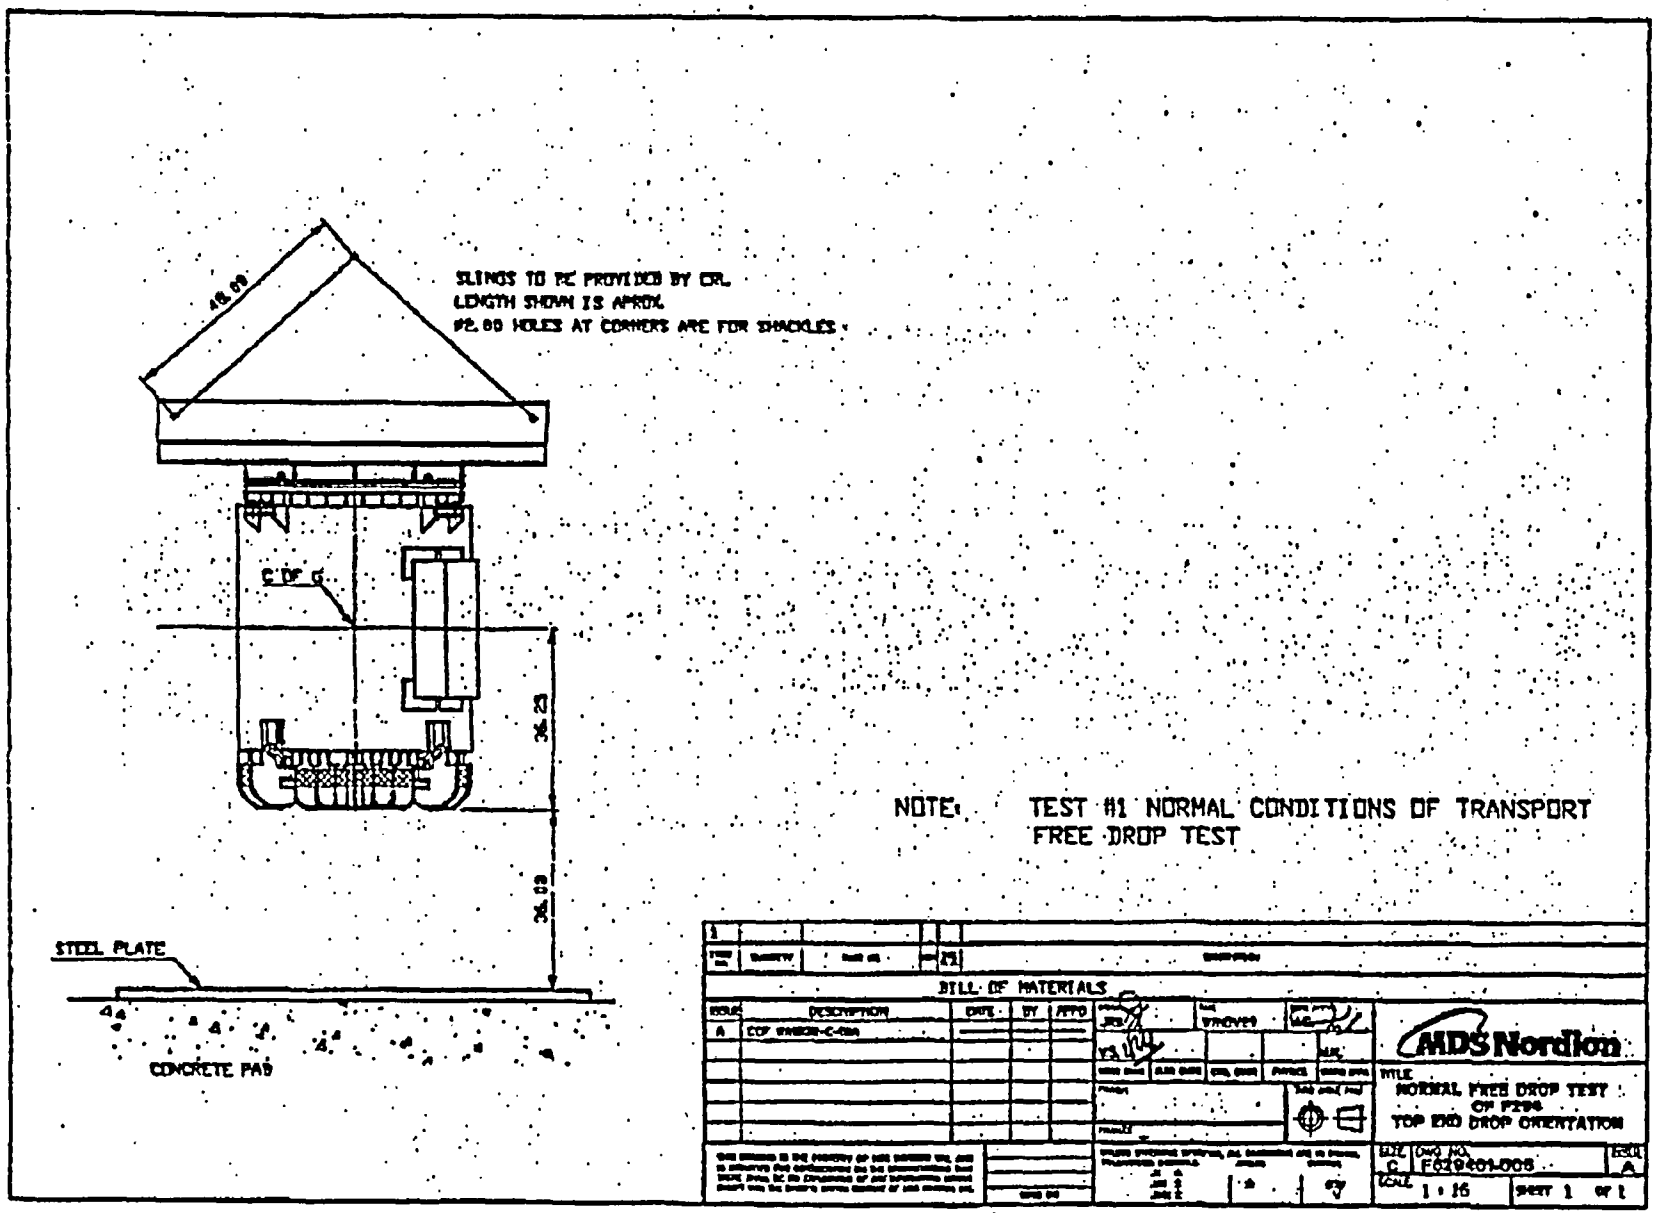
Figure 2.6.6-F2
3-Ft. Free Drop Test #1 in Top End (inverted) Orientation

1) 3-ft. free drop Test #1: top end drop orientation (i.e., inverted). See Figures 2.6.6-F2 (Dwg. F629401-005) and Figure 2.6.6-F3 (photo 9802-23308-5) as record of F-294 test packaging before the drop tests and Figures 2.6.6-F4 (photo 9802-23308-7) and Figure 2.6.6-F5 (photo 9802-23308-10) as record of the F-294 test packaging after the drop test. The closure plug, the crush shield and the cylindrical fireshield were all retained and remained securely attached. The principal damaged zones were centered around the crush shield. However, there was no breach of the primary container shell. The test observations are:
   1. Slight "ripple" on load spreader plate of crush shield.
   2. Mesh slightly bent inwards between two fins on crush shield.
   3. Up to 0.5 in. of deformation on the crush shield.
   4. No other visible change.

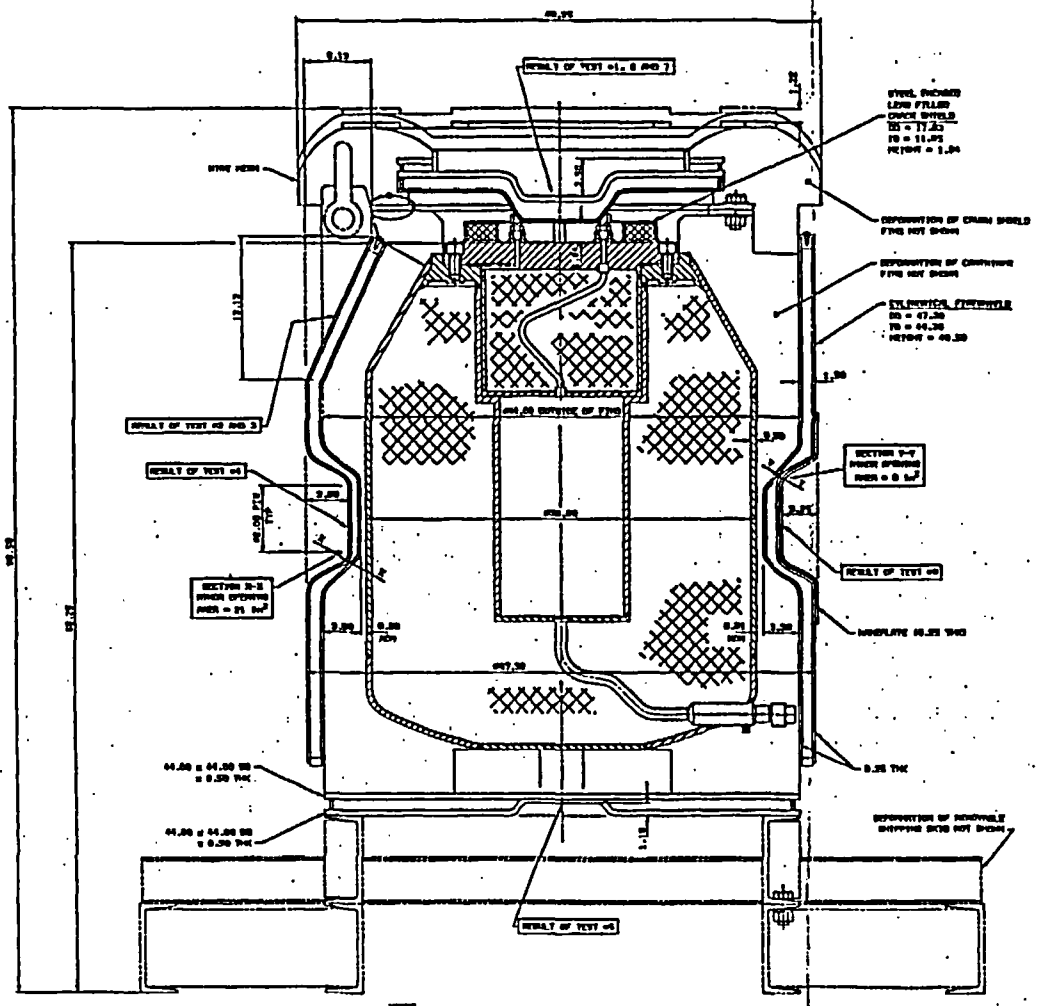
Figure 2.7.1-F10
F-294 Test Packaging Approximate Deformation Profile (After 8 Drop Tests)
(Dwg. F629401-022)

3. After the drop tests, the damage to the F-294 test packaging is as follows:
   1. There were no cracks in the F-294 cavity wall or the external primary shell of the container (flask). there were no cracks in the closure plug.
   2. Some container fin-to-fin welds were fractured. Some container-to-fin welds were fractured. Some container fins had deformed significantly.
   3. The closure plug was in place and had not come loose. The "neoprene" gasket of the closure plug bolted joint was not damaged. The lift lug of the closure plug was compressed by 0.66 in., primarily due to puncture pin impact.
   4. The fins of the crush shield and the container buckled in the standard J-shape or S-shape.
   5. The cylindrical fireshield and the crush shield were retained.

The damage to the thermal protection was approximately 800 in^2 out of total thermal protection of 9,257 in^2. This represents 8.6 % of total thermal protection area was damaged.
