One Line Description: **MODE RESTRAINT 4**CRDM Nozzle 26 Possible Flaw Indications

To: Mark Huting
From: Charles Tomes
Date: May 13, 2004
Subject: U1R28 Extent of Condition Evaluation for Penetration # 26 at PBNP
Copy To: John Paul Cowen, Lyle Bohn, Doug Cooper, Gary Van Middlesworth, James Schweitzer, Craig Lambert, Brian Kemp, Bill Jensen, Kim Bezzant, Gary Sherwood, Jim McCarthy

Purpose
The primary objective of this evaluation is to document the results of the extent of condition review of indications disclosed in penetration #26 at PBNP-1.

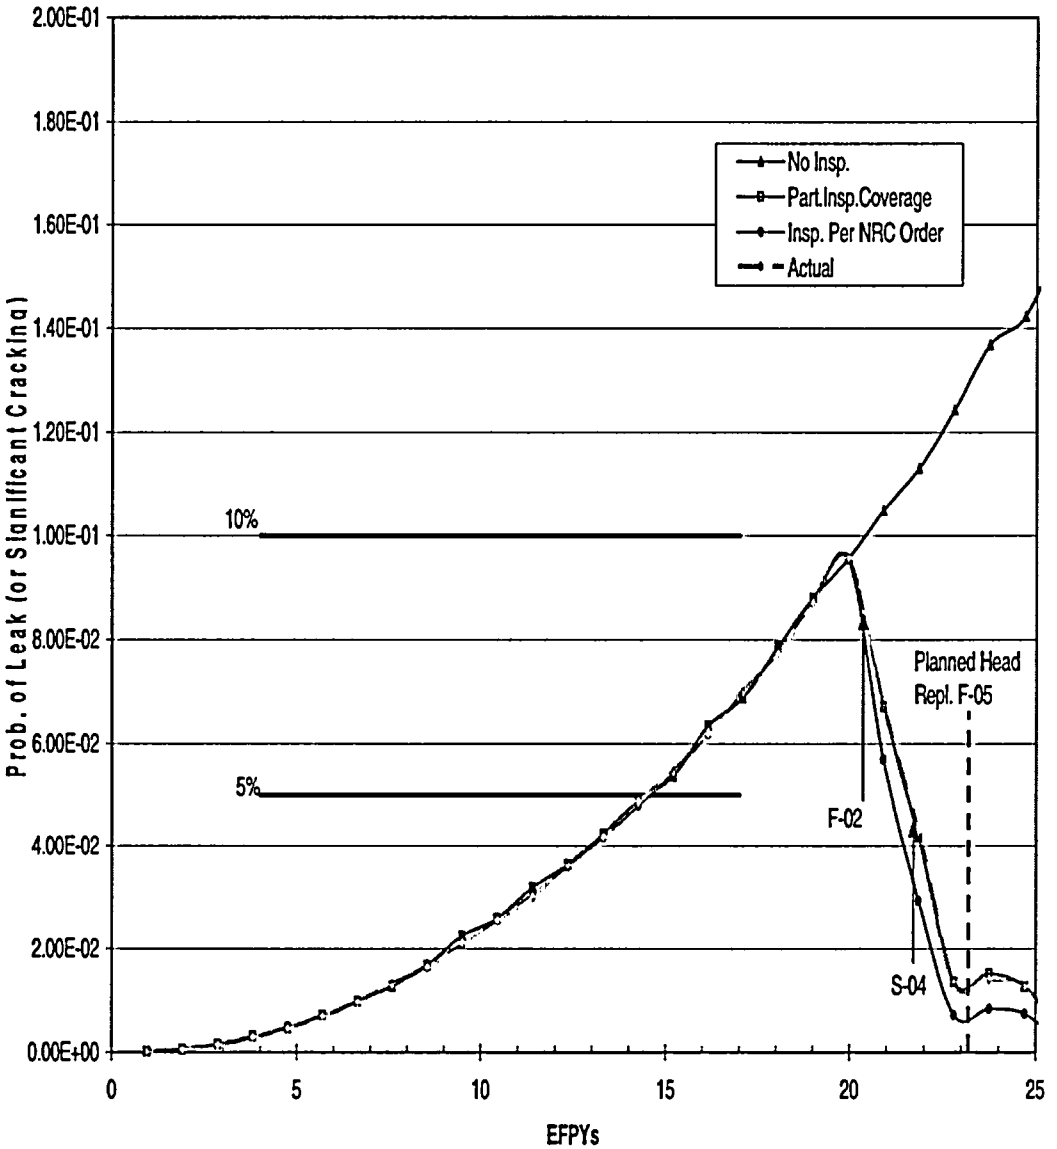
Figure 1
Probability of Leakage at PBNP U1

6. Operation of the reactor vessel head following repair of penetration #26 will not compromise nuclear safety or structural limits whether or not additional PT examinations are performed of j-groove welds. The probability of leakage over the next operating cycle is demonstrated to be acceptably small, < 1.5%, without performing additional PT examinations of the J-groove welds.
