SUBJECT: Indian Point Nuclear Generating Unit 3
Docket No. 50-286
NRC First Revised Order EA-03-009; Revised Relaxation Request for Inspection of IP3 Reactor Pressure Vessel Head

REVISED RELAXATION REQUEST FOR IP3 REGARDING ULTRASONIC TESTING
OF REACTOR PRESSURE VESSEL HEAD NOZZLES
IN ACCORDANCE WITH FIRST REVISED NRC ORDER EA-03-009, SECTION IV. F.

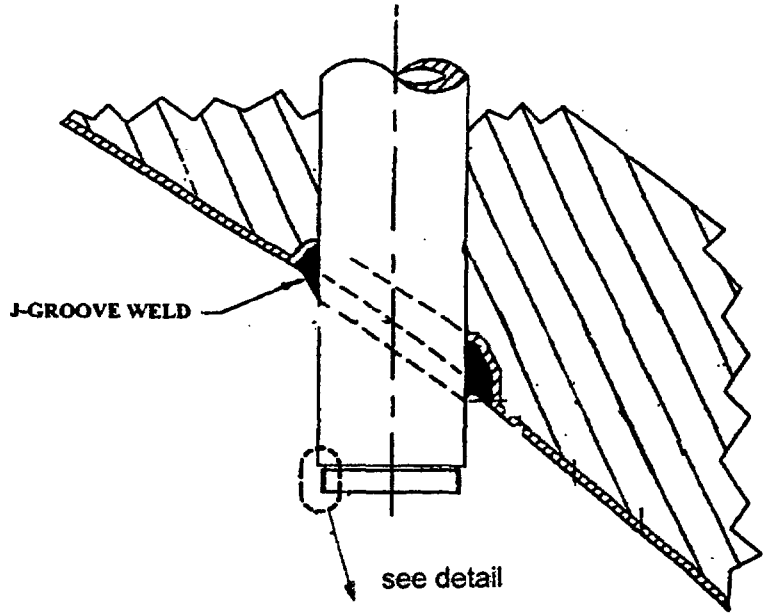
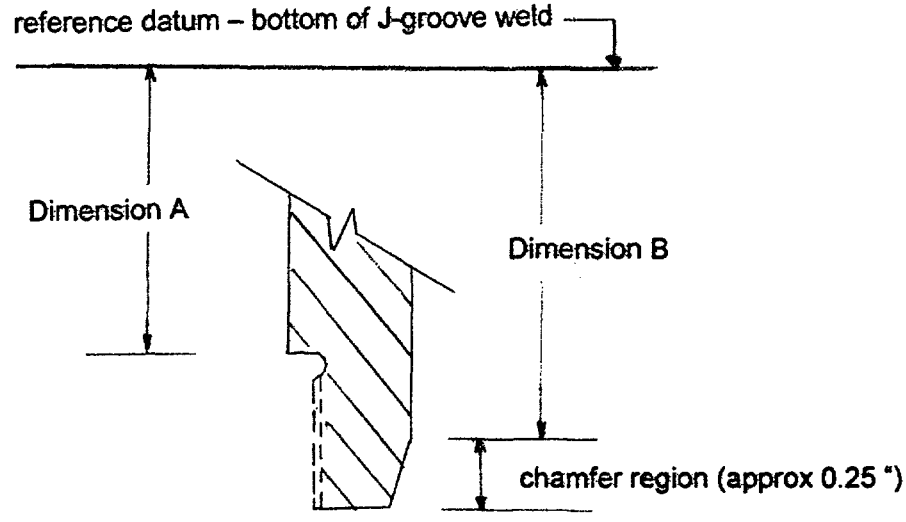
FIGURE 1-1

The design of the RPV head penetration nozzles (see Figure 1-1) includes a threaded section, approximately ¾ inches long, at the bottom of the nozzles. At 36 locations (nozzles numbers are listed in Table 1 and as shown in Figure 1-2) the dimensional configuration is such that the distance from the lowest point at the toe of the J-groove weld to the bottom of the scanned region (essentially the start of the threaded region) is less than the 1-inch lower boundary limit specified in section IV.C.5 (b) of the First Revised Order. Since UT and ECT results would not

be meaningful in the threaded region, Entergy proposes that the lower boundary of the inspection extend essentially to the start of the threaded region for UT. ECT scanning, as listed in Table 1, obtained greater than 1" coverage on the ID surface of the nozzle tube below the lowest point at the toe of the J-groove weld with no relevant indications noted. Leakage path assessments were performed and no leakage was noted.

the threaded region. Meaningful ECT data below approximately 0.25 inches was also limited because the eddy current coil tends to lose contact with the examination surface as it reaches the lead-in chamfer region (see attached Figure 1-1). As discussed above, the hardships in removing the guide funnels welded to the bottom of the nozzles precludes examination of the OD wetted surface areas of the nozzle tubes.

2. See Figure 1-1, Dimension A. UT inspection extends from the bottom of the J-groove weld to the top of the threaded region.

3. See Figure 1-1, Dimension B. ECT inspection extends from the bottom of the J-groove weld to the top of chamfer region.
