Omaha Public Power District

May 17, 2005
LIC-05-0062

SUBJECT: Fort Calhoun Station Unit No. 1, Response to Request for Additional Information on the Revised Relaxation Request for First Revised Order (EA-03-009) Establishing Interim Inspection Requirements for Reactor Pressure Vessel Heads at Pressurized Water Reactors

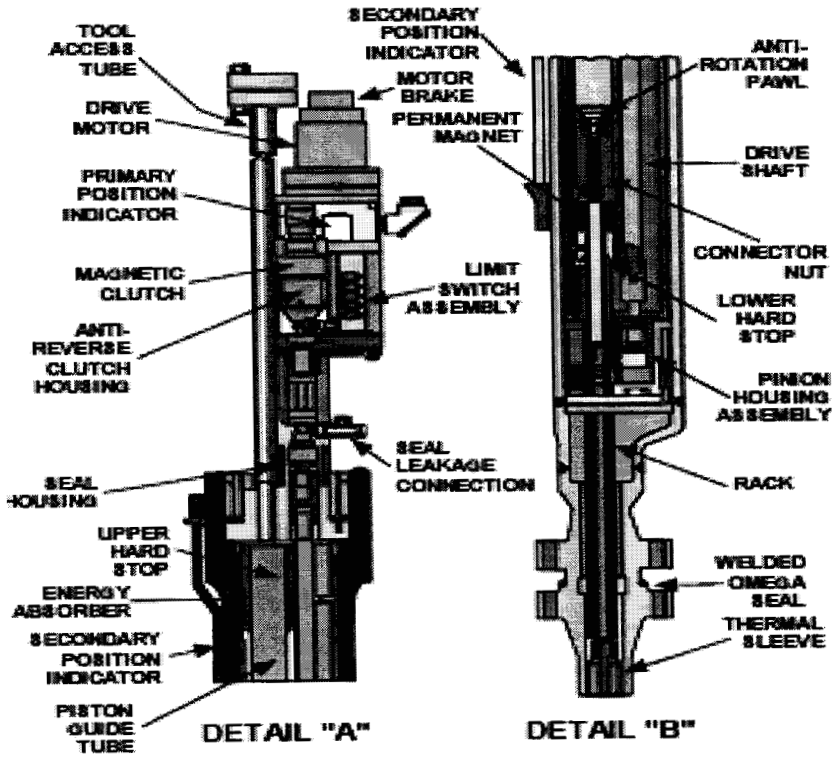
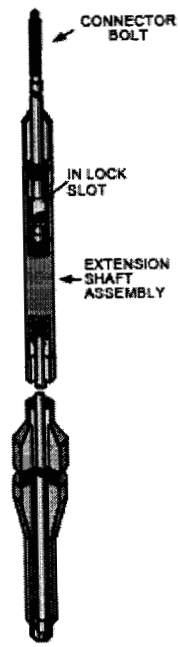
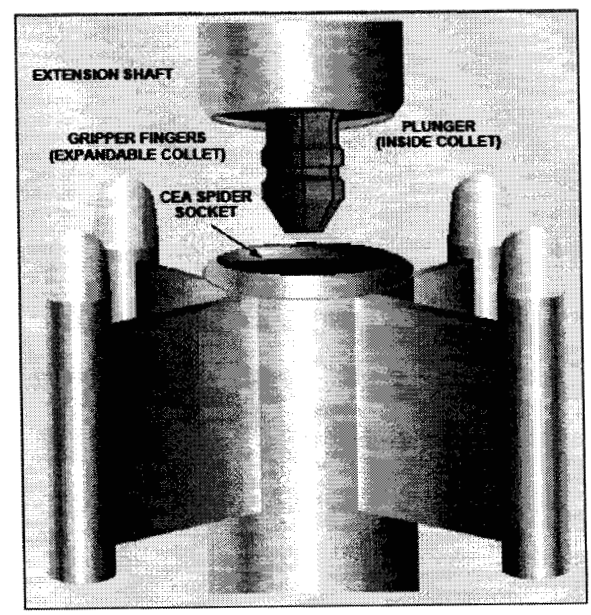
The basic component arrangement of the system is shown in Detail "A" (upper components) and Detail "B" (lower components). The components of interest in this discussion are as follows:

- Extension shaft assembly – supports the CEA spider
- Connector bolt – supports the extension shaft assembly
- Connector nut – supports the connector bolt
- Rack raises and lowers the rack extension to raise the CEA

The CEDM extension shaft assembly is inserted through the CEDM nozzle from underneath the RPV head and extends through the rack into the piston guide tube.

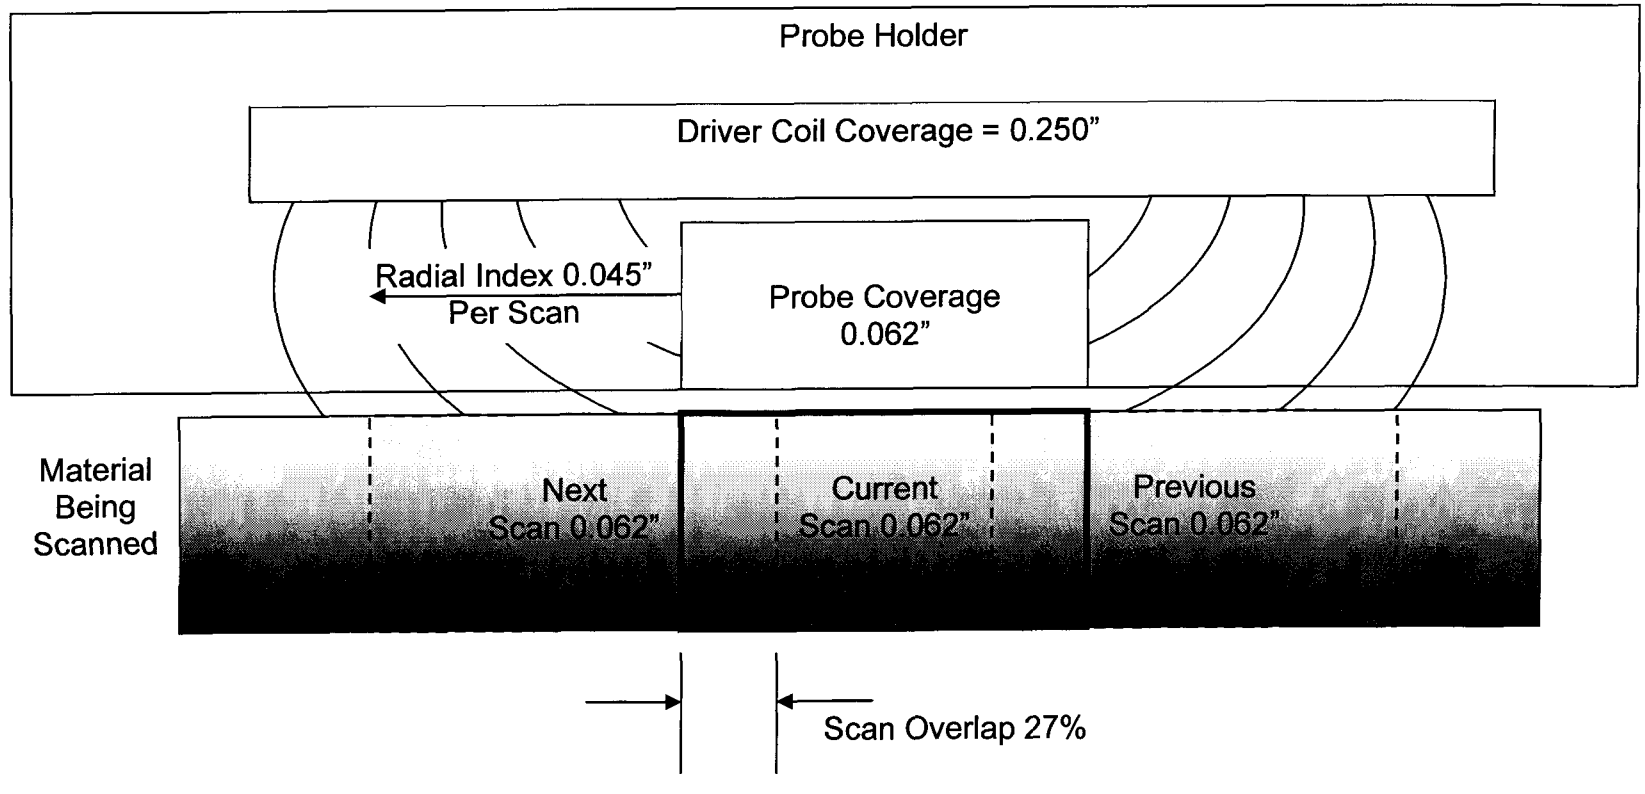
Attachment 1, Figure 1

Various CEDM nozzles have single missing scan line information in some areas. OPPD has determined in each case that a single missing scan line does not prevent determination of a potential significant flaw, due to the amount of overlap of adjacent scan line coverage in adjacent eddy current traces. These areas are considered to be fully inspected.

The geometry of the probe and driver coil in combination with size of the scanning grid and the defined overlap ensures that any indication, regardless of width or length, will be observed. Adjacent scan lines have an overlap of 27% as shown on Figure 1. This criterion is based on the number and location of sensors in the probe and the overlapping regions of sensitivity resulting from the scan line increment assuring that a valid indication of relevant length should be evident. An indication picked up in one scan line will also be seen by the adjacent scan lines. A missing scan line is most likely caused by small boric acid on deposits or crud accumulation on the nozzle or thermal sleeve surface which causes axial travel resistance on the probe.

Due to features in the scanning mechanism that prevent the probe delivery device from exceeding allowed force limits (intended to prevent probe failure during the scan), the probe automatically retracts when sufficient resistance is detected and begins to scan the next line.

Scan Coverage Geometry
