your energy partner
OPPD
Omaha Public Power District

May 14, 2005
LIC-05-0057

SUBJECT: Fort Calhoun Station Unit No. 1, Revised Relaxation Request for First Revised Order (EA-03-009) Establishing Interim Inspection Requirements for Reactor Pressure Vessel Heads at Pressurized Water Reactors

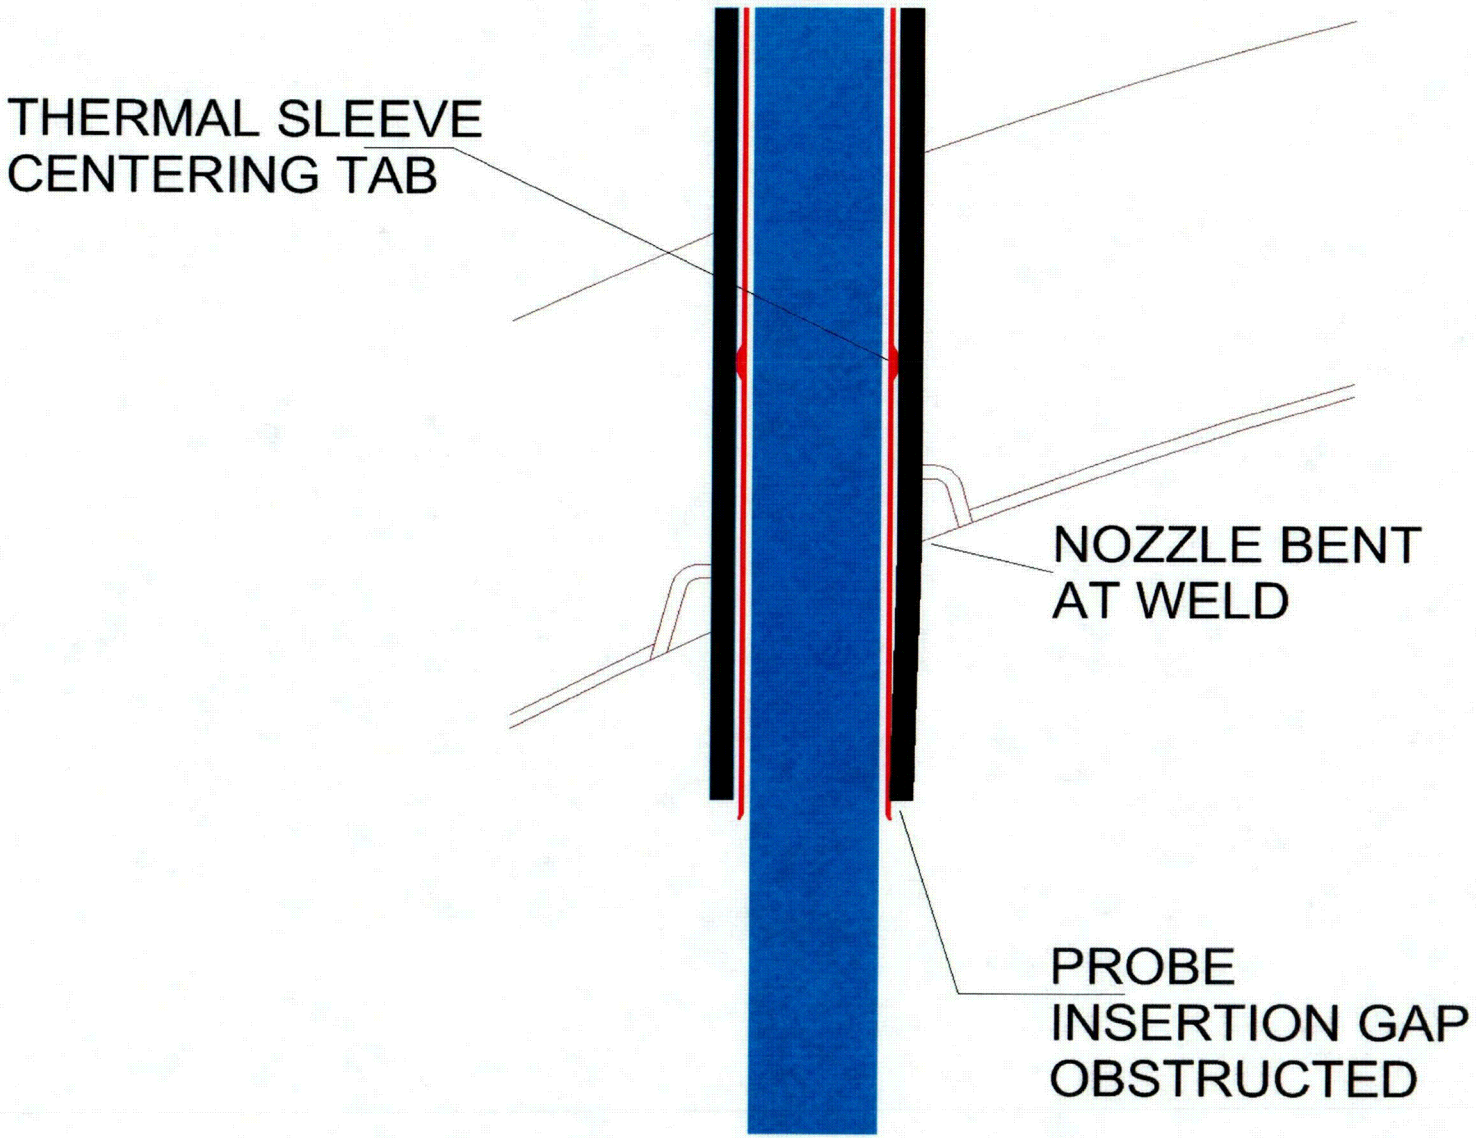
Attachment 1, Figure 6

During the performance of the FCS RPV head inspection in the Spring 2005 RFO, OPPD discovered that some of the concentrically designed CEDM nozzles and thermal sleeves were not aligned per design drawings, preventing probe access to some of the CEDM nozzle inner diameter (ID) areas (Figure 6). The blade-type ECT nozzle probe was designed to be inserted in the annulus between the CEDM nozzle and thermal sleeve for ID examination of the nozzle base material. The examination methodology incorporates an overlapping series of axial scans around the circumference of each nozzle. The CEDM nozzles appear to be slightly warped because of heat stresses from the initial welding process during construction of the RPV head. Due to the resulting off-center location of the thermal sleeves relative to the nozzles, the space between the nozzle and the thermal sleeve is insufficient in some places for probe insertion. OPPD developed a special tool to enable the thermal sleeves to be moved enough for probe insertion (Figure 7). This enabled access to most of the ID areas blocked by the off-center thermal sleeves. However, some ID areas for certain CEDM penetration nozzles were still inaccessible even when using the special tool, due to the need to limit the amount of force exerted by the special tool to protect the structural integrity of the thermal sleeves. The inspected areas of the ID of each CEDM nozzle for which relaxation is requested are depicted in the attached figures, which are designated by penetration number.

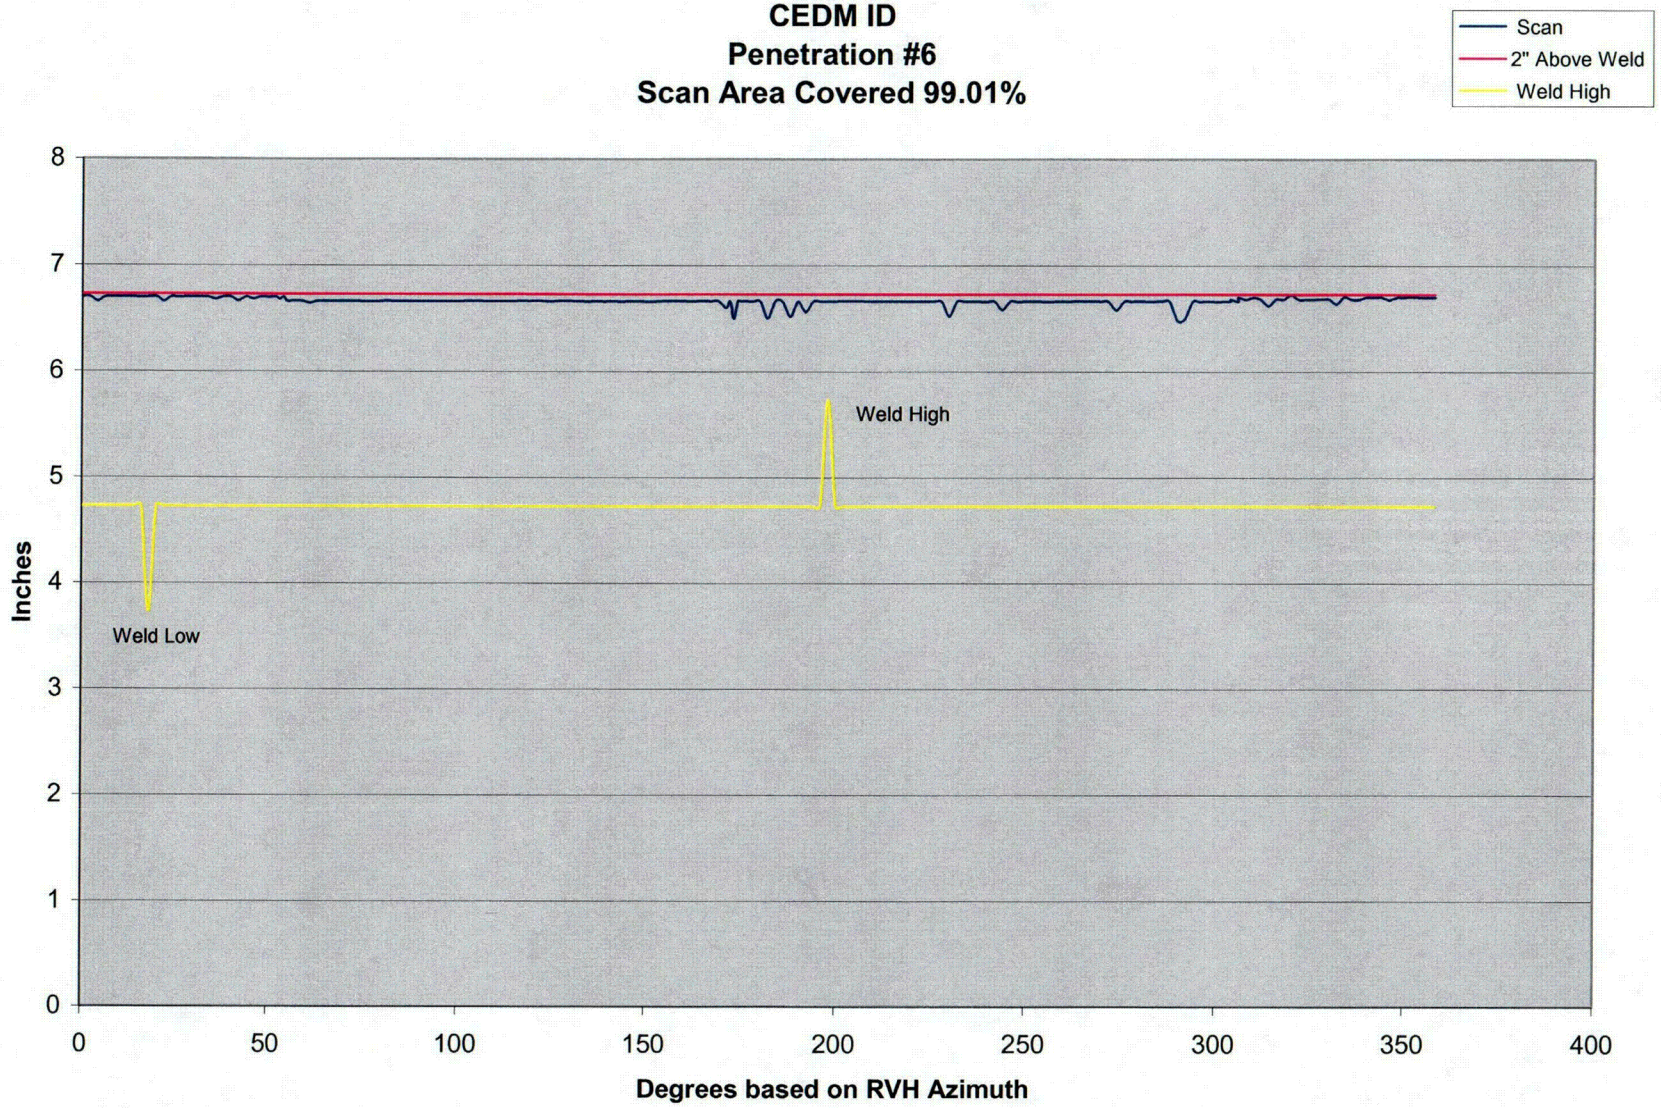
CEDM ID
Penetration #6
Scan Area Covered 99.01%
Scan
2" Above Weld
Weld High
Weld High
Weld Low
Inches
0
1
2
3
4
5
6
7
8
0
50
100
150
200
250
300
350
400
Degrees based on RVH Azimuth

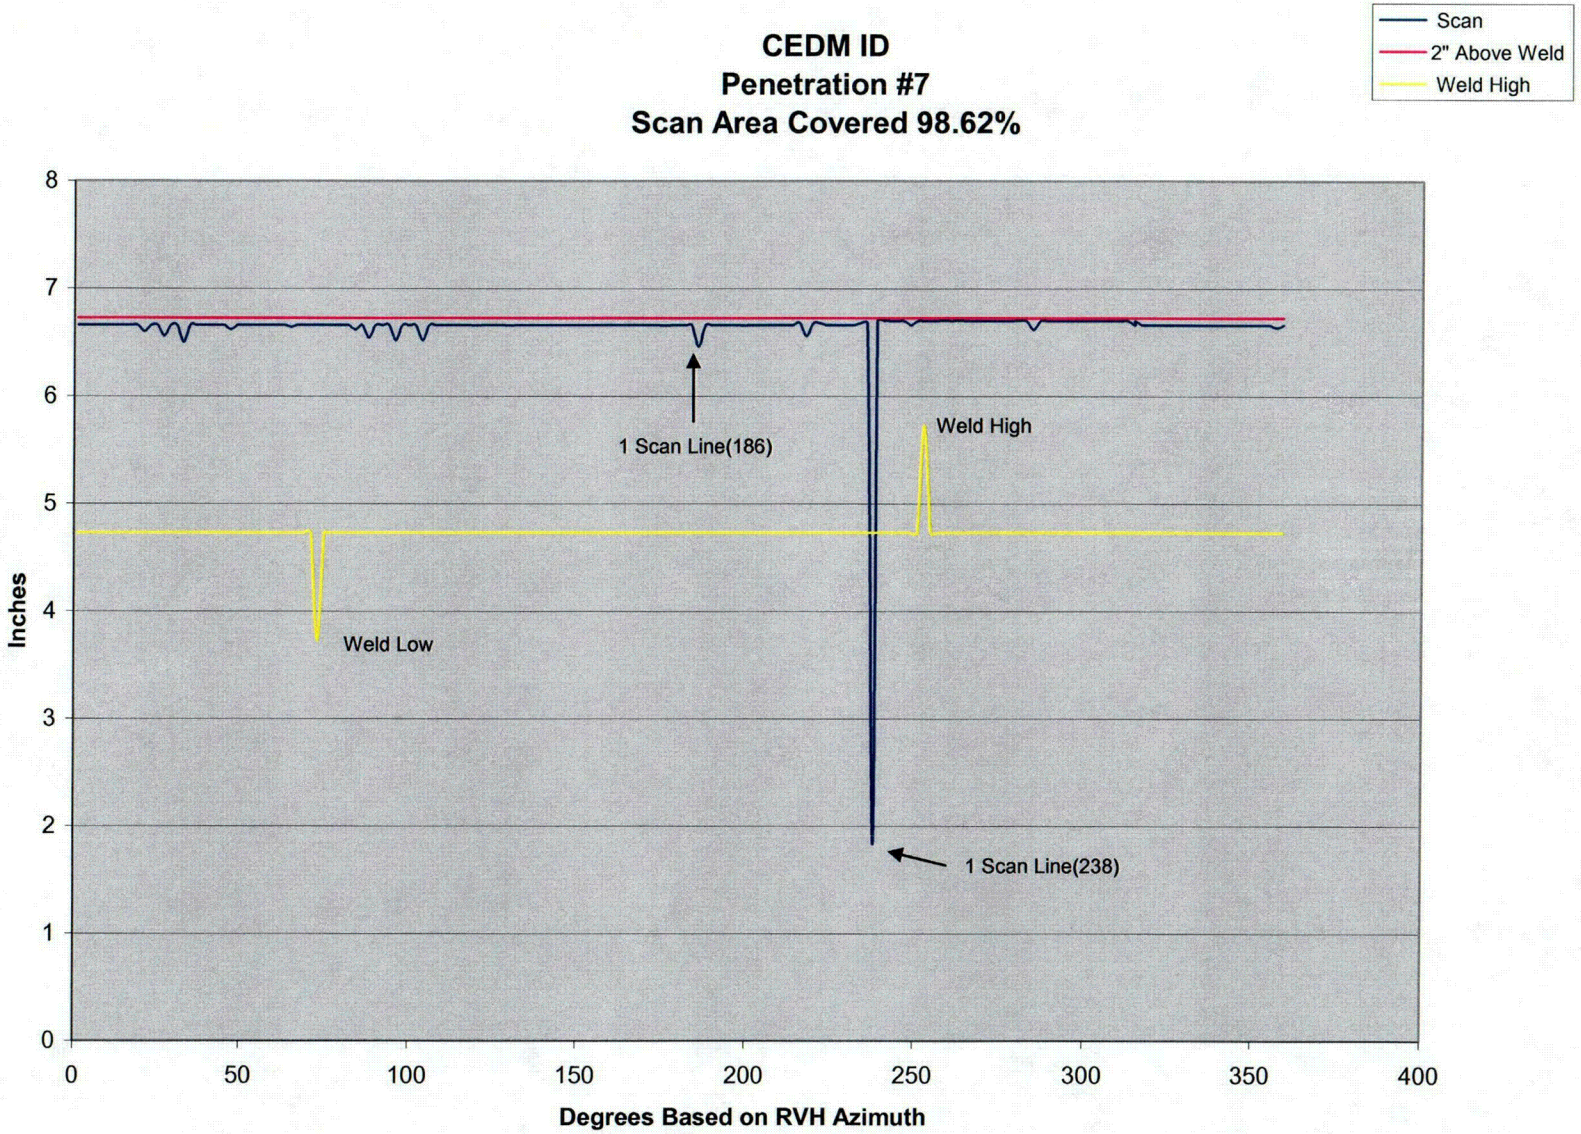
CEDM ID
Penetration #7
Scan Area Covered 98.62%
Scan
2" Above Weld
Weld High
Inches
Degrees Based on RVH Azimuth
1 Scan Line(186)
Weld High
Weld Low
1 Scan Line(238)
0
1
2
3
4
5
6
7
8
0
50
100
150
200
250
300
350
400

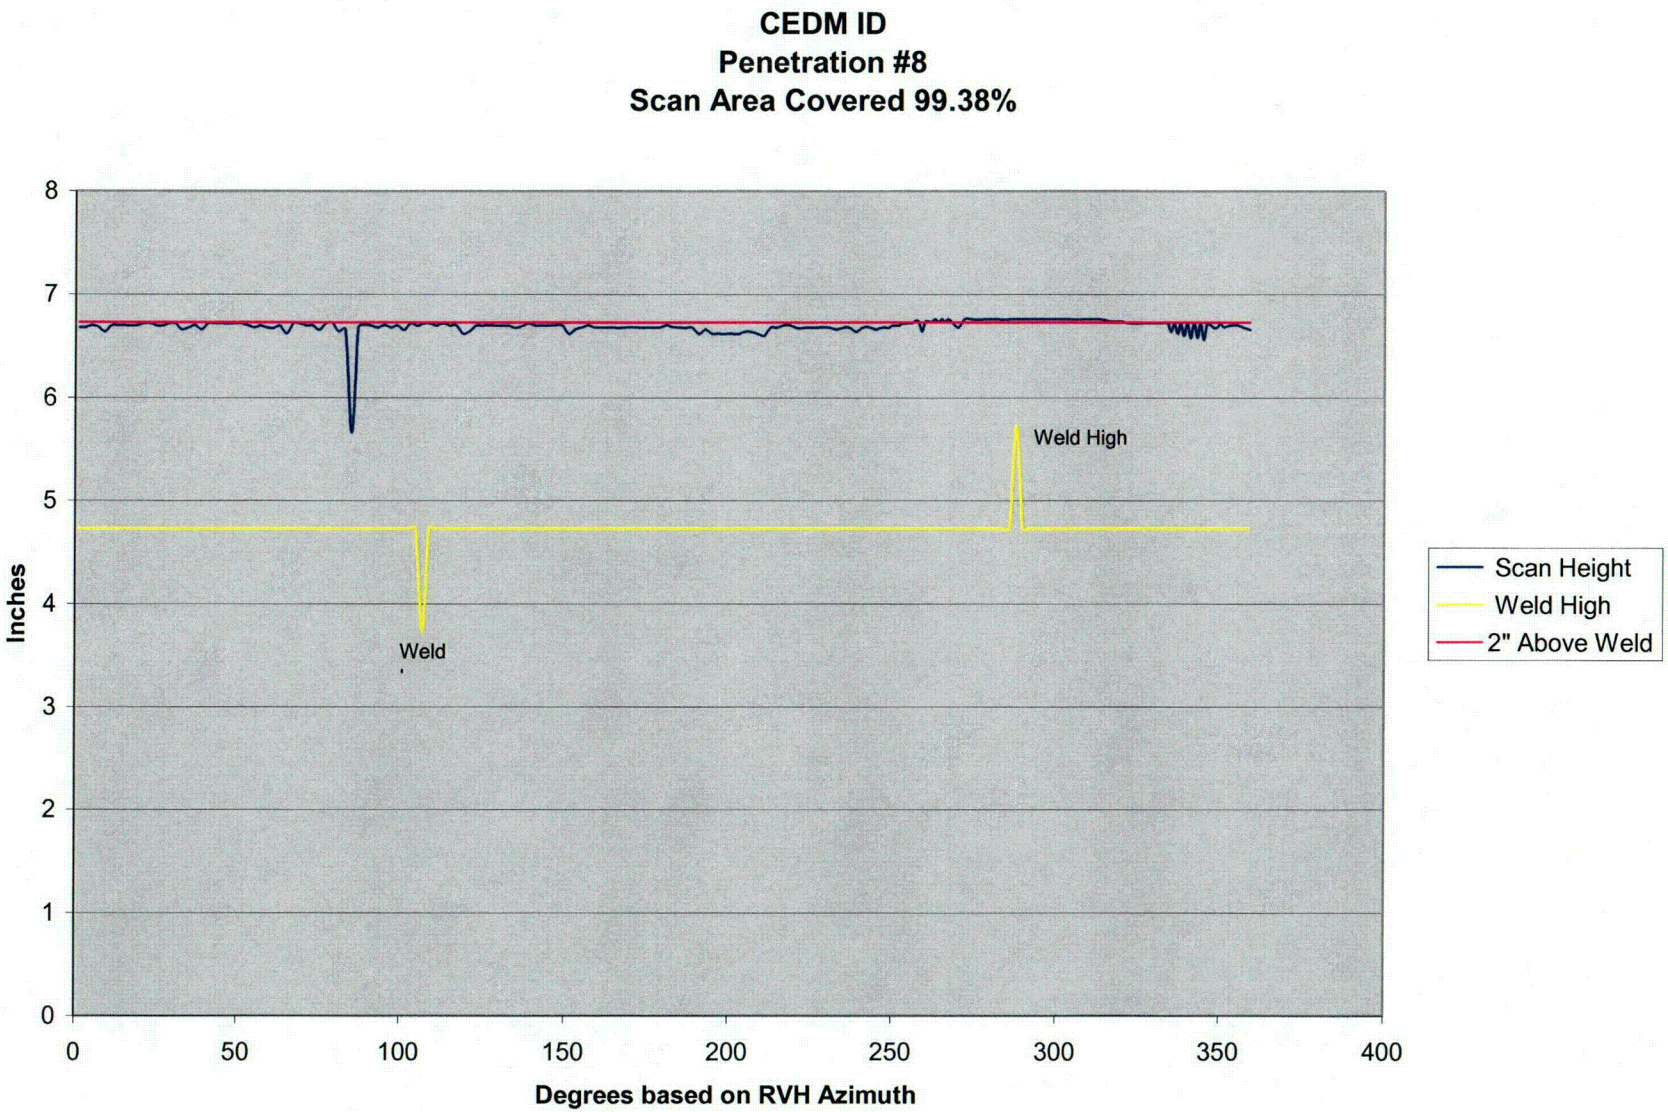
CEDM ID
Penetration #8
Scan Area Covered 99.38%
Inches
Degrees based on RVH Azimuth
Weld
Weld High
Scan Height
Weld High
2" Above Weld
0
1
2
3
4
5
6
7
8
0
50
100
150
200
250
300
350
400

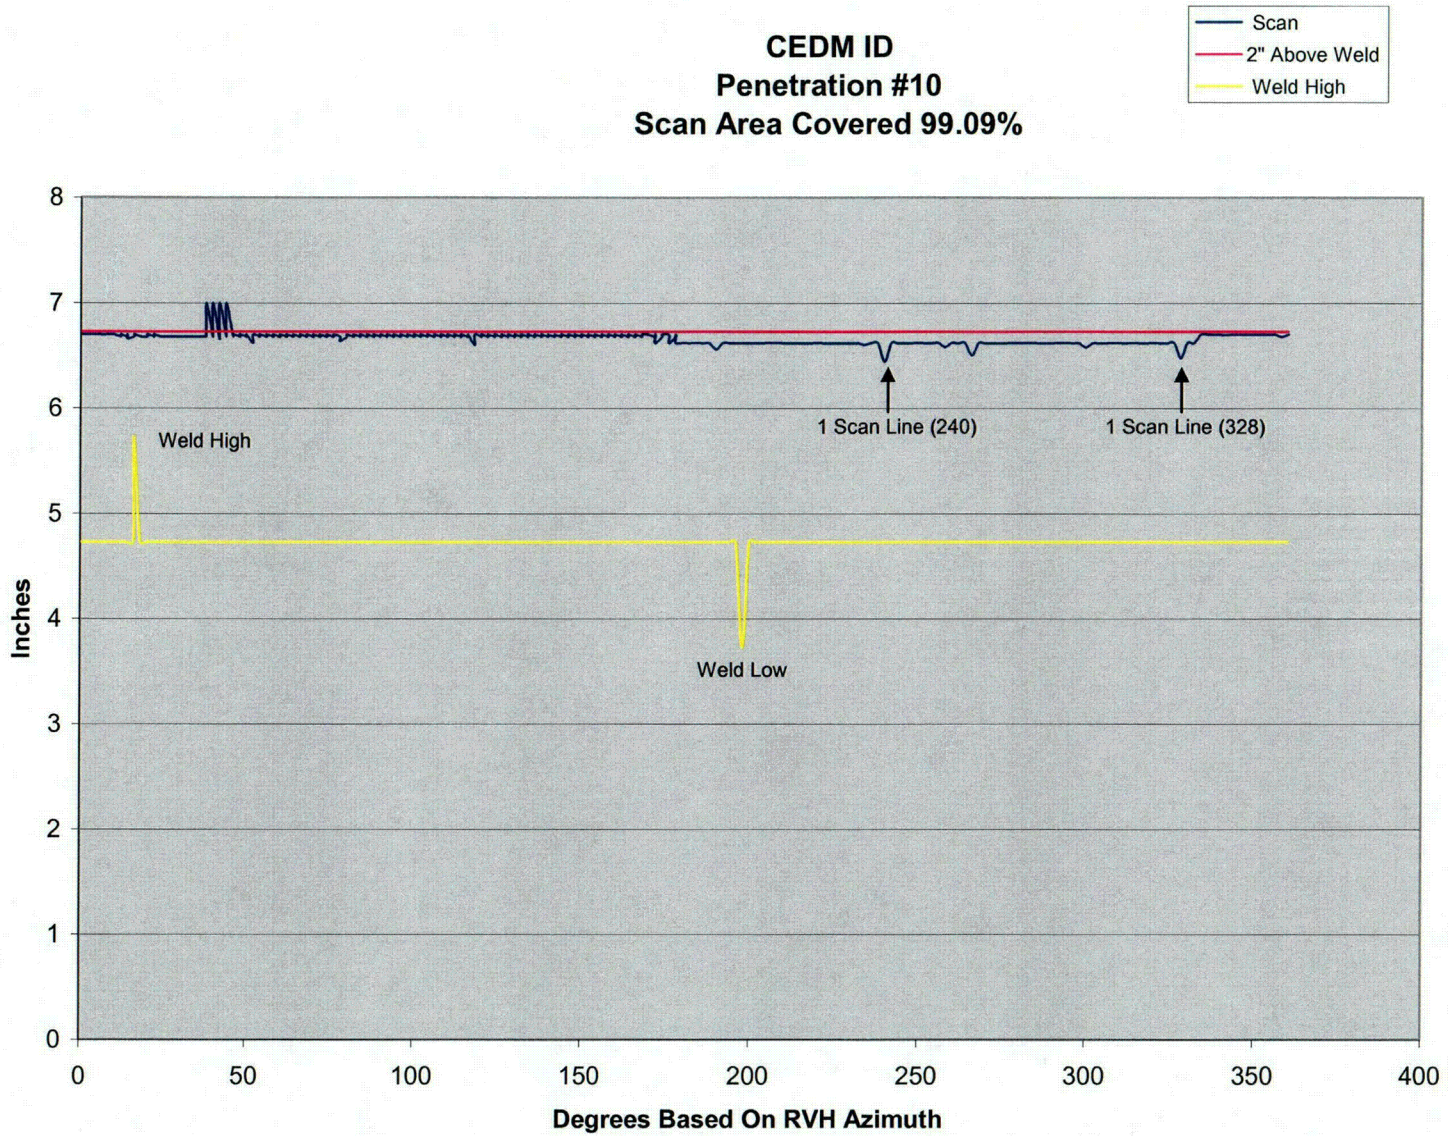
CEDM ID
Penetration #10
Scan Area Covered 99.09%
Scan
2" Above Weld
Weld High
Weld High
1 Scan Line (240)
1 Scan Line (328)
Weld Low
Inches
0
1
2
3
4
5
6
7
8
0
50
100
150
200
250
300
350
400
Degrees Based On RVH Azimuth

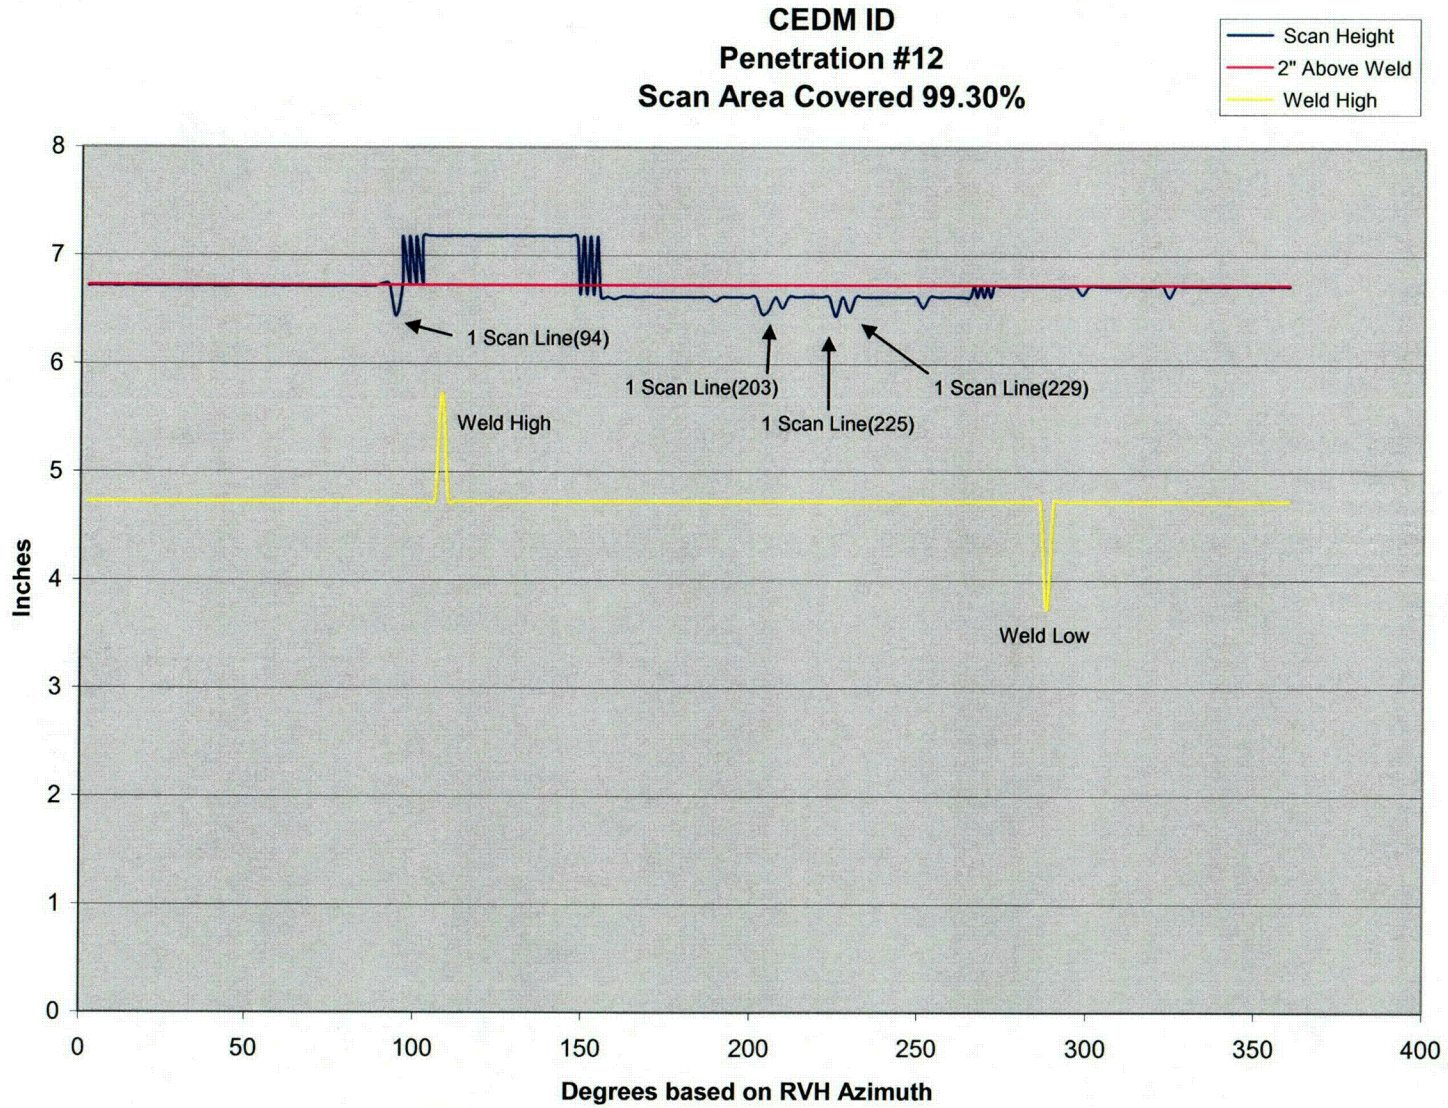
CEDM ID
Penetration #12
Scan Area Covered 99.30%
Scan Height
2" Above Weld
Weld High
1 Scan Line(94)
1 Scan Line(203)
1 Scan Line(225)
1 Scan Line(229)
Weld High
Weld Low
Inches
Degrees based on RVH Azimuth
0
1
2
3
4
5
6
7
8
0
50
100
150
200
250
300
350
400

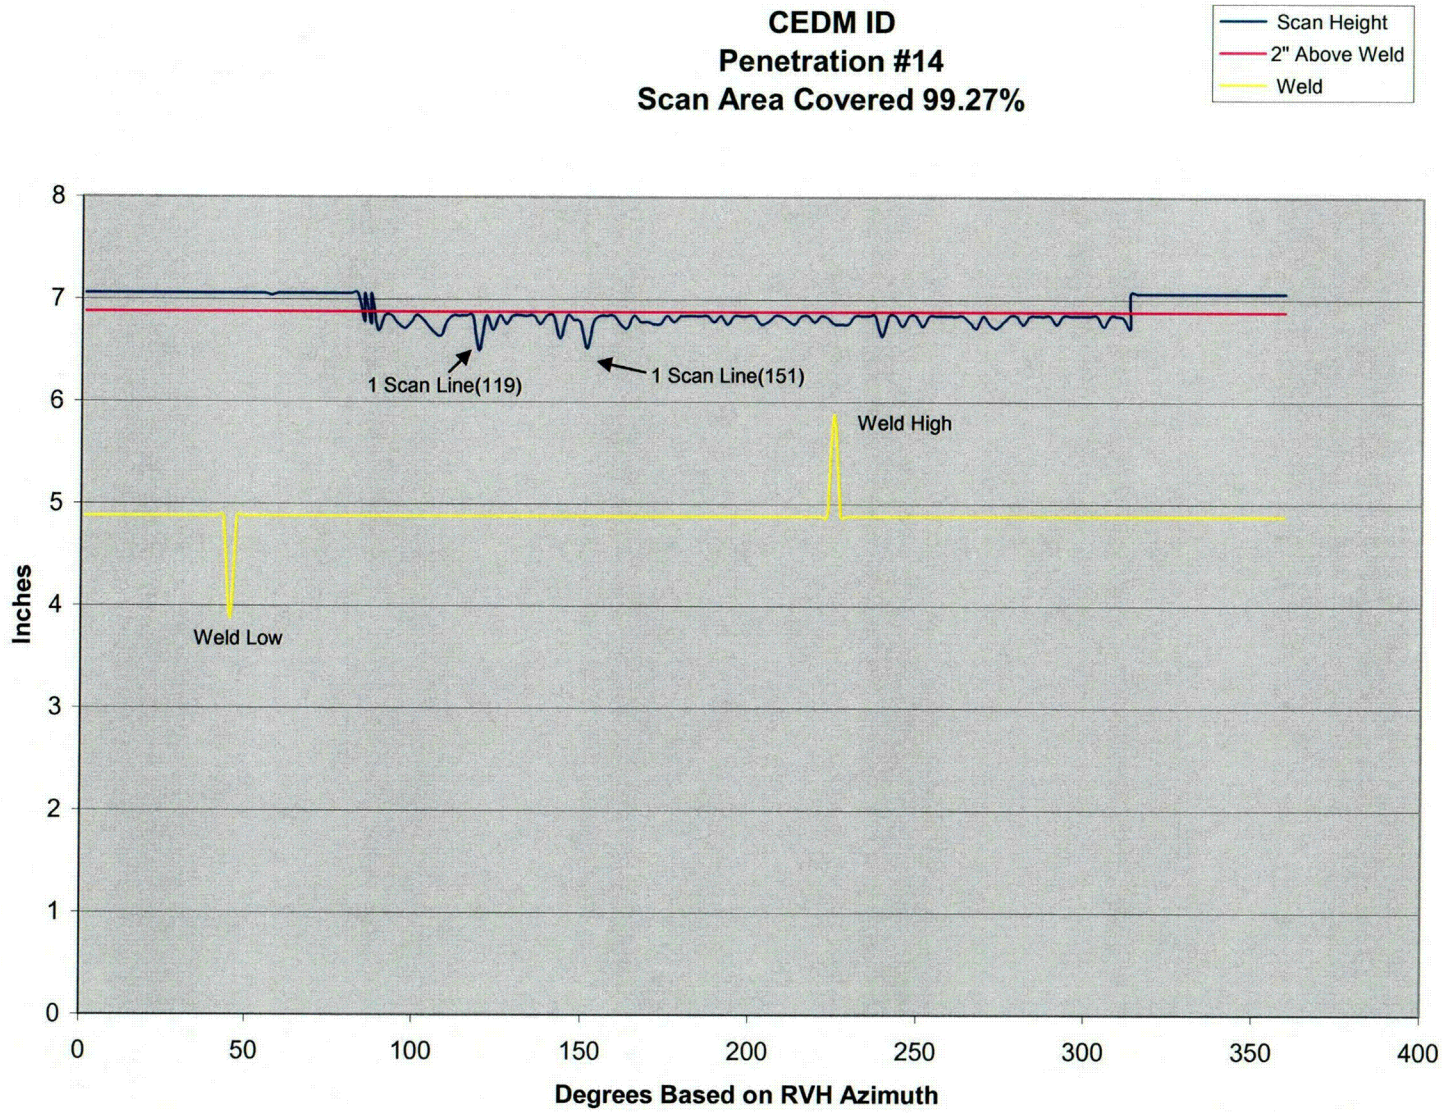
CEDM ID
Penetration #14
Scan Area Covered 99.27%
Scan Height
2" Above Weld
Weld
1 Scan Line(119)
1 Scan Line(151)
Weld High
Weld Low
Inches
Degrees Based on RVH Azimuth
0
1
2
3
4
5
6
7
8
0
50
100
150
200
250
300
350
400

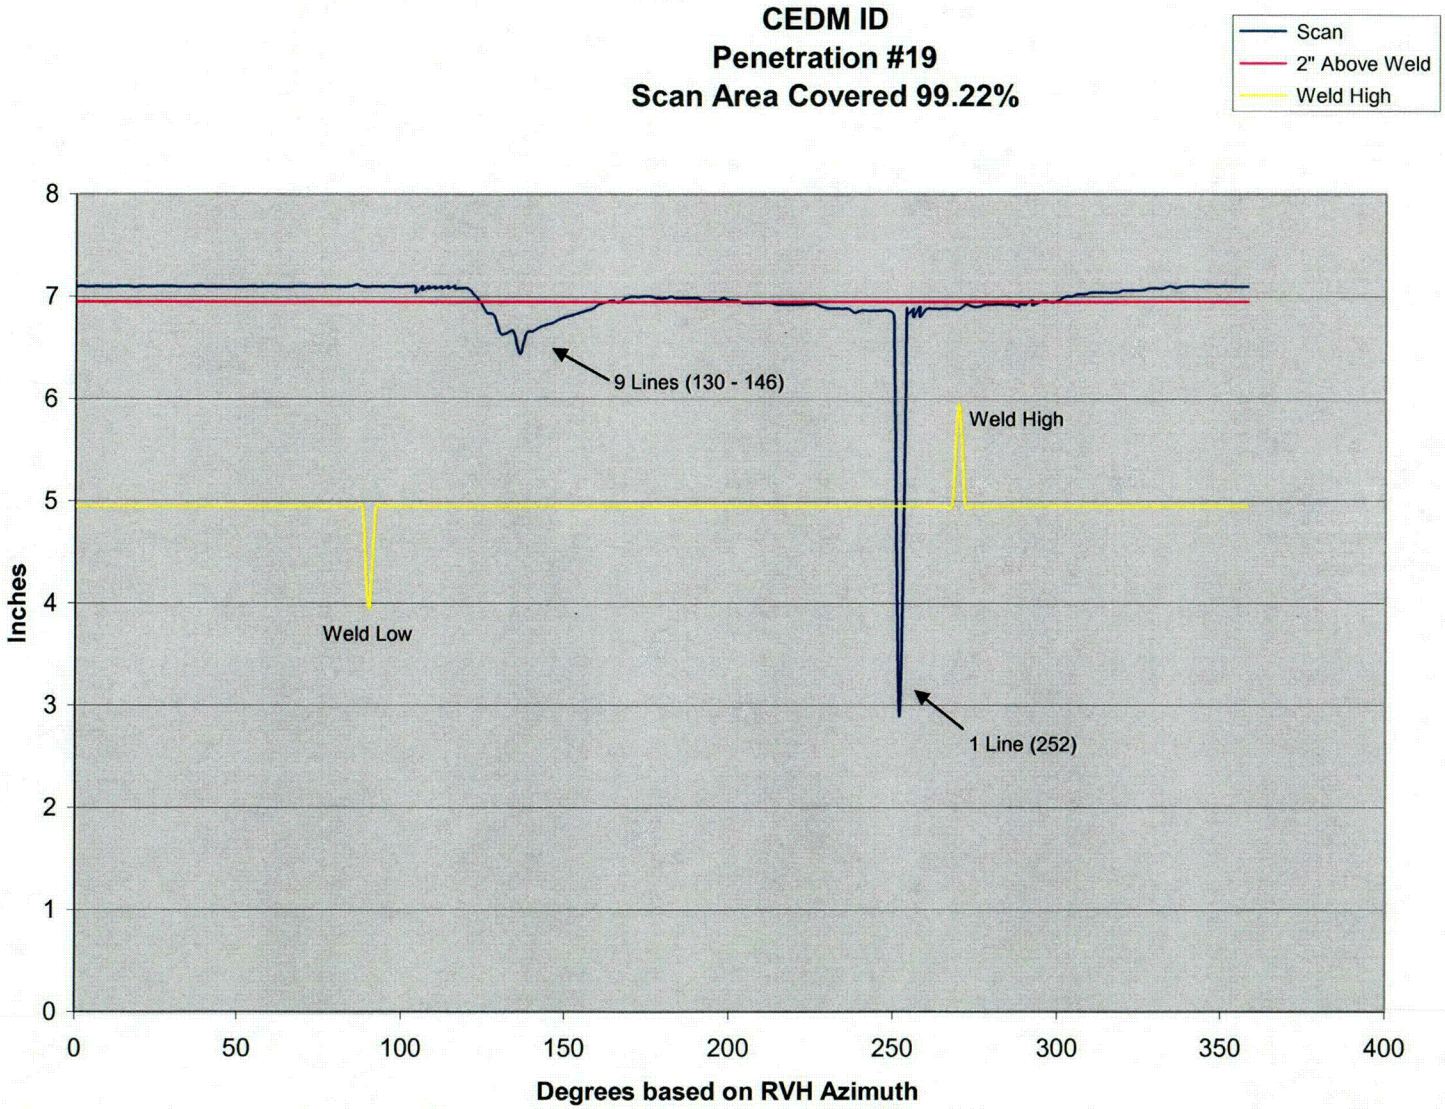
CEDM ID
Penetration #19
Scan Area Covered 99.22%
Scan
2" Above Weld
Weld High
9 Lines (130 - 146)
Weld High
Weld Low
1 Line (252)
Inches
Degrees based on RVH Azimuth
0
1
2
3
4
5
6
7
8
0
50
100
150
200
250
300
350
400

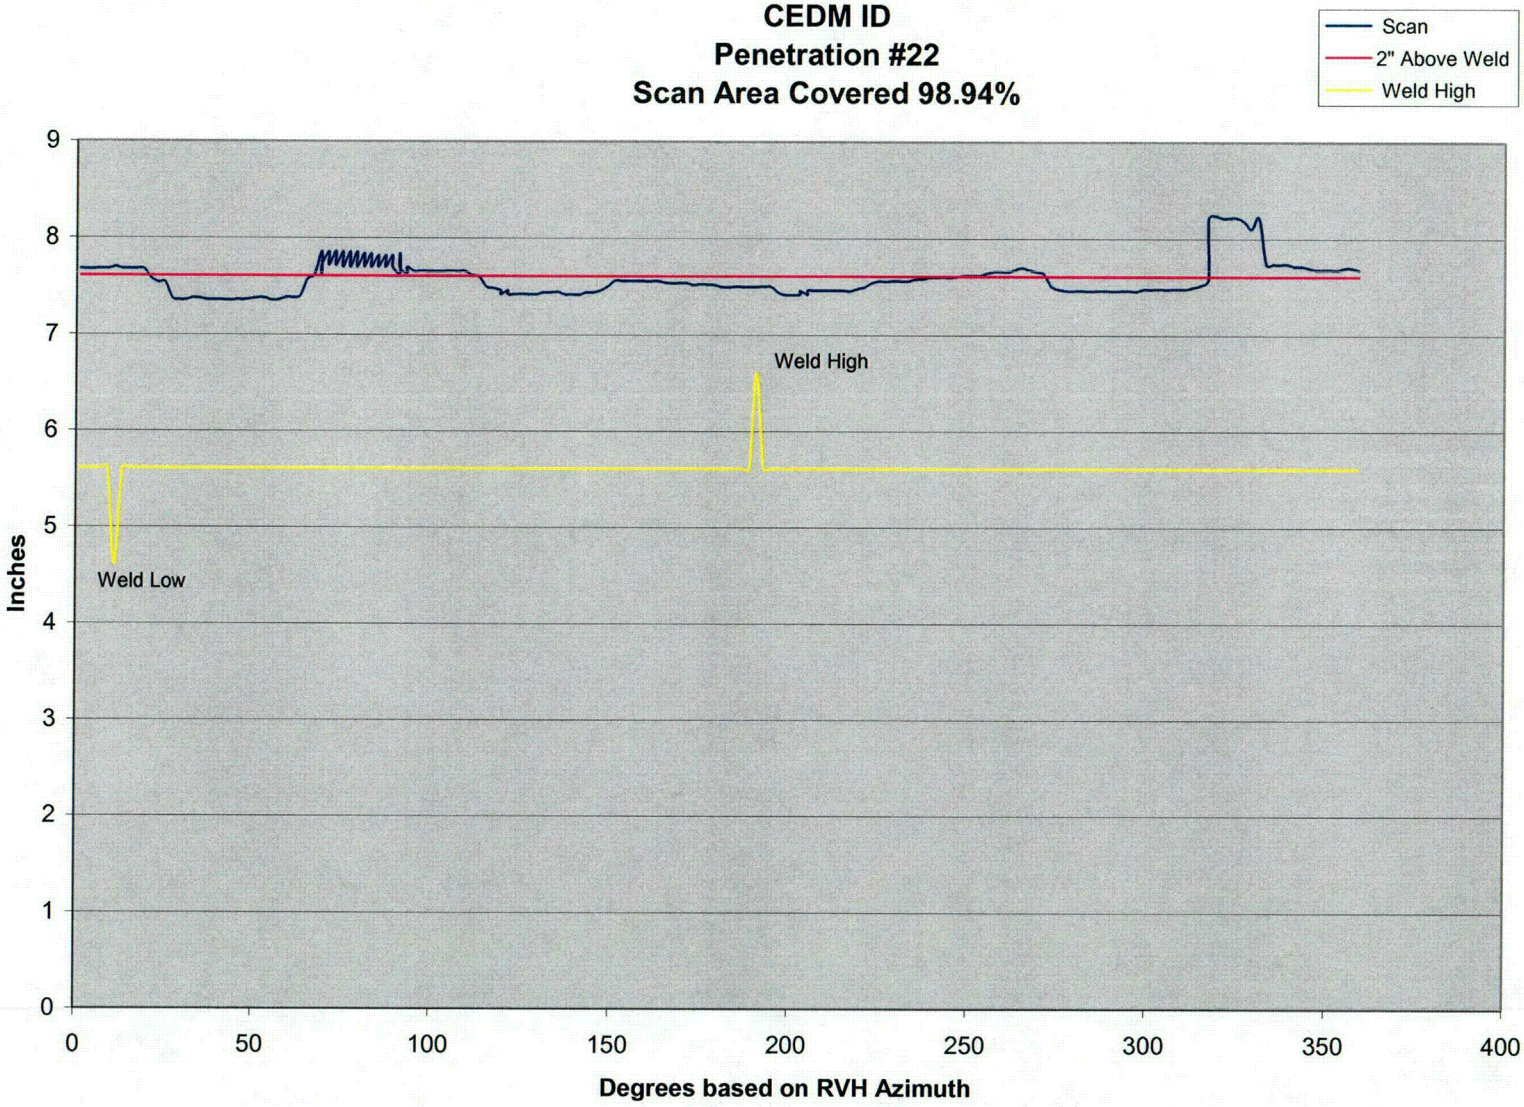
CEDM ID
Penetration #22
Scan Area Covered 98.94%
Scan
2" Above Weld
Weld High
Weld High
Weld Low
Inches
0
1
2
3
4
5
6
7
8
9
0
50
100
150
200
250
300
350
400
Degrees based on RVH Azimuth

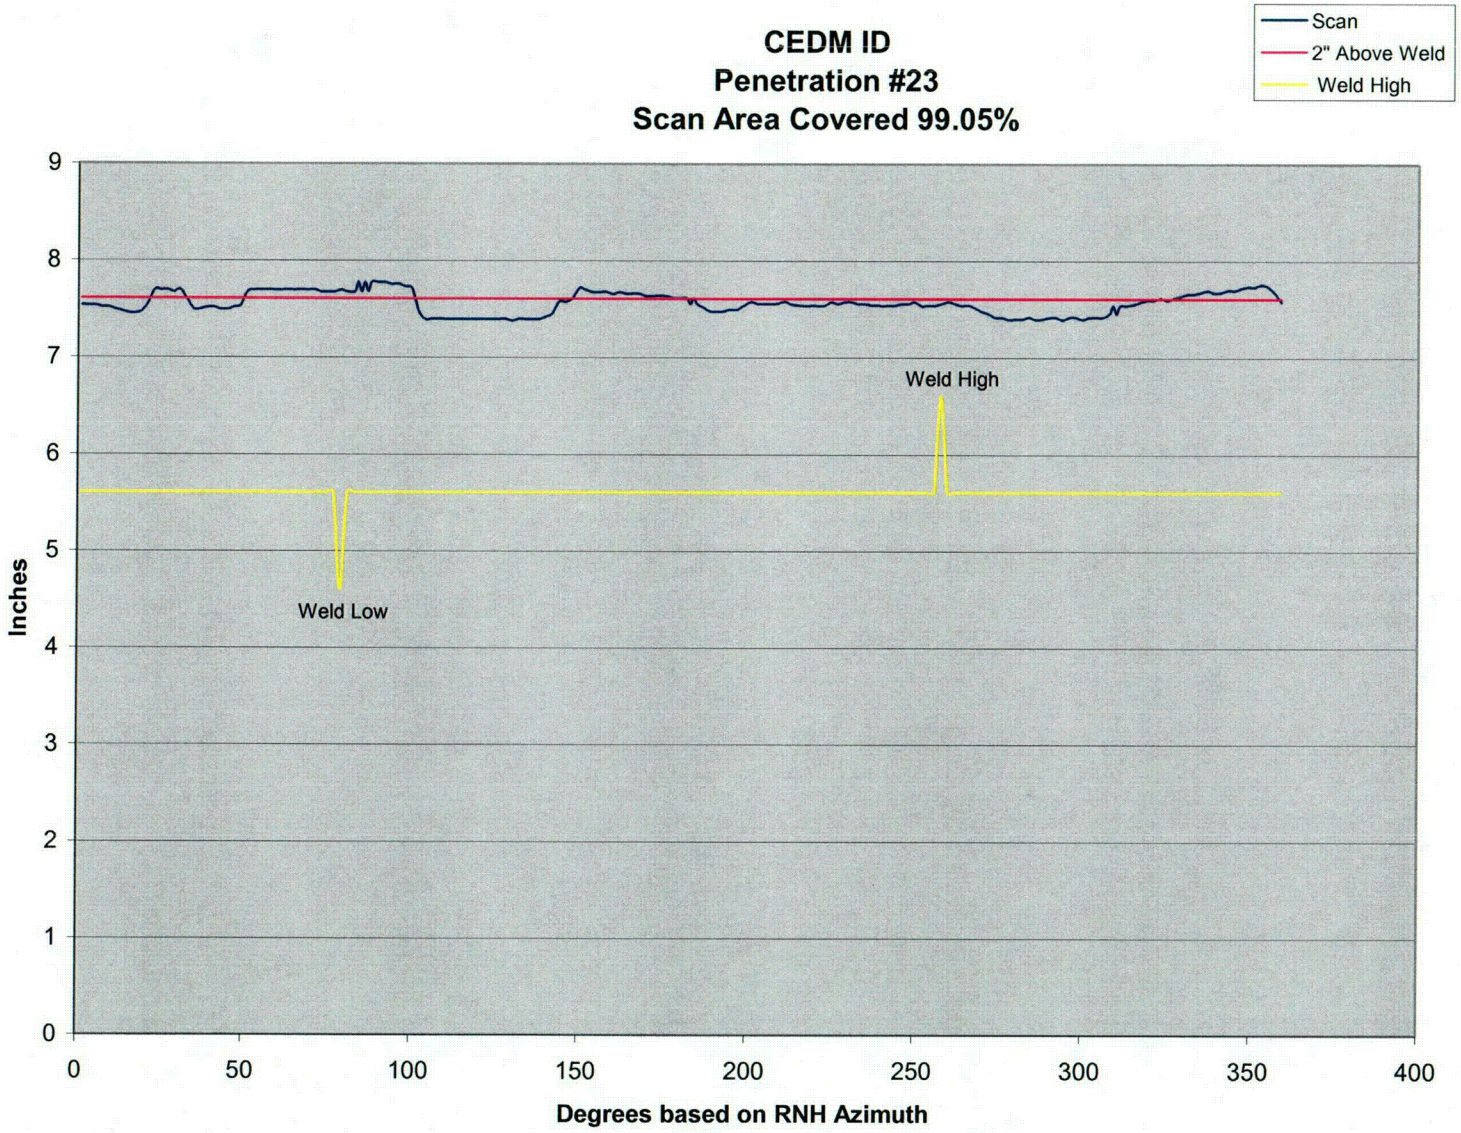
CEDM ID
Penetration #23
Scan Area Covered 99.05%
Scan
2" Above Weld
Weld High
Weld High
Weld Low
Inches
Degrees based on RNH Azimuth
0
1
2
3
4
5
6
7
8
9
0
50
100
150
200
250
300
350
400

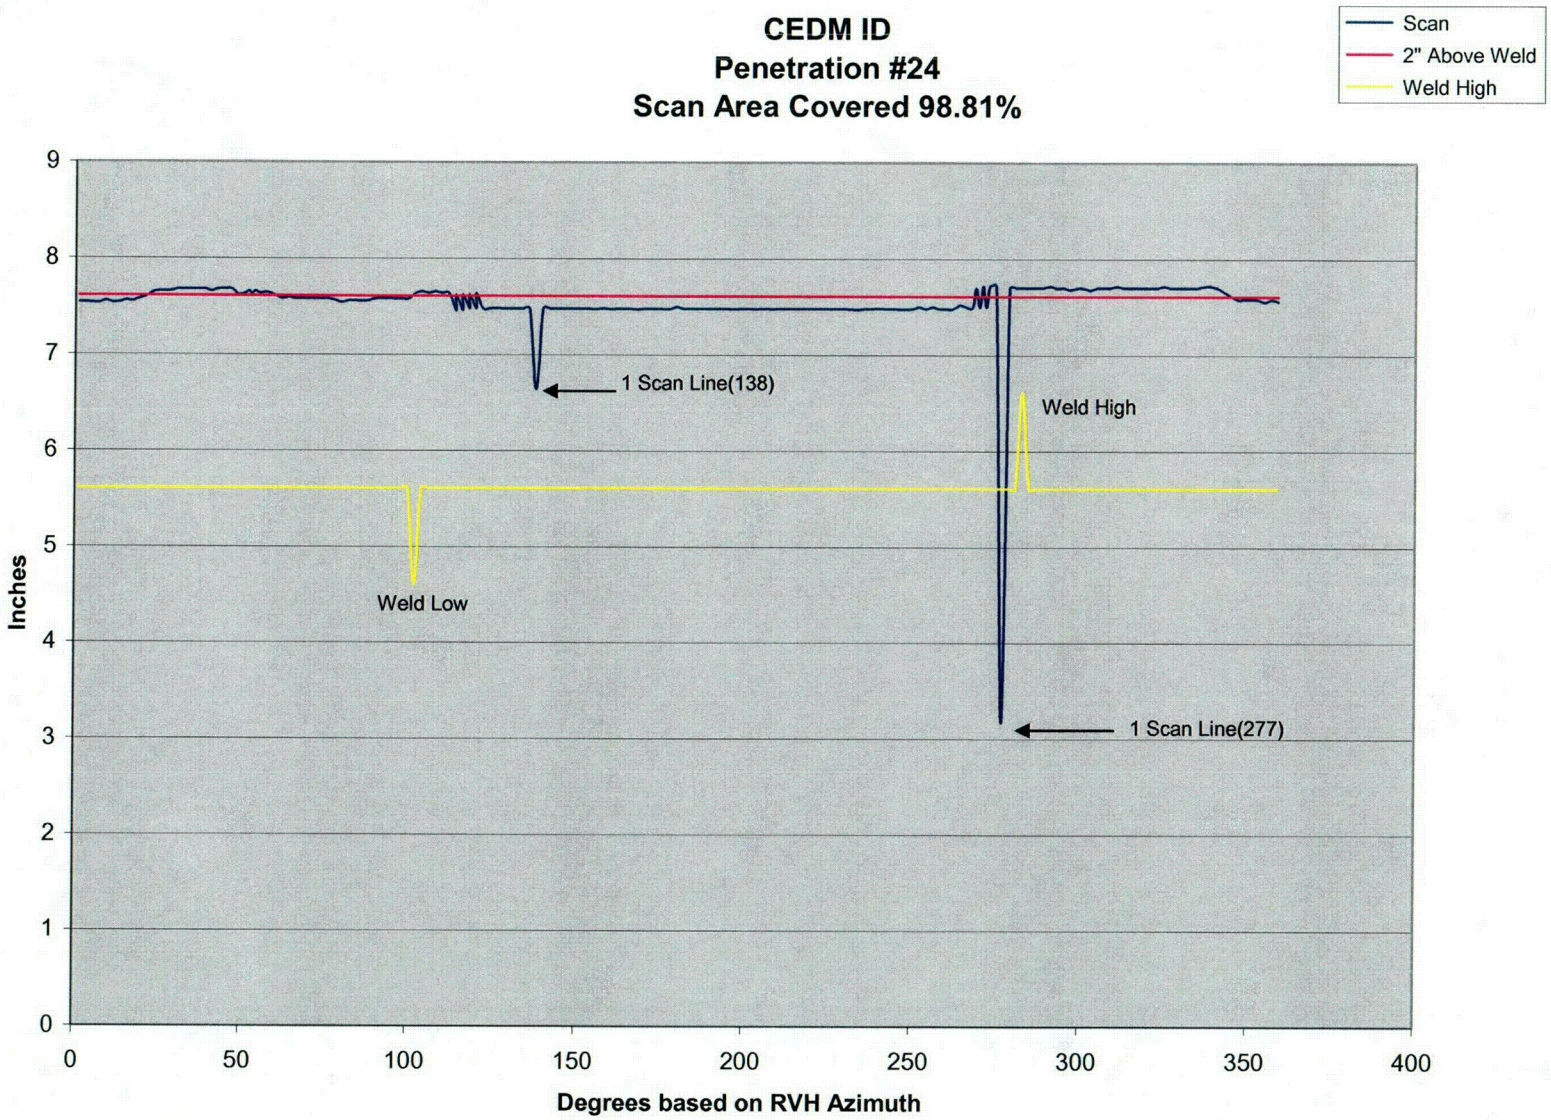
CEDM ID
Penetration #24
Scan Area Covered 98.81%
Scan
2" Above Weld
Weld High
Inches
Degrees based on RVH Azimuth
1 Scan Line(138)
Weld High
Weld Low
1 Scan Line(277)
0
1
2
3
4
5
6
7
8
9
0
50
100
150
200
250
300
350
400

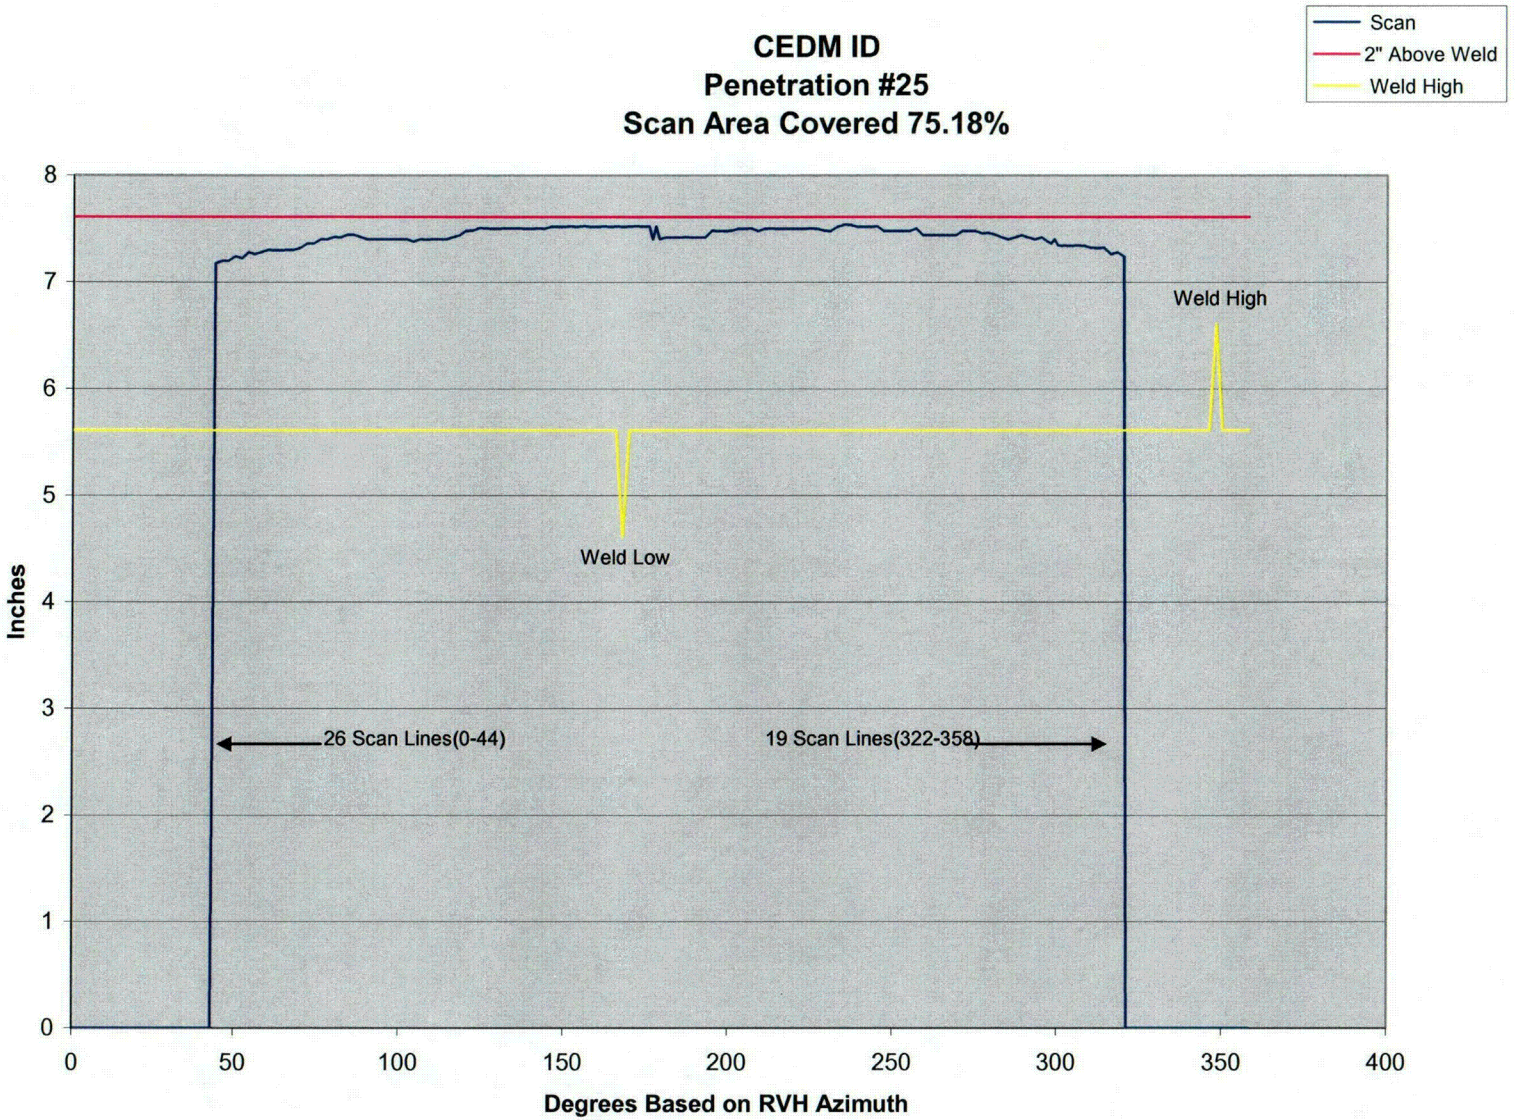
CEDM ID
Penetration #25
Scan Area Covered 75.18%
Scan
2" Above Weld
Weld High
Weld High
Weld Low
26 Scan Lines(0-44)
19 Scan Lines(322-358)
Inches
Degrees Based on RVH Azimuth
0
1
2
3
4
5
6
7
8
0
50
100
150
200
250
300
350
400

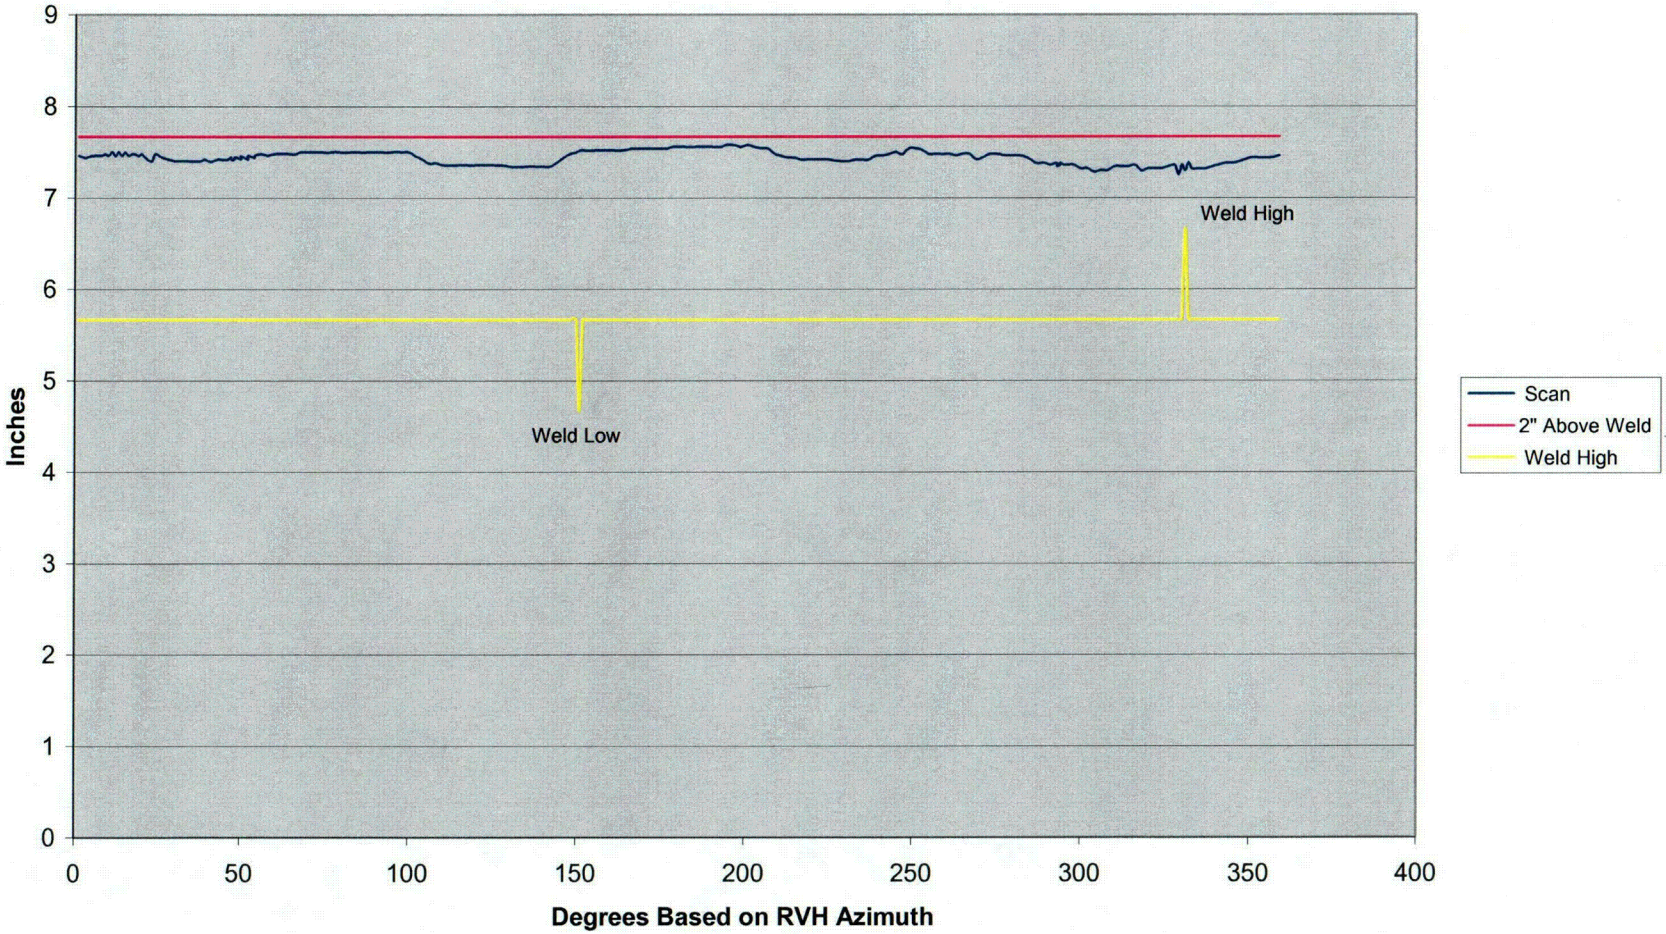
CEDM ID
Penetration #33
Scan Area Covered 96.99%
