your energy partner
OPPD
Omaha Public Power District

May 14, 2005
LIC-05-0057

SUBJECT: Fort Calhoun Station Unit No. 1, Revised Relaxation Request for First Revised Order (EA-03-009) Establishing Interim Inspection Requirements for Reactor Pressure Vessel Heads at Pressurized Water Reactors

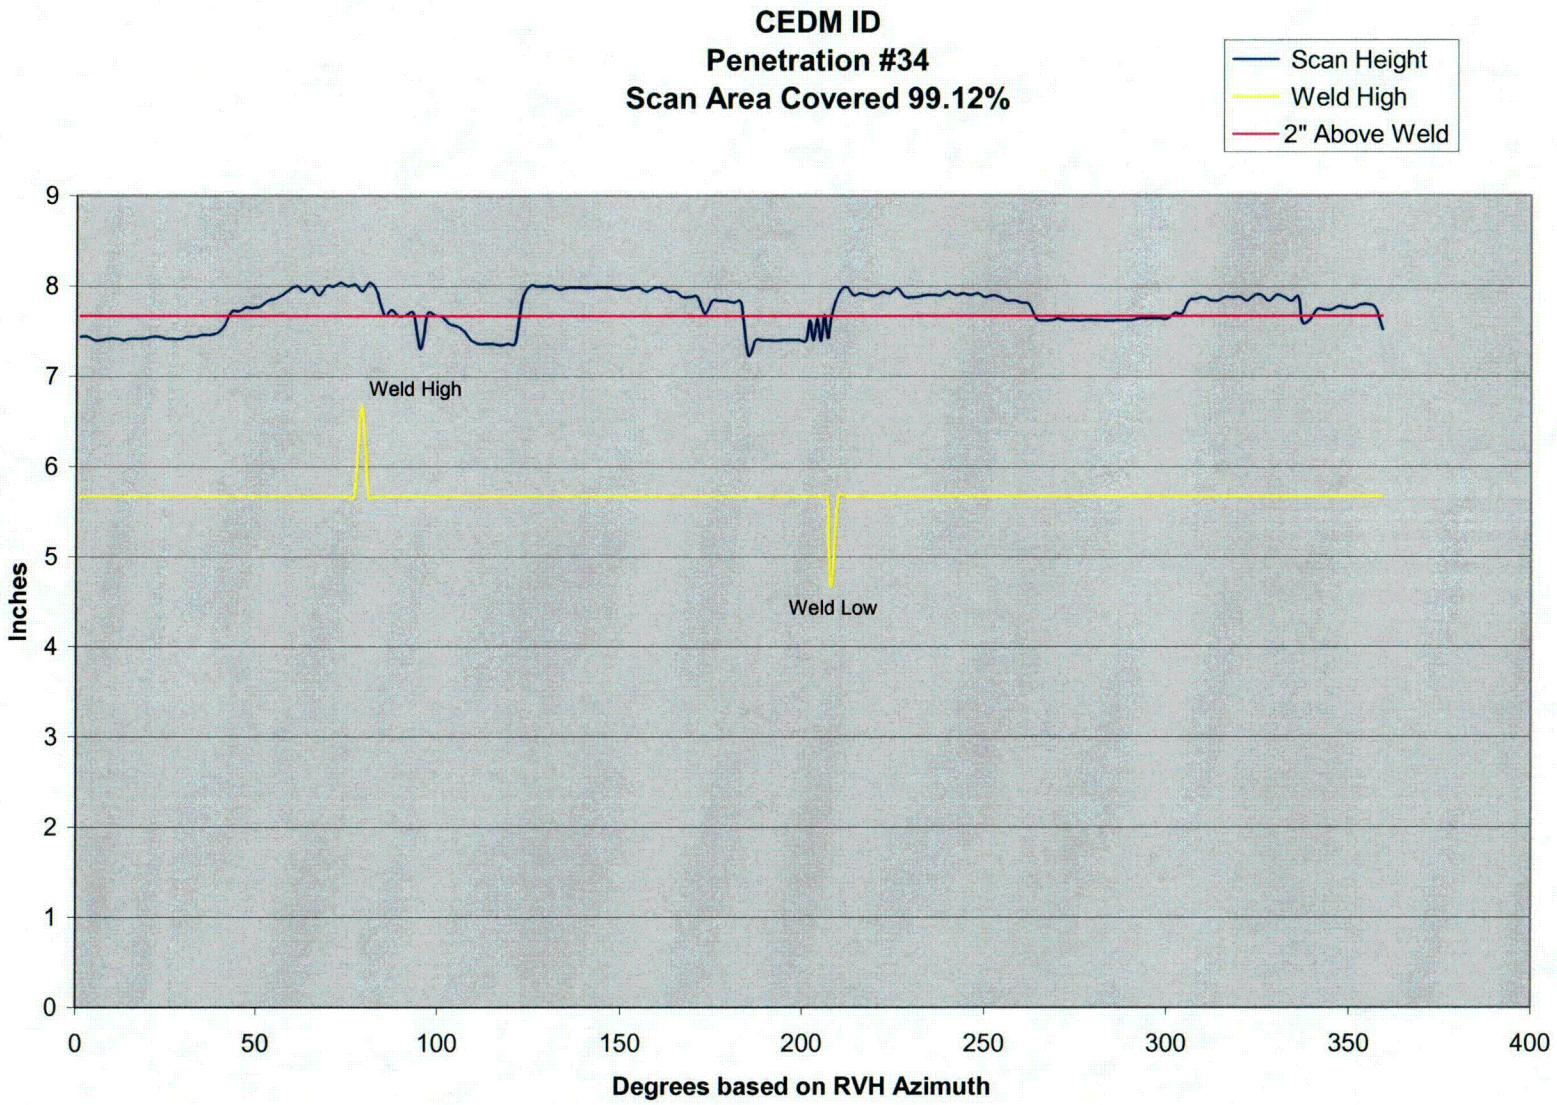
CEDM ID
Penetration #34
Scan Area Covered 99.12%
Scan Height
Weld High
2" Above Weld
Weld High
Weld Low
Inches
0
1
2
3
4
5
6
7
8
9
0
50
100
150
200
250
300
350
400
Degrees based on RVH Azimuth

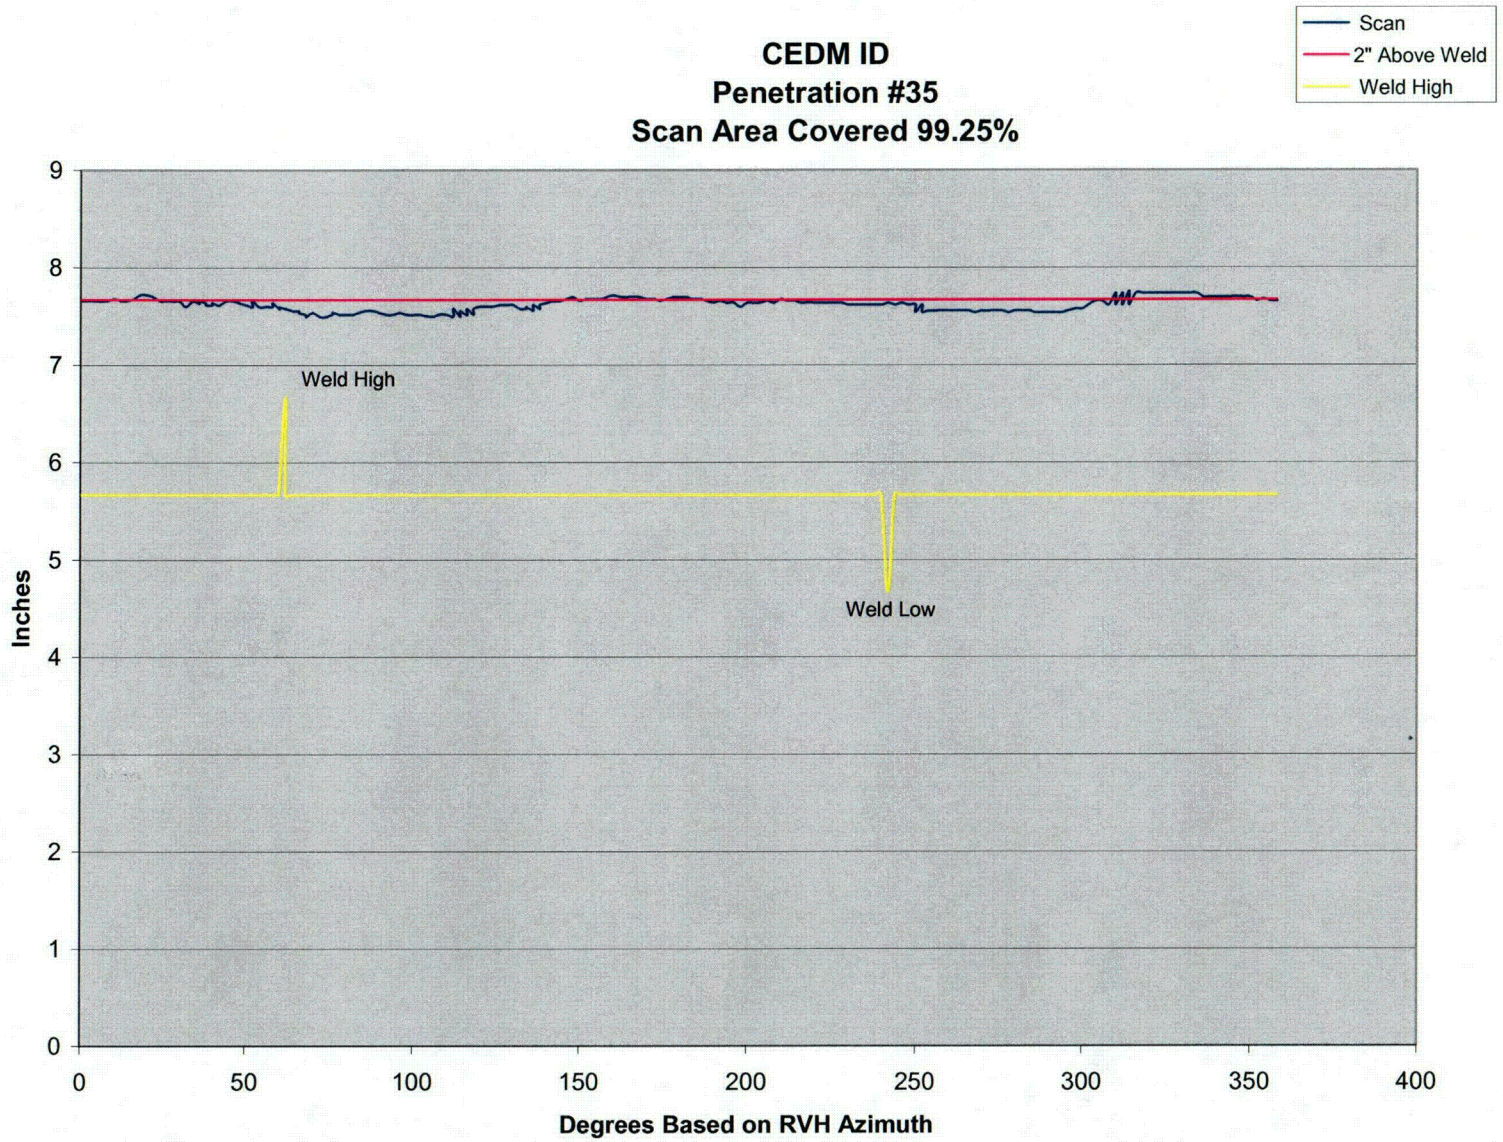
CEDM ID
Penetration #35
Scan Area Covered 99.25%
Scan
2" Above Weld
Weld High
Weld High
Weld Low
Inches
Degrees Based on RVH Azimuth
0
1
2
3
4
5
6
7
8
9
0
50
100
150
200
250
300
350
400

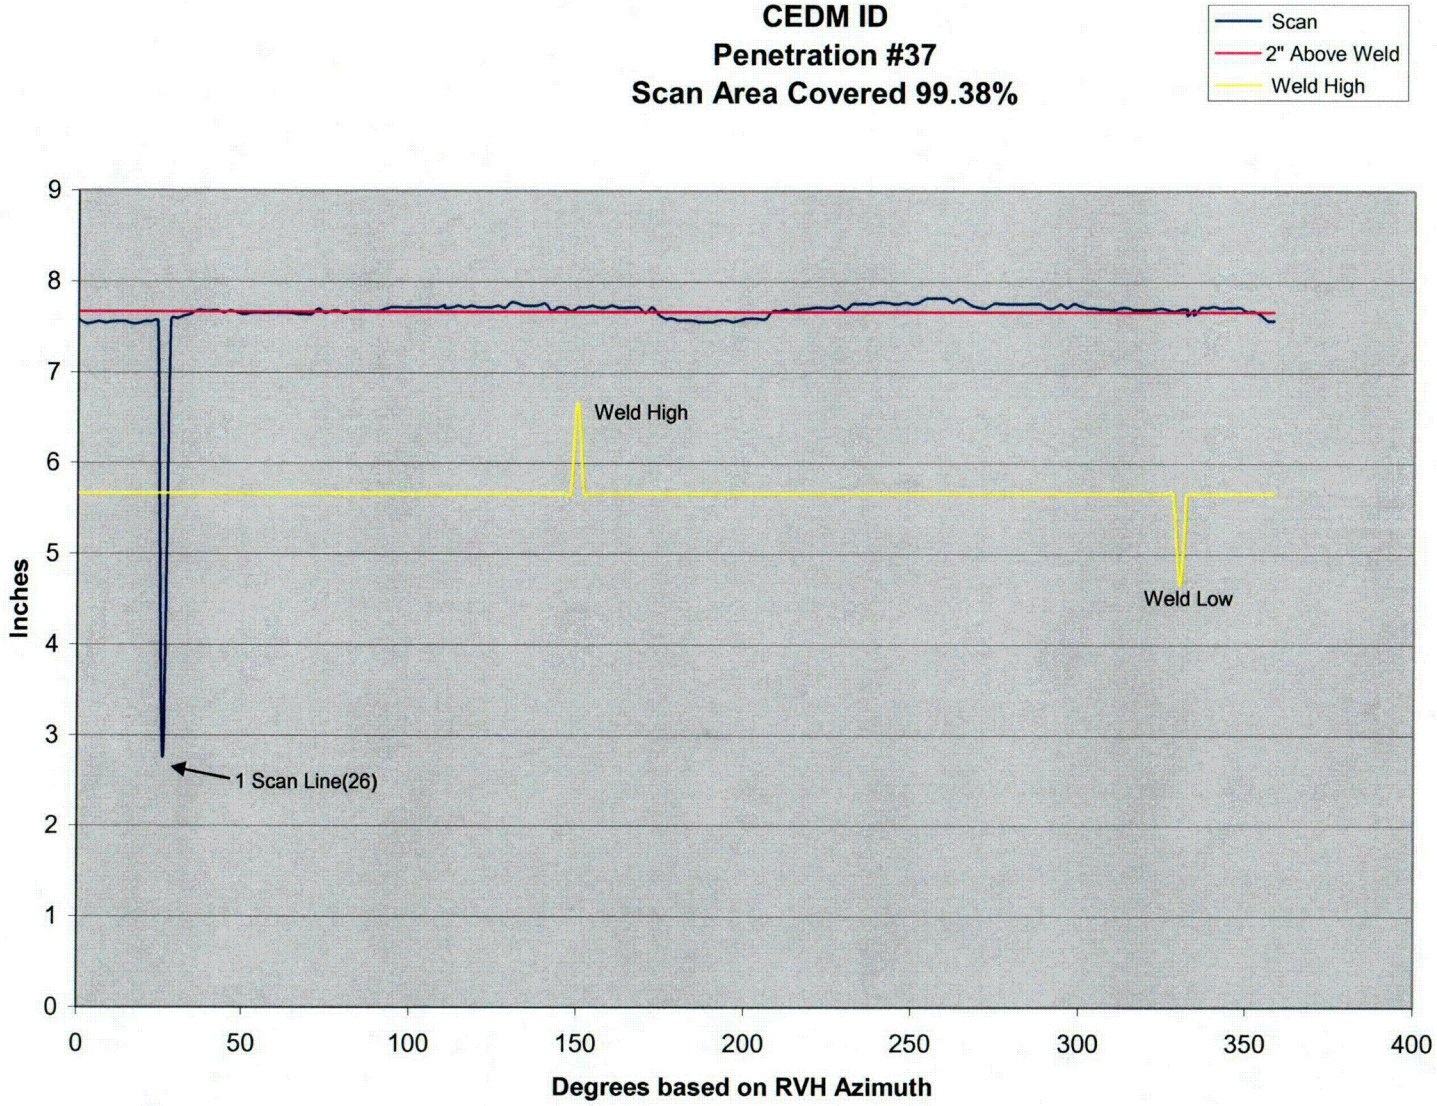
CEDM ID
Penetration #37
Scan Area Covered 99.38%
Scan
2" Above Weld
Weld High
Weld High
Weld Low
1 Scan Line(26)
Inches
Degrees based on RVH Azimuth
0
1
2
3
4
5
6
7
8
9
0
50
100
150
200
250
300
350
400

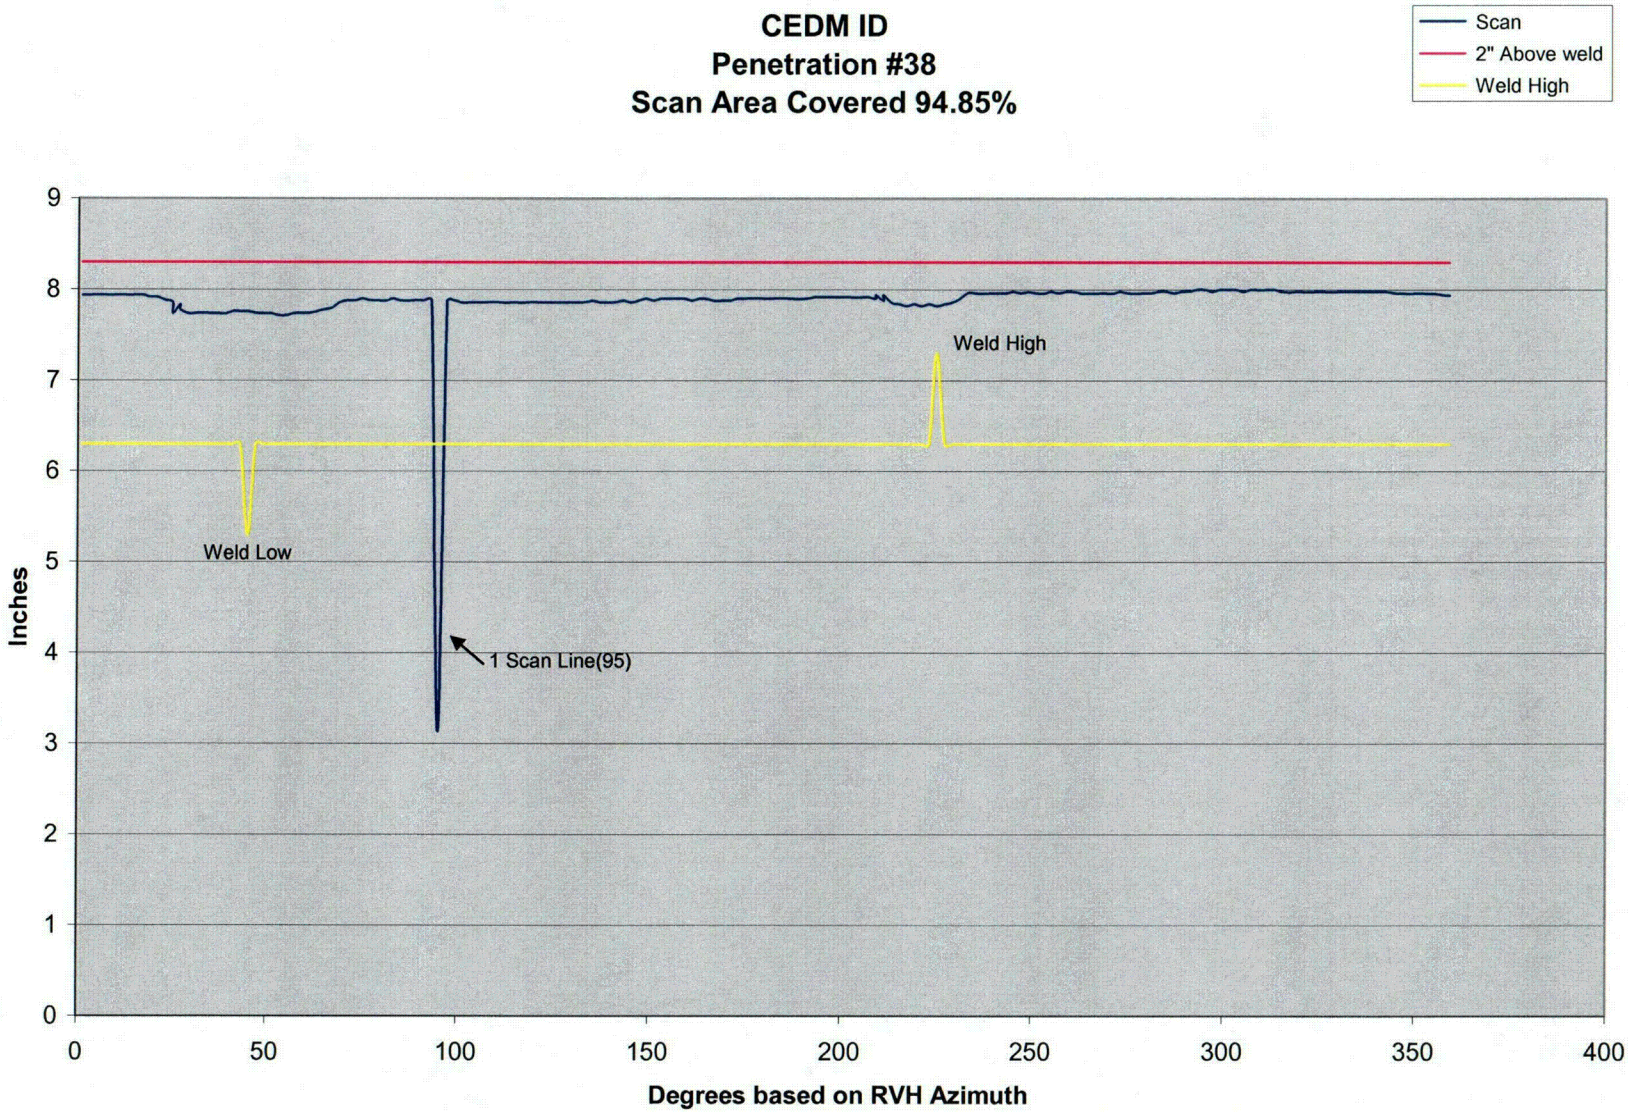
CEDM ID
Penetration #38
Scan Area Covered 94.85%
Scan
2" Above weld
Weld High
Weld High
Weld Low
1 Scan Line(95)
Inches
0
1
2
3
4
5
6
7
8
9
0
50
100
150
200
250
300
350
400
Degrees based on RVH Azimuth

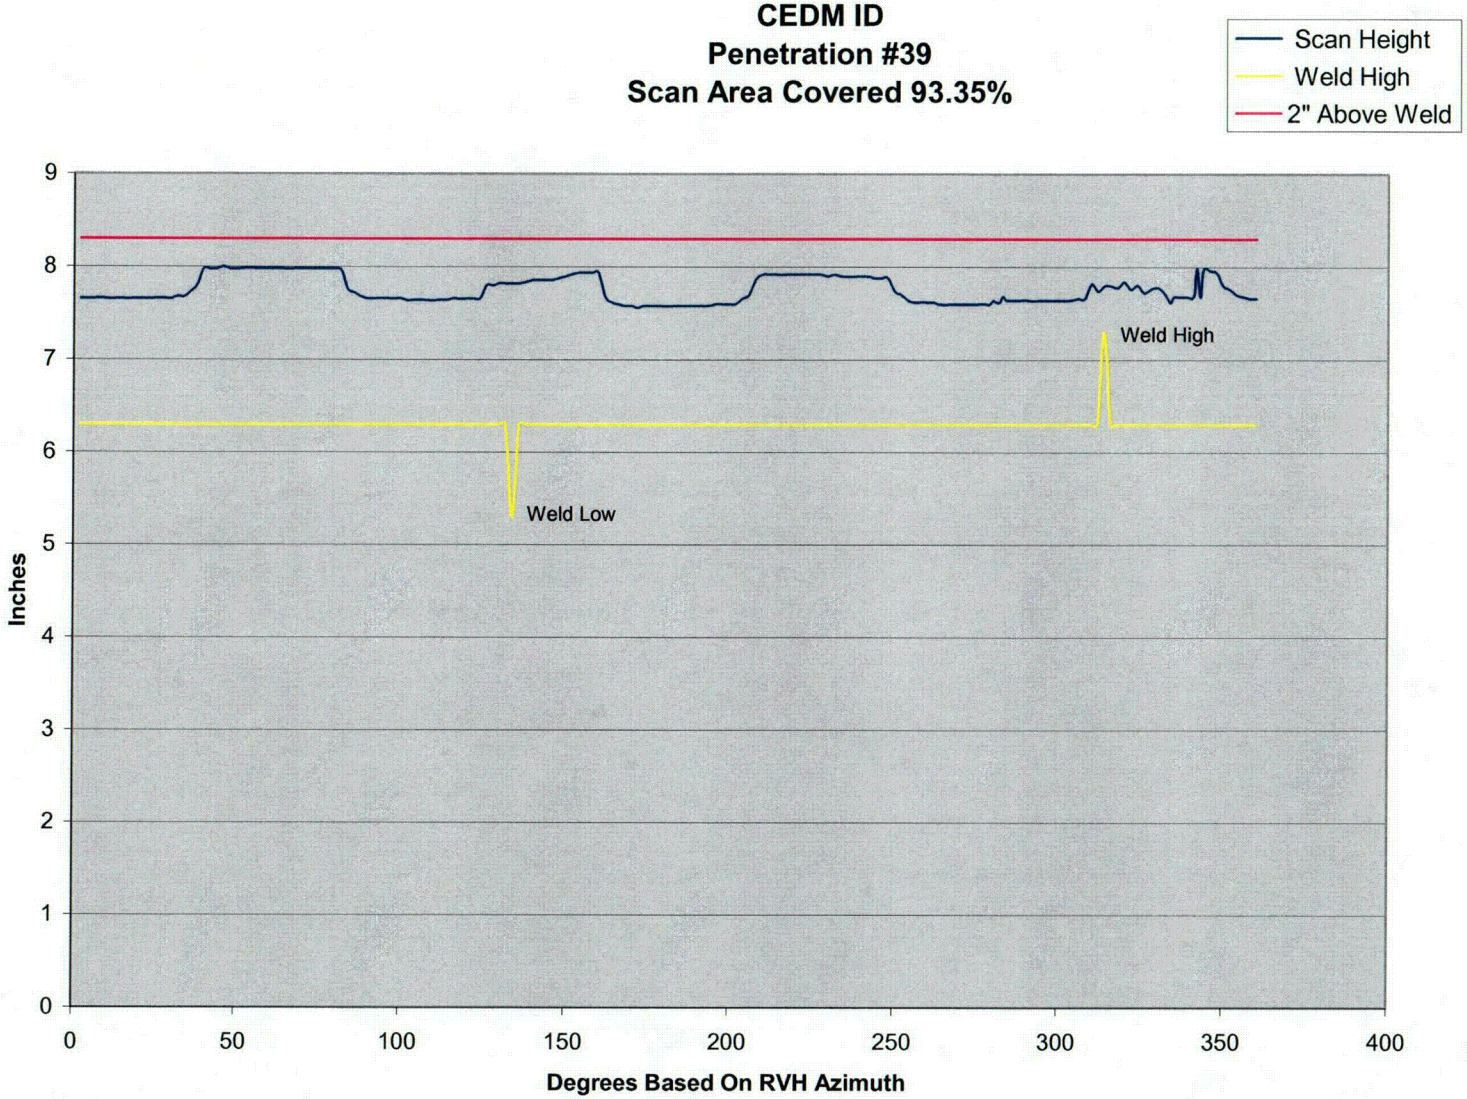
CEDM ID
Penetration #39
Scan Area Covered 93.35%
Scan Height
Weld High
2" Above Weld
Weld High
Weld Low
Inches
Degrees Based On RVH Azimuth
0
1
2
3
4
5
6
7
8
9
0
50
100
150
200
250
300
350
400

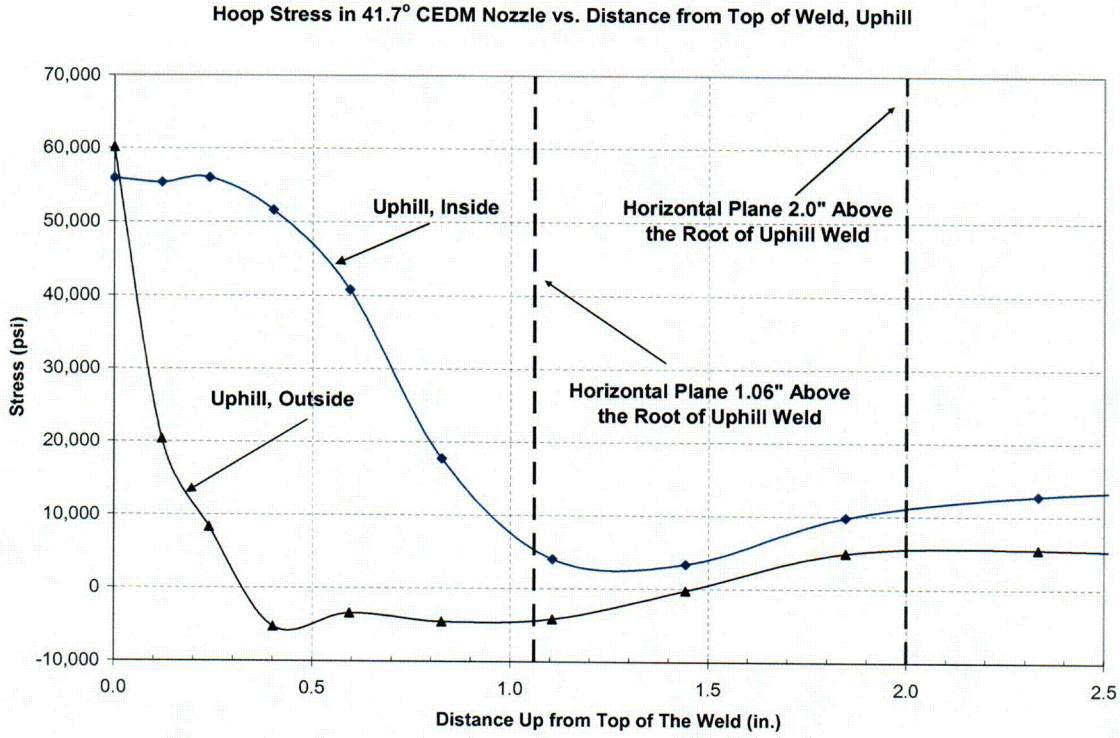
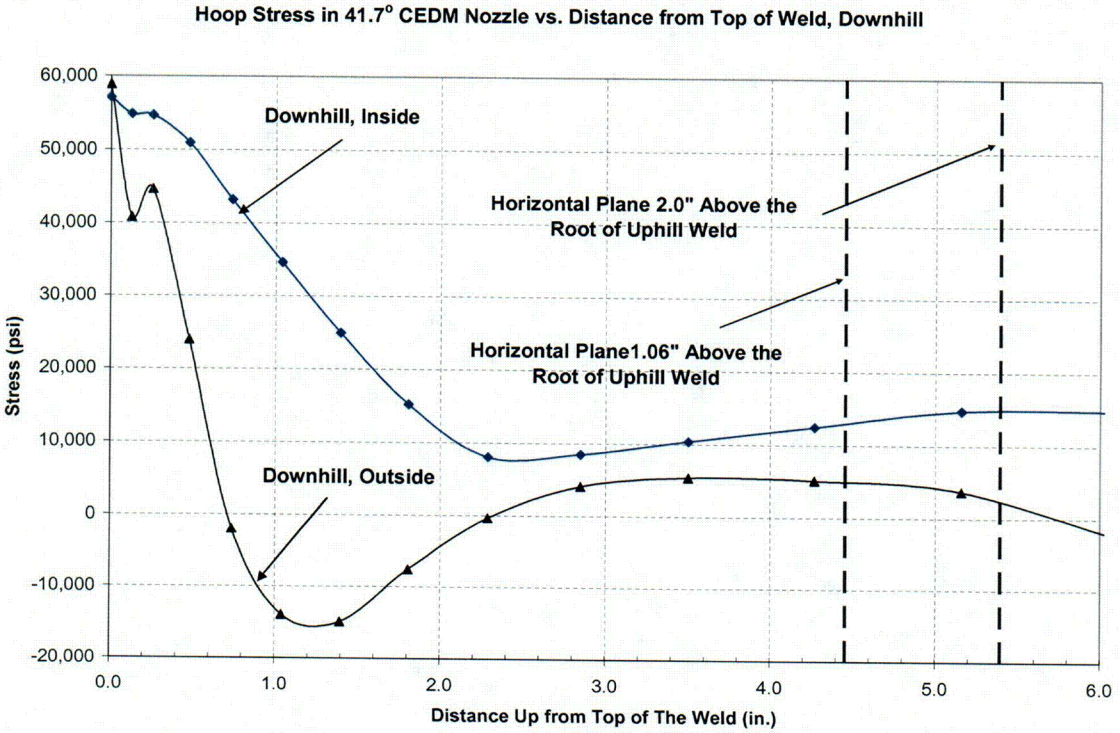
With respect to the missed inspection coverage for 41.7 Deg CEDM nozzles (Figures 6 and 7) from 1.06" up to 2.0" above the root of the uphill side J-groove weld for 360 Deg around, a review of the hoop stress distribution in this larger area indicated that the hoop stress distribution used previously to determine the crack growth curve for missed inspection coverage from 1.25" to 2.0" above the root of the J-groove weld remains applicable and therefore the resulting crack growth curve is still applicable to this larger area.

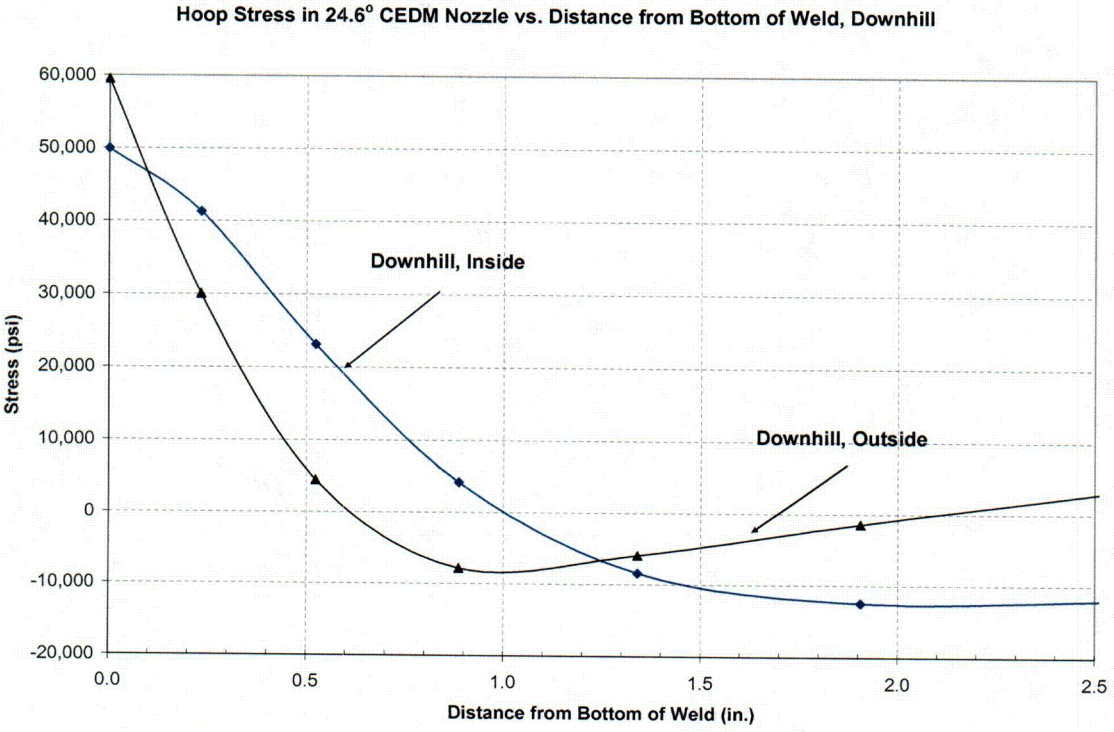
Figure 13

Figures 11-19 show the hoop stress distributions for the regions that are below the toe of the J-groove weld for the Fort Calhoun reactor vessel upper head penetrations. The stress distributions shown are for the inside and outside surface of the reactor vessel upper head penetrations. The stress distributions shown in Figures 11-19 are typical of those observed in the upper head penetration nozzles for other nuclear power plants. The stresses are highest in the vicinity of the J-groove weld and decrease rapidly as the distance below the toe of the J-groove weld increases. Based on Figures 11-19, the hoop stress for all the penetration nozzles is less than 20 ksi at a distance of 1 inch or more below the toe of the downhill side J-groove weld. Therefore, the inspection requirements given in NRC Order EA-03-009 is met provided inspection coverage of at least 1 inch below the toe of the J-groove weld can be achieved.

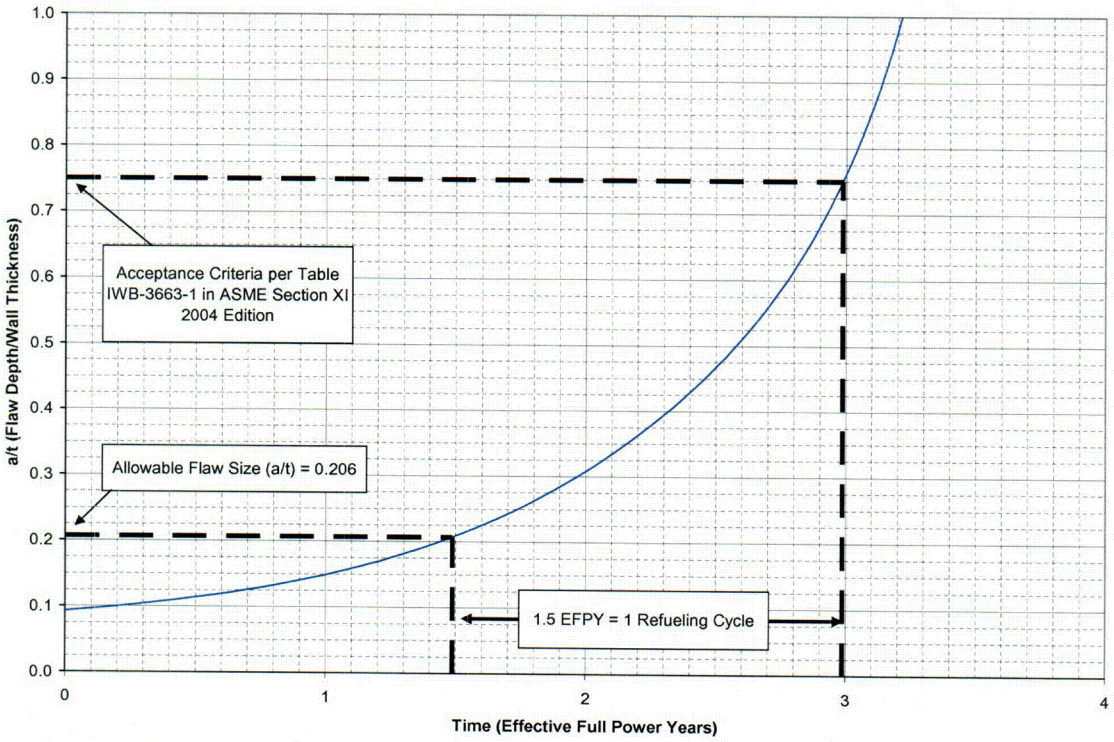
Figure 20

PWSCC crack growth calculation is performed assuming that a portion of the region (2" above the weld to 1" below the weld) on the uphill side of the CEDM nozzles cannot be inspected. The purpose of the calculation is to determine the maximum flaw size for an inside axial surface flaw that would grow to 75% of the wall thickness in one fuel cycle (18 months). The methodology used in the crack growth calculation is the same as that described in Section 3.0, except that the highest hoop stress distribution on the uphill side of the CEDM nozzle is used in the evaluation. Assuming an aspect ratio of 10, the crack growth result for the uphill side of CEDM nozzle angles of 24.6°, 37.3° and 41.7° are shown in Figure 20. Based on the result shown in Figure 20, for an inside axial surface flaw, a minimum initial flaw depth of 0.08 inch (21% part-through wall) is required to reach 75% of the wall thickness in one fuel cycle.

PWSCC Axial Inside Surface Crack Growth Prediction for 24.6°, 37.3° and 41.7° Uphill Side CEDM (Based on Highest Stress Distribution Above, At and Below the Weld)
