your energy partner
OPPD
Omaha Public Power District

May 17, 2005
LIC-05-0062

**SUBJECT: Fort Calhoun Station Unit No. 1, Response to Request for Additional Information on the Revised Relaxation Request for First Revised Order (EA-03-009) Establishing Interim Inspection Requirements for Reactor Pressure Vessel Heads at Pressurized Water Reactors**

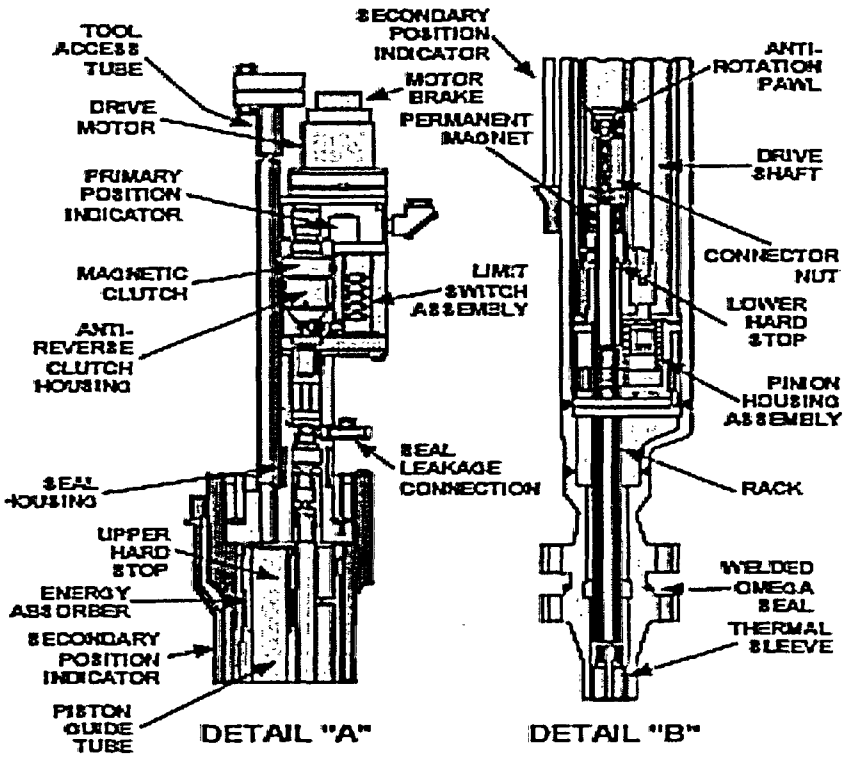
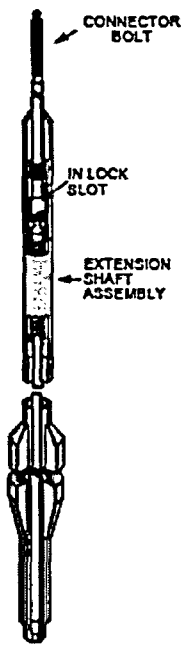
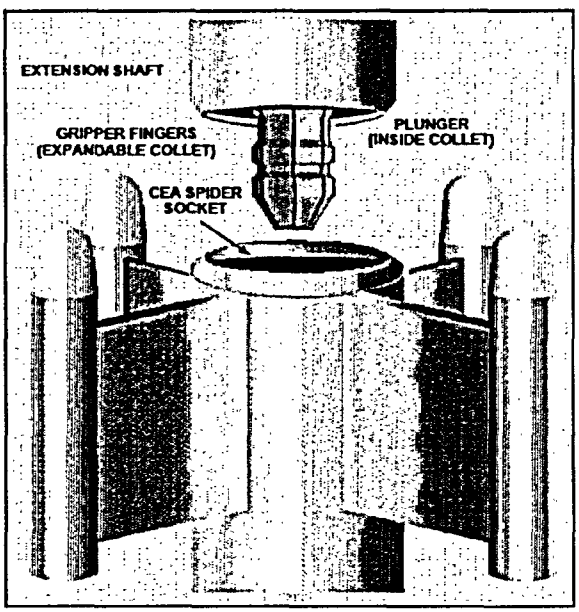
The basic component arrangement of the system is shown in Detail "A" (upper components) and Detail "B" (lower components). The components of interest in this discussion are as follows:

- Extension shaft assembly – supports the CEA spider
- Connector bolt – supports the extension shaft assembly
- Connector nut – supports the connector bolt
- Rack raises and lowers the rack extension to raise the CEA

The CEDM extension shaft assembly is inserted through the CEDM nozzle from underneath the RPV head and extends through the rack into the piston guide tube.

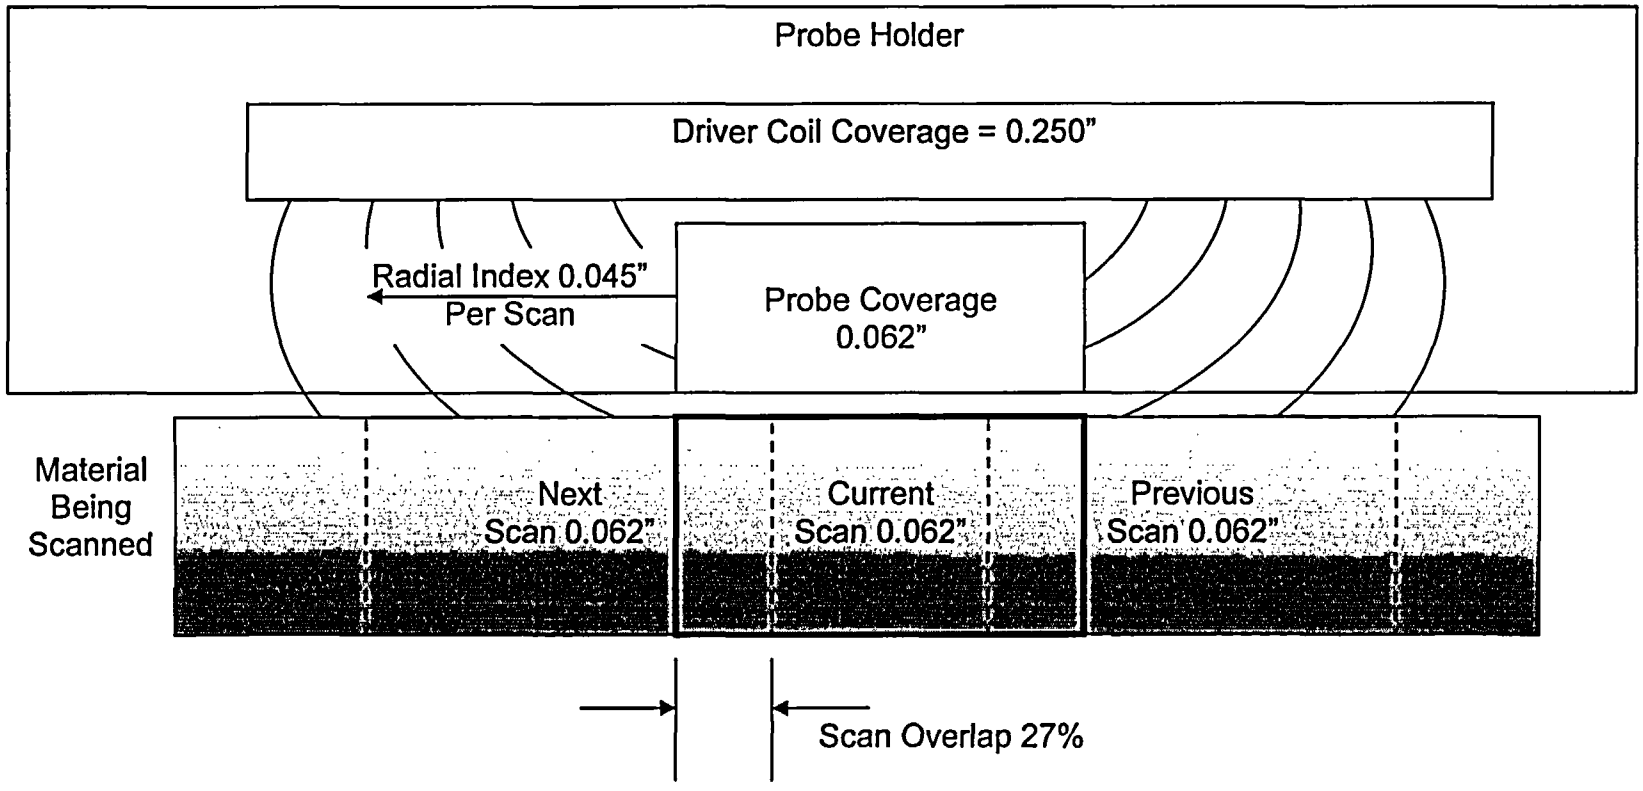
**Attachment 1, Figure 1**

Various CEDM nozzles have single missing scan line information in some areas. OPPD has determined in each case that a single missing scan line does not prevent determination of a potential significant flaw, due to the amount of overlap of adjacent scan line coverage in adjacent eddy current traces. These areas are considered to be fully inspected.

The geometry of the probe and driver coil in combination with size of the scanning grid and the defined overlap ensures that any indication, regardless of width or length, will be observed. Adjacent scan lines have an overlap of 27% as shown on Figure 1. This criterion is based on the number and location of sensors in the probe and the overlapping regions of sensitivity resulting from the scan line increment assuring that a valid indication of relevant length should be evident. An indication picked up in one scan line will also be seen by the adjacent scan lines. A missing scan line is most likely caused by small boric acid on deposits or crud accumulation on the nozzle or thermal sleeve surface which causes axial travel resistance on the probe.

Scan Coverage Geometry
