Subject: Braidwood Station, Unit 2, 60-Day Response to First Revised NRC Order EA-03-009, "Issuance of First Revised NRC Order (EA-03-009) Establishing Interim Inspection Requirements for Reactor Pressure Vessel Heads at Pressurized Water Reactors"

"Braidwood Unit 2 – A2R11
Reactor Vessel Head Penetration Examination
April 2005"

Final NDE Report

WDI-PJF-1303058-FSR-001

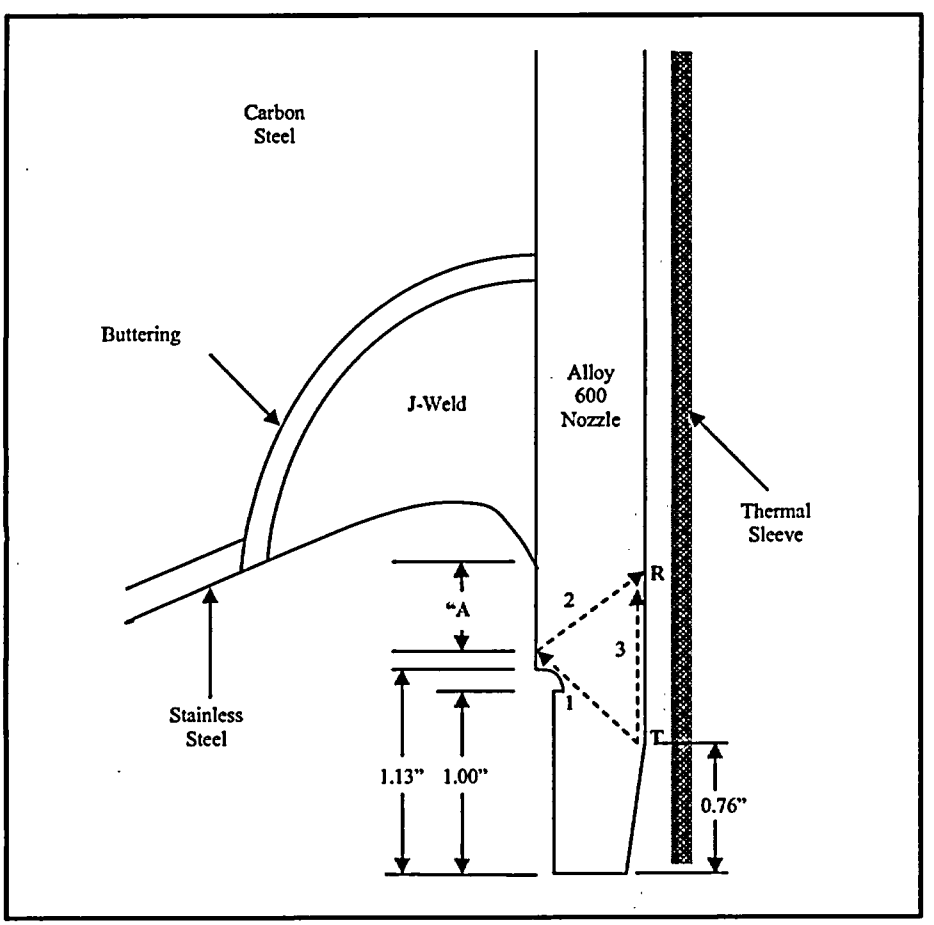
Figure 4-1: Illustration of Axially Oriented TOFD Examination Coverage on Braidwood Unit 2 Penetration Geometry at 0° (Downhill Side)

The configuration of a sleeved Braidwood CRDM penetration tube is illustrated in Figure 4-1. This figure represents the tube-to-head geometry at the penetration 0° azimuth, or "downhill" side of the tube. The bottom ends of all penetration tubes are threaded on the OD surface and have a chamfer on the ID surface. The threads extend from the bottom of the tube to an elevation of approximately 1.00" where a thread relief is machined. The top of the thread relief is 1.13" above the bottom of the tube. The distance from the top of the thread relief to the bottom of the fillet of the J-groove weld, identified as "A", varies based on location of the penetration in the head. These distances are generally longer for penetrations at "inboard" locations and become progressively shorter for penetrations located further away from the center of the head. The ID surface chamfers are machined at a 20^0 angle from the bottom of the tube to an elevation of 0.76".
